Re: Heavenly Mountain Resort 2017 through 2021 Environmental Monitoring Program Five Year Comprehensive Report

Date: January 18, 2022

Facility Name: Heavenly Mountain Resort

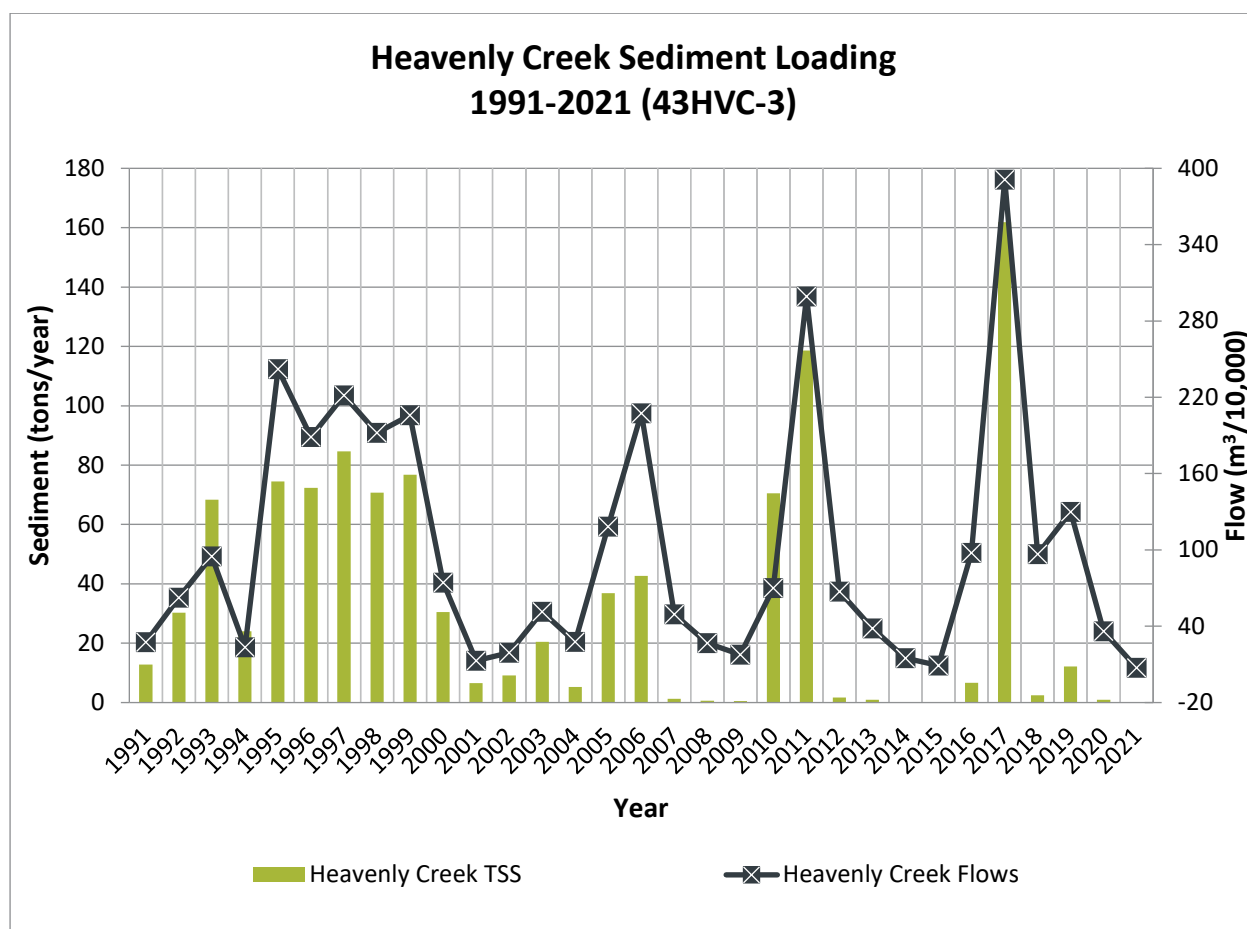
Figure 3-3 Heavenly Creek Sediment Loading at the Property Line Monitoring Site (43HVC-3) from 1991 to 2021

Figure 3-3 illustrates sediment loading at the Property Line monitoring site (43HVC-3) for WYs 1991 through 2021. Again, superimposed on the sediment load is the total calculated flow per year in cubic meters (divided by 10,000) at the Property Line monitoring site. When the whole period of record is considered, the 2011 and 2017 spikes in sediment loading are associated with high streamflows in wet years. In addition, streamflow data from 2007 through 2009 and 2012 to 2015 compare to the drought conditions in 2020 and 2021. During drought conditions, decreased streamflow, depth, and velocity provide minimal sediment loading. Extreme wet years and increased streamflow tend to increase sediment loading; however, average to slightly above-average WYs, such as 2016, 2018, and 2019, only have a slight increase in TSS. Compared to the 1993 and 2005 streamflow data, which are the closest comparisons to the 2016, 2018, and 2019 streamflow values, TSS (tons/year) is considerably lower. Moderate- to average-precipitation WYs and their associated streamflow have increased TSS loading, but this is not nearly as prevalent and high as the 1990s and early 2000s total TSS loading. The minimal increase in sediment loading for an average precipitation year may be attributed to prescribed on-mountain treatment and BMP improvement/maintenance limiting and preventing sediment from entering the streams.

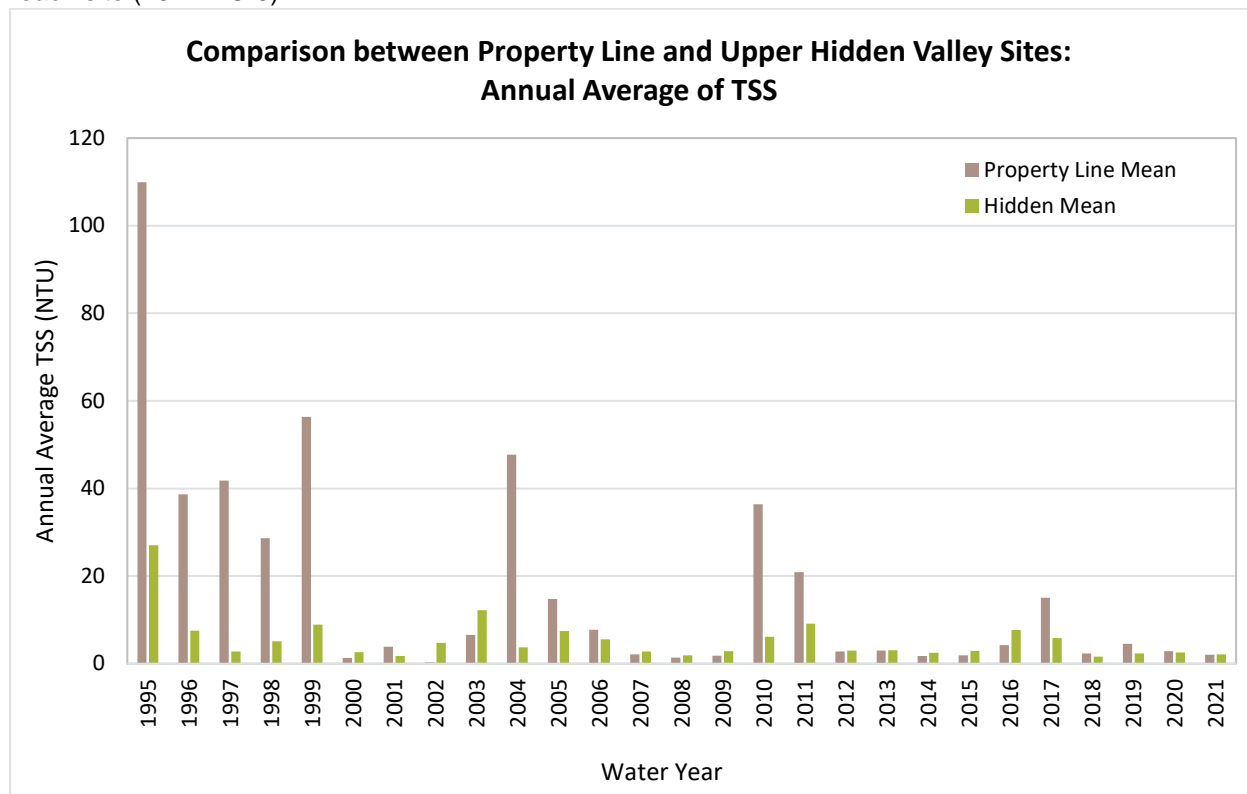
Figure 3-4 Comparison of Annual Averages of TSS between the Property Line Monitoring Site and Reference Reach Site

enough data to show any trends; therefore, only data since 2012 are shown here. This data comparison shows that annual averages of TSS, total phosphorus, total nitrogen, and turbidity at the Property Line monitoring site (43HVC-3) have approximately returned to baseline conditions. Annual averages of chloride at the Property Line monitoring site (43HVC-3) remain problematic, compared to the reference reach site (43HDVC-5).

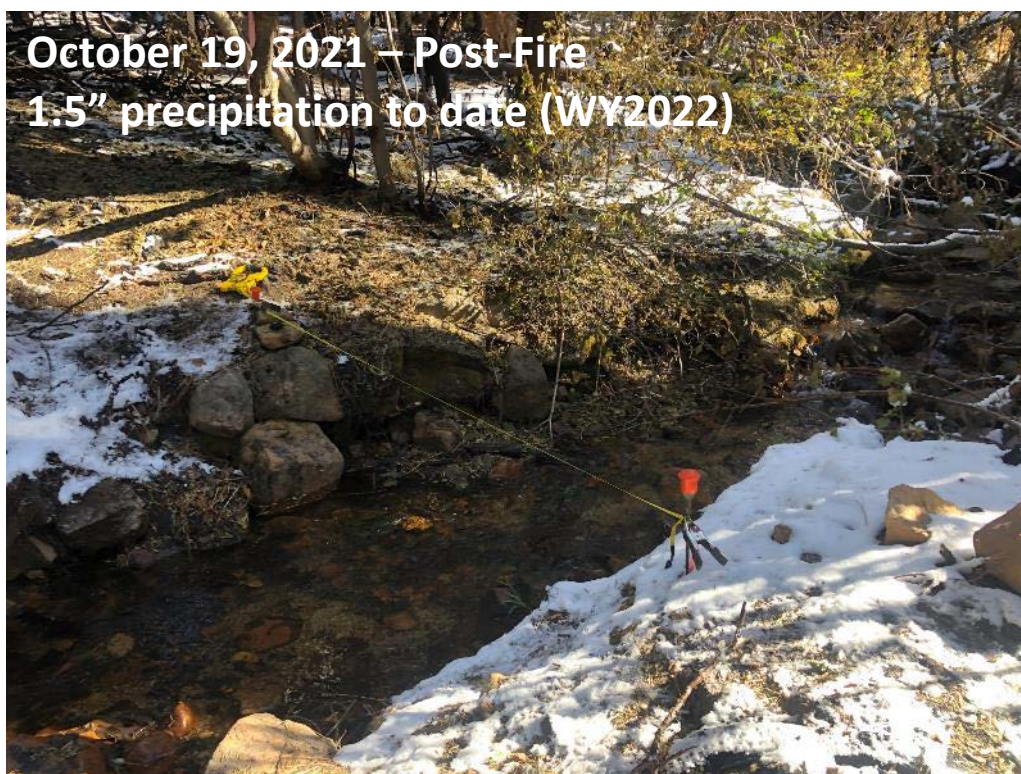
Figure 3-12 Hidden Valley Creek Reference Reach Site (43HDVC-5) in October 2021 (Post-Fire), Looking Upstream from Left Bank

As Heavenly Valley Creek and the monitoring sites/reaches did not burn, the current conditions at the reference reach are no longer representative of an unimpaired reach for comparison. However, no other more appropriate reaches are present in the nearby vicinity. Close monitoring during the next 5-year period is recommended, and reconsideration of the site for continued use as a reference reach should be weighed, based on the site's recovery to pre-fire conditions, availability of an alternative reference reach, and implications of changing the reference reach for a project that has a long-term data set (more than 30 years). During the next 5-year period, determinations of "background" values for comparison to project values should be made based on previous correlations between streamflow and chemical characteristics at Hidden Valley Creek from past (pre-fire) monitoring.

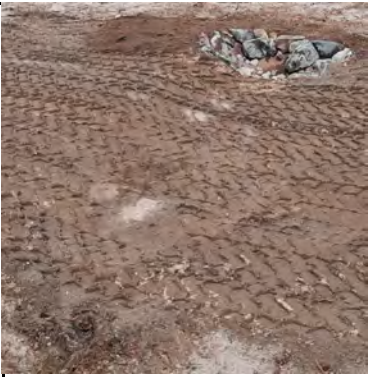
All Mountain	10/1/2021	Mountain roadways used by employees and vendors inspected and in good condition.	Ongoing maintenance taking place, including addition of road base, maintaining water bars. Data provided to USFS as part of annual roads report.

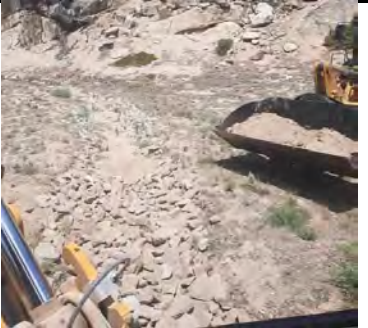
All Mountain	10/1/2021	Rope lines in place along roadways to prevent unauthorized "off road" driving. Triple rope lines used in Draba areas on Upper Mountain.	Ropes to be removed prior to first snow for winter season.	
Maggie's & Hellwinkles	10/1/2021	Sediment basins and energy dissipaters are in good condition, maintained and cleaned out post storm events	Sediment basins have adequate capacity and are ready for winter	
Creek Area & Groove	10/1/2021	Rock Lined channels are in good shape. Rock Lined ditch at Groove chair has plenty of remaining sediment holding capacity.	Routine maintenance was done on the rock lined ditch around the base terminal of Groove chair.

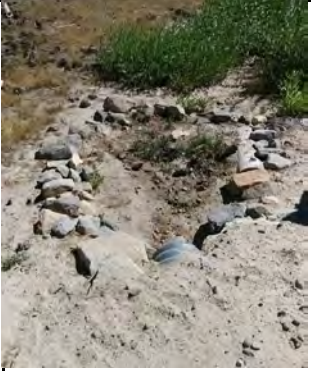
Cal Base Parking Lot	9/20/2021	French drain in driveway not functional due to build up of sediment in trench	Crews cleaned out and removes sediment. Functional and ready for winter.

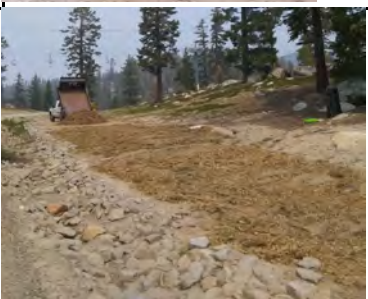
All Mountain	10/1/2021	Gullies and rills on slopes and roadways ok. After any major rain events our Trails Maintenance Crews and Heavy Equipment Operators address any problems right away.	Middle Section of Groove Trail identified as a Hot Spot due to riling. Crew performed a "rip and chip" treatment, seeded and irrigated.

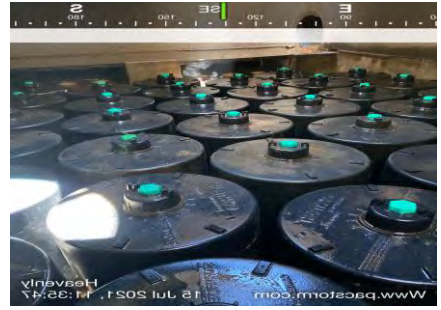
Partial maintenance

No filter replaced

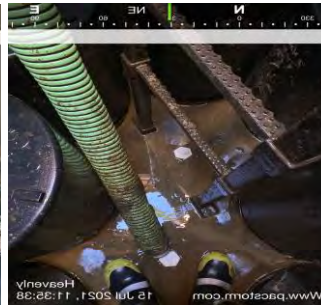
Partial maintenance

No filters replaced
