Heavenly Mountain Resort

Mitigation and Monitoring Plan
Annual Report (October 2020 –
September 2021)

Prepared for
Tahoe Regional Planning Agency

May 2, 2022

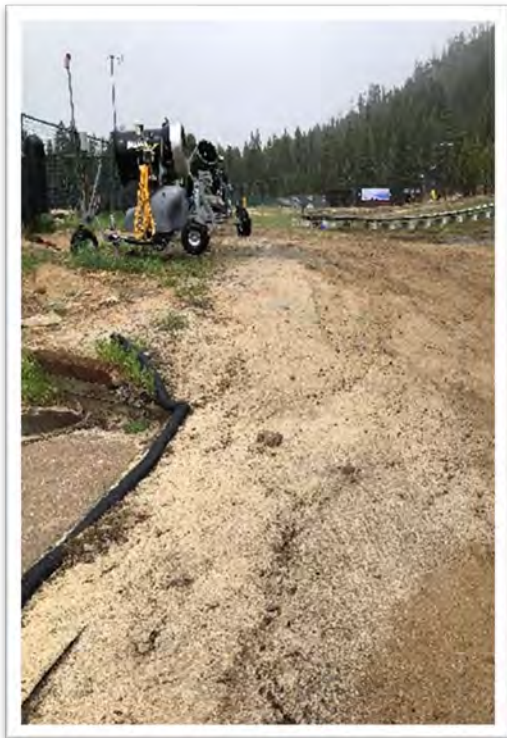
Before: Loose soils and woodchip mulch adjacent to patio pavement behind Lodge.

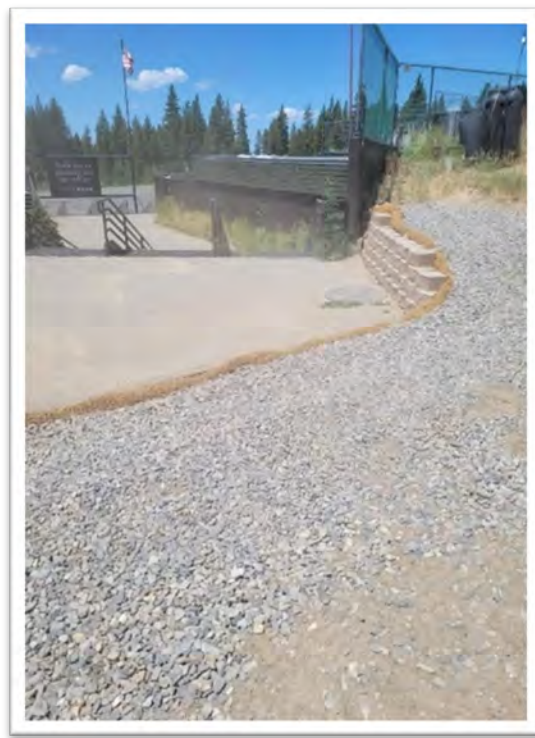
On the east side of the California Base Lodge, in the Bijou Creek watershed, two areas were identified for this 2021 WMRP project where erosion resistance could be improved by constructing drain rock "buffers". These "buffers" slow runoff and enhance infiltration, thereby reducing potential for sediment and woodchips to be conveyed into paved areas, which runoff to the storm drain systems connecting to Bijou Creek. A 6-foot-wide buffer of 1.5-inch drain rock, lined with filter fabric, was constructed for approximately 300 feet between the summer access road and the paved patios behind the lodge. Another 6-foot buffer of 3-to-8-inch diameter rock, lined with filter fabric, was built at the summer maintenance road entrance to the parking lot. Larger rock was used to withstand the occasional vehicle traffic.

After: Drain rock buffer installed behind the Lodge between access and patio.

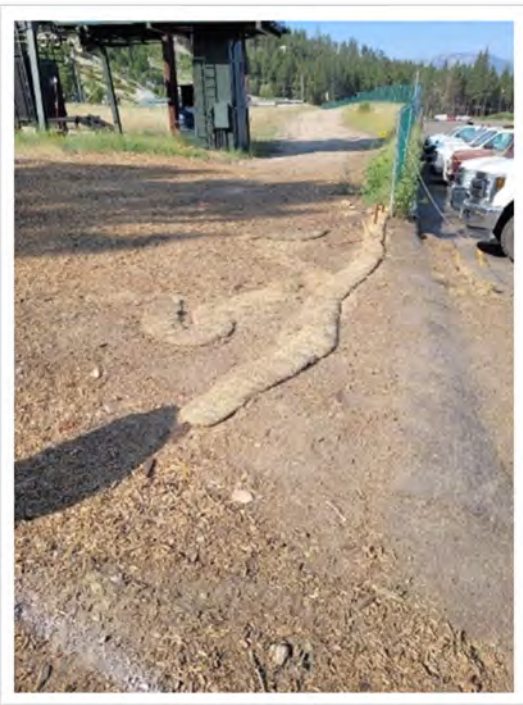
Before: Loose soils and woodchips.

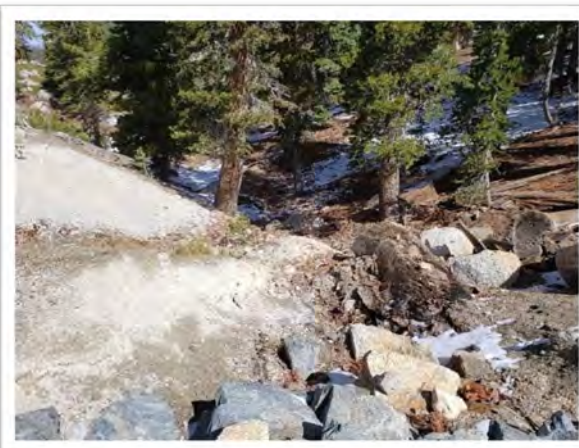
2020 Before Repairs

To reduce the potential for erosion and sediment transport, a steep gully was identified as a 2020 hot spot location at Ridge Bowl. Treatment included embedding rip rap to armor the existing drop. At the base of the drop, pine needles and woodchips were hand-tilled into the soil to increase infiltration, then riprap was placed on top of the conditioned soil.

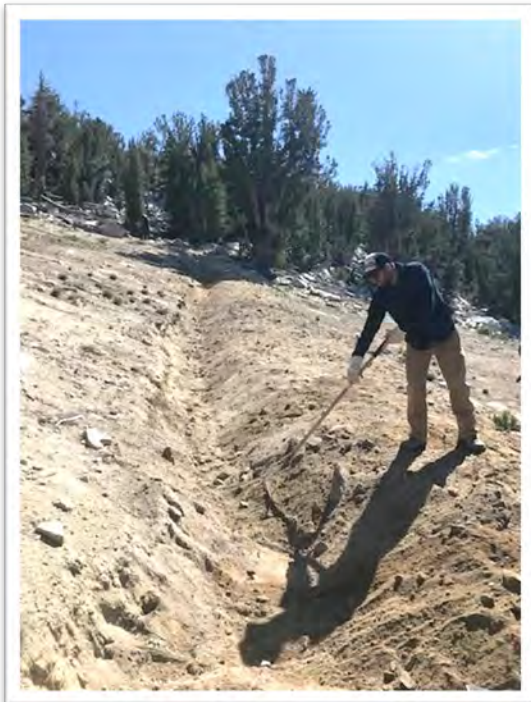
2020 Repairs

The Big Dipper Run WMRP project in 2020 involved repairing waterbars and outlets that had overtopped and failed, causing rilling on the ski slope between waterbars. In 2020, sediment that accumulated in the waterbars was removed to reestablish depth and grade. Wood chips were also incorporated into the swales created by the waterbars to improve infiltration and sediment capture.

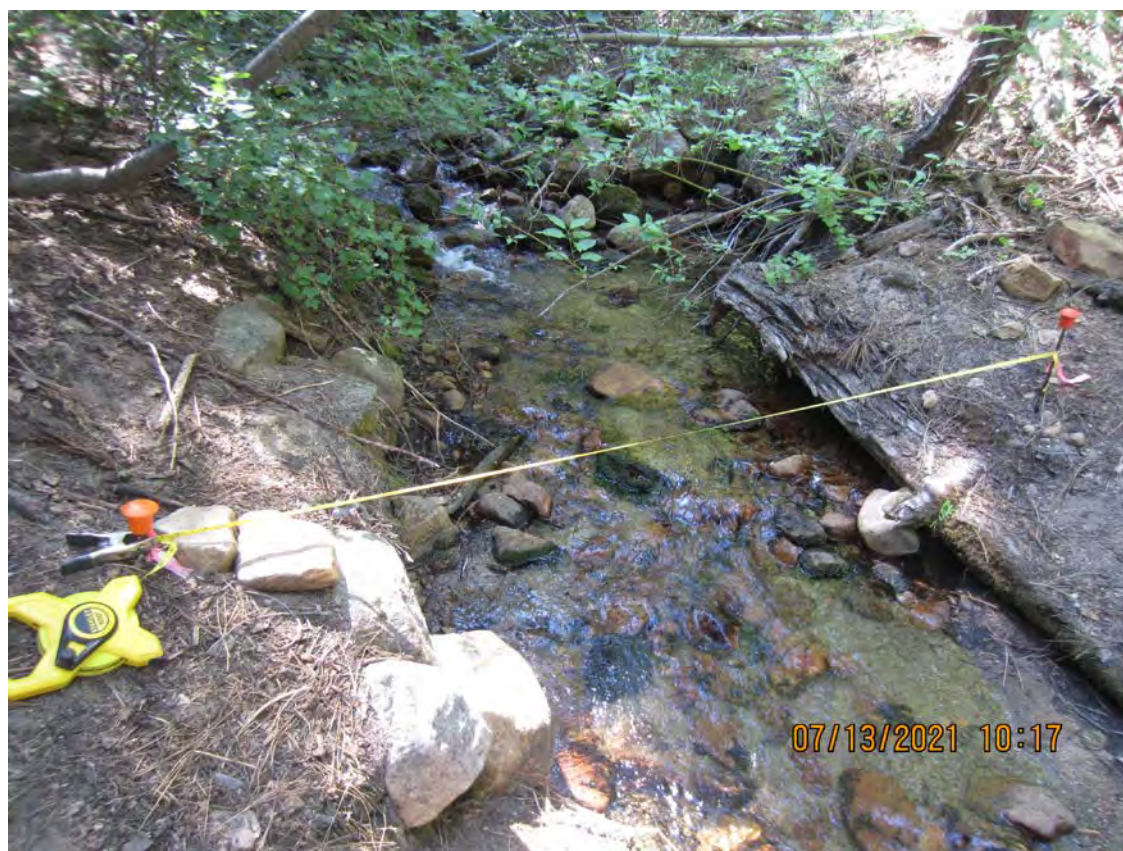
Figure 3-10 Hidden Valley Creek Reference Reach Site (43HDVC-5) in July 2021 (Pre-Fire), Looking Upstream from Right Bank

As Heavenly Valley Creek and the monitoring sites/reaches did not burn, the current conditions at the reference reach are no longer representative of an unimpaired reach for comparison. However, no other more appropriate reaches are present in the nearby vicinity. Close monitoring during the next 5-year period is recommended, and reconsideration of the site for continued use as a reference reach should be weighed, based on the site's recovery to pre-fire conditions, availability of an alternative reference reach, and implications of changing the reference reach for a project that has a long-term data set (more than 30 years). During the next 5-year period, determinations of "background" values for comparison to project values should be made based on previous correlations between streamflow and chemical characteristics at Hidden Valley Creek from past (pre-fire) monitoring.

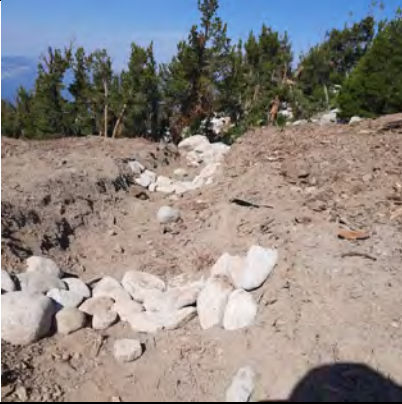
Upper Ridge Run	10/1/2021	Minor overtopping of sediment basins along the roadway at the receiving area of the Cal Dam Sediment Removal Project.	Addition of water bar with check dams and increased capacity of basins.

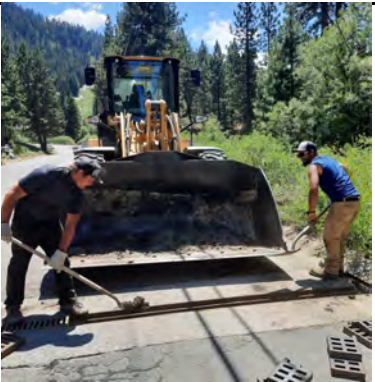
Cal Base Parking Lot	9/20/2021	French drain in driveway not functional due to build up of sediment in trench	Crews cleaned out and removes sediment. Functional and ready for winter.

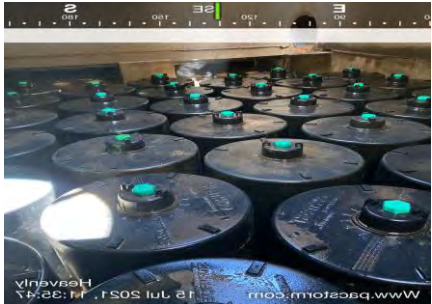
Partial maintenance

No filter replaced

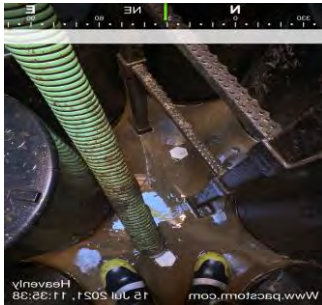
Partial maintenance

No filters replaced
