Heavenly Mountain Resort

Mitigation and Monitoring Plan Annual Report (October 2014 – September 2015)

Prepared for Tahoe Regional Planning Agency

May 2, 2016 (Revised August 2016)

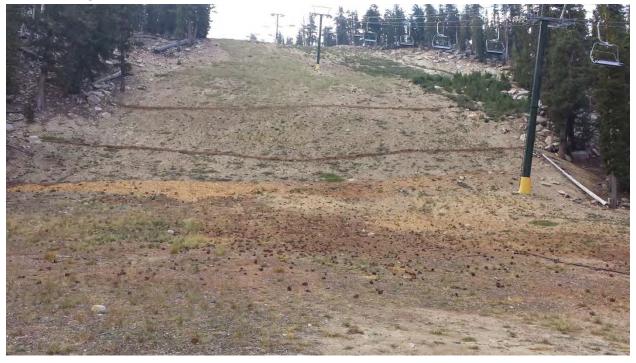
Double Down Lower after Full Restoration Treatment. 2 full run width Pine Needle Filter Berms above Infitration/Vegetated Swale.

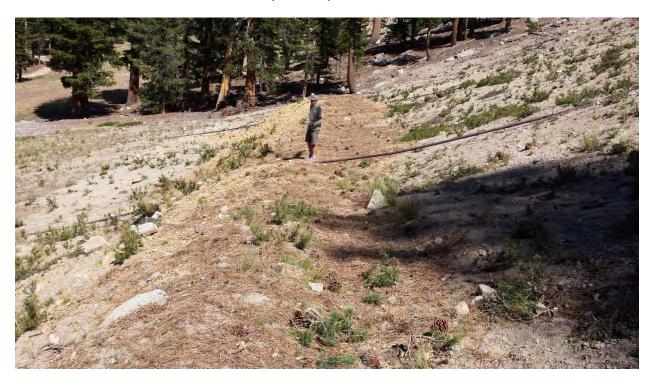
Double Down Lower Infiltration Swale Completed September 2^{nd} . 2015

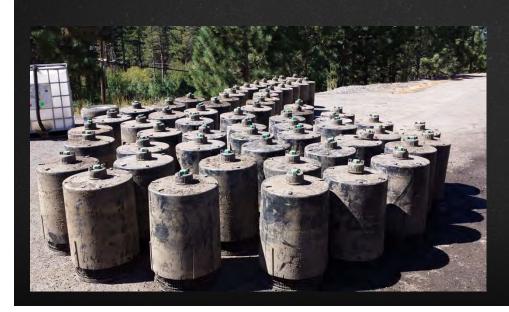
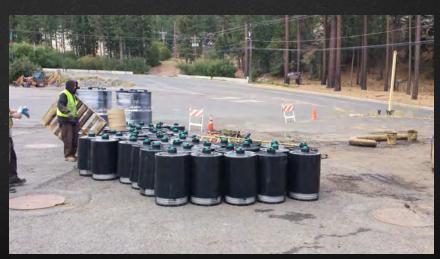
CML Storm Filters

Over 200 filters replaced in 2014

Full cartridge replacement of all 456 filter since installation in 2008, completed in 2014

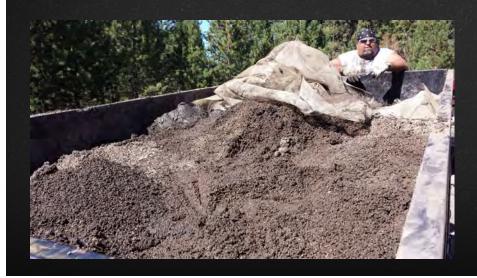
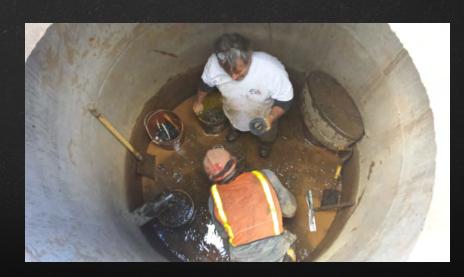
CML Storm Filters continued

Dozens of cubic yards of spend filter media and sediment removed in 2014

Sacrificial filters before being replaced with 14 new phosphorus filter media, which is showing positive improvements in WQ

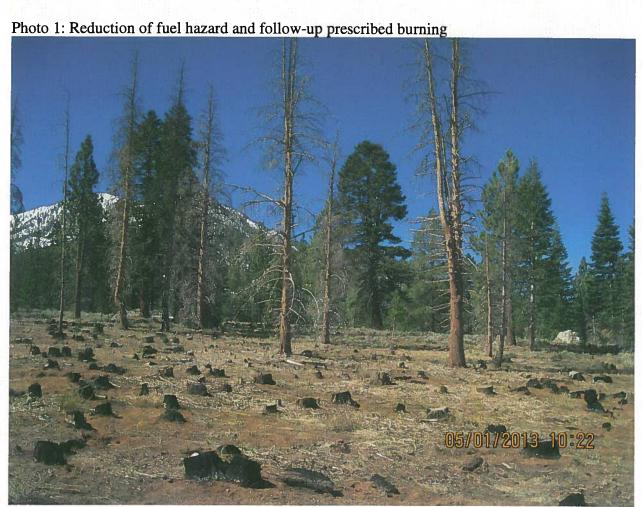
The result of the site visit to monitor the completion of these objectives proved satisfactory. The high levels of lodgepole mortality (from Mountain Pine Beetle) were cut, piled and burned, reducing the risk of stand replacing fire. The understory in the older portions of the stand was thinned to levels that would effectively improve resiliency for the long-term. There was evidence of adequate stocking of naturally regenerating seedlings throughout the treated area of the stand.

Photo 2: Natural regeneration occurring within the stand.
