Mitigation and Monitoring Plan Annual
Report (October 2014 – September 2015)

Heavenly Mountain Resort BMP Effectiveness Monitoring

2015 Annual Report & Construction Season Summary

April 27, 2016

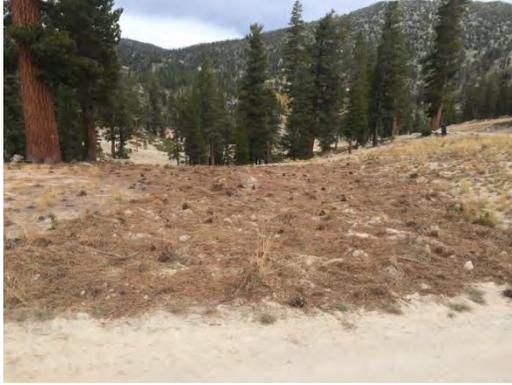
<p>Full Hogan treatment to infiltrate road drainage above Blue Angel Chute - 2015</p>

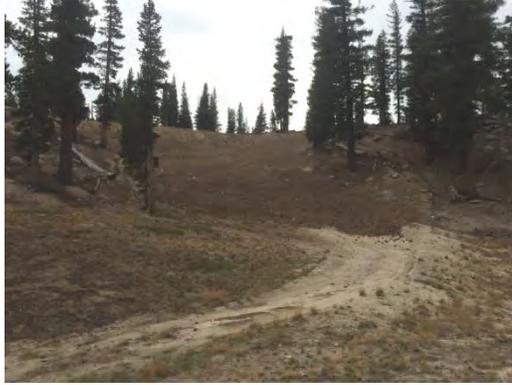
<p>Thick surface mulch added to slope; accumulated sediment removed at bottom of slope. 2015</p>

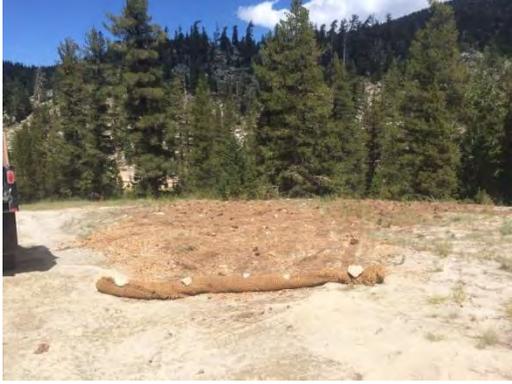
<p>Before - eroding water bar</p>

<p>After - Water bar to infiltration swale conversion complete</p>
<p>15</p>

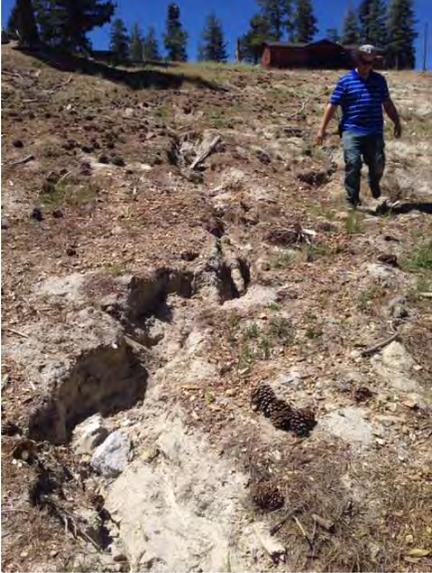
<p>Gully formed in spring 2015.</p>

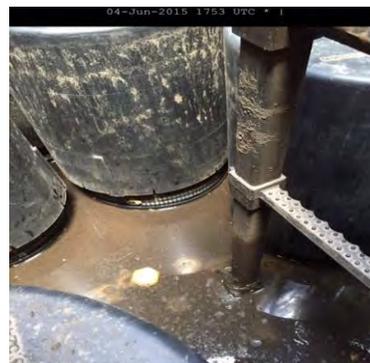
less than .5" sediment. Media loose and unimpacted.

Maintenance not recommended

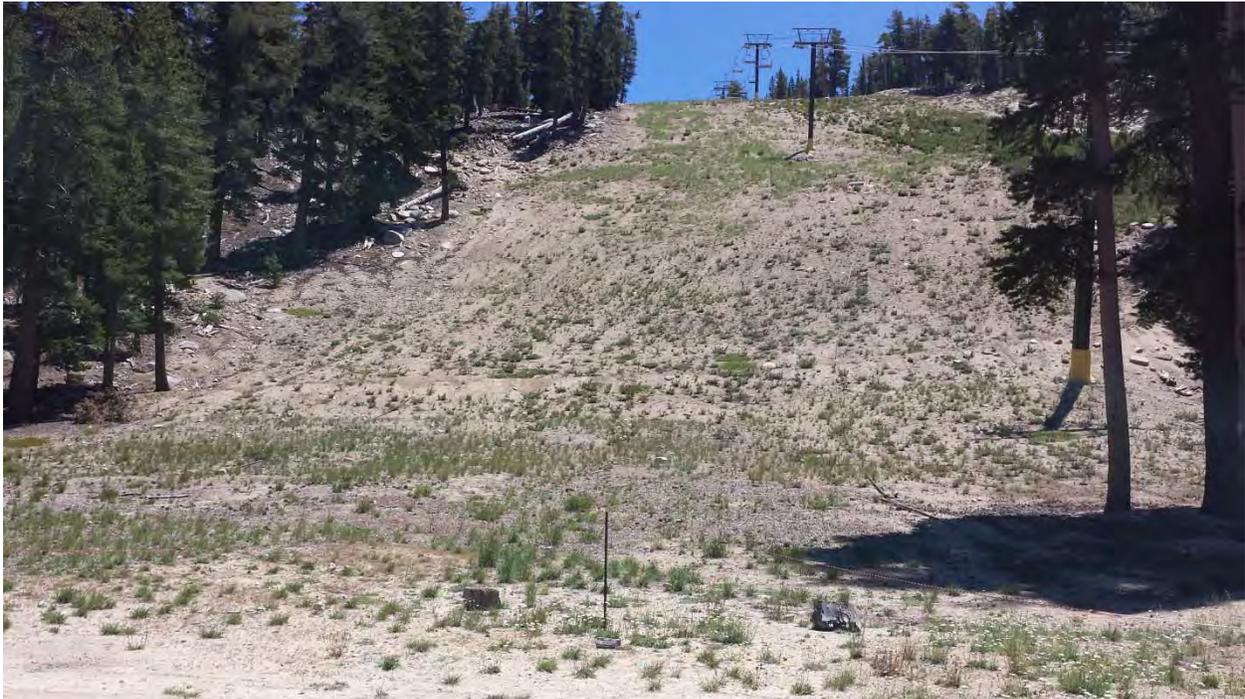
Double Down Lower Run before Treatment 7-29-15:
