Heavenly Mountain Resort

Mitigation and Monitoring Plan
Annual Report (October 2016 –
September 2017)

Prepared for
Tahoe Regional Planning Agency

May 1, 2018

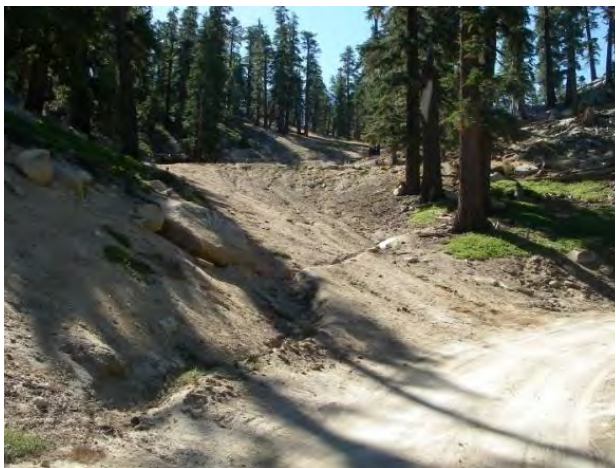
Hand Grenade Chute Before: bare soils, rilling, water bar minimally functioning

The goal for the restoration treatment was to install rock armor on the gully, restore the water bar above the switch back to function properly, “rip and chip” the steep ski slope and install a new culvert at the road crossing. The restoration treatment included 21 cubic yards of pine needle mulch, 18 cubic yards of wood chips, 22 tons of riprap and 20 pounds of Heavenly seed mix. A hydroseeder was used to apply mulch and seed to the slope. A row of pine needle wattles was installed at the toe of the slope. The “rip and chip” method involves tilling and loosening the soil to provide depressions for water to collect (“rip”) and mulch application provides organic matter to support microorganism growth in the existing soils (“chip”).

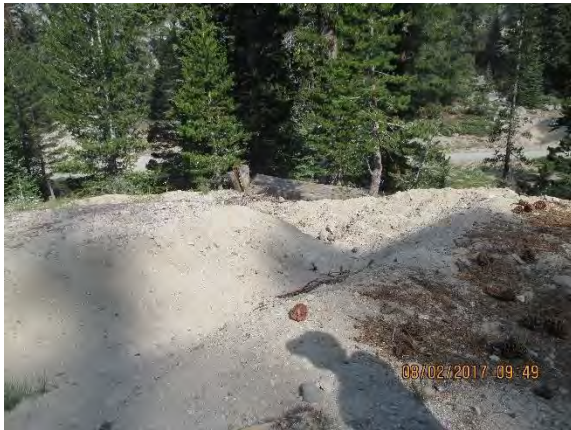
Maggie's Run Before: bare soils, waterbar not functioning properly

In 2017, additional efforts were made to convert an existing water bar into an infiltration spreading area and reconnect a culvert to pass runoff. The lower portion of the run was mulched with 75 cubic yards of pine needles to further slow and infiltrate runoff. In addition, the water bars on the road shoulder were refurbished with wood chips. The wood chips were incorporated into the soil after it was loosened and waterbars were reshaped to reduce flow concentration. The goal was to transform the water bars, which were originally designed to concentrate runoff. The photos on the following page show Heavenly’s thorough effort to improve erosion resistance on these high priority erosion hot spots.

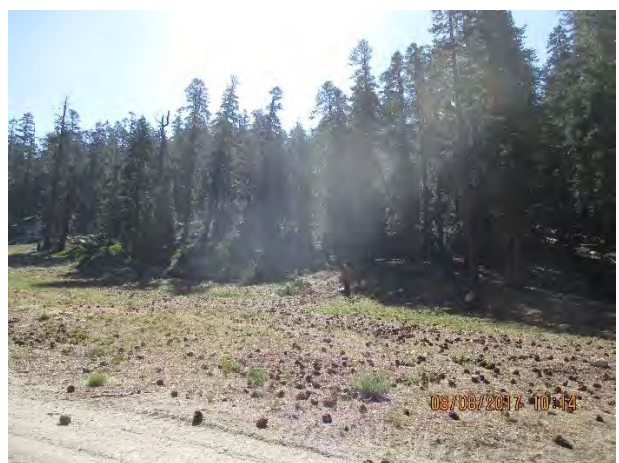
Before: Existing vegetation requiring irrigation with little erosion resistance.

After: Mulch application and re-grading of water bars into infiltration spreading areas to increase erosion resistance.

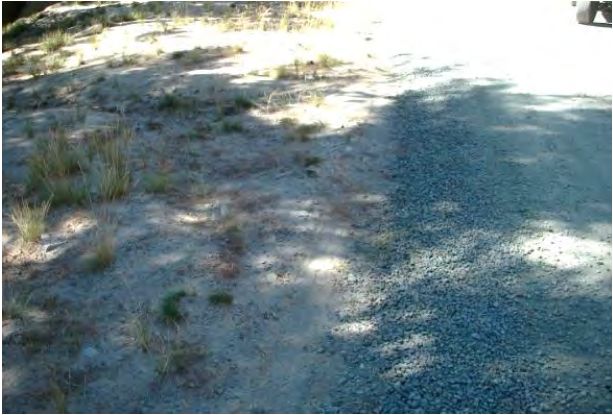
Hot Spot 4

Before: Small gully connecting road runoff to creek.

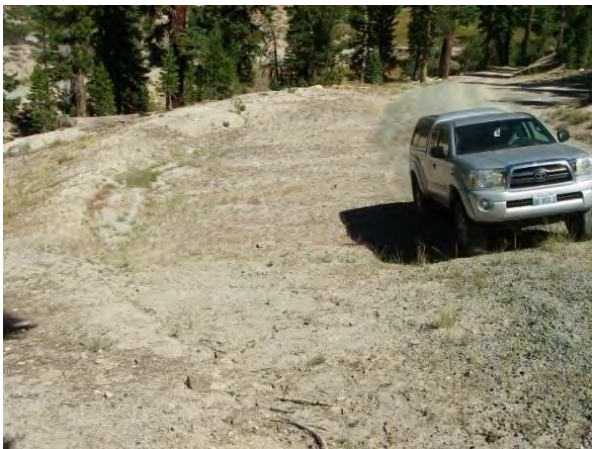
Hot Spot 5

Before: Water bar creating quasi-basin off Maggie's, which overtops to down drain direct to creek when full.

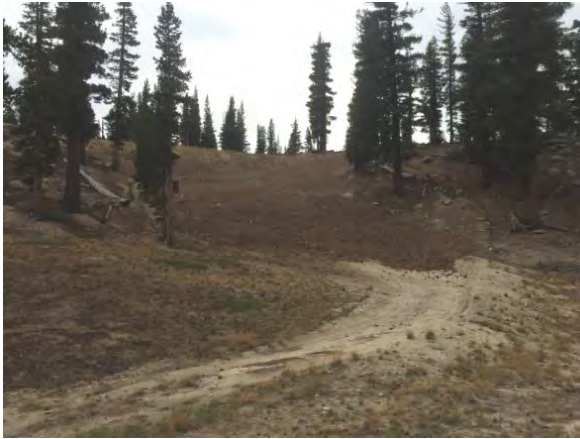
Hot Spot 6

Before: Sediment plume and incising waterbars downslope of road, all caused by concentrated road runoff.

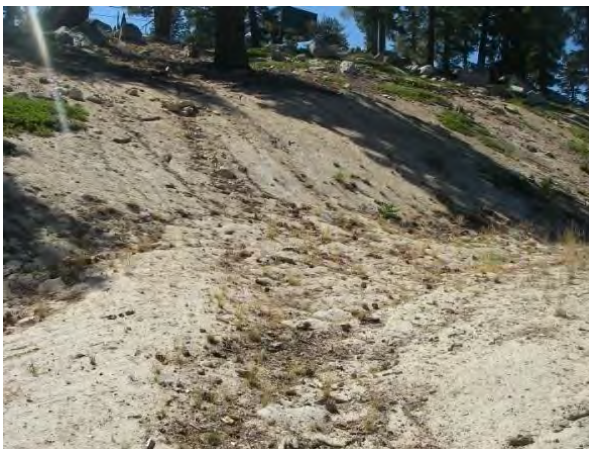
Hot Spot 9

Before: Large plume of deposited sediment and eroding slope above (just downslope of 277 sidehill).

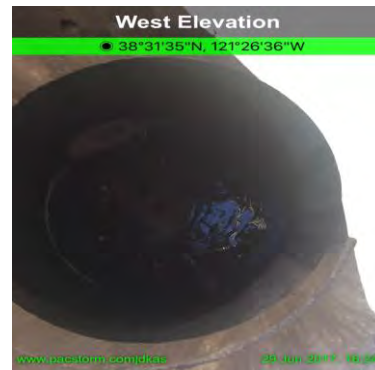
Unit #3 - 7 Phosphorous Cart MH

Cartridges submerged

Maintenance recommended due to high water level

Notes: Unit #3 maintenance recommended due sacrificial filters submerged.

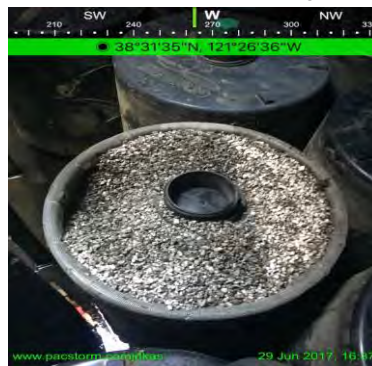
Unit #4 - 114 ZPG Cart MH

Maintenance recommended

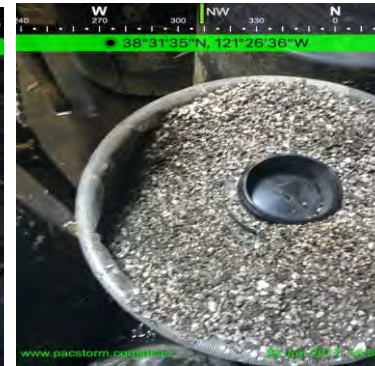
impacted media

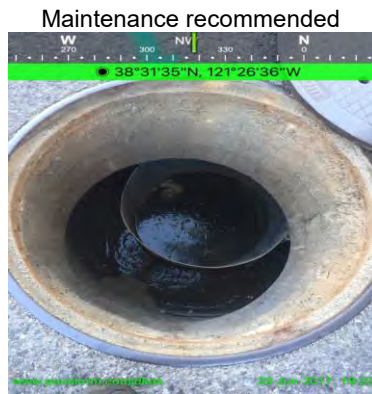
CDS Hydrodynamic Separator

Maintenance recommended

Notes: Unit #9 requires maintenance due to submerged filter cartridges. CDS Unit has large amount of organic debris and fine sediment. Maintenance recommended.

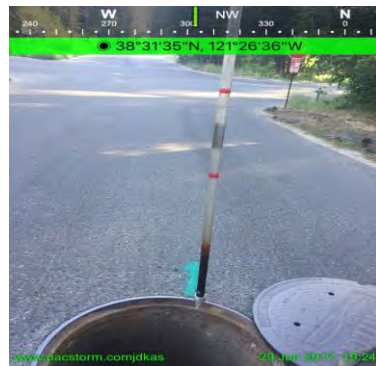
Sediment in sump is 13\".

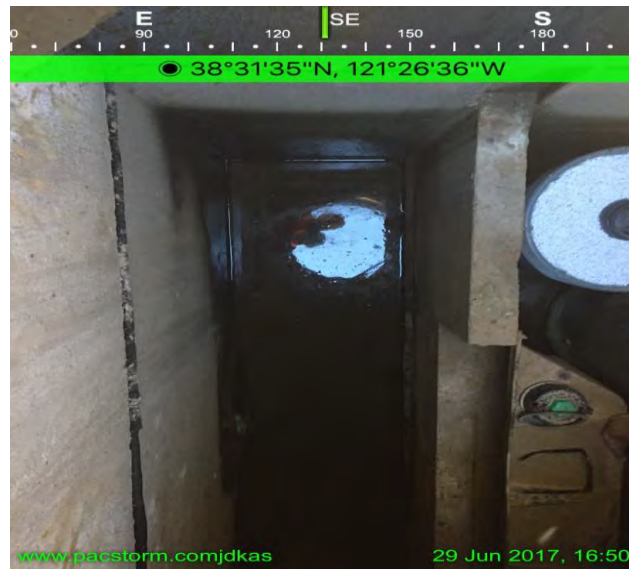
Outlet bay clean and clear of sediment. Repairs to outlet bay
holding well. No maintenance recommended.

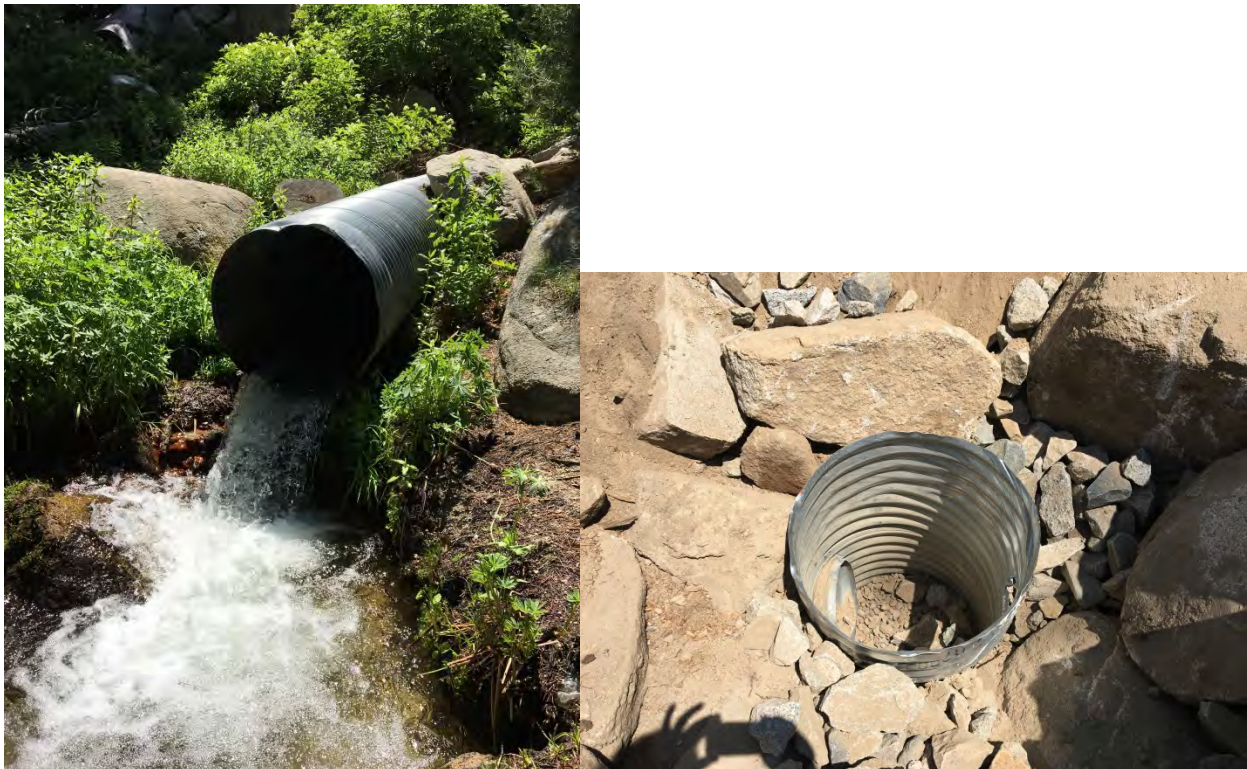
Lower Cal Trail 36" culvert & all other HVC culverts inspected 7-20-17/Culvert connection Sky Road

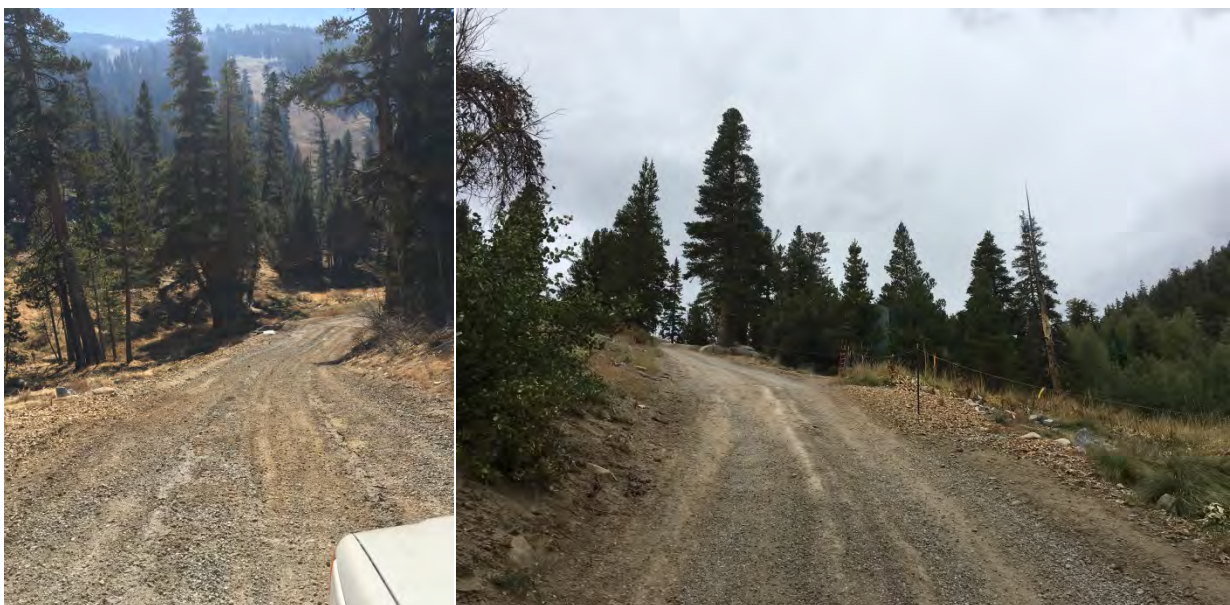
Hellwinkel's Road soil binder and maintained in early July & Oct. 2017. Signs were in place at top and bottom for 5 MPH, and 4WD Low Required. This has kept speeds down, and improved road condition

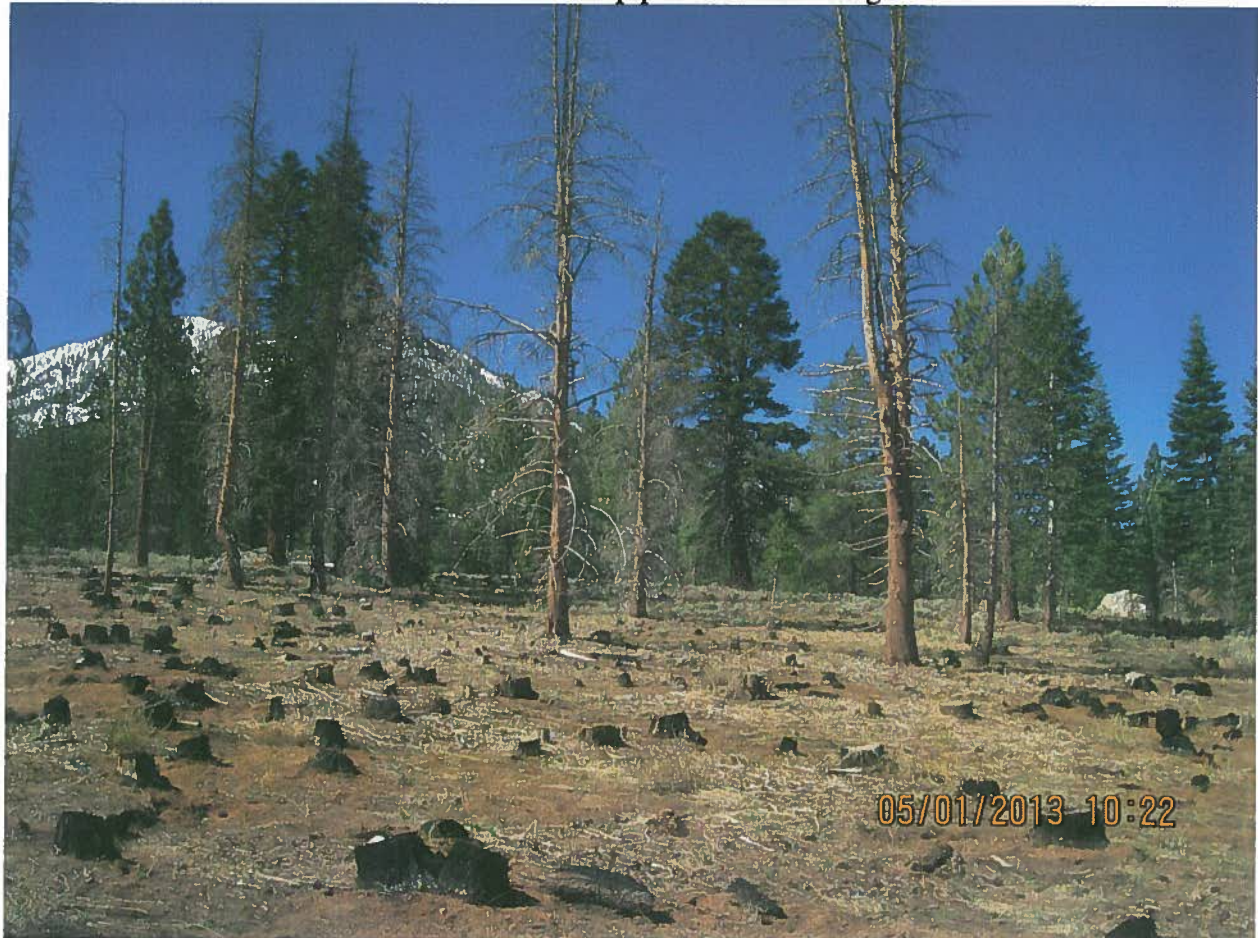
Photo 1: Reduction of fuel hazard and follow-up prescribed burning
