Heavenly Mountain Resort Mitigation and Monitoring Plan Annual Report

October 2009 – October 2010

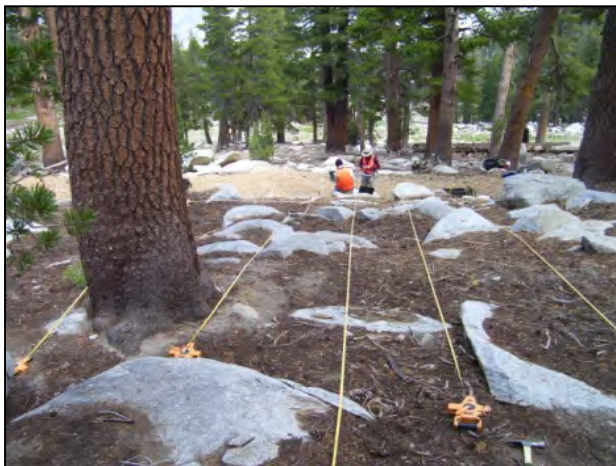
Photos from the cleared and uncleared ski run show no notable changes in surface conditions or evidence of erosion (Figure 29, Figure 30, Figure 31, and Figure 32).

Figure 29. Northbowl uncleared ski run, 2008 (photo point 3).

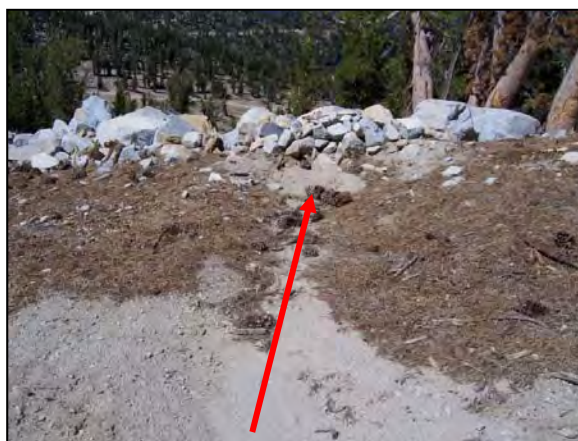
In 2010, erosion on the road next to the road shoulder plot, and sedimentation in the road shoulder plot were observed. Some of the mulch at the road shoulder plot was under sediment from the road (Figure 107).

Figure 107. Sediment from road erosion on the road shoulder plot. Arrow shows the direction of water flow.

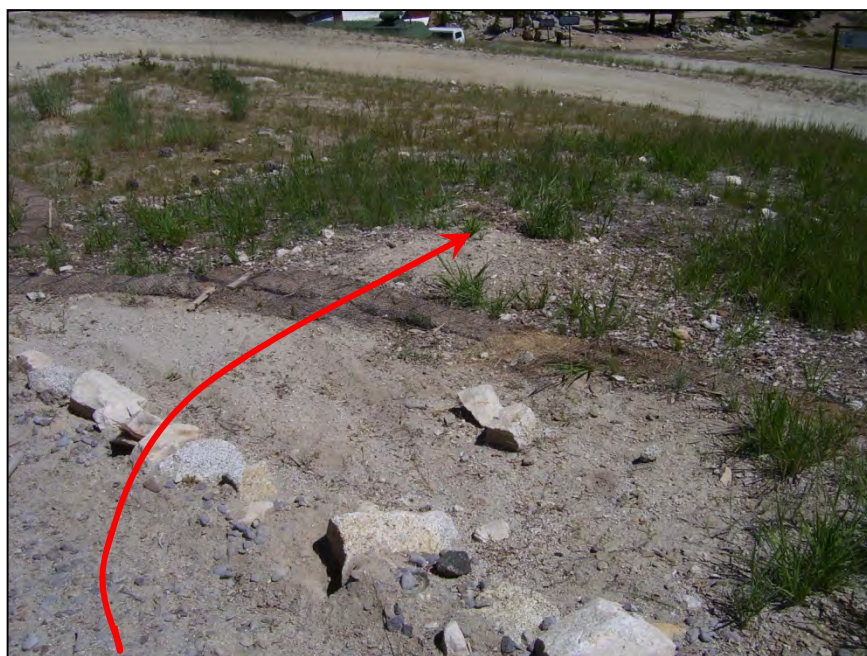
Figure 131. Lakeview Lodge. Sediment from the road at the top of the Gun Barrel top restoration site at the Lakeview Lodge project. Sediment is visible both above and below the wattle. An area of approximately 3 m² was affected. The red arrow shows the path of sediment movement.

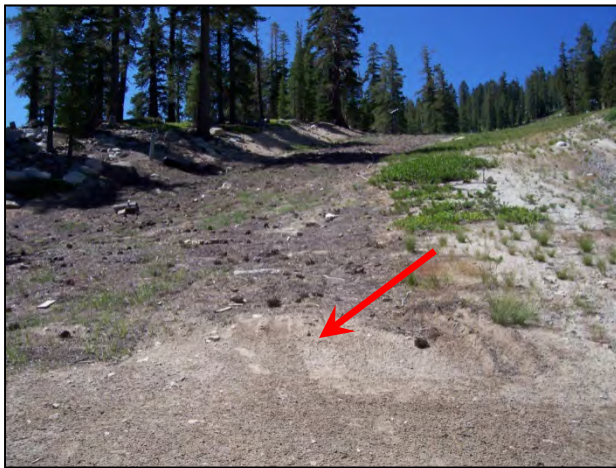
In 2010, at the upper slope, no major signs of erosion were present. However, at the lower slope, several areas of concern were documented. Tire tracks were observed going both across and up the slope (Figure 153 and Figure 154). Additionally, concentrated drainage from the road upslope of the lower treatment area caused rilling, gullying, and deposition in the lower treatment area (Figure 155, Figure 156, Figure 157 and Figure 158). The success criterion, which states that no visible signs of rills, gullies, sediment transport, or sediment deposition can be present, was met for the upper slope, but was not met for the lower slope in 2010. Concentrated drainage from roads has also caused erosion problems on several other restoration projects at Heavenly.

Figure 153. Stagecoach lower slope, August 2010. Red arrow points to tire tracks headed up the slope.

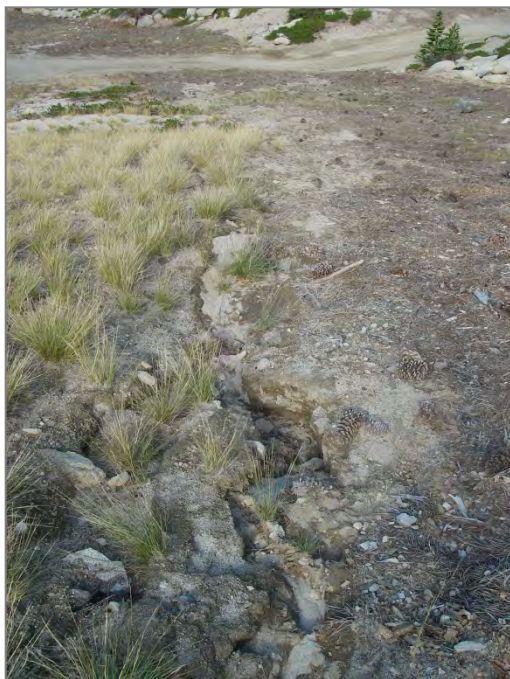
Figure 157. Gully along Stagecoach lower treatment area, August 2010. This gully was caused by concentrated drainage from the road upslope.

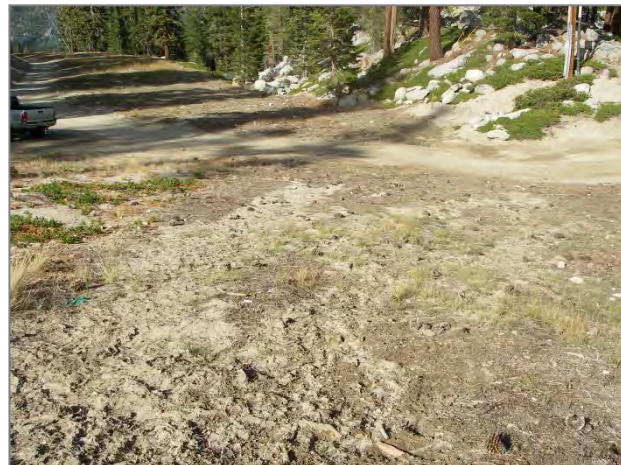
Figure 158. Deposition near the bottom of the Stagecoach lower treatment area, August 2010.
