Table 1. Heavenly Erosion Hot Spot Summary Matrix (Sky Basin Drainage Area – Upper CA-1 Watershed)

APPENDIX 3.1-G
MOTT CANYON (WATERSHED
NV-1) EROSION ASSESSMENT

MOTT CANYON (NV-1) EROSION ASSESSMENT

August 2014

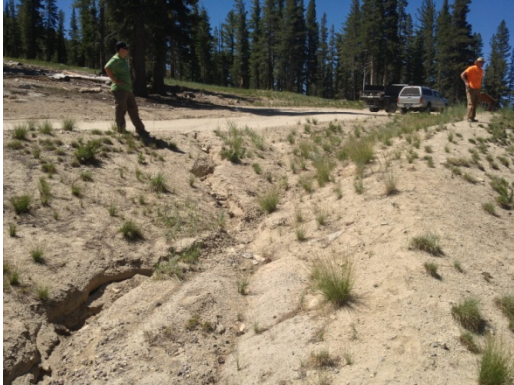
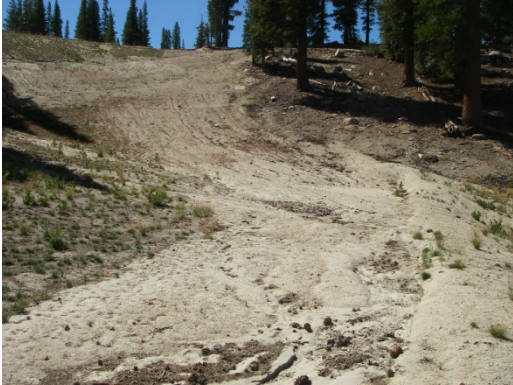
Hot Spot #	Photo 1	Photo 2
6

Hot Spot #	Type	Erosion Risk	Active Erosion	Active Deposition	Proximity to Stream/SEZ	Connectivity to Stream/SEZ	Overall Priority	Problem Description	Treatment Recommendation(s)
6	Water Bar	H	Y	Y	L	L	L	Giant sediment plume and incising WBs downslope of road, all caused by concentrated road runoff	re-direct road runoff away from slope, then remove WBs on slope and stabilize with full restoration treatment (~15,000sf)
7	Gully	M	Y	Y	L	L	L	Road drainage to breached WB formed gully down fir-covered ski run.	maintain drainage to WB on ski run; rake out gully; apply thick mulch to lower ski run above road (~2500sf)
13	Water Bar	H	Y	Y	M	H	H	water bar draining to reservoir	install PN wattles as sediment forebay; create small infiltration swale at WB outlet (~500sf)
30	Disturbed area	L	N	Y	H	H	M	bare and poorly vegetated area under Sky Deck (~3000sf)	restoration and planting shade-tolerant meadow/riparian species

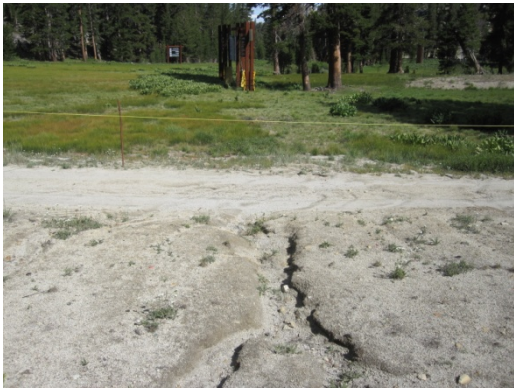
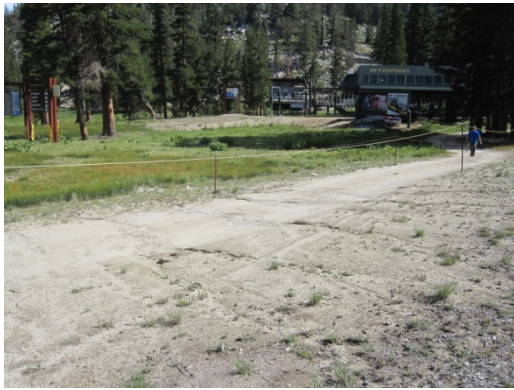
31	ski run	M	Y	Y	H	H	H	erosion from bare ski run area above road (and on road) directly to meadow below	full restoration treatment (~2500sf)
32	swale	M	Y	Y	H	H	H	rock-lined swale around Canyon base filled with sediment; sediment plume into meadow	remove sediment and rebuild rock-lined swale; install several mulch filter berms in swale; remulch lift loading areas as needed to maintain surface mulch (~500sf)
33	ski run	H	Y	Y	H	M	H	steep ski run (lower double down) with low surface cover and sparse trees; water bar near bottom of run filled with sediment and overtopped	rehab water bar and convert to infiltration swale; install several mulch berms on ski run OR cover lower portion of ski run with mulch (1500-15,000sf, depending on treatment)
34	ski run	H	Y	Y	H	H	H	steep ski run (lower ridge run/sky chute) with little surface cover and widespread erosion; several v-shaped water bars direct water to a culvert system that leads to meadow and several water bars have overtopped (causing erosion below)	rehab water bars and convert to infiltration swales; install several mulch berms on ski run OR cover ski run with mulch (2500-15,000sf, depending on treatment)

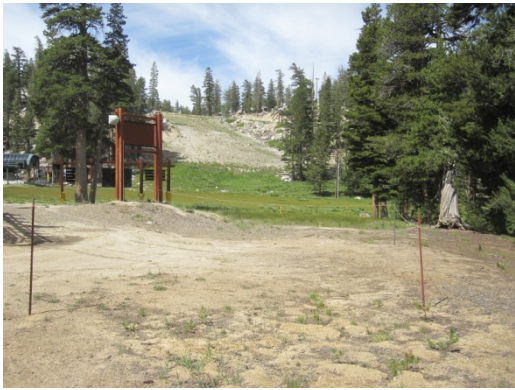
35	road	M	N	N	H	H	H	bare, compacted vehicle turnaround and access to Sky lift	maintain wood chip mulch cover on turnaround area near creek (~500sf)

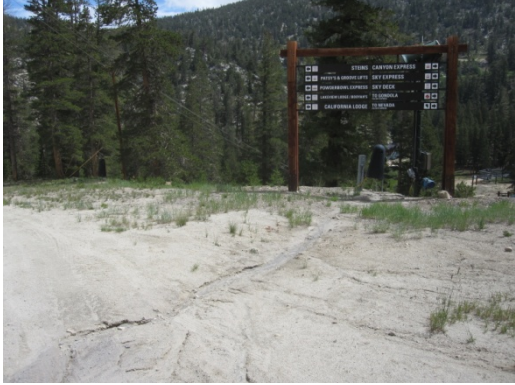
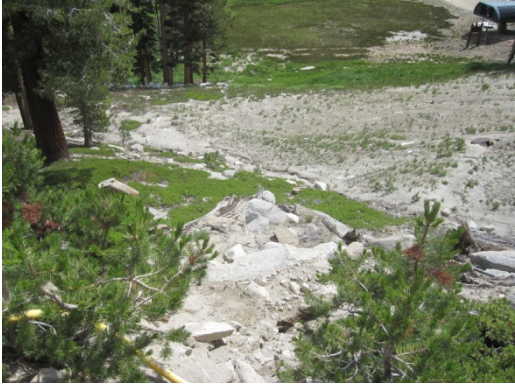
Hot Spot #	Type	Erosion Risk	Active Erosion	Active Deposition	Proximity to Stream/SEZ	Connectivity to Stream/SEZ	Overall Priority	Problem Description	Treatment Recommendation(s)
								base, which is ~20ft from creek channel	
36	water bar	H	Y	Y	M	H	H	water bar draining road is causing erosion under large ski run sign, compromising power box, and contributing runoff and sediment to ski run below (lower ridge run - hot spot 34)	create spreading/infiltration area at water bar outlet and add pine needle filter berms to trap sediment (~500sf)
37	water bar	H	Y	Y	L	H	H	road drainage collects at V-shaped water bar with culvert direct to meadow; erosion along water bar (head cutting); water bar overtopped at culvert inlet, causing erosion downslope	rehab water bars and convert to infiltration swales; rake out and mulch rills (~1000sf)
38	water bar	H	Y	Y	L	H	H	road drainage directed along water bar on ski run; erosion along water bar and downslope where water bar overtopped	rehab water bars and convert to infiltration swales; also rebuild water bar on roadway; ; rake out and mulch rills on ski run (~1000sf)

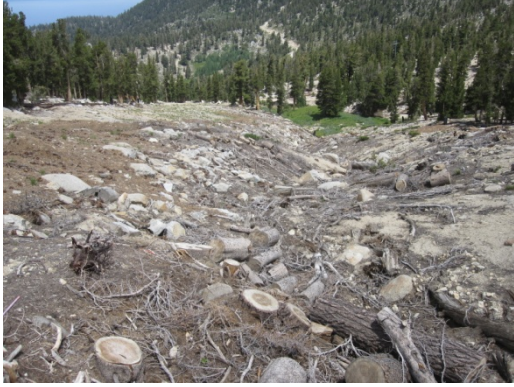
39	ephemeral drainage	H	Y	Y	L	H	L	large ephemeral drainage; lots of woody debris in flow line and moderate mulch cover in surrounding areas	no action recommended
40	water bar	H	Y	Y	L	M	L	many water bars on high roller ski run above and below summer road; many have failures where they have overtopped, causing erosion downslope	rehab water bars at failure points and convert into infiltration swales through soil loosening, wood chip incorporation (~10,000-15,000sf)
41	water bar	H	Y	Y	L	H	M	ski run (upper ridge run) with ~6 eroding water bars that direct runoff into large drainage that eventually outlets at the Canyon lift base and connects to Sky Meadow; many water bars have failures.	rehab water bars at failure points and convert into infiltration swales through soil loosening, wood chip incorporation (~10,000-15,000sf)

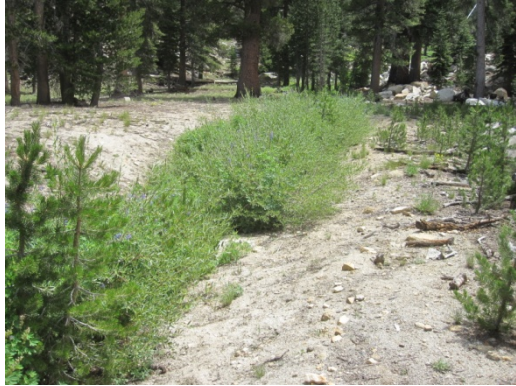
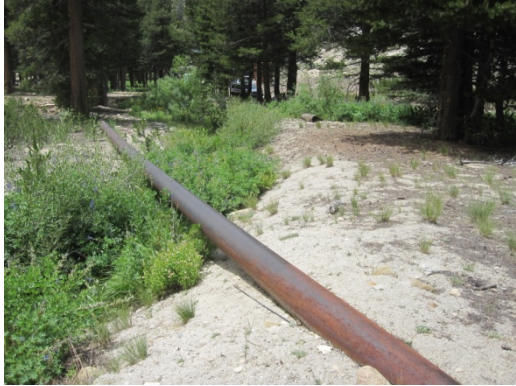
Hot Spot #	Type	Erosion Risk	Active Erosion	Active Deposition	Proximity to Stream/SEZ	Connectivity to Stream/SEZ	Overall Priority	Problem Description	Treatment Recommendation(s)
42	stream channel	M	N	N	H	H	M	south fork of SEZ channel above Sky Meadow culvert with mostly bare soil and moderately steep slopes on both sides of channel; old decomposed jute and plastic netting observed from previous USFS erosion control efforts; generally no visible erosion from banks; channel is somewhat straight and incised but no significant head cuts or bank erosion observed	definitely potential for restoration/stabilization of banks (loosening/seeding/mulch - no fabric); approx ~5000sf of bare soil along channel
43	stream channel	M	Y	Y	H	H	M	bank erosion and sediment plume in south fork of SEZ channel above Sky Meadows culvert	bank stabilization/restoration treatment (loosening/seeding/mulch - no fabric); ~300sf

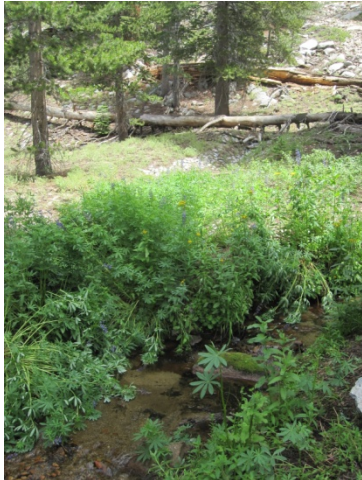
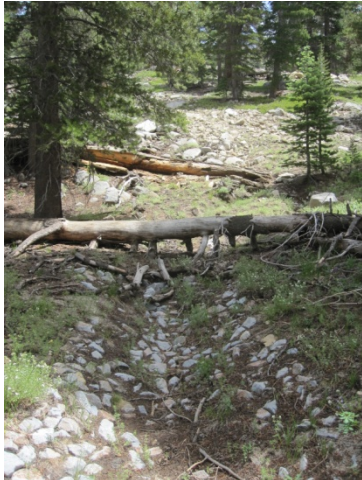
44	stream channel	M	Y	Y	H	H	M	sediment plume in south fork of SEZ channel above Sky Meadows culvert; sediment appears to have come from short section of rock-lined swale upslope of creek; no obvious bank erosion	decommission rock-lined swale, which appears to unnecessarily collect dispersed runoff from rocky slope above it (~1000sf)
45	water bar	H	Y	Y	H	H	H	very steep section of road (Hellwinkle's) is delivering sediment downslope into a fingered section of the north fork of the SEZ channel above Sky Meadows culvert; rills and gullies formed on hillside below road and above channel	stabilize rills/gullies on hillside, and address road runoff. Road options: 1) surface and/or pave road; 2) decommission road and use only for emergency access; 3) improve infiltration capacity and conduct very frequent maintenance at sediment basins along road (~1000-5000sf)
46	water bar	H	Y	Y	H	H	H	very steep section of road (Hellwinkle's) is delivering sediment downslope into a fingered section of the north fork of the SEZ channel above Sky Meadows culvert; minor rilling on hillside below road and above channel	options: 1) surface and/or pave road; 2) decommission road and use only for emergency access; 3) improve infiltration capacity and conduct very frequent maintenance at sediment basins along road (~1000-5000sf)

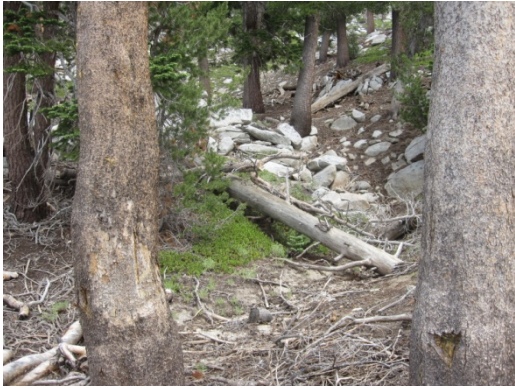
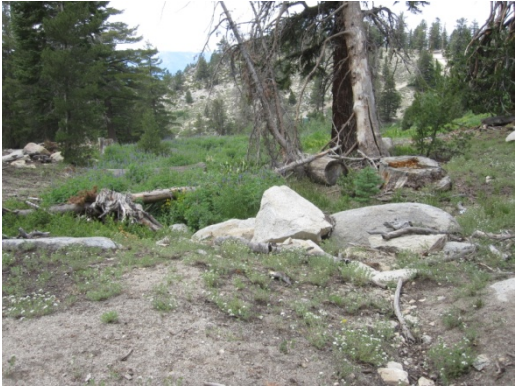
Hot Spot #	Type	Erosion Risk	Active Erosion	Active Deposition	Proximity to Stream/SEZ	Connectivity to Stream/SEZ	Overall Priority	Problem Description	Treatment Recommendation(s)
47	ephemeral drainage	M	Y	Y	L	H	L	large ephemeral drainage at crossing with lower Cal trail; relatively stable and well vegetated with small meadow below road crossing; evidence of flow during recent rain events but no obvious sediment transport	no action recommended
48	gully	M	Y	Y	L	M	L	well-established gully formed at downslope end of lower Cal trail; collects water from large drainage area; moderate amount of erosion and deposition observed from recent rain storm	full restoration treatment along gully (maintain general swale-like shape) to slow and infiltrate surface runoff during spring snowmelt and rain storms; installation of mulch filter berms would provide short-term benefits (~1500sf)
49	ski run	H	Y	Y	H	M	H	steep ski run (lower Ellie's) with compacted soil, moderate veg cover, and visible rilling; water bar near bottom of run filled with sediment and overtopped in several locations	rehab water bar and convert to infiltration swale; install several mulch berms on ski run OR cover lower portion of ski run with mulch (1500-15,000sf, depending on treatment)
