SKY BASIN (UPPER CA-1 WATERSHED) EROSION ASSESSMENT

Kevin Drake, CPESC

August 2014

MOTT CANYON (NV-1) EROSION ASSESSMENT

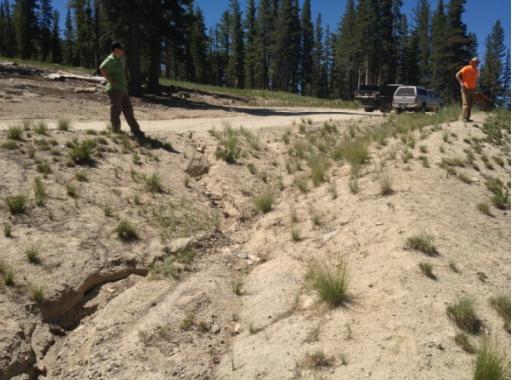
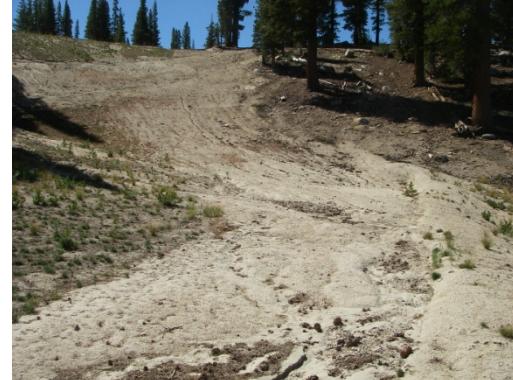
Hot Spot #	Photo 1	Photo 2
6

Hot Spot #	Type	Erosion Risk	Active Erosion	Active Deposition	Proximity to Stream/SEZ	Connectivity to Stream/SEZ	Overall Priority	Problem Description	Treatment Recommendation(s)
6	Water Bar	H	Y	Y	L	L	L	Giant sediment plume and incising WBs downslope of road, all caused by concentrated road runoff	re-direct road runoff away from slope, then remove WBs on slope and stabilize with full restoration treatment (~15,000sf)
7	Gully	M	Y	Y	L	L	L	Road drainage to breached WB formed gully down fir-covered ski run.	maintain drainage to WB on ski run; rake out gully; apply thick mulch to lower ski run above road (~2500sf)
13	Water Bar	H	Y	Y	M	H	H	water bar draining to reservoir	install PN wattles as sediment forebay; create small infiltration swale at WB outlet (~500sf)
30	Disturbed area	L	N	Y	H	H	M	bare and poorly vegetated area under Sky Deck (~3000sf)	restoration and planting shade-tolerant meadow/riparian species

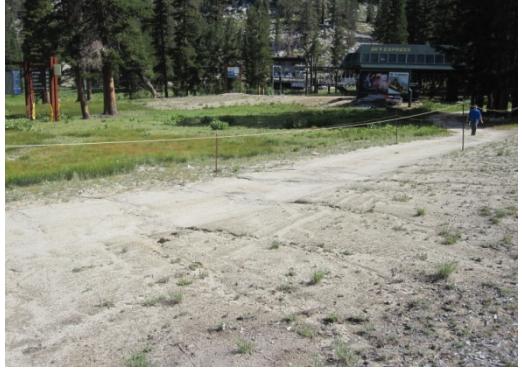
31	ski run	M	Y	Y	H	H	H	erosion from bare ski run area above road (and on road) directly to meadow below	full restoration treatment (~2500sf)
32	swale	M	Y	Y	H	H	H	rock-lined swale around Canyon base filled with sediment; sediment plume into meadow	remove sediment and rebuild rock-lined swale; install several mulch filter berms in swale; remulch lift loading areas as needed to maintain surface mulch (~500sf)
33	ski run	H	Y	Y	H	M	H	steep ski run (lower double down) with low surface cover and sparse trees; water bar near bottom of run filled with sediment and overtopped	rehab water bar and convert to infiltration swale; install several mulch berms on ski run OR cover lower portion of ski run with mulch (1500-15,000sf, depending on treatment)
34	ski run	H	Y	Y	H	H	H	steep ski run (lower ridge run/sky chute) with little surface cover and widespread erosion; several v-shaped water bars direct water to a culvert system that leads to meadow and several water bars have overtopped (causing erosion below)	rehab water bars and convert to infiltration swales; install several mulch berms on ski run OR cover ski run with mulch (2500-15,000sf, depending on treatment)

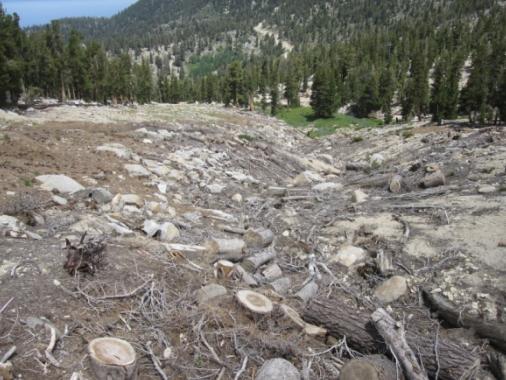
39	ephemeral drainage	H	Y	Y	L	H	L	large ephemeral drainage; lots of woody debris in flow line and moderate mulch cover in surrounding areas	no action recommended
40	water bar	H	Y	Y	L	M	L	many water bars on high roller ski run above and below summer road; many have failures where they have overtopped, causing erosion downslope	rehab water bars at failure points and convert into infiltration swales through soil loosening, wood chip incorporation (~10,000-15,000sf)
41	water bar	H	Y	Y	L	H	M	ski run (upper ridge run) with ~6 eroding water bars that direct runoff into large drainage that eventually outlets at the Canyon lift base and connects to Sky Meadow; many water bars have failures.	rehab water bars at failure points and convert into infiltration swales through soil loosening, wood chip incorporation (~10,000-15,000sf)

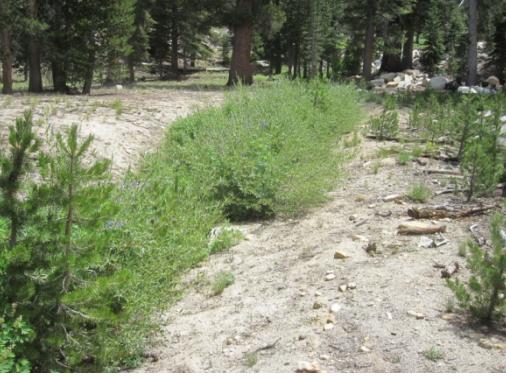
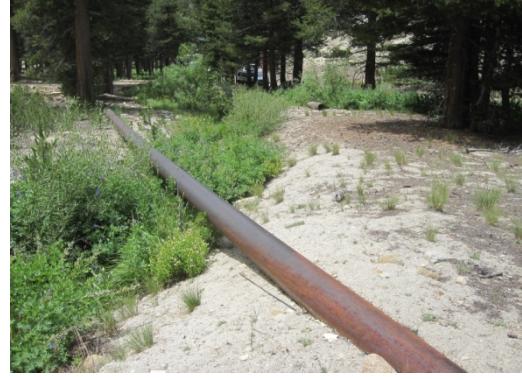
Hot Spot #	Type	Erosion Risk	Active Erosion	Active Deposition	Proximity to Stream/SEZ	Connectivity to Stream/SEZ	Overall Priority	Problem Description	Treatment Recommendation(s)
42	stream channel	M	N	N	H	H	M	south fork of SEZ channel above Sky Meadow culvert with mostly bare soil and moderately steep slopes on both sides of channel; old decomposed jute and plastic netting observed from previous USFS erosion control efforts; generally no visible erosion from banks; channel is somewhat straight and incised but no significant head cuts or bank erosion observed	definitely potential for restoration/stabilization of banks (loosening/seeding/mulch - no fabric); approx ~5000sf of bare soil along channel
43	stream channel	M	Y	Y	H	H	M	bank erosion and sediment plume in south fork of SEZ channel above Sky Meadows culvert	bank stabilization/restoration treatment (loosening/seeding/mulch - no fabric); ~300sf

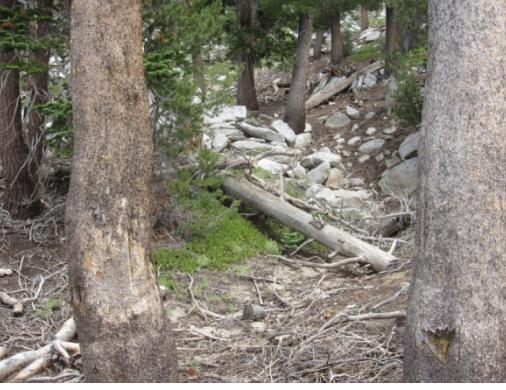
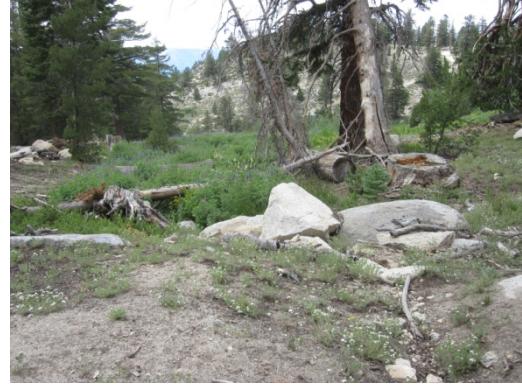
Hot Spot #	Type	Erosion Risk	Active Erosion	Active Deposition	Proximity to Stream/SEZ	Connectivity to Stream/SEZ	Overall Priority	Problem Description	Treatment Recommendation(s)
47	ephemeral drainage	M	Y	Y	L	H	L	large ephemeral drainage at crossing with lower Cal trail; relatively stable and well vegetated with small meadow below road crossing; evidence of flow during recent rain events but no obvious sediment transport	no action recommended
48	gully	M	Y	Y	L	M	L	well-established gully formed at downslope end of lower Cal trail; collects water from large drainage area; moderate amount of erosion and deposition observed from recent rain storm	full restoration treatment along gully (maintain general swale-like shape) to slow and infiltrate surface runoff during spring snowmelt and rain storms; installation of mulch filter berms would provide short-term benefits (~1500sf)
49	ski run	H	Y	Y	H	M	H	steep ski run (lower Ellie's) with compacted soil, moderate veg cover, and visible rilling; water bar near bottom of run filled with sediment and overtopped in several locations	rehab water bar and convert to infiltration swale; install several mulch berms on ski run OR cover lower portion of ski run with mulch (1500-15,000sf, depending on treatment)

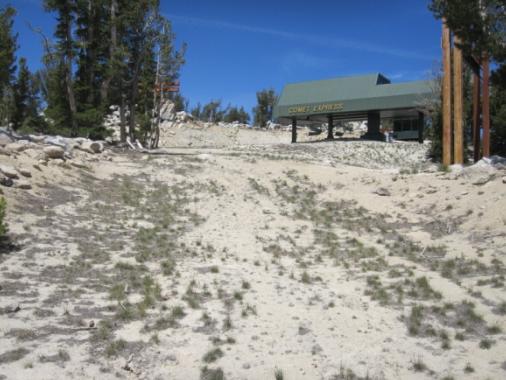
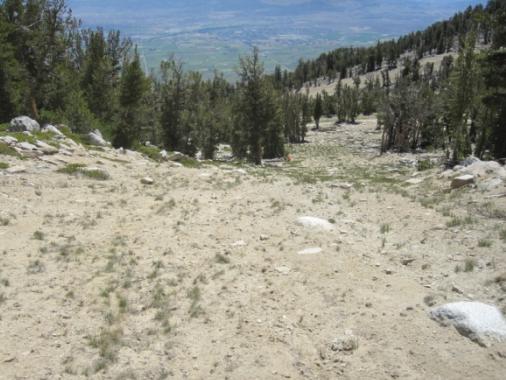
5	ski run/road	Y	M	Y	Y	L	M	H	compacted ski run/old road below Comet lift top terminal sheds water onto Aries ski run, contributing to ski run erosion issues (linked to HS #4)	create infiltration/spreading area at top of Aries ski run (before ski run steepens)
6	rill/gully	Y	M	Y	Y	L	M	H	~4 distinct large rills on ski run at proposed trail crossing	soil restoration treatment to stabilize rilling area below rocks
7	water bar	Y	H	Y	Y	L	M	H	proposed trail crossing at water bar with erosion, which collects runoff from at least 150ft of dirt road	design stable drainage crossing for trail
8	proposed trail	Y	L	N	N	L	H	H	proposed trail switchback very near dipper drainage; lots of bare soil but no visible erosion	shift trail alignment so it doesn't drain to dipper drainage

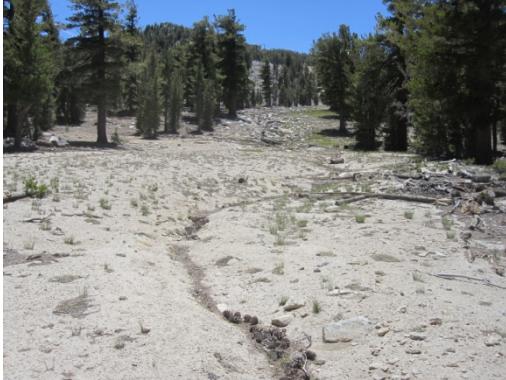
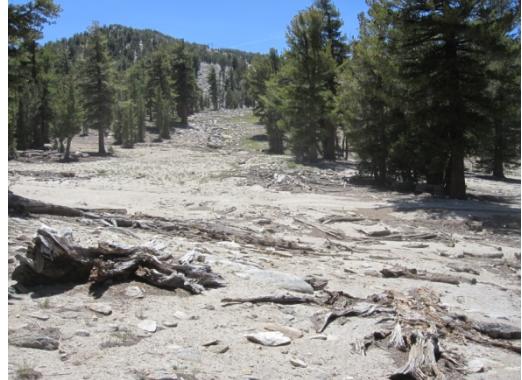
Hot Spot #	Feature Type	Hot Spot-Proposed Trail Interaction	Erosion Risk	Active Erosion	Active Depos.	Prox to stream or SEZ	Connect. to stream or SEZ	Overall Priority	Problem Description, Notes	Mitigation Recommendations
19	road-drainage crossing	N	H	Y	Y	M	M	M	lower end of dipper drainage crosses summer road; know to carry moderate flow during spring runoff	install mulch berms in channel above and below road; create infiltration/spreading area below road
20	drainage	Y	L	Y	Y	M	L	H	proposed trail alignment crosses defined drainage (created by concentrated runoff from water bars on Orion's ski run upslope)	realign trail to avoid drainage or design stable drainage crossing
21	drainage	Y	M	Y	Y	M	L	H	proposed trail alignment crosses defined drainage (created by concentrated runoff from water bars on Orion's ski run upslope)	realign trail to avoid drainage or design stable drainage crossing
22	drainage	Y	L	Y	Y	M	L	H	proposed trail alignment crosses defined drainage (created by concentrated runoff from water bars on Orion's ski run upslope)	realign trail to avoid drainage or design stable drainage crossing

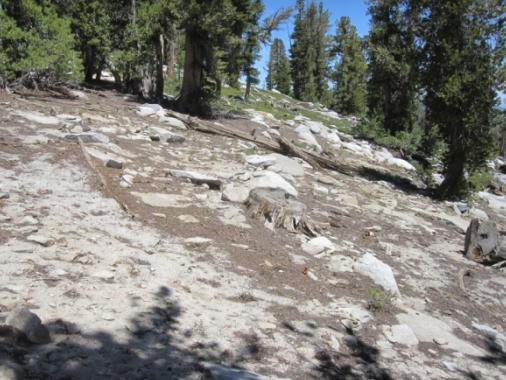
ID	Feature Type	Hot Spot-Proposed Trail Interaction	Erosion Risk	Active Erosion	Active Depos.	Prox to stream or SEZ	Connect. to stream or SEZ	Problem Description, Notes	Mitigation Recommendations
3	proposed trail	N	L	N	N	L	L	proposed trail alignment - low erosion risk	no action recommended
4	drainage	N	H	Y	Y	L	H	dipper drainage (legacy impact)	no action recommended
