Heavenly Mountain Resort Mitigation and Monitoring Plan Annual Report

October 2008 – October 2009

April 30, 2010

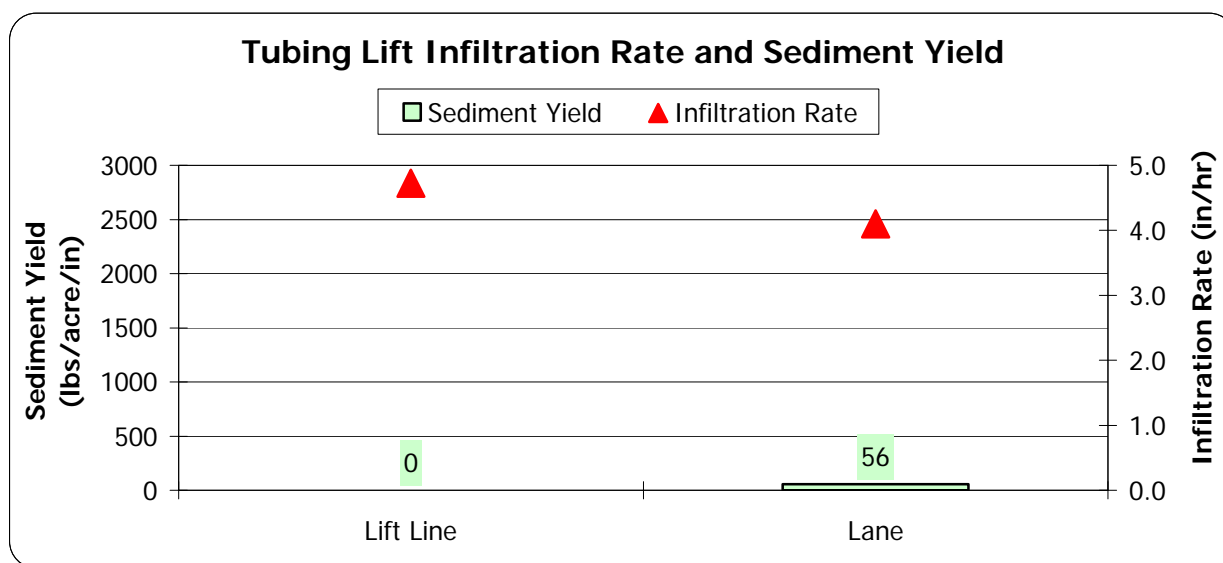
At the tubing lift line, there was no runoff, and therefore, no sediment production (Figure 21). At the tubing lane, the average steady state sediment yield was 56 lbs/acre/in. The higher sediment yield at the lane was most likely not related to the shallower penetrometer DTR measured on transects at the tubing lane (Figure 22). Shallower penetrometer DTRs can lead to less infiltration and higher sediment yields in some cases. The penetrometer DTR measured within the rainfall frames did not reflect the transect measurements at the tubing lane. At the lift line, the penetrometer DTR within the frame was 10.2 inches, compared to 10.8 inches at the lift lane. For comparison, typical native or treated sites have sediment yields less than 100 lbs/acre/in. The infiltration rate was 4.1 in/hr at the tubing lane and 4.7 in/hr at the lift line.

Figure 21. Tubing Lift Infiltration Rate and Sediment Yield. The lift line had a sediment yield of zero and an infiltration rate of 4.7 in/hr, while the lane had a sediment yield of 56 lbs/acre/in and an infiltration rate of 4.1 in/hr.

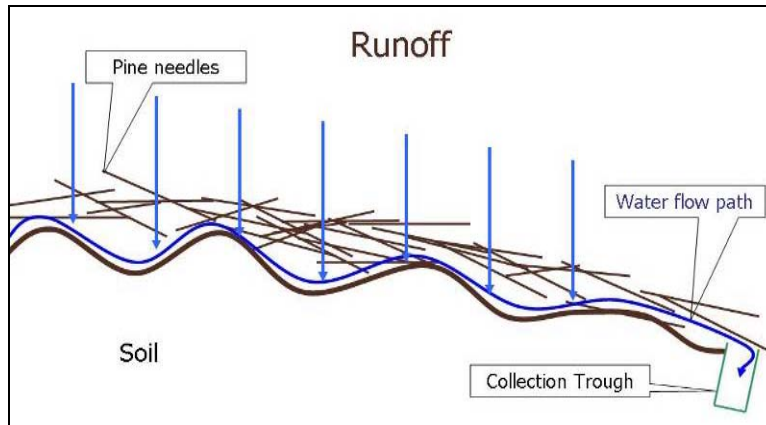
Figure 33. Water penetrating the pine needle mulch and running off after reaching the soil. There is no infiltration into the soil. Runoff is then captured in the collection trough.

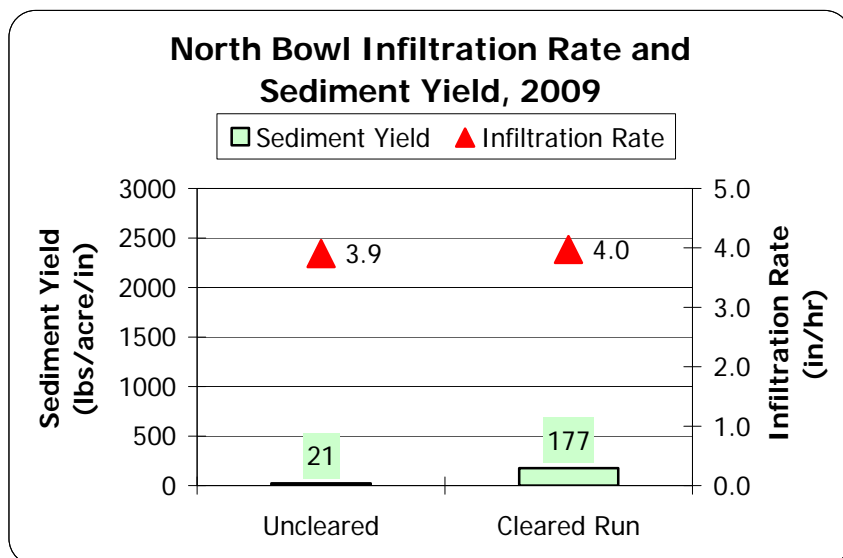
The infiltration rate was similar at the cleared run (4.0 in/hr), compared the uncleared run (3.9 in/hr). The success criterion for infiltration rate, which states the infiltration rate can be no more than 0.8 in/hr lower than the pre-treatment infiltration rate, was met.

Figure 35. North Bowl Infiltration Rate and Sediment Yield, 2009. The sediment yield at the North Bowl cleared run (177 lbs/acre/in) was 743% higher than the sediment yield at the uncleared run (21 lbs/acre/in). The infiltration rate was similar at cleared run (4.0 in/hr) and the uncleared run (3.9 in/hr).

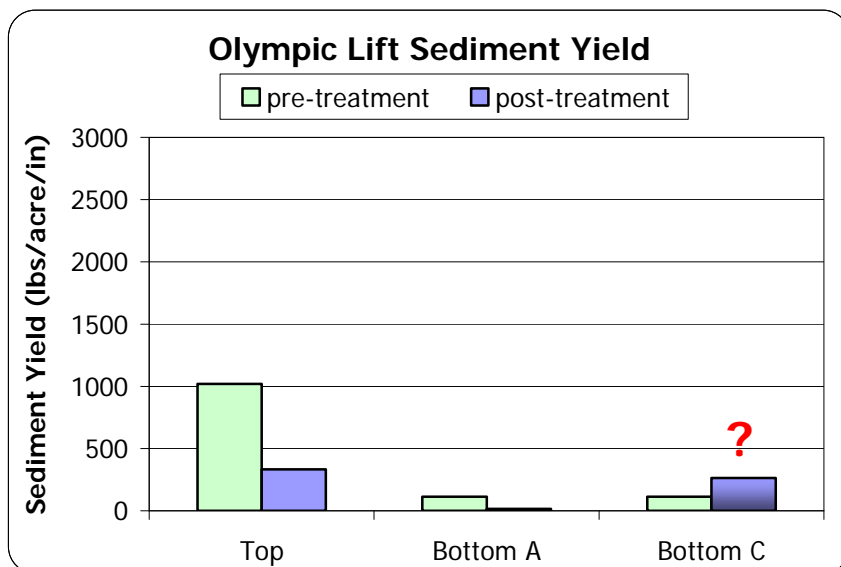
Figure 66. Olympic Lift Sediment Yield. Sediment yield decreased by 67% from 1,019 to 334 lbs/acre/in at the top and by 88% from 113 to 14 lbs/acre/in at bottom A. Sediment yield increased by 151 lbs/acre/in or 133% at bottom C from 113 to 264 lbs/acre/in (see callout next to this graph).

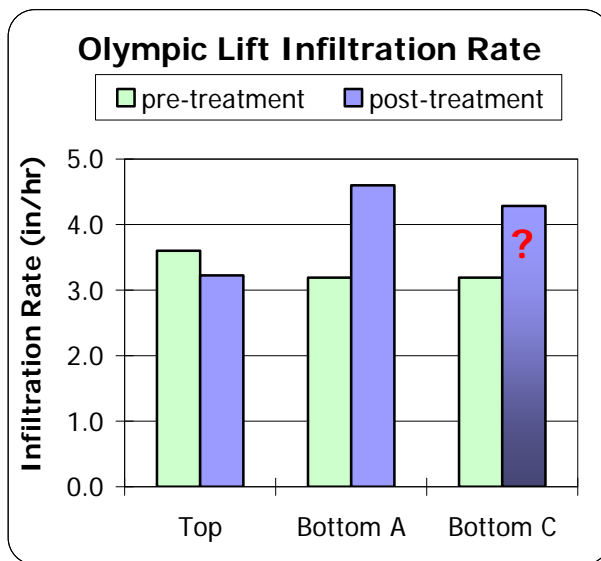
The success criterion, which states that the post-treatment infiltration rate must be no more than 0.8 in/hr lower than the pre-treatment infiltration rate, was met for Olympic lift top, bottom A, and bottom C.

Figure 68. Olympic Lift Infiltration Rate. The average infiltration rate at the Olympic lift top decreased by 0.4 in/hr post-treatment. The average infiltration rate post-treatment at the Olympic lift bottom exhibited a 34-44% increase.

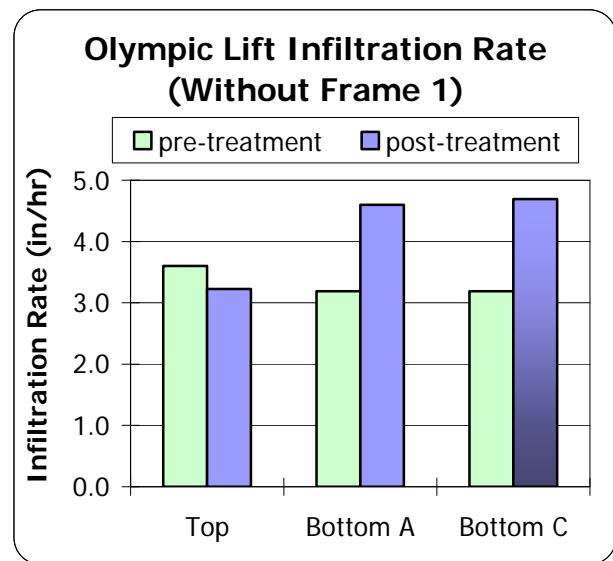
Figure 69. Olympic Lift Infiltration Rate without Frame 1. When Frame 1 (hydrophobic result) was removed from the average, the post-treatment (4.7 in/hr) infiltration rate was 47% higher than the pre-treatment infiltration rate (3.2 in/hr).

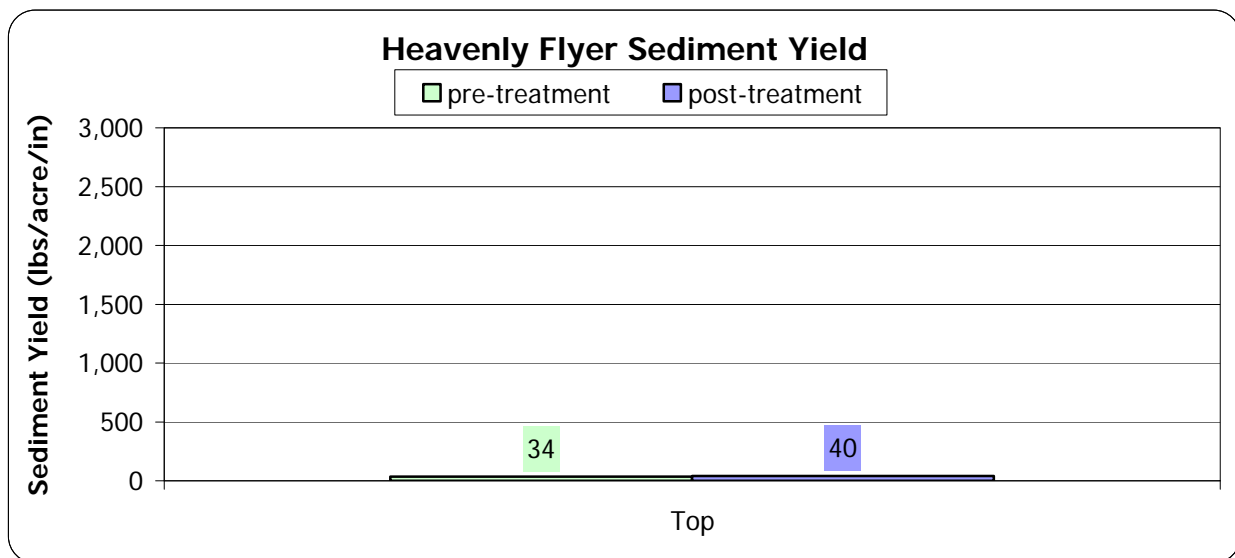
The post-treatment sediment yield at the Heavenly Flyer top (40 lbs/acre/in) was nearly the same as the pre-treatment sediment yield (34 lbs/acre/in, Figure 82). The success criteria, which states that the post-treatment sediment yield cannot be more than 100 lbs/acre/in higher than the pre-treatment sediment yield, was met.

Figure 82. Heavenly Flyer Sediment Yield. The sediment yield was 34 lbs/acre/in pre-treatment, compared to 40 lbs/acre/in post-treatment.

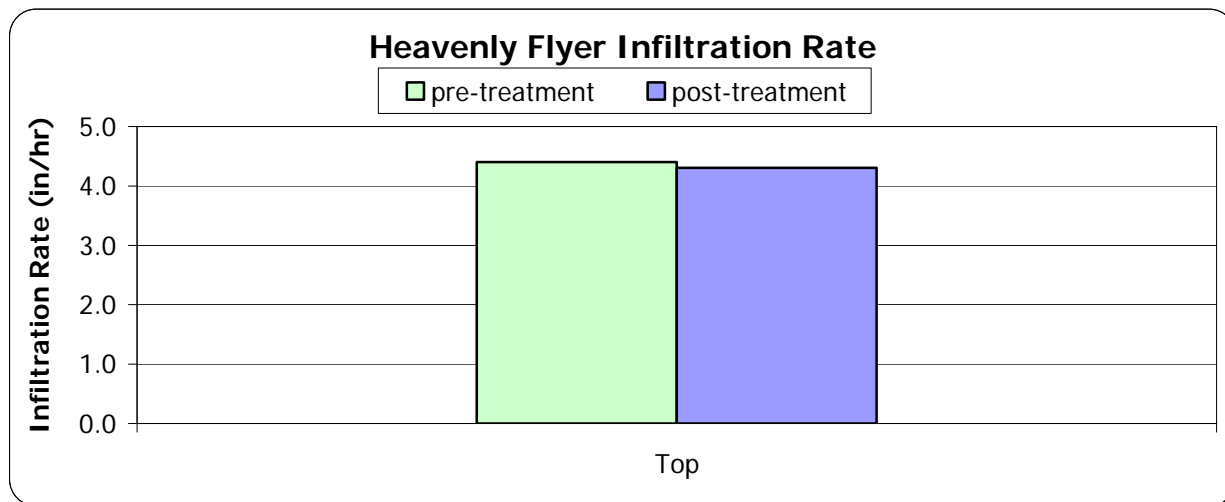
The average infiltration rate at the Heavenly Flyer post-treatment (4.3 in/hr) was similar to the average infiltration rate pre-treatment (4.4 in/hr, Figure 83). The success criterion, which states the post-treatment infiltration rate can not be more than 0.8 in/hr lower than the pre-treatment infiltration rate, was met.

Figure 83. Heavenly Flyer Infiltration Rate. The infiltration rate was 4.4 in/hr pre-treatment, compared to 4.3 in/hr post-treatment.

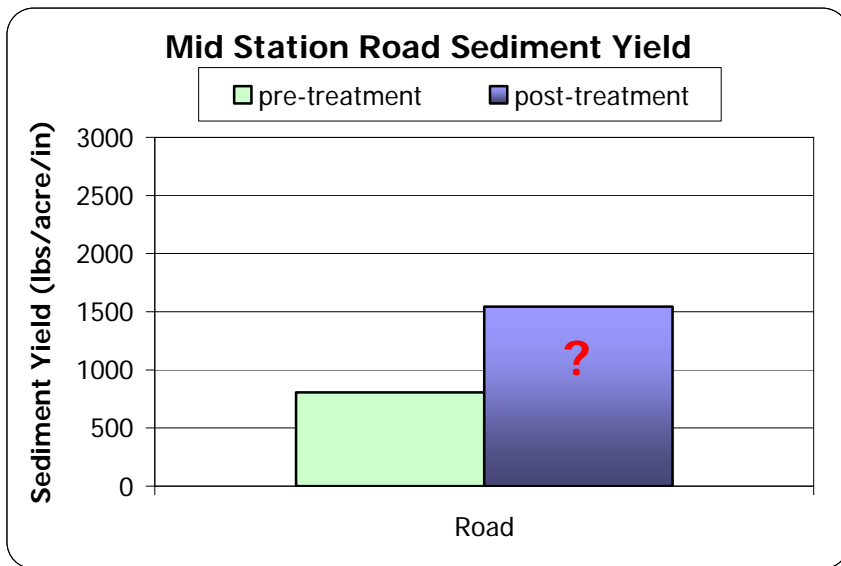
Figure 96. Mid Station Road Sediment Yield. The post-treatment sediment yield 48% or 735 lbs/acre/in higher than the pre-treatment sediment yield.

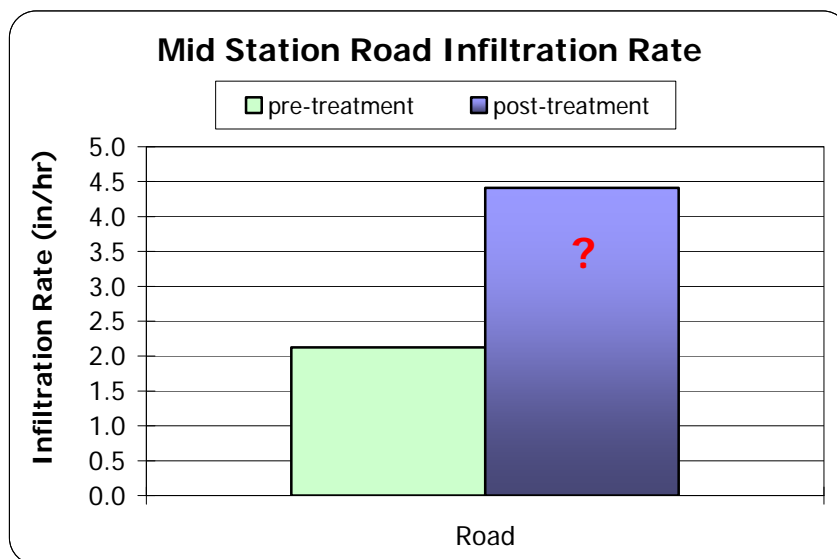
The average infiltration rate at the Mid Station Road post-treatment (4.4 in/hr) was 2 times higher than pre-treatment (2.1 in/hr; Figure 98). Examining the infiltration rates by frame will aid in understanding why the infiltration rate was highest for the post-treatment simulations, which had the highest sediment yield before the outlier was removed. Generally, high sediment yields are linked with low infiltration rates. The Frame 1 infiltration rate was 4.3 in/hr (sediment yield: 24 lbs/acre/in), the Frame 2 infiltration rate was 4.7 in/hr (no runoff or sediment), and the Frame 3 infiltration rate was 4.2 in/hr (sediment yield: 4,604 lbs/acre/in). The Frame 1 and Frame 3 infiltration rates were very similar even though the sediment yields varied widely. This may be because the relatively small animal disturbance area produced a majority of the sediment, but did not cover a large enough area to reduce the overall infiltration rate. The success criterion, which states the post-treatment infiltration rate must be no more than 1.5 in/hr lower than the pre-treatment infiltration rate, was met.

Figure 98. Mid Station Road Infiltration Rate. The average infiltration rate post-treatment 2 times higher than the pre-treatment infiltration rate.

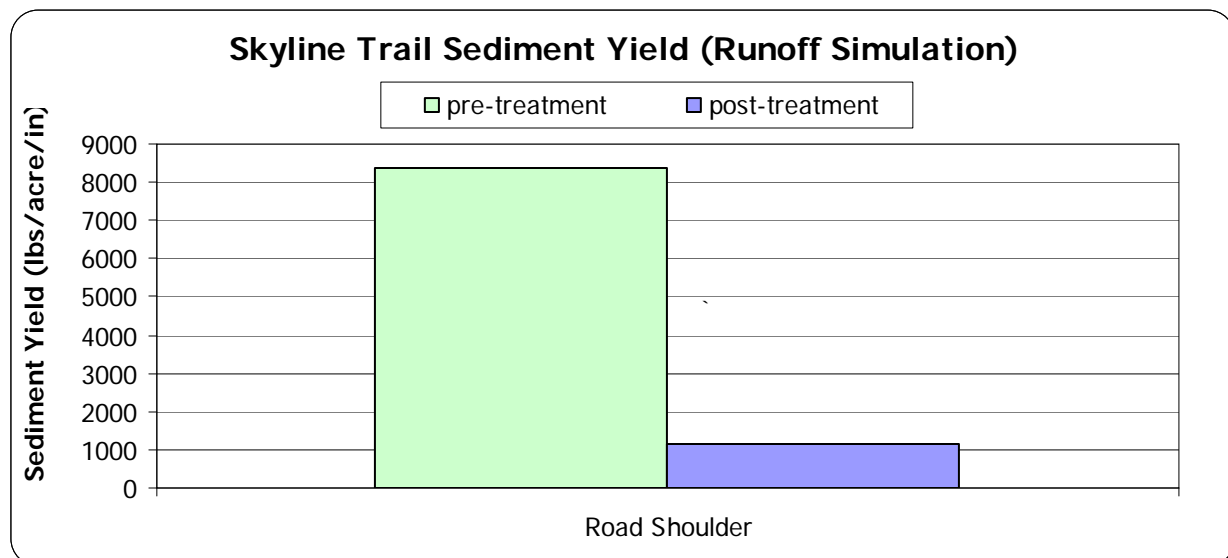
The post-treatment sediment yield at the Skyline Trail road shoulder (1,140 lbs/acre/in) was 86% lower than the pre-treatment sediment yield (8,386 lbs/acre/in, Figure 118). The success criterion, which states that the post-treatment sediment yield must be no more than 100 lbs/acre/in higher than the pre-treatment sediment yield, was met.

Figure 118. Skyline Trail Sediment Yield (Runoff Simulation). Sediment Yield decreased by 86% post-treatment. Note the different scale for this runoff simulation graph (max of 9,000 lbs/acre/in versus max of 3,000 lbs/acre/in for the rainfall simulation graphs).

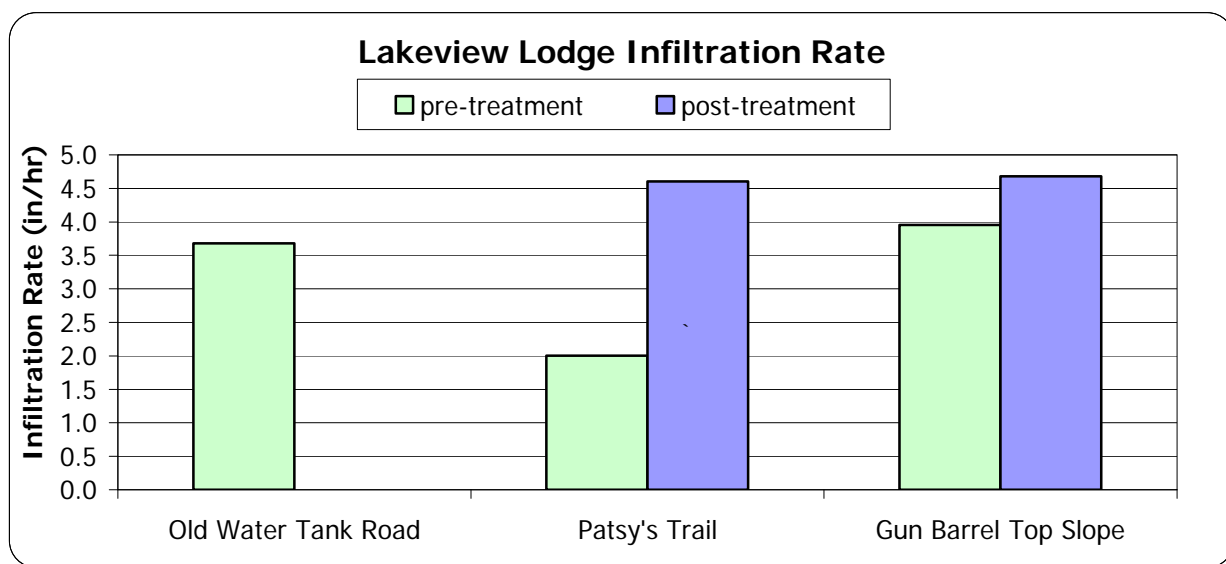
Figure 141. Lakeview Infiltration Rate (Rainfall Simulation). The infiltration rate at the Gun Barrel top slope increased by 18% post-treatment, while the infiltration rate at Patsy's Trail increased by 130% post-treatment. Runoff simulation was conducted at Patsy's Trail pre-treatment, while rainfall simulation was conducted post-treatment.

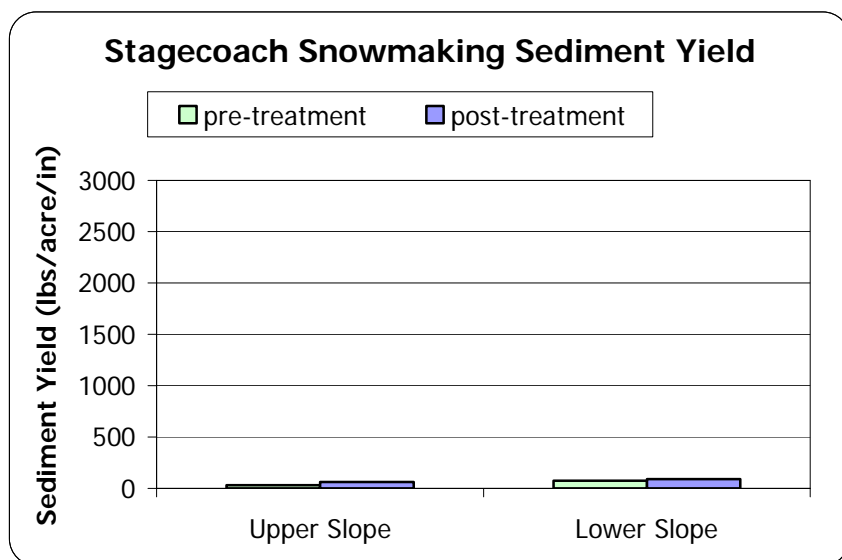
Figure 161. Stagecoach Snowmaking Sediment Yield. Sediment yield increased by 20% to 103% post-treatment. All sediment yields were under 100 lbs/acre/in.
