STAFF REPORT

Subject: Postmistress Properties LLC Land Capability Challenge,
1949 Glenbrook Inn Road, Glenbrook, Douglas County, NV;
Portion of APN 1418-10-802-010; TRPA File No.: LCAP2022-0779

BAILEY LAND CAPABILITY CHALLENGE FINDINGS

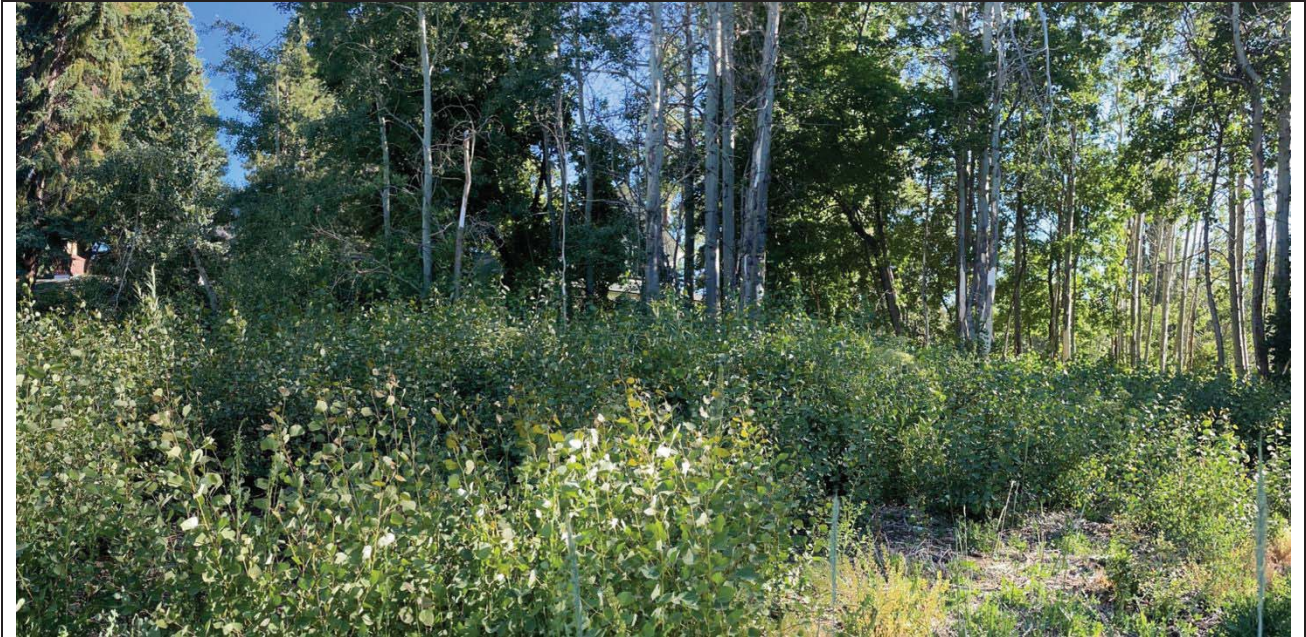
Photo 1 – View upslope (south) at upper portion of study area where high capability soils occur. Vegetation is quaking aspen, mountain maple and forbs/grasses. Steeper area in foreground has 16 to 20% slopes and qualifies for Class 4. Less steep land in background (10 to 16% slopes) qualifies for Class 6. Field study conducted in Oct. 2019 and Nov. 2020 by R.J. Poff & Associates, and observed by TRPA contractors.

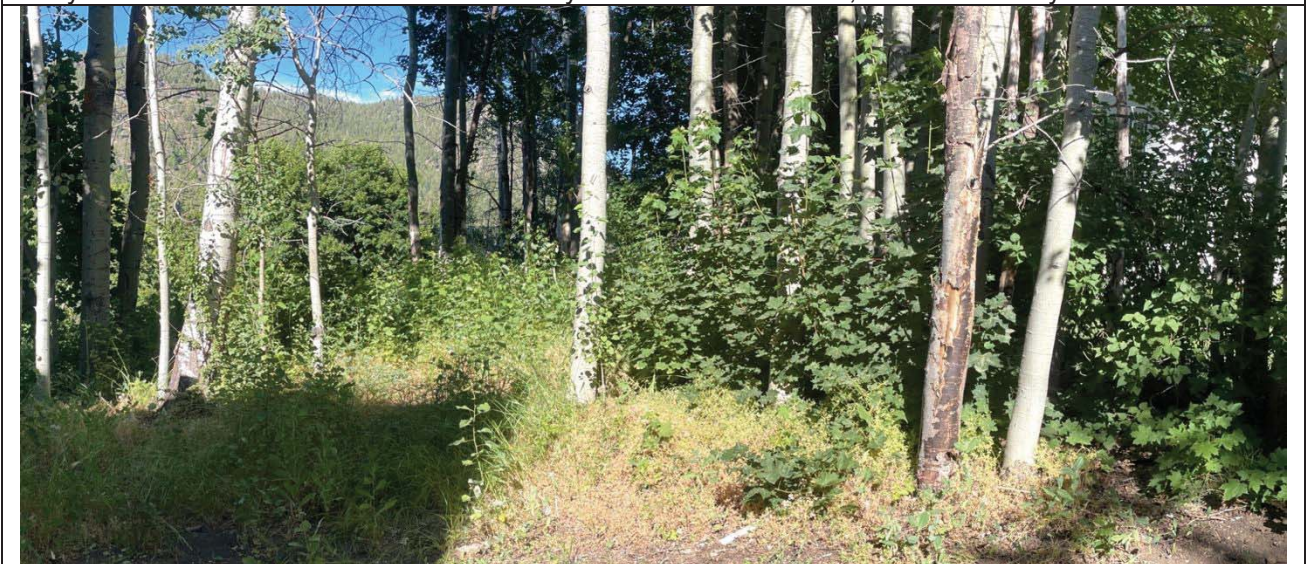
Photo 2 – View east and northeast at southwest portion of study area, which supports mixture of mountain maple and quaking aspen. Soils in this vicinity are moderately to well drained, and have dark surface horizon indicative of organic matter accumulation. Soils at rated as HSB-B and Class 6 (0-16% slopes). Existing residence beyond left edge of photograph.

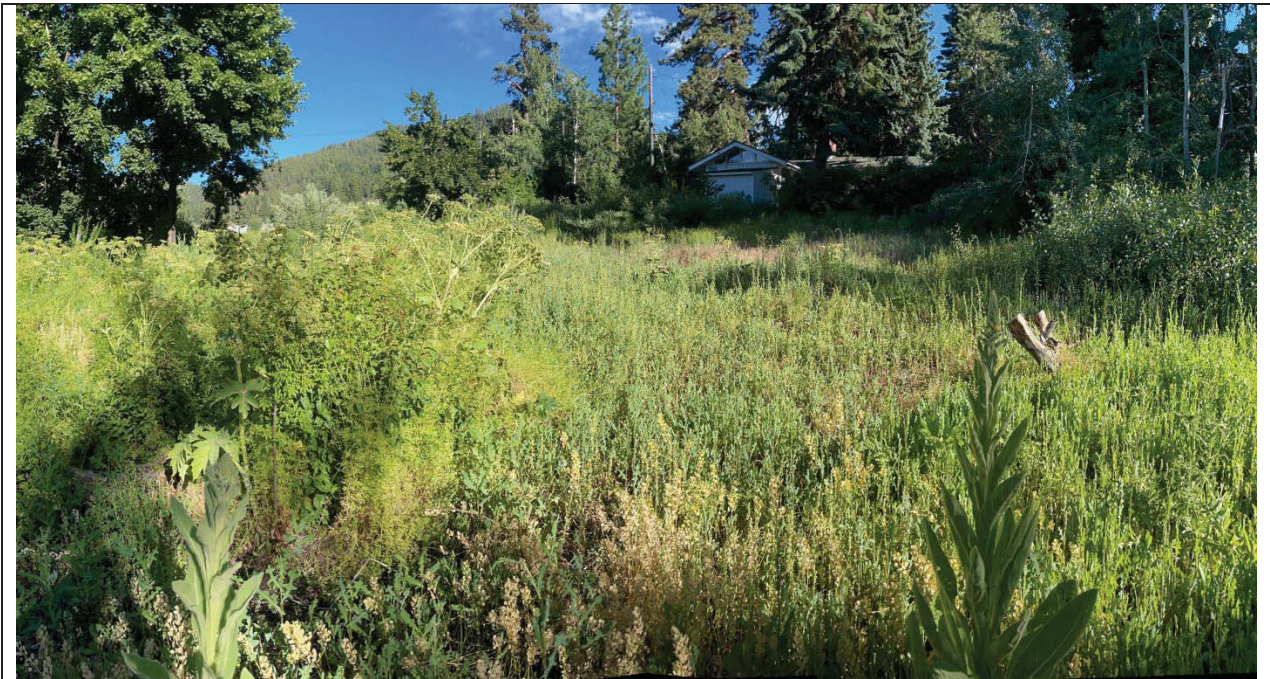
Photo 3 – View to south at southeast portion of study area. This vicinity of the study area consists of Stream Environment Zone (SEZ), which extends from the top of slope (background) to Glenbrook Creek (behind photographer). SEZ land (Class 1B) composes 77% of the study area, while remainder of land is Class 4 and Class 6. Vegetation in this vicinity was thinned for forest fuels reduction in 2020.

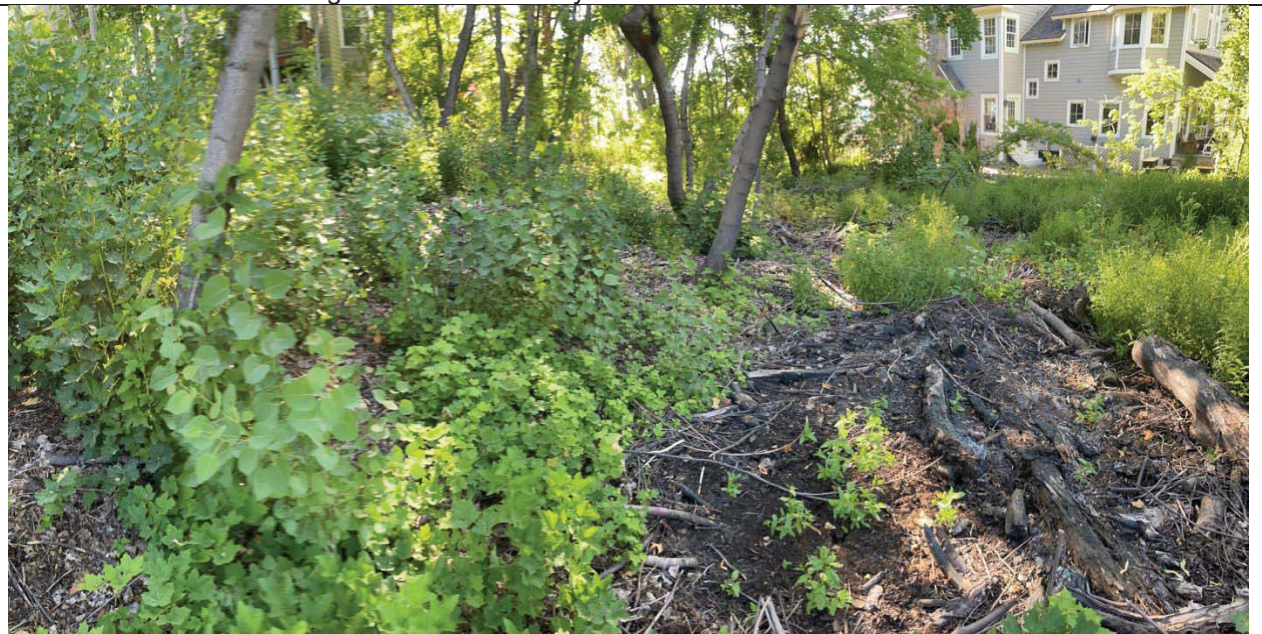
Photo 4 – View to southwest at south-center portion of study area at interface of Class 6 soils (left side of photo) and Class 4 soils (right side). The soils in this vicinity are deep, have non-gravelly loamy to sandy clay loam textures. This landform is a relict alluvial terrace and likely formed from deltaic sediments when prehistoric lake levels submerged this land. Foreground has burn pile from forest fuels reduction.

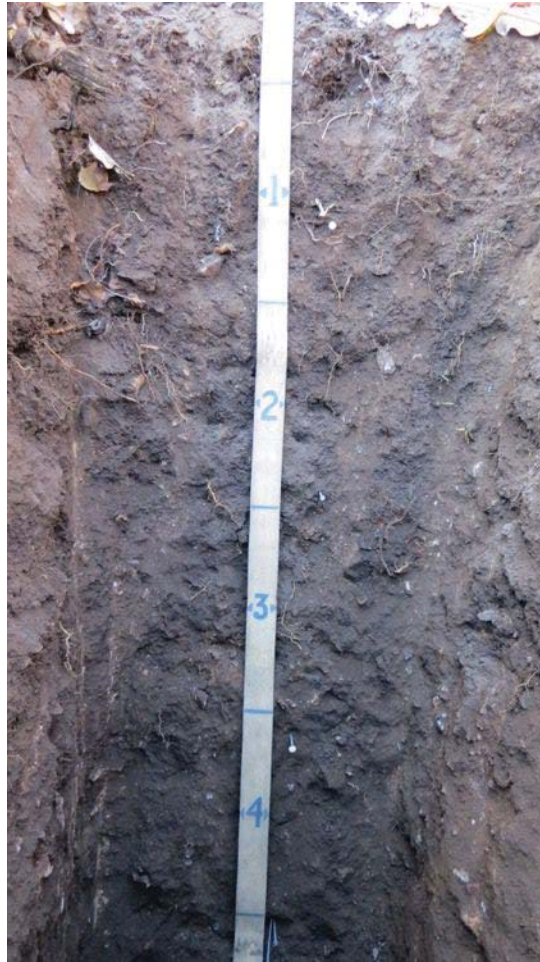
Soil Pit 1 Profile, XXX 0-16 percent slope

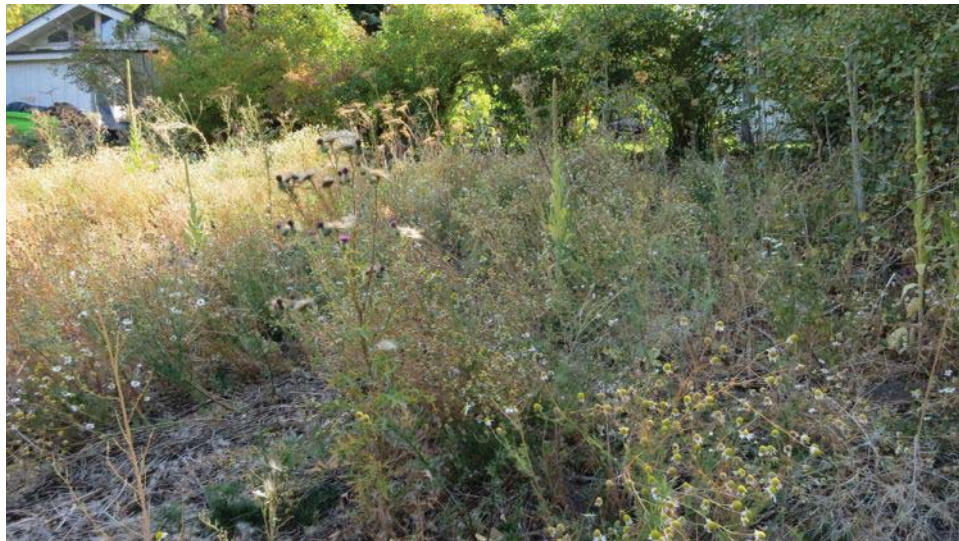
Soil Pit 1 Site, XXX 0-16 percent slope

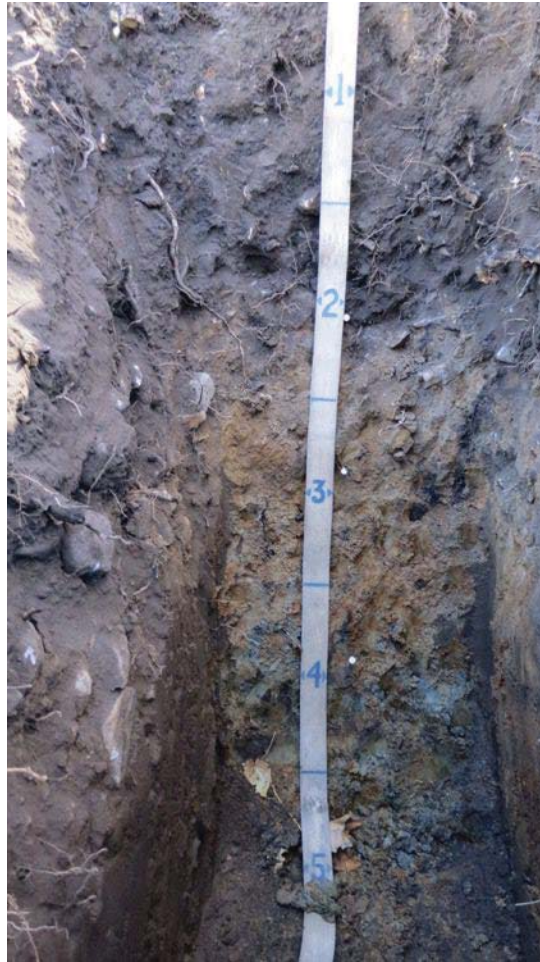
A photo of the pit is in Appendix 4, page 2. When described, the soil was dry to 26 inches, slightly moist from 26 to 36 inches, and wet from 36 to 60 inches.

Soil Pit 2 Profile, XXX 16-30 percent slope

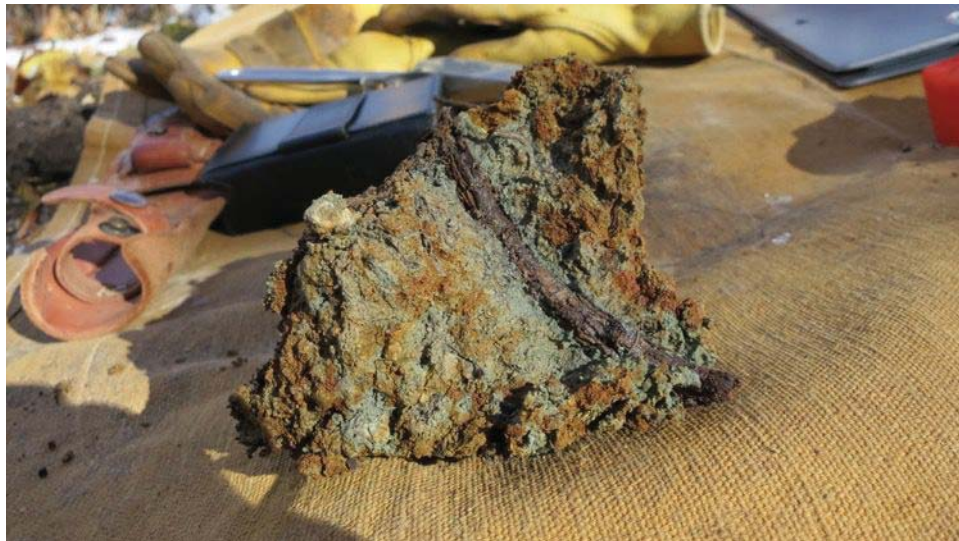
Soil Pit 2 Redox Features, XXX 16-30 percent slope

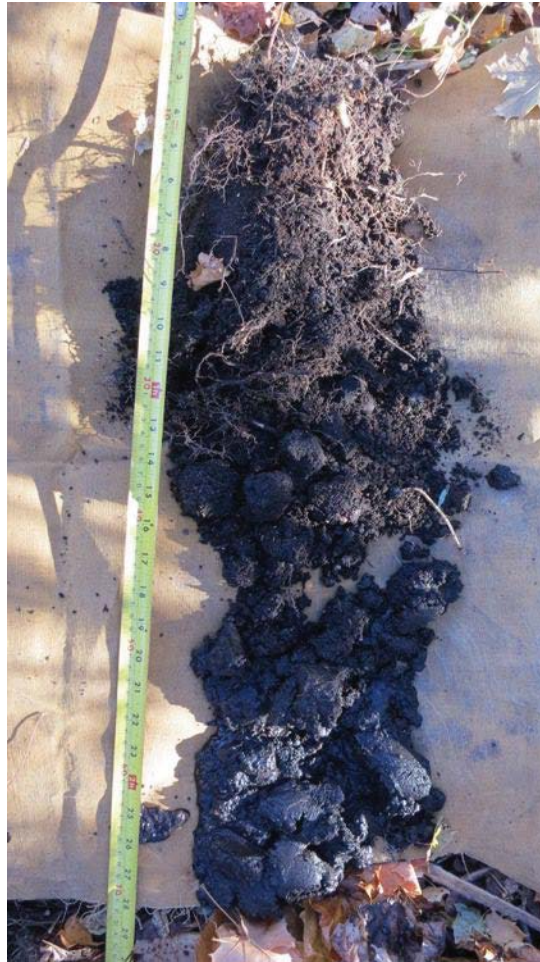
Soil Pit 3 Profile, SEZ (Lo)

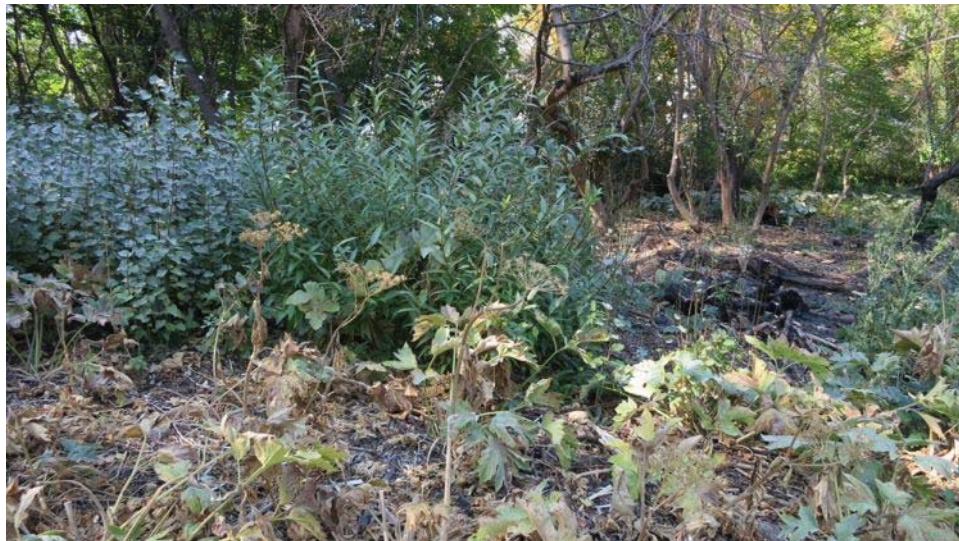
Described by Roger Poff on November 12, 2020 from a hand-dug soil pit plus an auger boring to 42 inches (saturated soil did not allow excavation). This soil is representative of soils in the SEZ. This soil is located on a nearly level portion of the SEZ. The site had been recently cleared, piled, and burned for fire protection. Vegetation is dominantly willow and willow and aspen sprouts, skunk cabbage, carex, and assorted weeds. A photo of the soil and landscape is in Appendix 4, page 3.

Soil Pit 3 Site, SEZ (Lo)

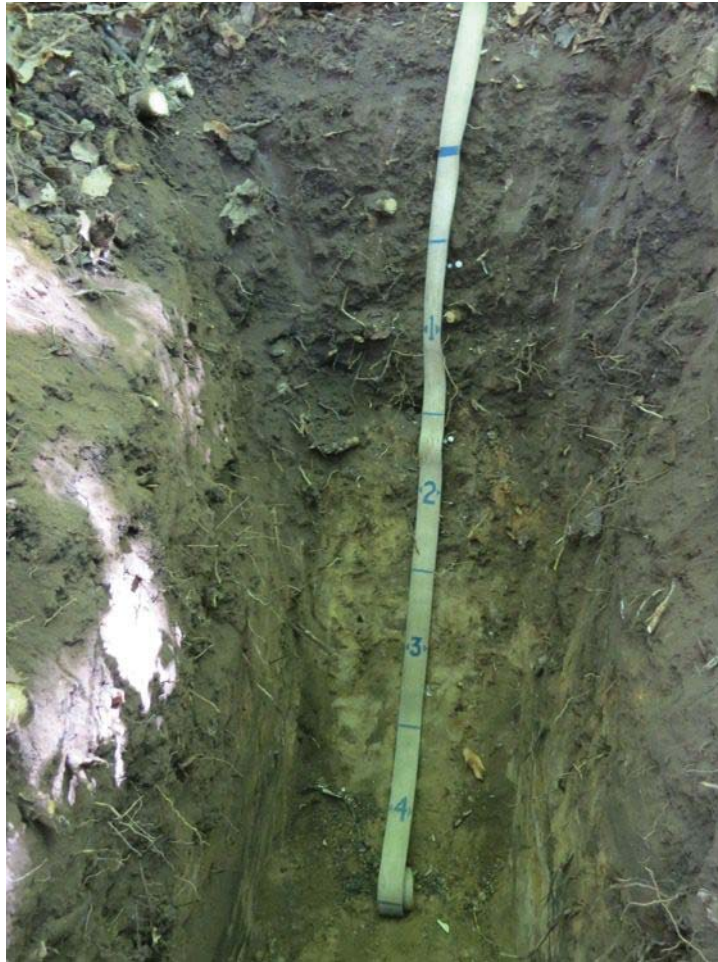
Soil Pit 4 Profile, XXX 0-16 percent slope

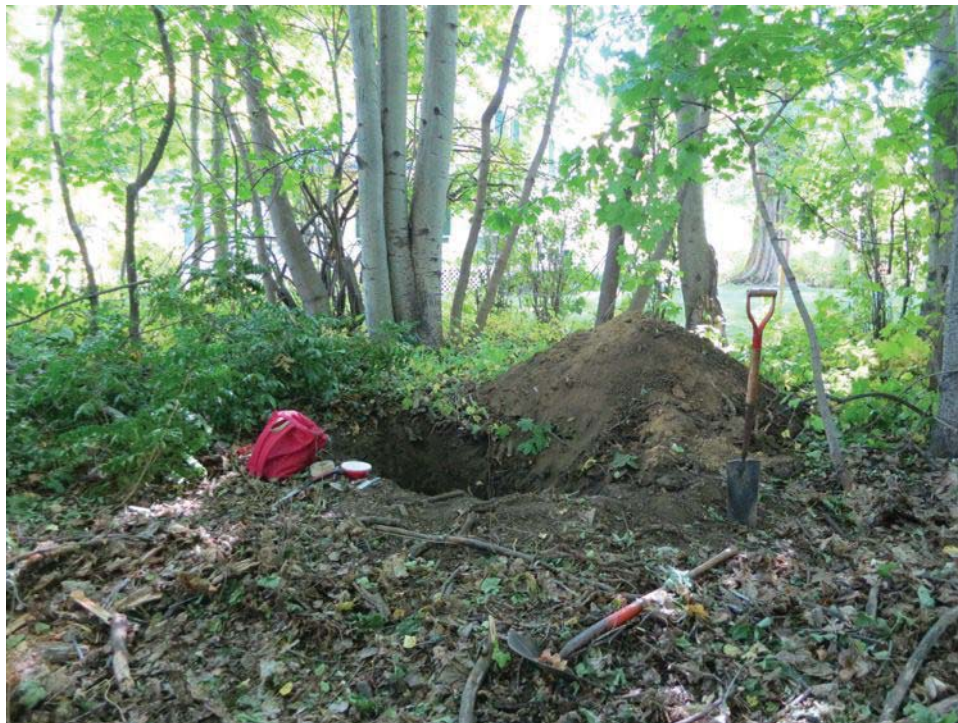
Soil Pit 4 Site, XXX 0-16 percent slope

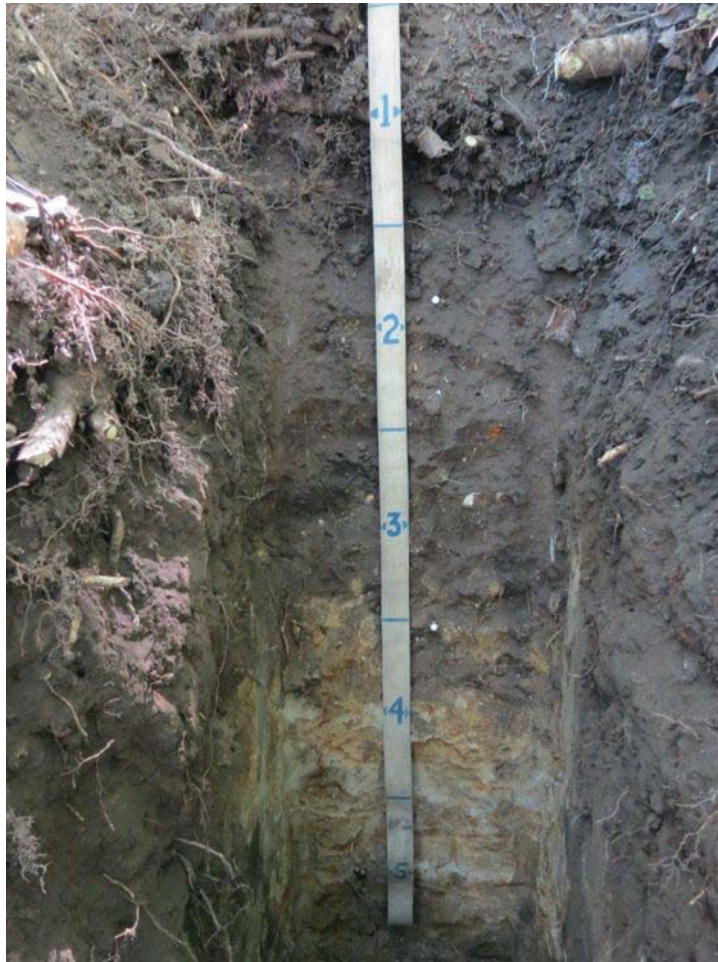
Surface conditions and vegetation are similar to those described for Pit #4. When described, the soil was very dry to 58 inches, then moist to 64 inches. This moderately well-drained soil has a thicker A horizon, darker surface colors, and more pronounced redox features below 40 inches than Soil Pit #4. These changes in soil properties are typical of soils located closer to the Class 1b boundary. A photo of the pit is in Appendix 4, page 5.

Soil Pit 5 Profile, XXX 16-30 percent slope

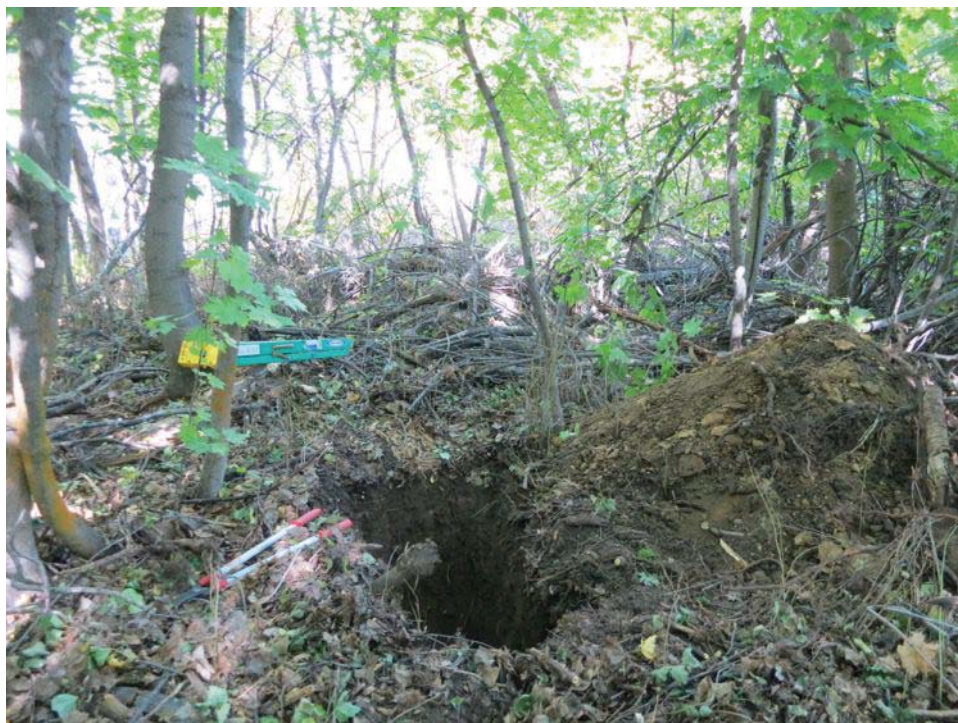
Soil Pit 5 Site, XXX 16-30 percent slope
