STAFF REPORT

Subject Backholm Land Capability Challenge 81 Observation Drive, Placer County, California APN: 093-120-010, TRPA File No.: LCAP2023-0197

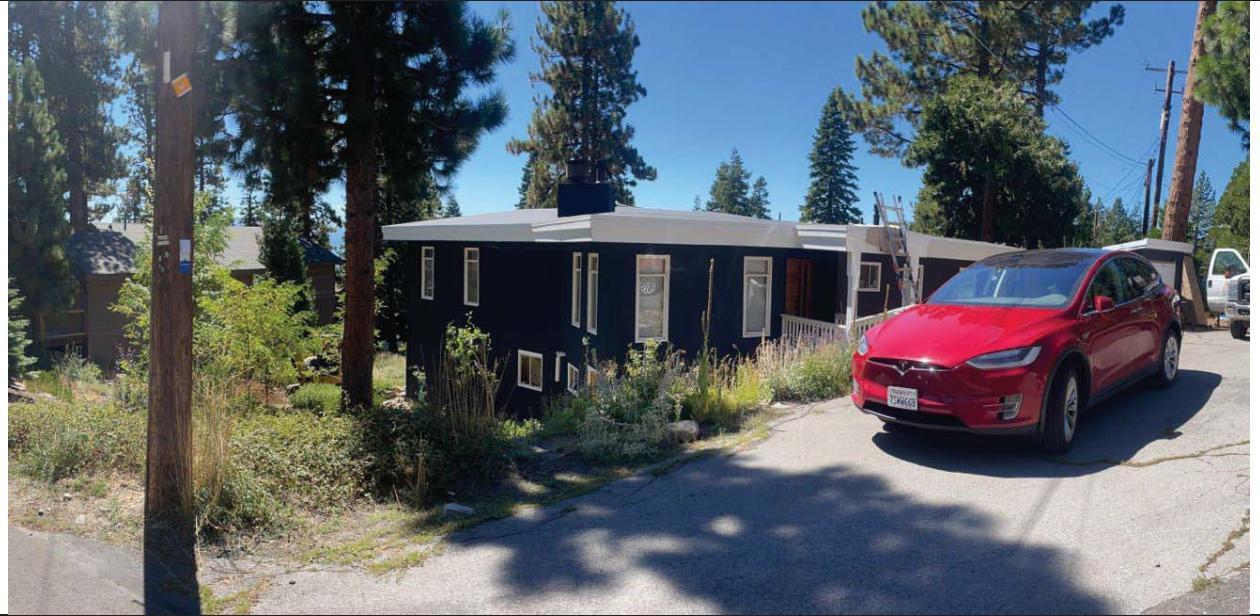
Photo 1 – View southwest at driveway and residence entrance (behind red car). The land surface drops off abruptly (foreground), because it was over-steepened from street construction (circa 1970s). Vegetation consists of Jeffrey pine, incense cedar, ornamental trees, greenleaf manzanita, huckleberry oak, bitterbrush, sagebrush, prostrate ceanothus & creeping snowberry.

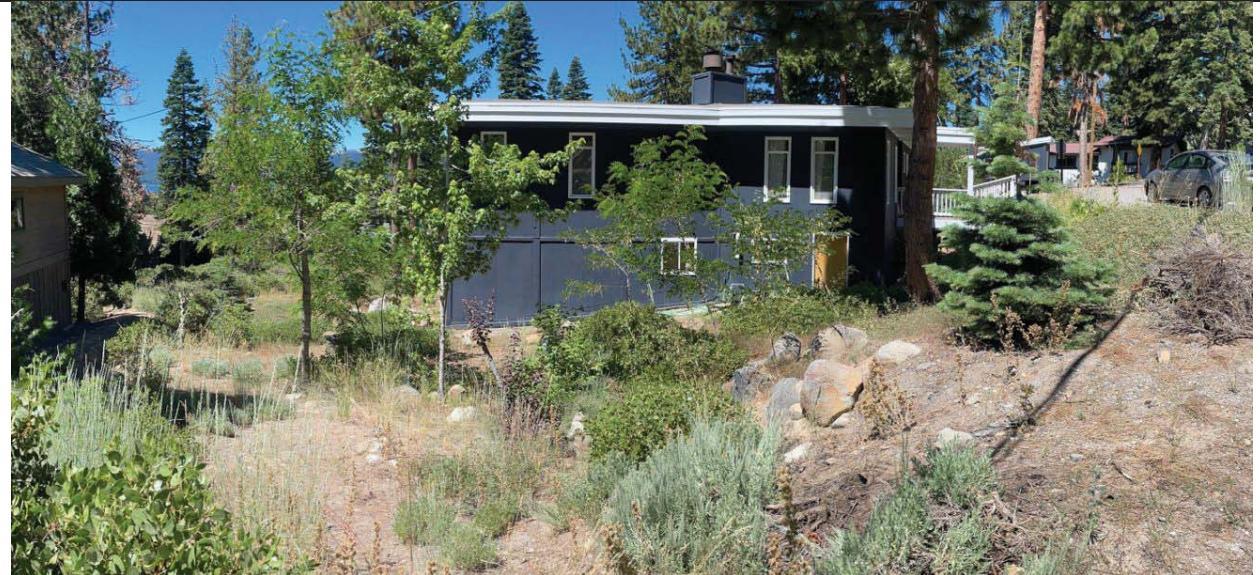
Photo 2 – View west at east portion of property (abuts Observation Drive). Natural slopes in this vicinity are roughly 15% (southwest aspect). Visible boulders were placed when road and/or residence constructed (not exposed bedrock).

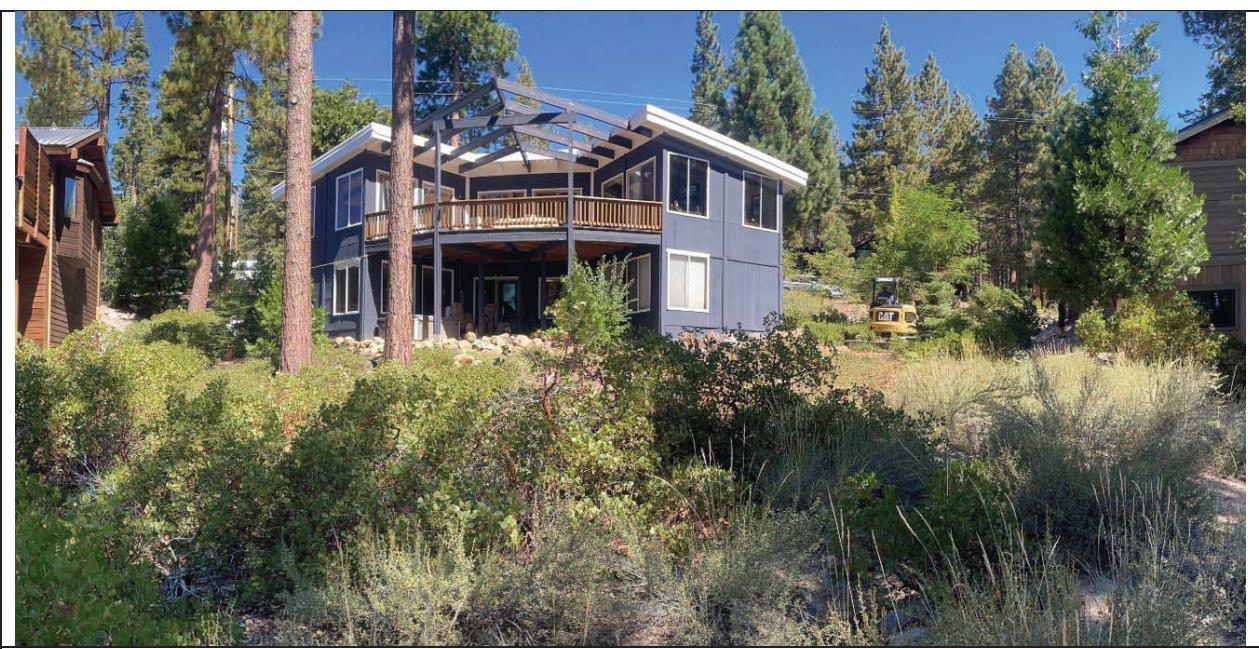
Photo 3 – View to north at residence located in north-center of parcel. The backyard is partially landscaped near the residence, but mostly native greenleaf manzanita, bitterbrush and grasses in the southern part (foreground). The backyard generally has 13% slopes, so the deep soils qualify this area (and majority of parcel) as Class 6.

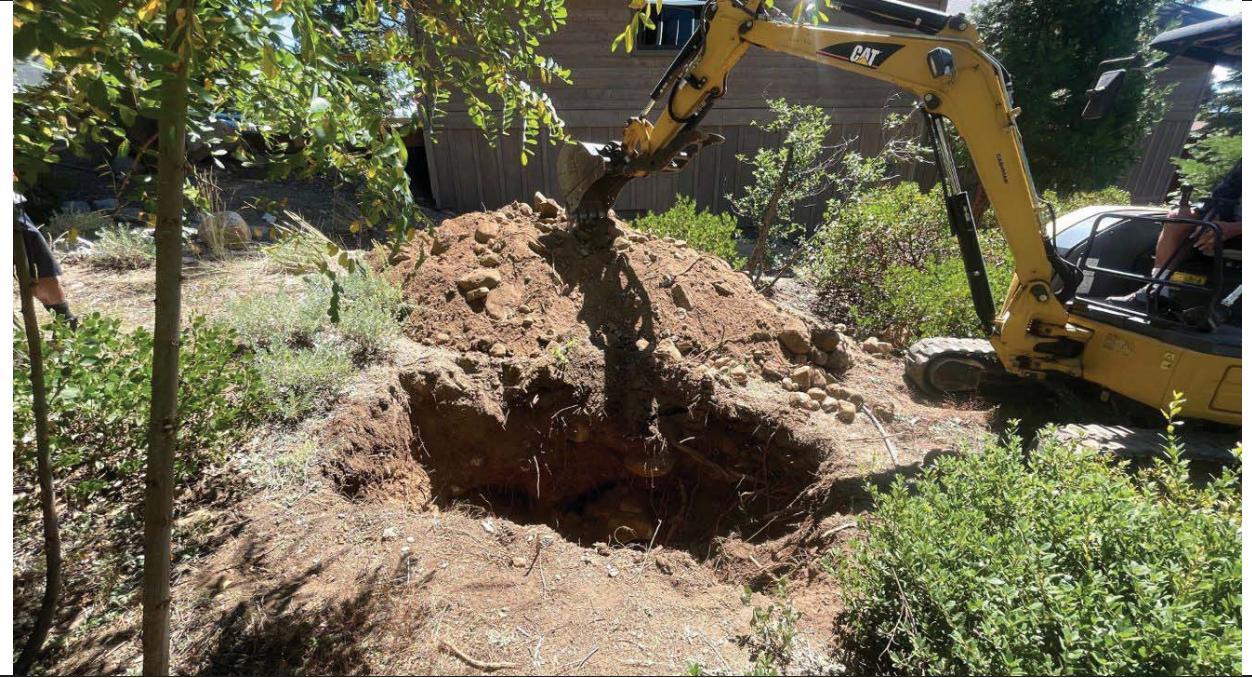
Photo 4 – View to southeast edge of parcel where Test Pit no. 1 was excavated by backhoe. The pit was located about 35 feet west of Observation Drive and 15 feet north of the south property line. Slopes are 15% in this vicinity. The test pit showed the property has deep soils that become increasingly more gravelly with depth (no root restriction nor evidence of seasonal water table).

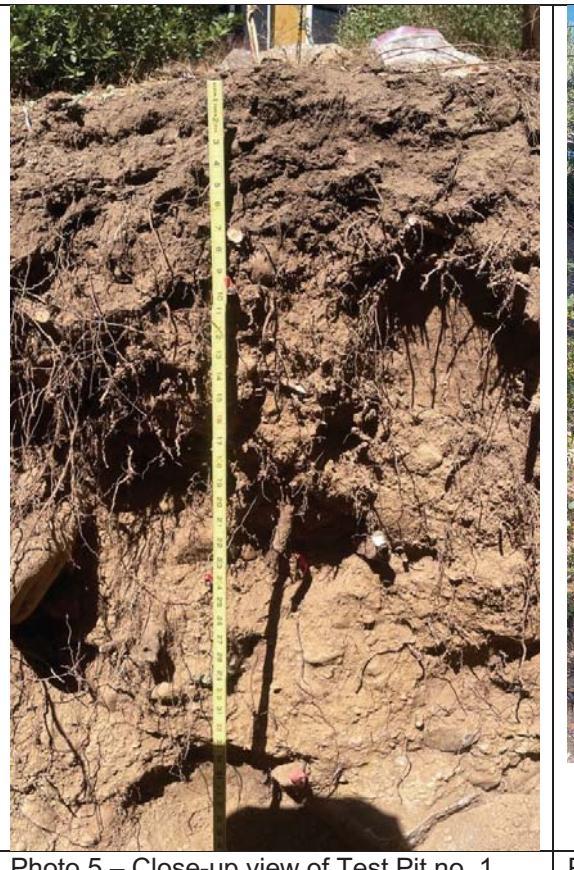
Photo 5 - Close-up view of Test Pit no. 1 showing gravelly-sandy surface layer with many fine and medium roots. While subsoil layers had increasing gravel content, root penetration was still extensive. Fine and medium size roots were observed at a depth of 54+ inches. The underlying substratum (at 39 inches) has rounded pebbles, gravels and cobbles which attained their smooth condition when ancient lake levels occurred at this elevation. This soil is unlike the mapped Umpa series, and unlike the Jorge-Tahoma soil types due to the waveinfluenced substratum. This is an unnamed inclusion (XXX). For slopes 16 to 30%, this soil rates as Class 4 and Class 6 for slopes 0 to `6%, as per Table 4 of the land capability system.

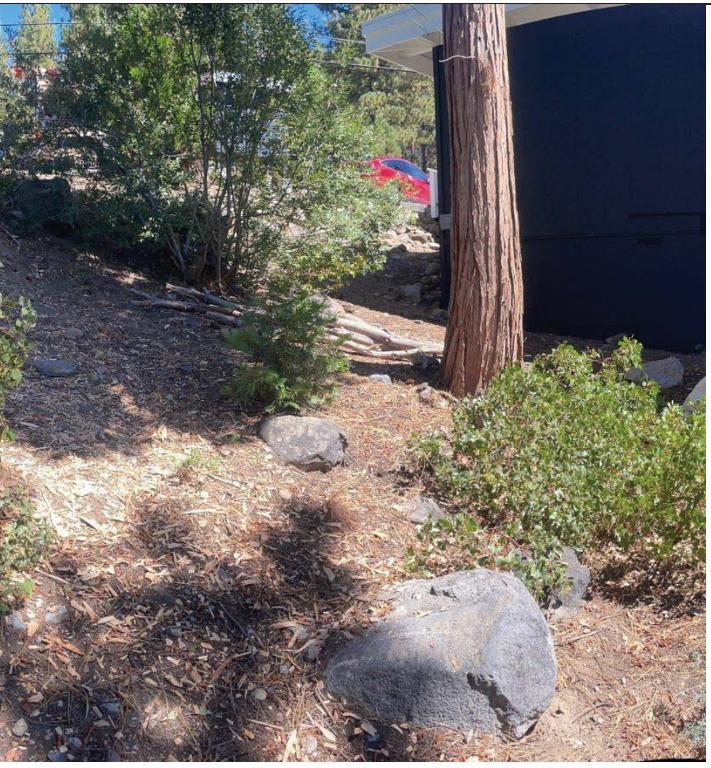
Photo 6 – View northwest side of residence (dark building at right), where the natural slope was artificially steeped by road construction (circa 1970s). For land capability purposes, the natural slopes are relied upon. The natural slope remains to the right of the tree and boulders, about 17% in this vicinity. Such slope qualifies this portion of the property as Class 4 for slopes 16 to 30%. The boulders in foreground presumably excavated when residence was constructed.

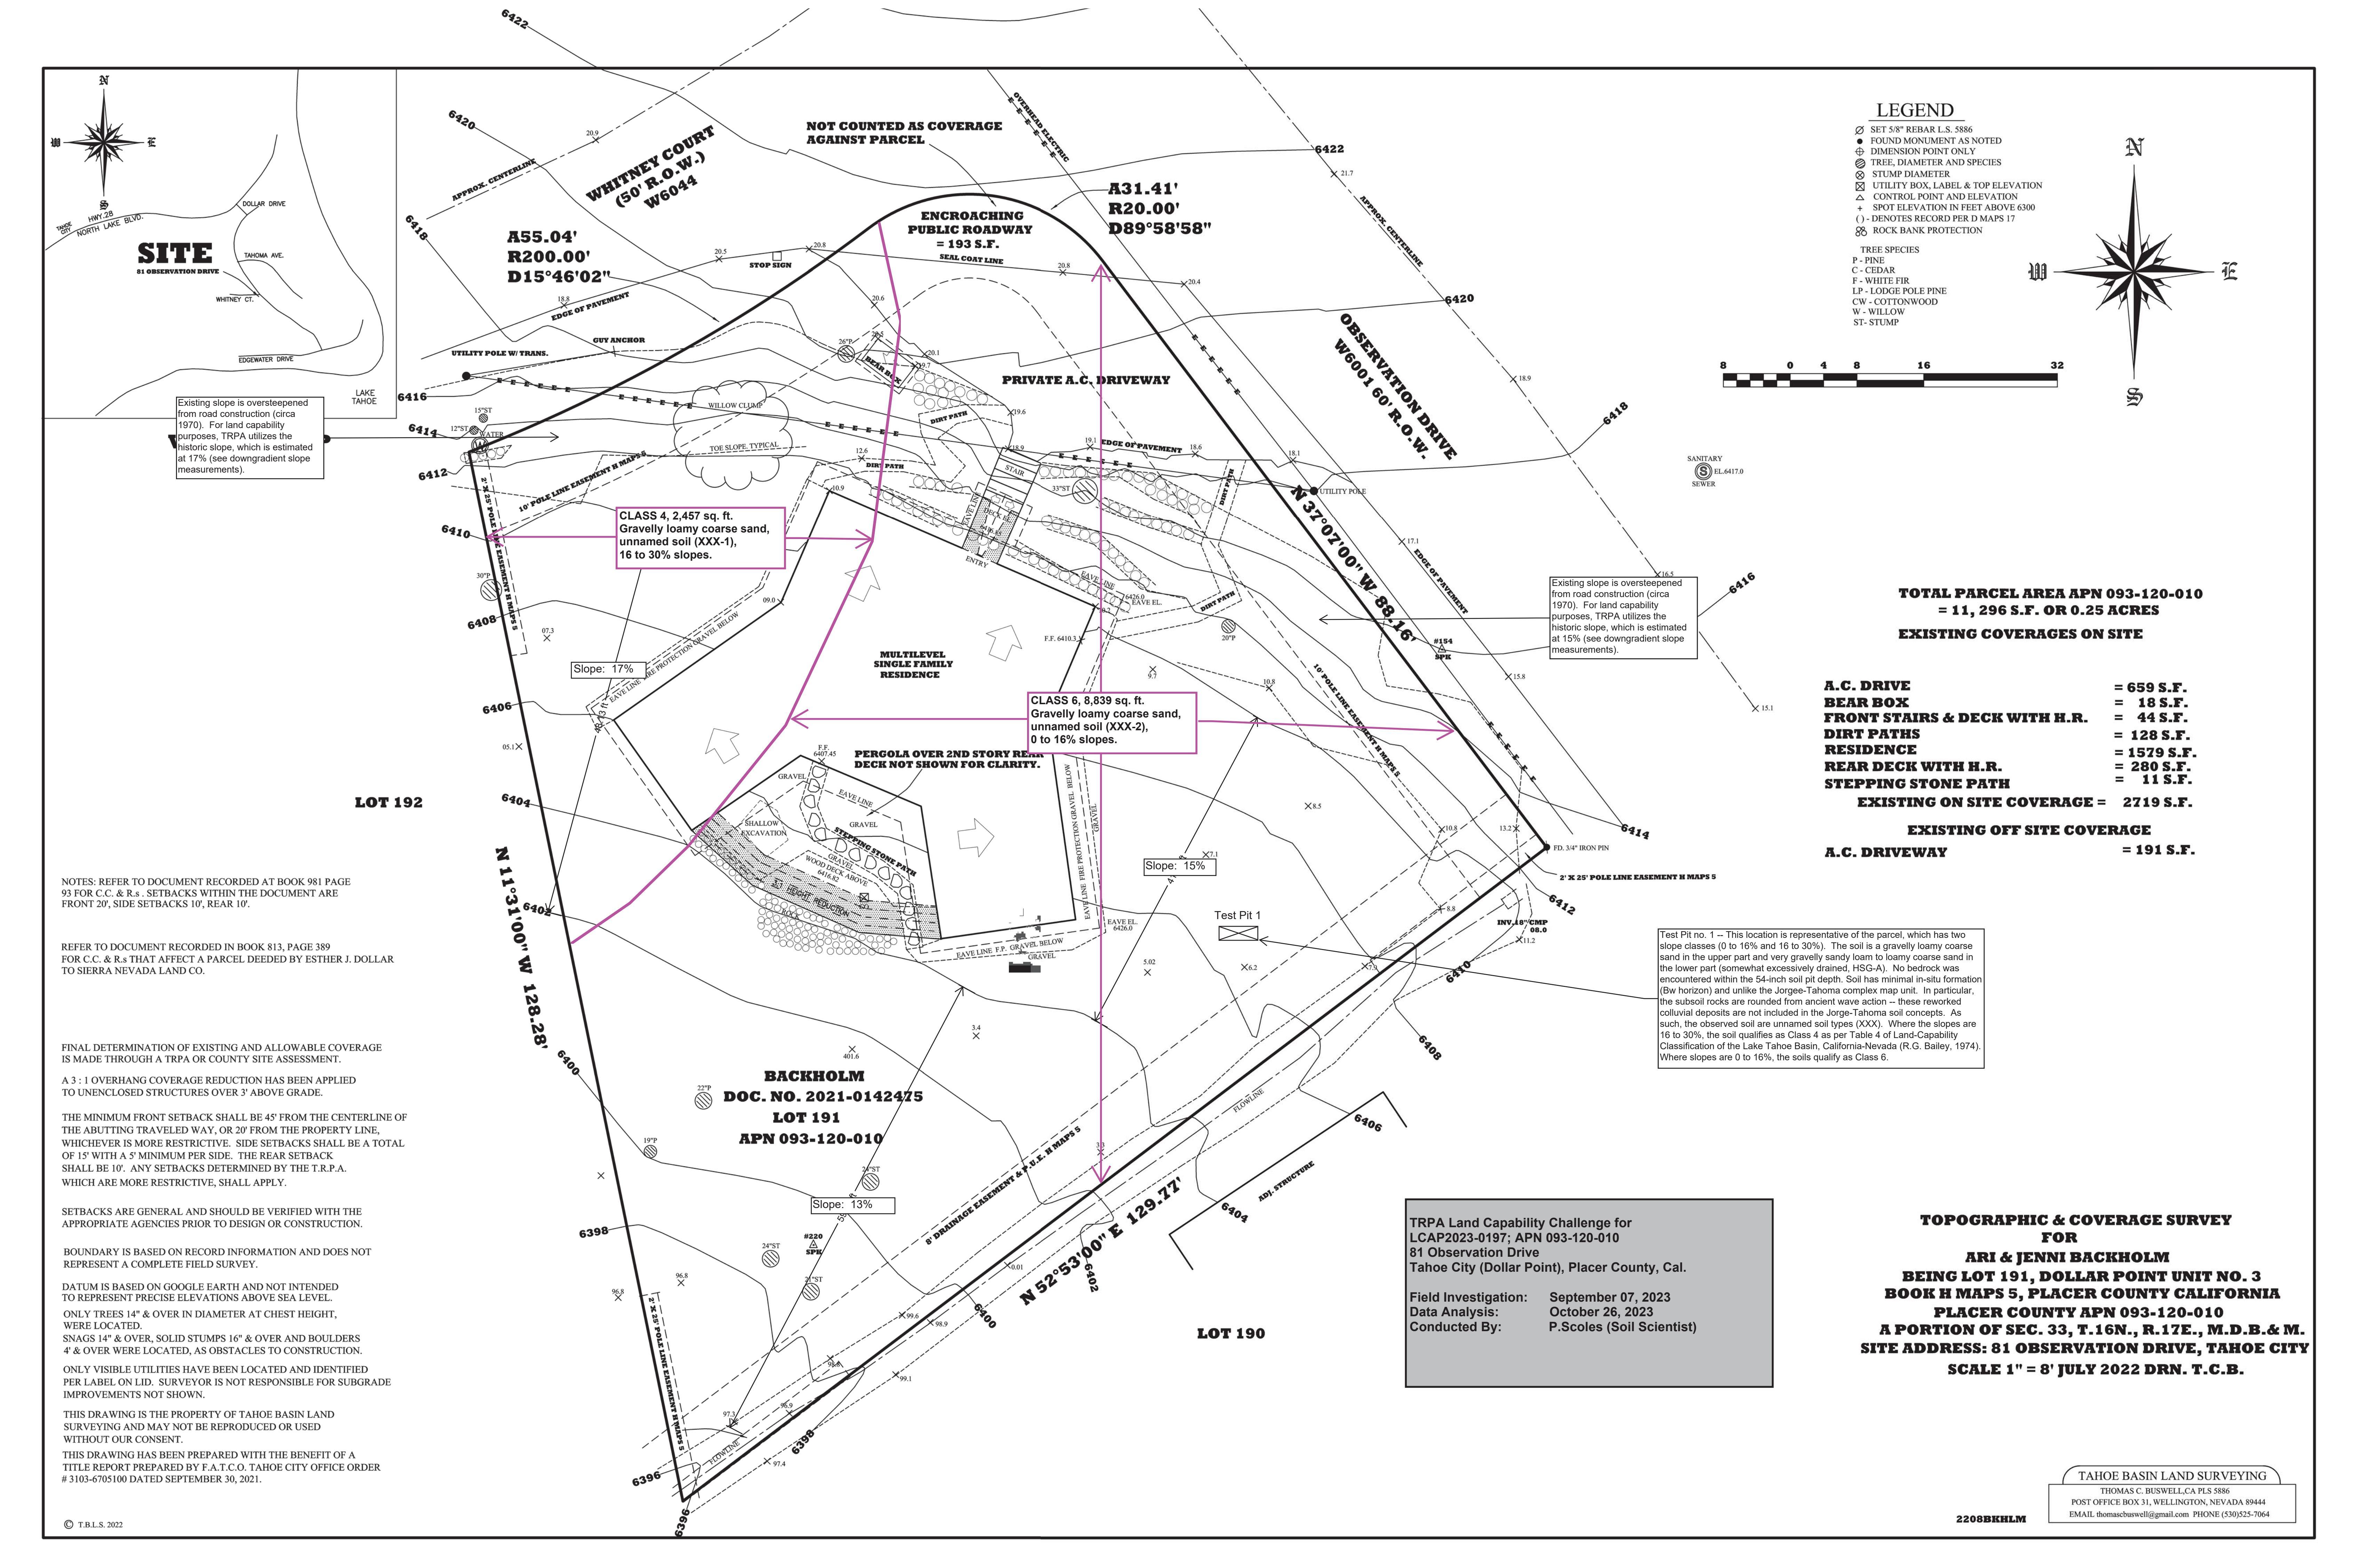
Attachment C October 2023 Land Capability Challenge Recommendation Map

accordance with Table 4 of Land-Capability Classification of the Lake Tahoe Basin, California-Nevada (R.G. Bailey, 1974), the land capability rating for the observed soil is Class 4 for slopes 16 to 30% (unnamed, XXX-1) and Class 6 for slopes 0 to 16% (unnamed, XXX-2). The table below summarizes the soil types, slope classes, as well as changes in land capability concluded by this land capability challenge.

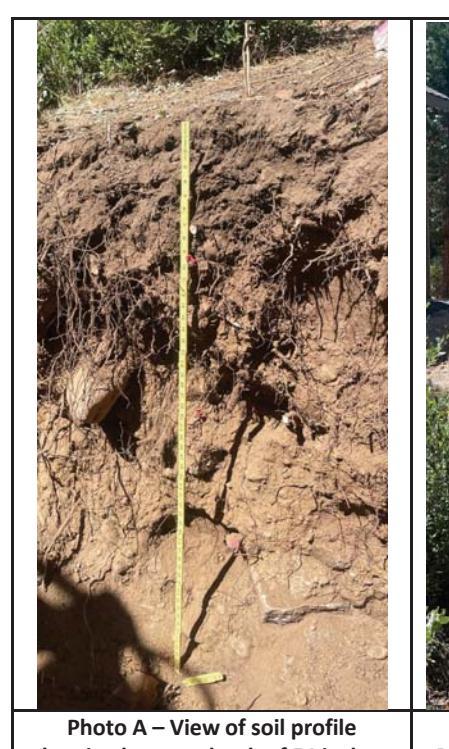
Photo A – View of soil profile showing bottom depth of 54 inches. Fine and medium root penetration to bottom. No indication of seasonal water table.

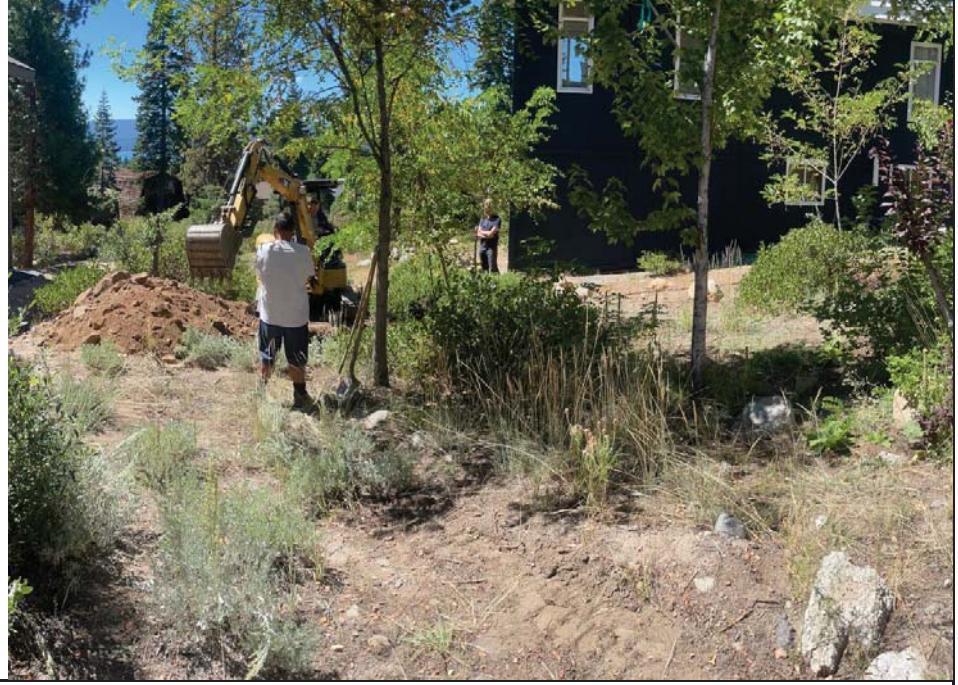
Photo B – View southwest at Test Pit 1, located 17 feet southeast of residence, 35 feet west of east property line and 15 feet north of south property line. Pit location is representative of parcel and has a 15% slope. The soil layers are composed of mixed colluvium over bedrock (not observed). Land surface has 5 to 10% surface stone and boulders (floaters).
