MEMORANDUM

Subject: R&R Edgewater LLC Land Capability Challenge
3395 Edgewater Drive, Placer County, California
APN: 093-082-007, TRPA File No.: LCAP2023-0037

**Land Capability Challenge
R&R Edgewater LLC
3995 Edgewater Drive
Placer County, California
(APN 093-082-007)**

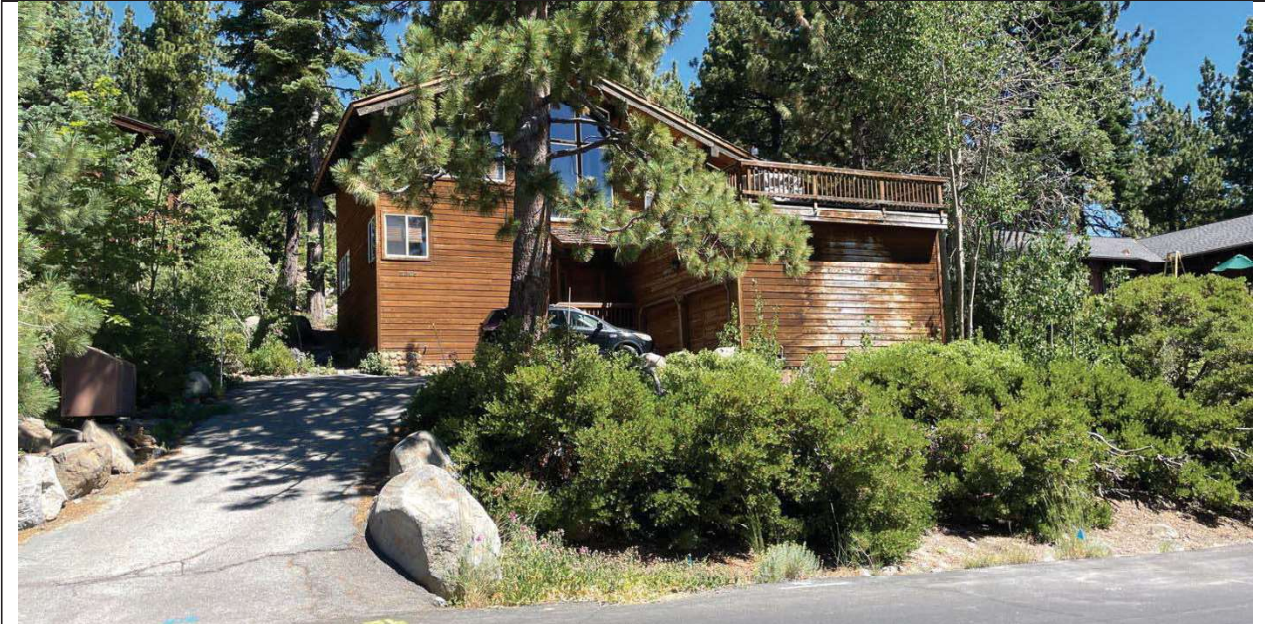
Photo 1 – View upslope (north) at south side of property. Dominant vegetation is Jeffrey pine, white fir, aspen, greenleaf manzanita and huckleberry oak. Small area in foreground is over-steepened from street construction (circa 1970).

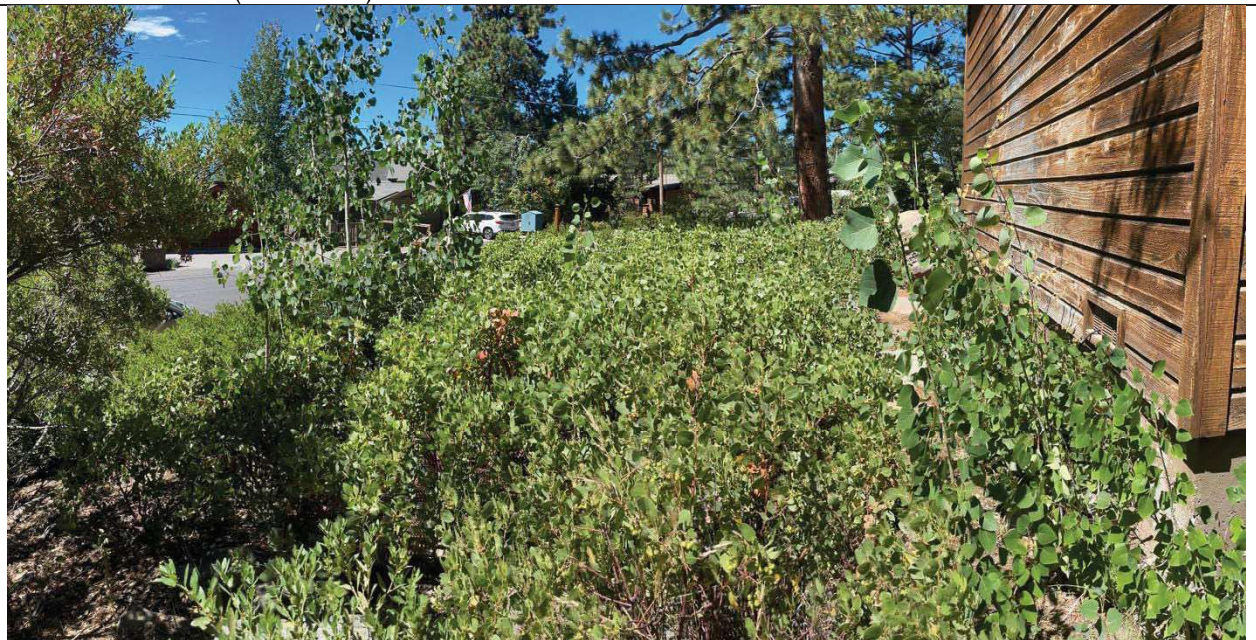
Photo 2 – View southwest at south portion of property, which supports mostly greenleaf manzanita and huckleberry oak, plus a few planted aspen. Natural slopes in this vicinity are 16 to 18% (south aspect).

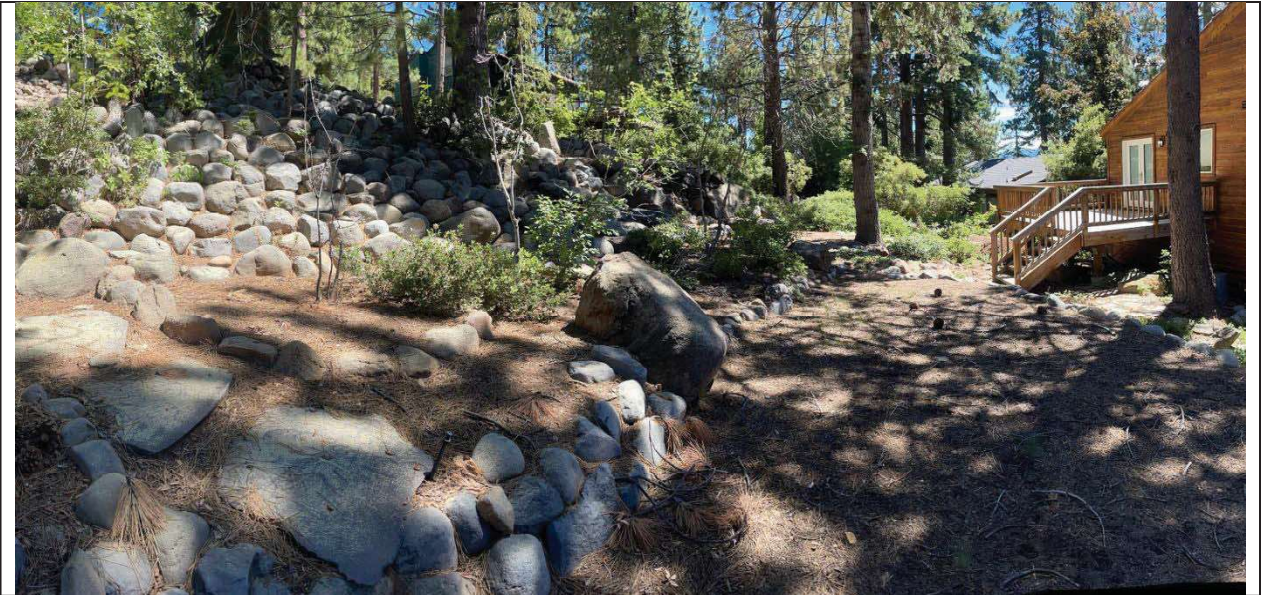
Photo 3 – View to east at upper (north) part of property. The backyard has several created terraces separated by rock retaining walls. At upper left, rock armored surface atop 40 to 55% slopes that were over-steepened when adjacent Dardanelles Avenue was constructed (circa 1970). For land capability matters, TRPA utilizes natural (historic) slopes, which are estimated at 20% for this vicinity.

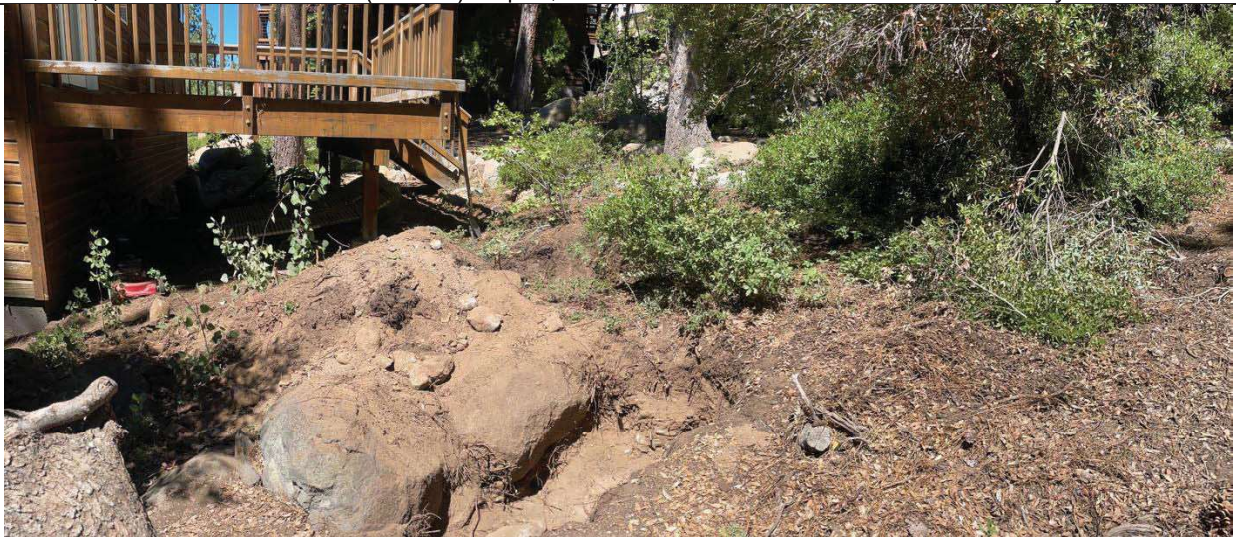
Photo 4 – View to east edge of parcel where sample site 7/25/23-1 was hand-excavated about 15 feet northeast of residence (just east of small deck, behind dirt pile). Slopes are 20% in this vicinity. The test pit showed the property has deep soils that become increasingly rocky with depth.

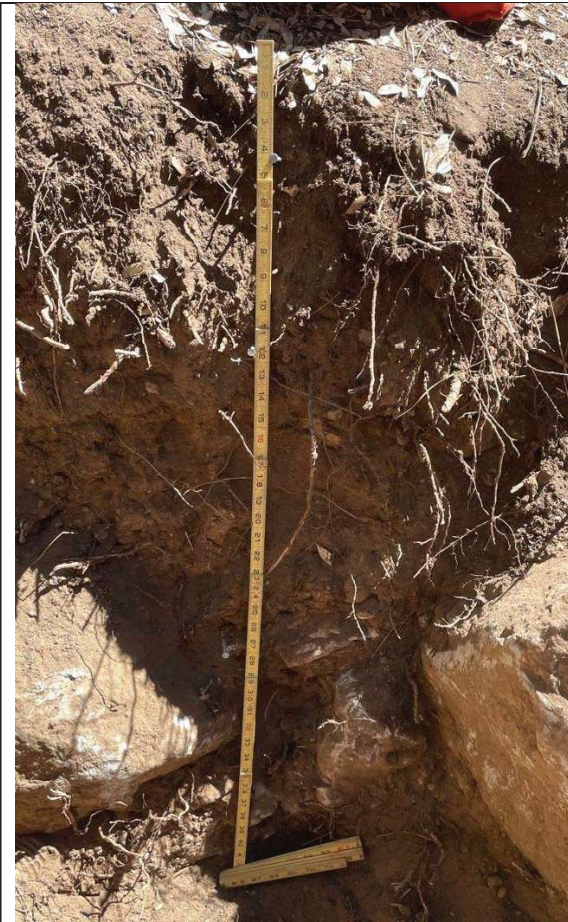
Photo 5 – Close-up view of sample site 7/25/23-1 showing surface layer with many fine and medium roots. Subsoil layers had increasing rockiness, but still contained many medium roots and common coarse roots. Note rounded shape of boulders, which attained their smooth condition when ancient lake levels occurs at this elevation and wave-washed the rocks. While similar to the Jorge-Tahoma soil types, the wave-influenced subsoil makes it an unnamed inclusion (XXX). For slopes 16 to 30%, this soil rates as Class 4 as per Table 4 of the land capability system.

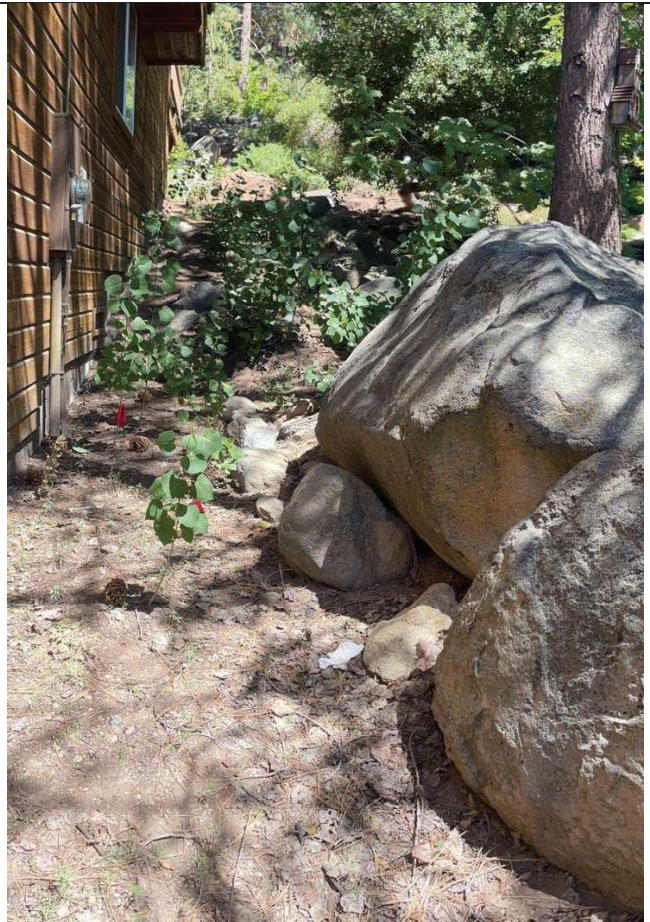
Photo 6 – View north along east side of residence. Soil pit in upper-center of photo (right of residence, above aspen saplings). The slope in this vicinity is ranges from 17 to 20%. Boulders in foreground presumably excavated when residence was constructed. Boulders of similar size (or smaller) prevented hand-digging of soil pit deeper than 44 inches – still sufficient depth of land capability evaluation.

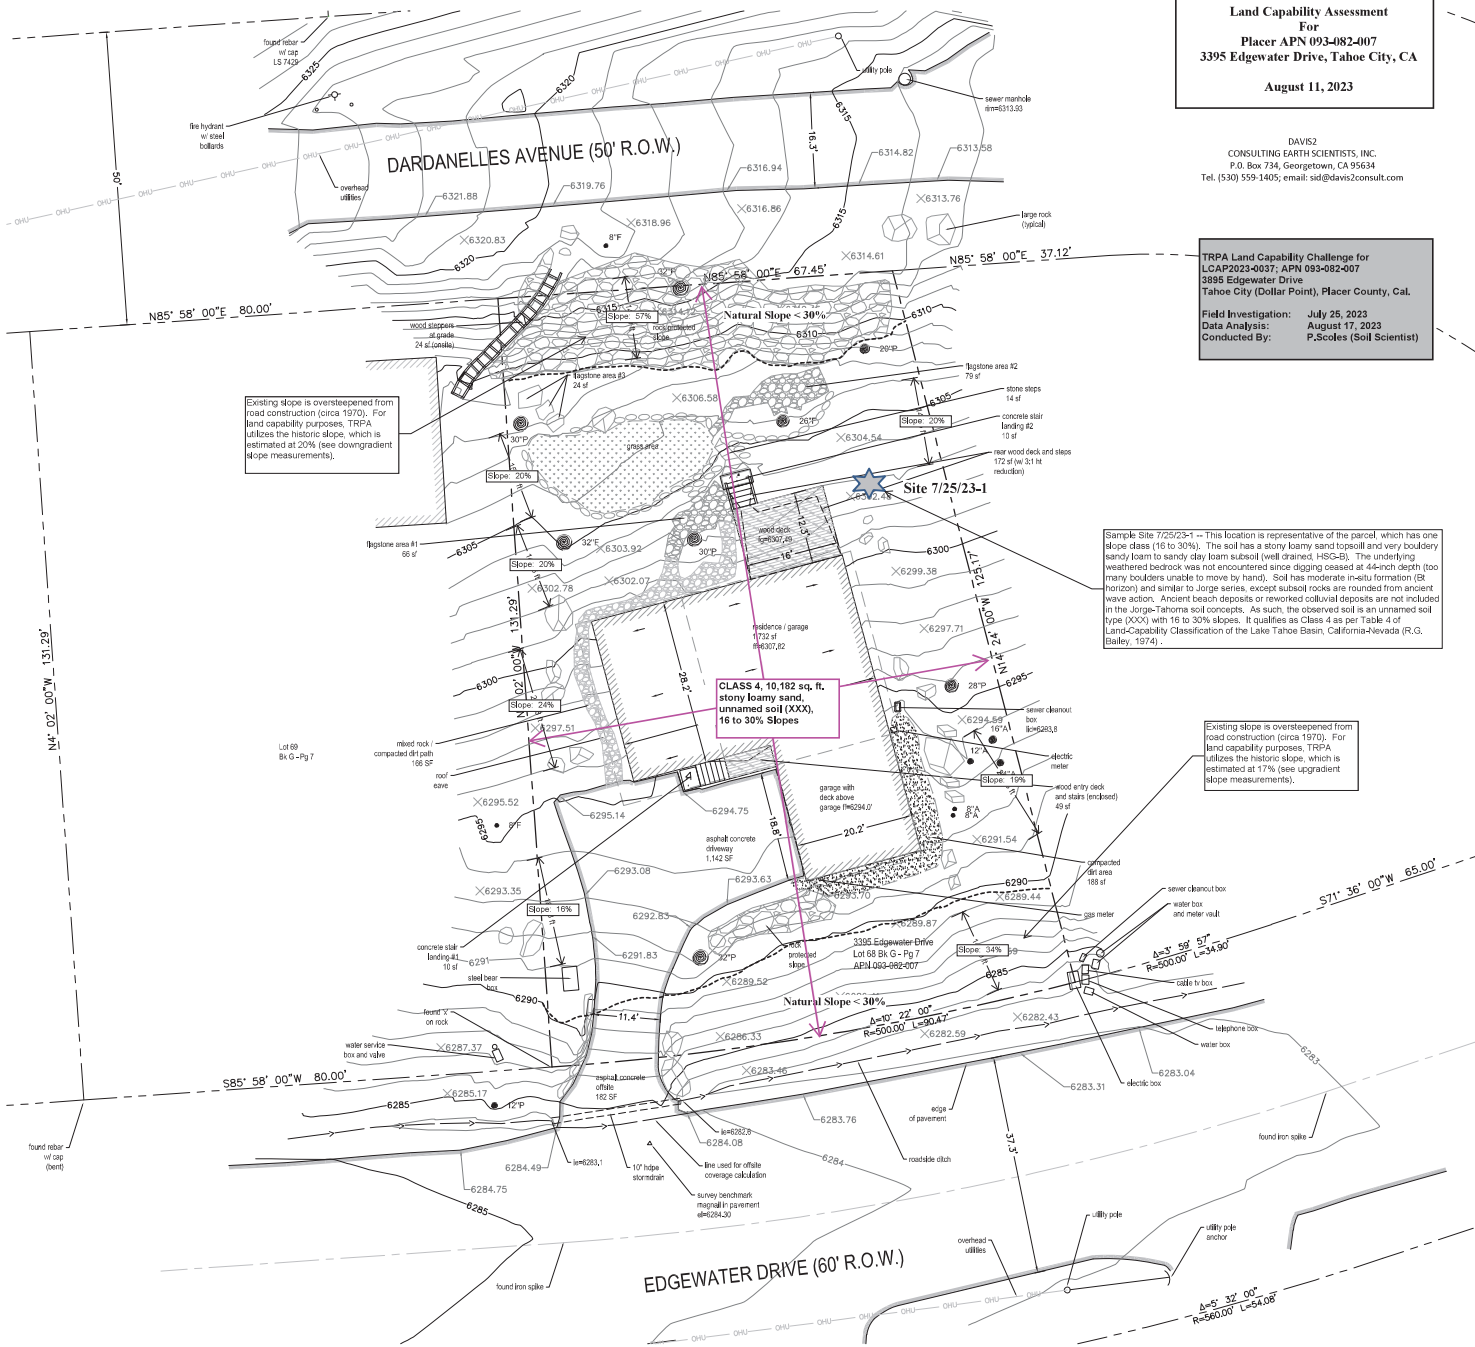
Existing slope is overstepped from road construction (circa 1970). For land capability purposes, TRPA utilizes the historic slope, which is estimated at 20% (see downgradient slope measurements).

Sample Site 7/25/23-1 -- This location is representative of the parcel, which has one slope class (16 to 30%). The soil has a stony loamy sand topsoil and very bouldery sandy loam to sandy clay loam subsoil (well drained, HSC4-B). The underlying weathered bedrock was not encountered since digging ceased at 44-inch depth (too many boulders unable to move by hand). Soil has moderate in-situ formation (Bk horizon) and similar to Jolge series, except subsoil rocks are rounded from ancient wave action. Ancient beach deposits or reworked colluvial deposits are not included in the Jolge-Tahoma soil concepts. As such, the observed soil is an unnamed soil type (XXX) with 16 to 30% slopes. It qualifies as Class 4 as per Table 4 of Land-Capability Classification of the Lake Tahoe Basin, California-Nevada (R.G. Bailey, 1974).

Existing slope is overstepped from road construction (circa 1970). For land capability purposes, TRPA utilizes the historic slope, which is estimated at 17% (see upgradient slope measurements).

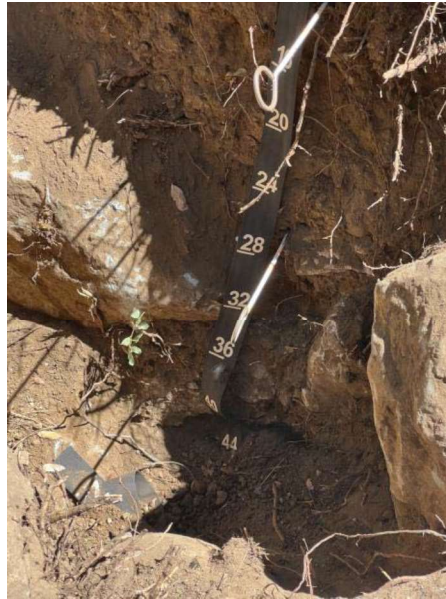
Fig. 3 – soil profile.

- Oi 0 – 2 inches, conifer, needles and duff.
- A1 2 - 4 inches, grayish brown (10YR 5/2) and very dark grayish brown (10YR 3/2) moist; stony loamy sand; moderate fine granular structure; soft, loose, nonsticky and nonplastic; many fine medium roots; many very fine and fine interstitial pores; slightly acid; ten percent gravel and thirty percent stones, clear smooth boundary.

- A2 4 - 12 inches, grayish brown (10YR 5/2) and very dark grayish brown (10YR 3/2) moist; gravelly loamy sand; weak fine granular structure; soft, loose, nonsticky and nonplastic; many fine medium coarse roots; many very fine and fine interstitial pores; slightly acid; ten percent gravel and thirty percent stones, clear smooth boundary.

- Bt1 12 – 28 inches, light brown (7.5YR 6/3) and brown (7.5YR 4/3) moist; very blocky sandy loam; moderate medium subangular blocky structure; slightly hard, very friable, slightly sticky and nonplastic; common fine medium coarse roots; common fine medium tubular pores; few thin clay films line tubular pores; medium acid; ten percent gravel and thirty percent boulders; gradual wavy boundary.

- Bt2 28 – 44+ inches, light brown (7.5YR 6/4) and brown (7.5YR 4/4) moist; very bouldery sandy clay loam; moderate medium subangular blocky structure; slightly hard, friable, slightly sticky and slightly plastic; common fine medium coarse roots; common fine medium tubular pores; common thin clay films occur on faces of peds and line tubular pores; medium acid; ten percent gravel and thirty percent boulders.
