MEMORANDUM

Subject Burgess Land Capability Challenge 744 Chapel Lane, Placer County, California APN: 094-251-009; TRPA File #: LCAP2023-0051

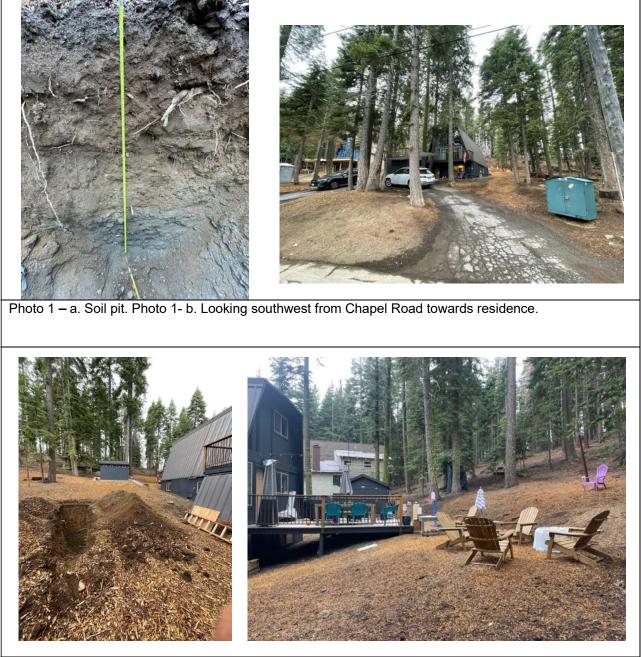
Photo 2 – a. View across pit to west- northwest. Photo 2- b. View of rear deck looking south. Class 4 area above, to right of deck.
