STAFF REPORT

Date: January 11, 2024

Subject: Moore Land Capability Challenge
 362 and 370 Beaver Street, Kings Beach, Placer County, CA
 APN: 090-212-010; TRPA File no: LCAP2023-0268 and
 APN: 090-212-024; TRPA File no. LCAP2023-0269

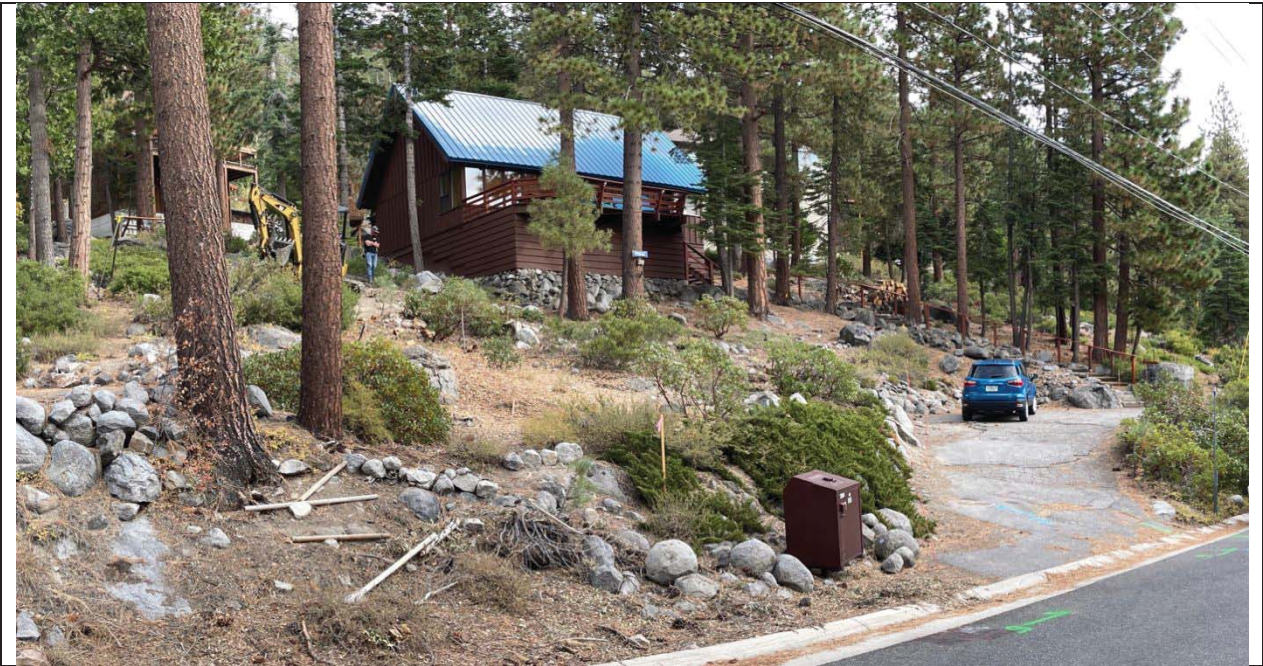
Photo 1 – View to east and southeast from northwest corner of project area. Slopes are 30 to 33% just below the residence. Slopes are artificially steeper adjacent to driveway; however, historic slope condition is utilized for land capability challenges.

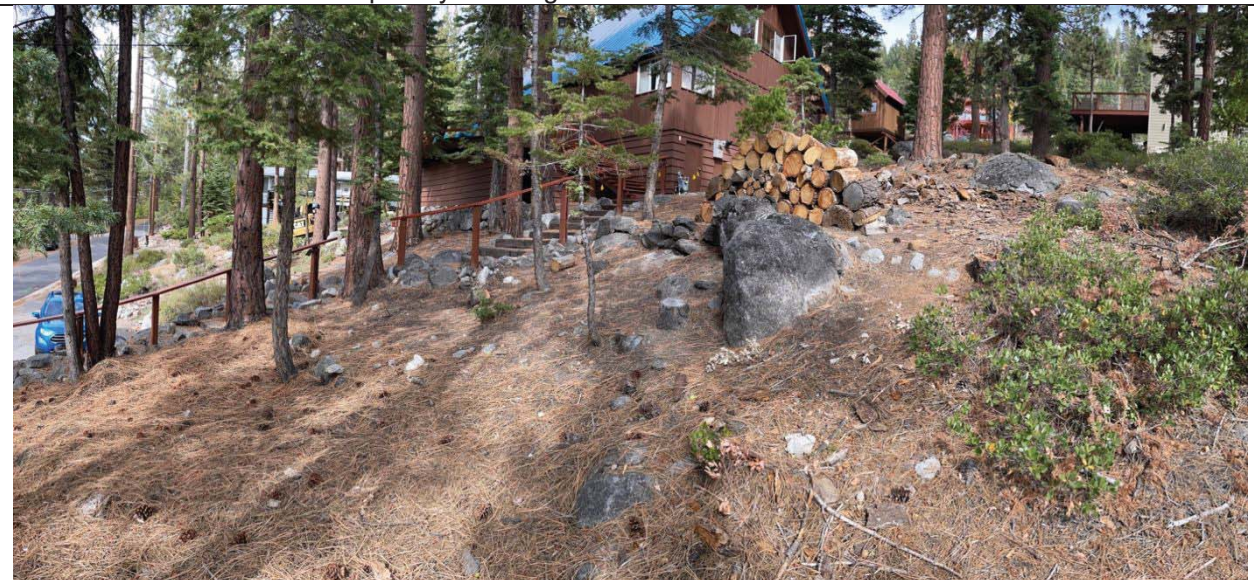
Photo 2 – View to north by northeast from southwest corner of project area. Natural slopes are 30 to 33% in left portion of photo and decreasing to 24% at far right. Dominant trees are Jeffery pine, white fir, with lesser amounts of incense cedar. Surface stones and boulders amount to 15 to 20% ground cover.

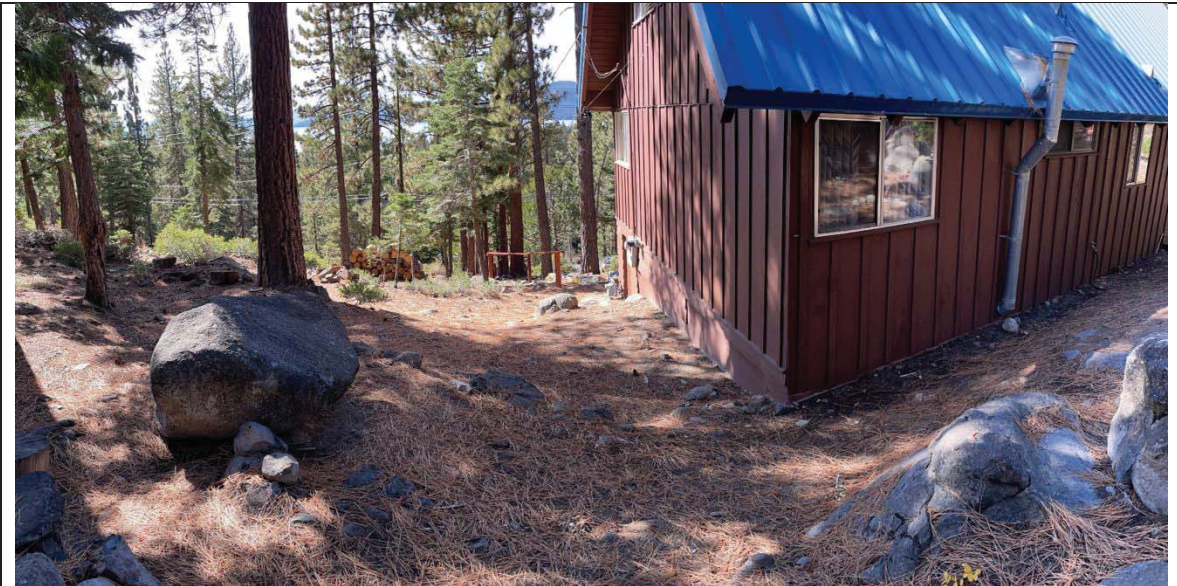
Photo 3 – View to west (downslope) from southeast corner of APN 090-212-024 (residence parcel). Understory saplings and shrubs (huckleberry oak, bitterbrush) have been thinned around residence for fire protection. Boulders in foreground are free-standing (not attached to bedrock).

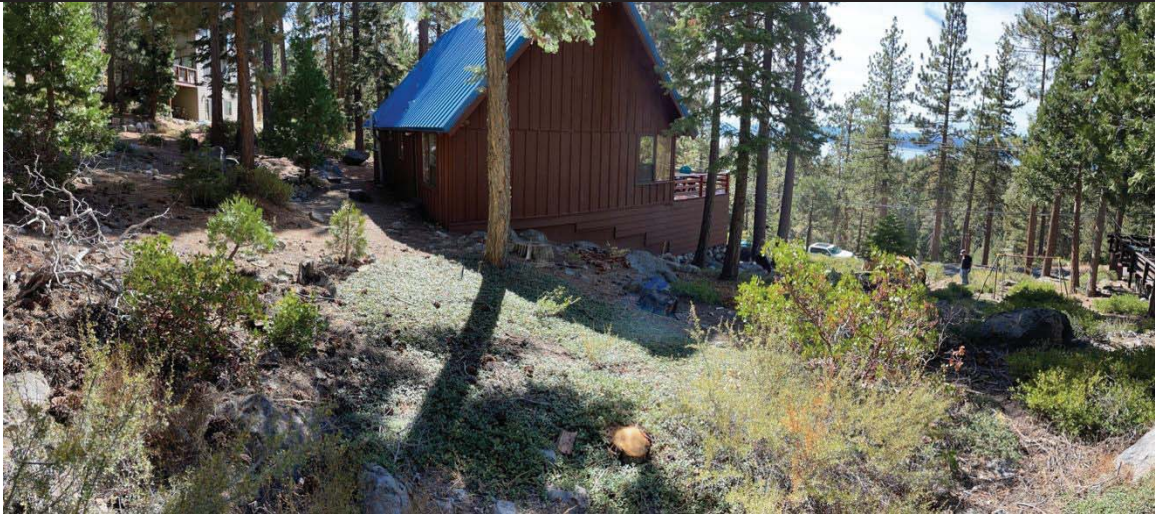
Photo 4 – View to south to southwest from northeast corner of project area. The east (upper) part of project area has 21 to 29% slopes. Where fewer trees, vegetated ground cover is 40 to 50% and duff cover is 50 to 60%. The observed soils are deep (60+ inches), well drained and have moderate permeability in the subsoil. Such conditions are consistent with Hydrologic Soil Group B (no subsurface water or root penetration limitations).

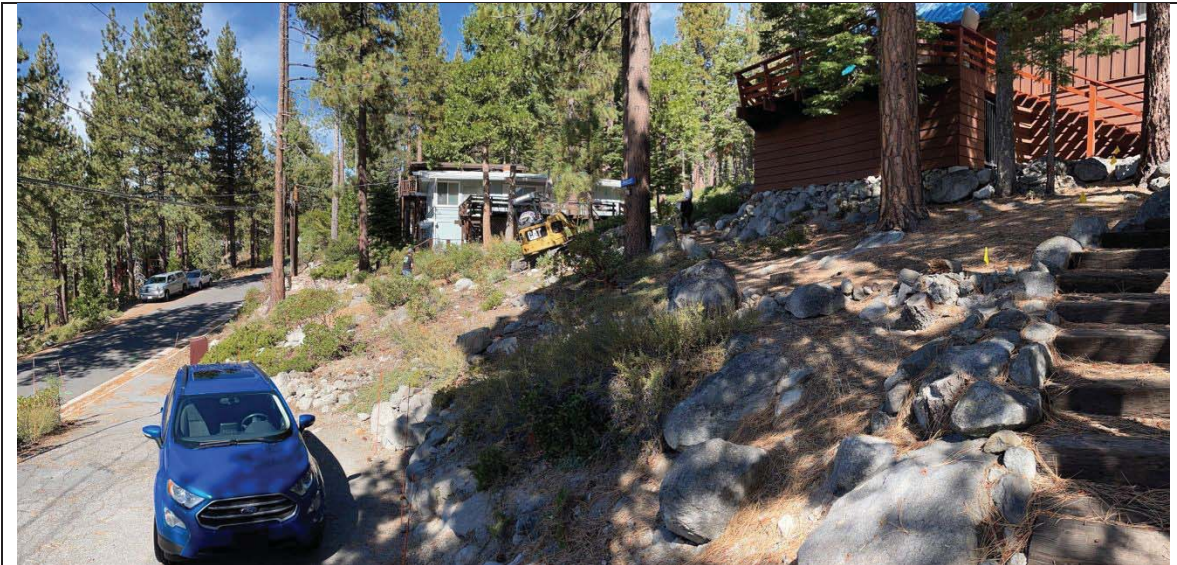
Photo 5 – View to north at driveway (left) and stairs to residence (right). The slopes immediately above and below driveway are artificially steepened. Natural slopes in this area are 33% (apparent on parcel immediately to south), which qualifies such land as Class 1A. The soil pit location (center, background) was undisturbed, except for fire protection vegetation thinning.

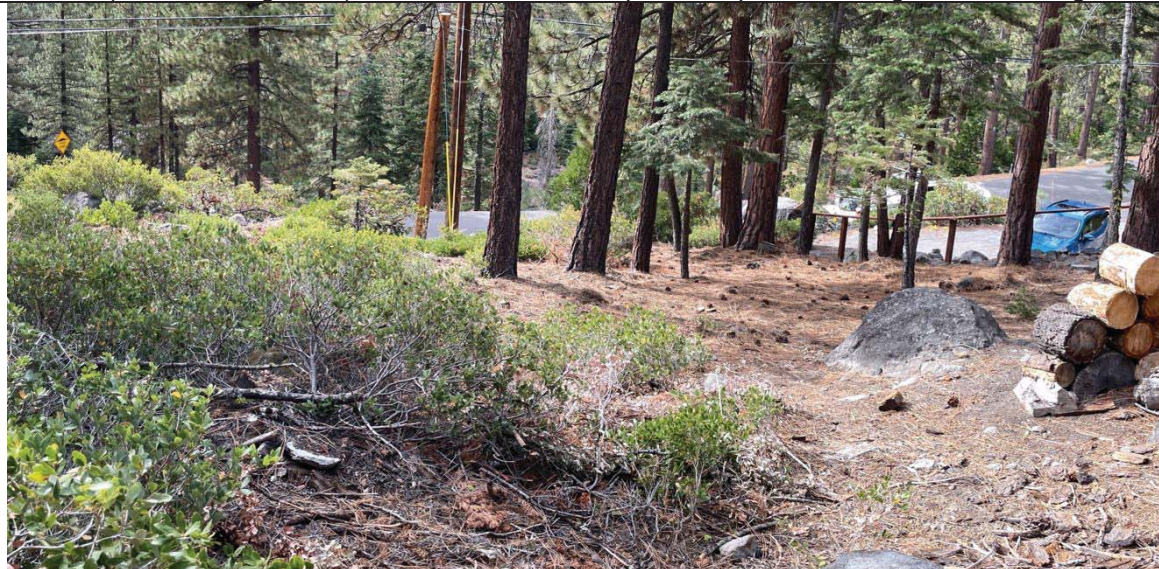
Photo 6 – View to west (downslope) at APN 090-212-010. This parcel is vacant and has similar vegetation and ground cover conditions as the residence parcel (APN 090-212-024, beyond right edge of photo). Due to potential damage to pathway, stair damage, and access around boulders, it was not possible to excavate a soil pit on the vacant parcel. The observed soil profile has 3 inches of duff, then 12 inches of a dark olive brown topsoil (A horizon). The underlying subsoil (argillic Bt horizon) is a dark grayish brown clay loam having 40 to 60% gravel, cobbles and stones. At 45 inches, the soil material becomes highly decayed bedrock (C horizon) having very gravelly sandy loam textures. While the observed soil does not match the NRCS mapped Umpa series, it does resemble the Jorge-Tahoma soil mapping unit identified in the 1974 Soil Survey of Lake Tahoe Basin. For slopes 15 to 30%, the Jorge-Tahoma soil qualifies as Class 4.

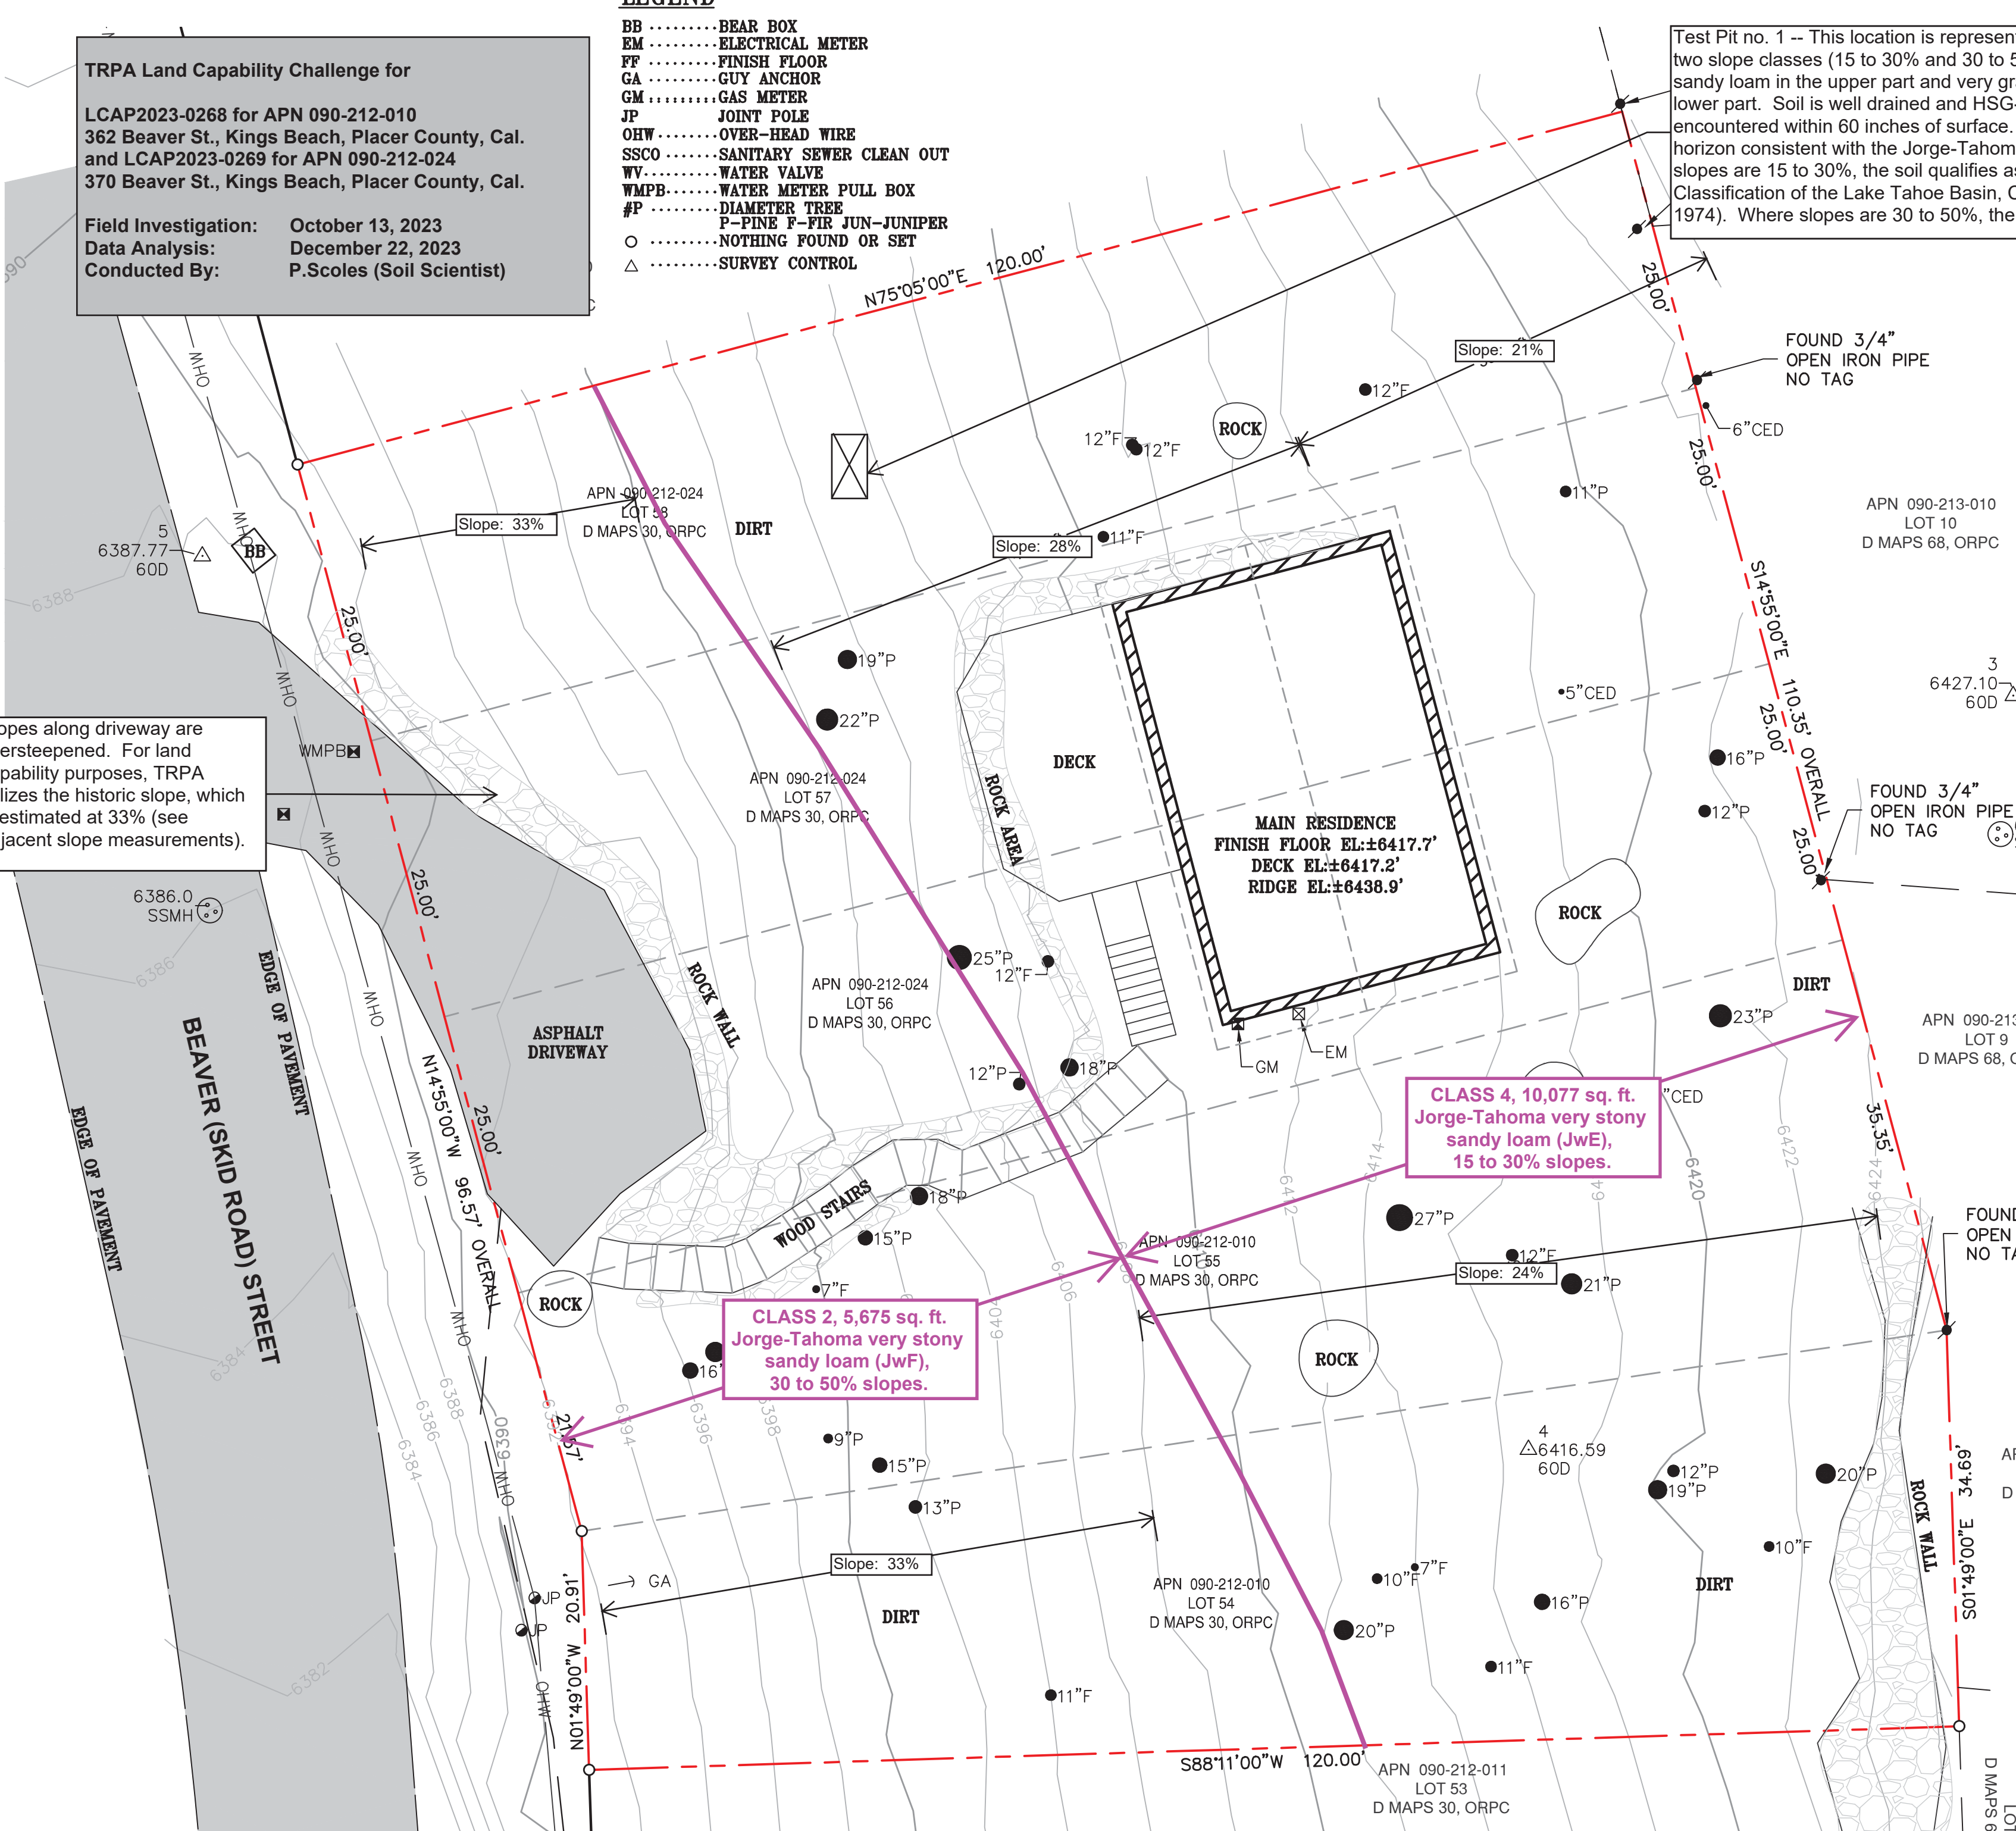
Attachment C
December 2023 Land Capability Challenge Recommendation Map

Test Pit no. 1 -- This location is representative of project area, which has two slope classes (15 to 30% and 30 to 50%). The soil is a gravelly sandy loam in the upper part and very gravelly-cobbly clay loam in the lower part. Soil is well drained and HSG-B. No bedrock or groundwater encountered within 60 inches of surface. Soil is deep and has argillic horizon consistent with the Jorge-Tahoma complex map unit. Where the slopes are 15 to 30%, the soil qualifies as Class 4 as per Land-Capability Classification of the Lake Tahoe Basin, California-Nevada (R.G. Bailey, 1974). Where slopes are 30 to 50%, the soils qualify as Class 2.

Slopes along driveway are oversteepened. For land capability purposes, TRPA utilizes the historic slope, which is estimated at 33% (see adjacent slope measurements).

CLASS 2, 5,675 sq. ft.
 Jorge-Tahoma very stony
 sandy loam (JwF),
 30 to 50% slopes.

CLASS 4, 10,077 sq. ft.
 Jorge-Tahoma very stony
 sandy loam (JwE),
 15 to 30% slopes.

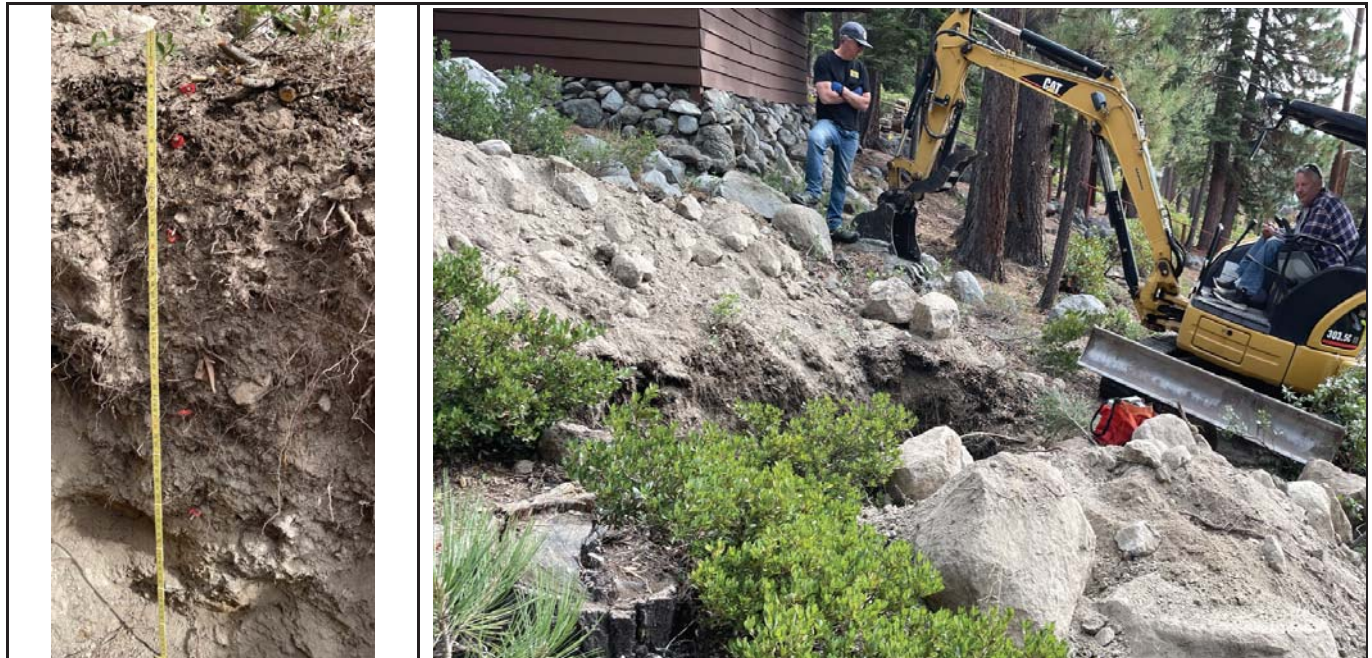
**362 and 370 Beaver Street (Roger & Kathryn Moore Parcels; APN: 090-212-020 and 090-212-024);
Kings Beach, Placer County, Calif. – Test Pit 1 (TP-1)**

Photo A – View of soil profile showing bottom depth of 60+ inches. Fine and medium root penetration in substratum. No indication of seasonal water table. HSG-B.

Photo B – View south at Test Pit 1, located 25 feet northwest of residence (downgradient front yard). This vicinity has a 28% slope above (east) the test pit, and 32% slope below (west) of the pit. The surface layers are composed of mixed colluvium, while the underlying landform is an ancient debris flow. Large boulders in substratum appear to be ‘floaters’ (not attached to bedrock). Ground cover is good (40-50% vegetation, 50-60% duff).

Soil does not match 1974 soil survey (Umpa very stony sandy loam, 5 to 15% slopes, UmE and 15 to 30% slopes, UmF). Onsite soil conditions formed from colluvium and ancient debris flow, which is consistent with Jorge-Tahoma very stony, sandy loam, 15 to 30% slopes (JwE) and 30 to 50% slopes (JwF). The Jorge-Tahoma soil is well drained and moderate subsoil permeability (HSG-B). In accordance with the Land-Capability Classification of the Lake Tahoe Basin (Bailey, 1974), the JwE soils with slopes 15 to 30% qualify as Class 4, while JwF soils with slopes 30 to 50% qualify as Class 2.
