STAFF REPORT

Subject: Mountain Meadow Retreat, LLC Land Capability Challenge, 1091 Johnson Boulevard, City of South Lake Tahoe, CA, APN 027-241-031, TRPA File Number LCAP2021-0062

**LAND CAPABILITY ANALYSIS FOR
1091 JOHNSON BLVD., SOUTH LAKE TAHOE,
EL DORADO COUNTY, CAL. (APN 027-241-031)**

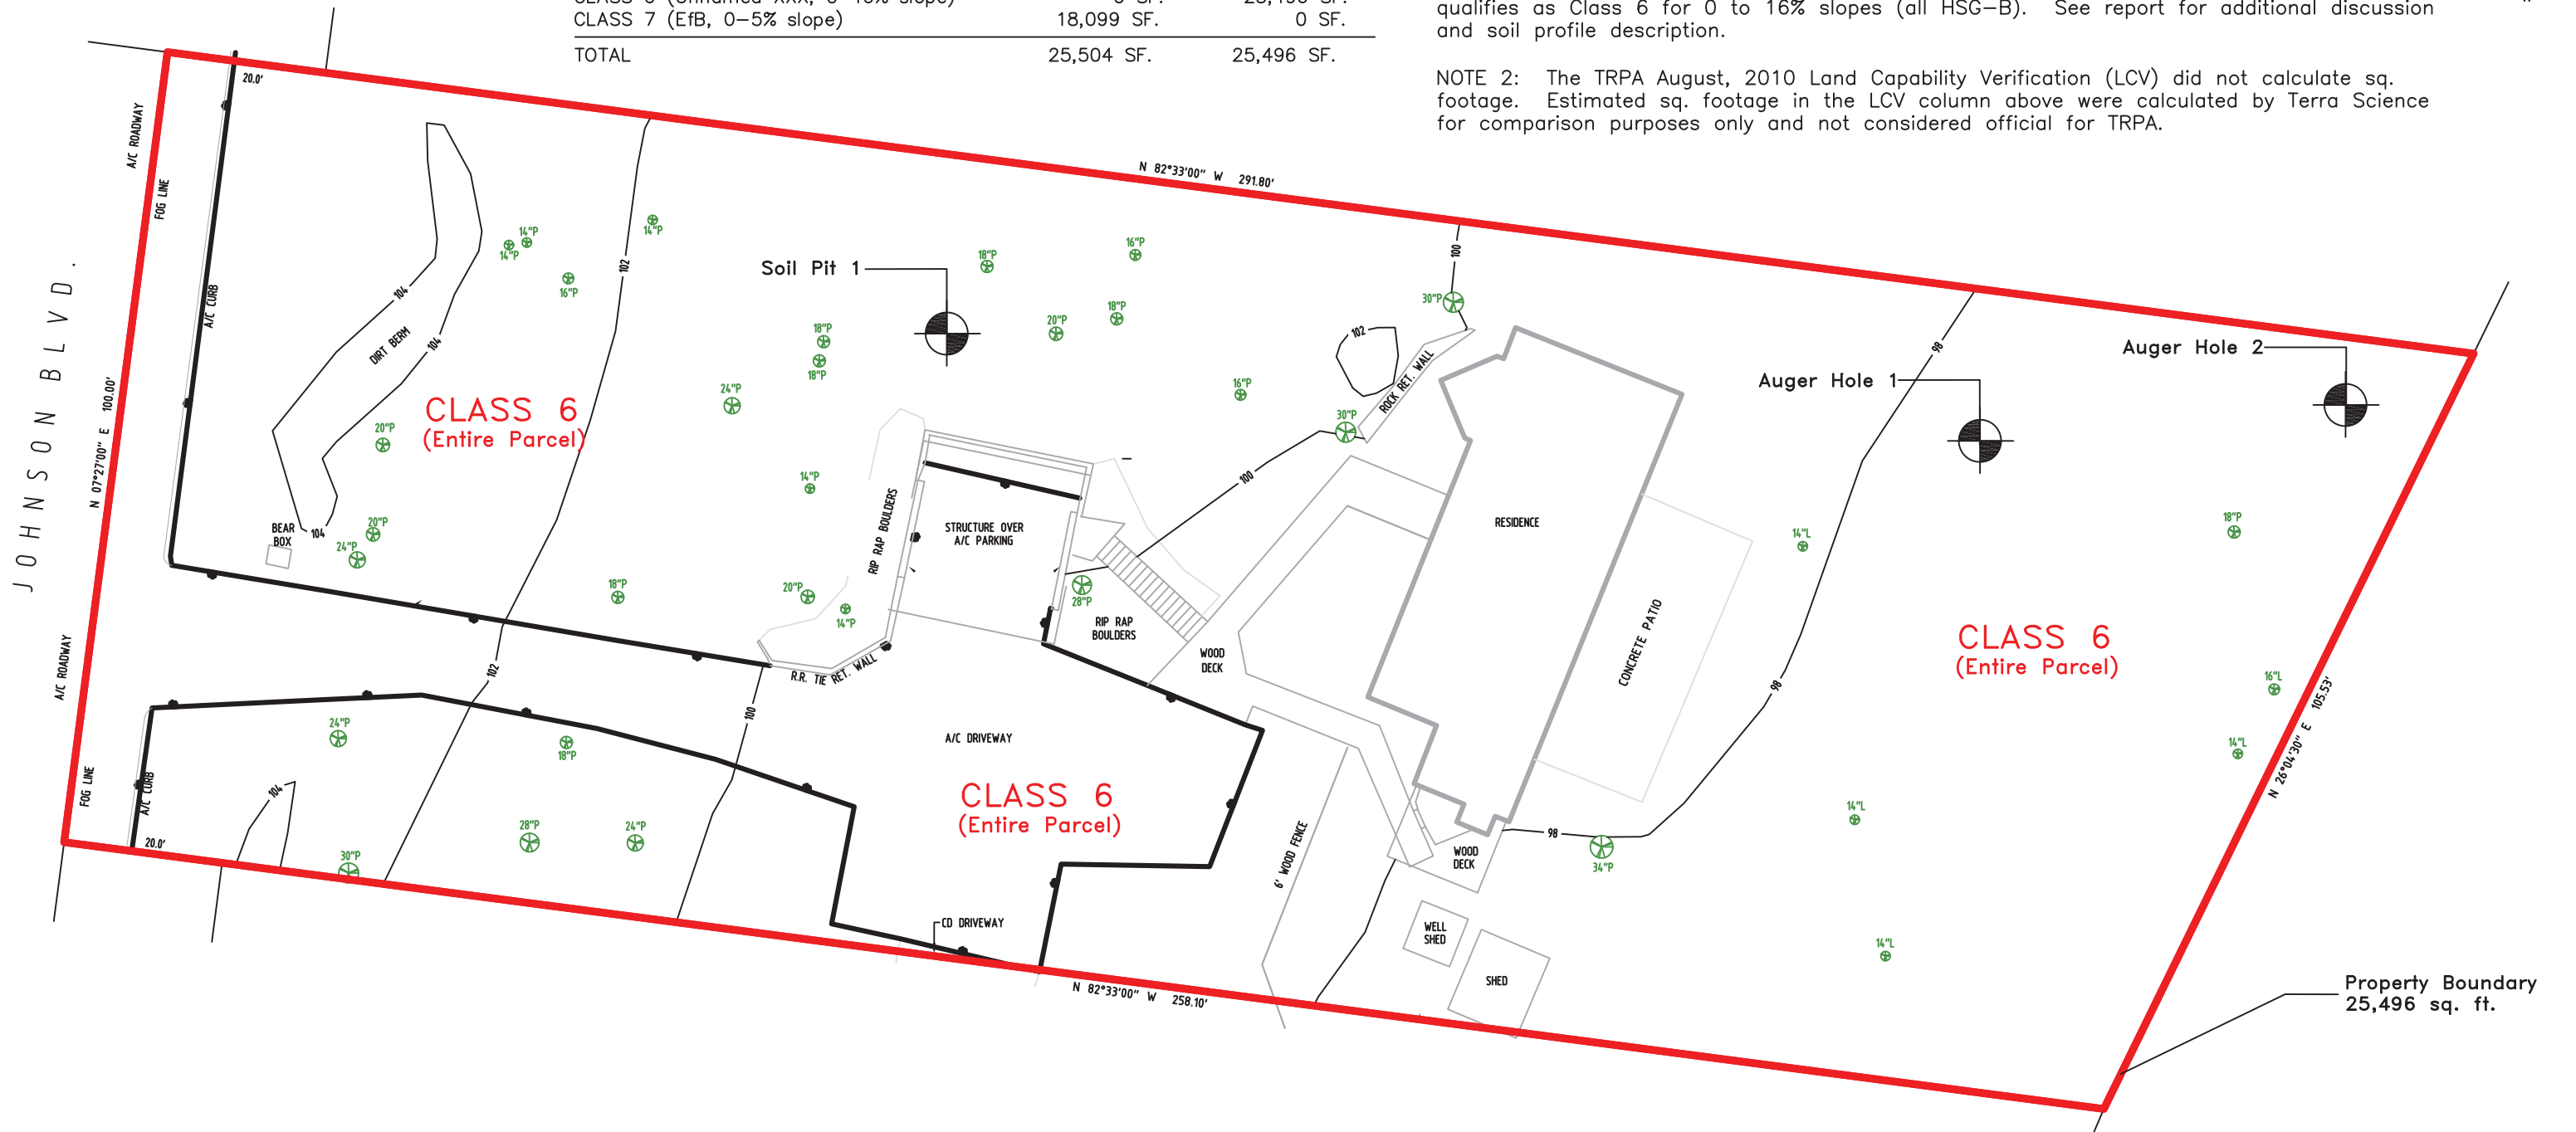
FIGURE
C-1

NOTE 1: Land Capability Analysis conducted by soil scientist, Phil Scoles on August 27 and November 05, 2020. The onsite soil has fine sandy loam textures throughout (lake terrace deposit from glacial outwash). Soil conditions for the subject property are similar to the mapped EfB soil (1974 soil survey), except the soil has a seasonal high water table 31 to 46 inches from the surface. Such wetness is apparent by >5% Fe redox soft masses in the matrix, which indicates the soil is moderately well to well drained. The central concept of the EfB soil does not include well drained and moderately well drained. As such, the onsite soil is unnamed (designated as XXX). In accordance with Table 4 of the Land-Capability of Lake Tahoe Basin, California-Nevada (Bailey, R.G.), this unnamed soil qualifies as Class 6 for 0 to 16% slopes (all HSG-B). See report for additional discussion and soil profile description.

NOTE 2: The TRPA August, 2010 Land Capability Verification (LCV) did not calculate sq. footage. Estimated sq. footage in the LCV column above were calculated by Terra Science for comparison purposes only and not considered official for TRPA.

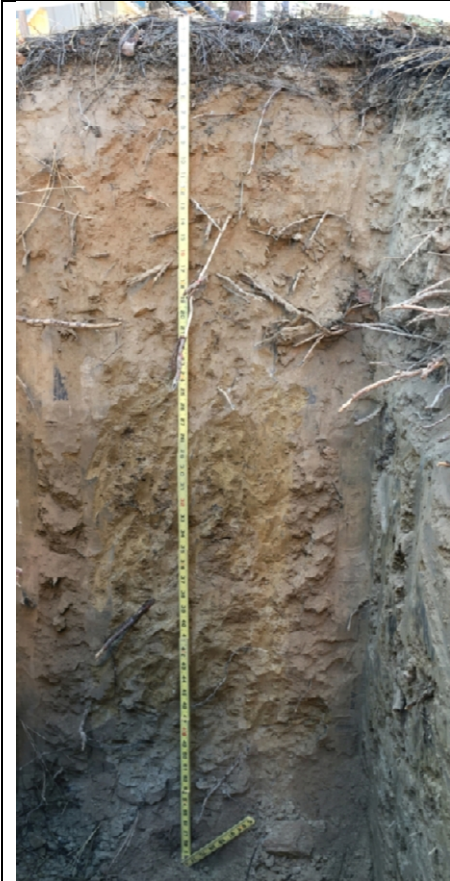
Photo 1. Soil Pit 1
(Depth = 58 in.)

One soil pit (excavated by backhoe) and two auger observations were described to 58 inches. Soil Pit no. 1 was located approximately 12 feet northwest of the carport/office, 90 feet east of Johnson Blvd, and 25 feet south of the north property line. This soil is on lake terrace formed from glacial outwash from mixed parent material. The soil at this pit is characterized by a very fine sandy loam surface texture, with very fine sandy loam, and heavy, very fine sandy loam below 21 inches. Redoximorphic features begin at 37 inches with 2 to 3% dark yellowish brown (10YR 3/6 moist) iron redoximorphic concentrations and 2% 2.5Y 5/2 matrix depletions. This soil is very deep, moderately well drained, and is a member of Soil Hydrologic Group B. The vegetation is an open Jeffrey pine forest with grasses.

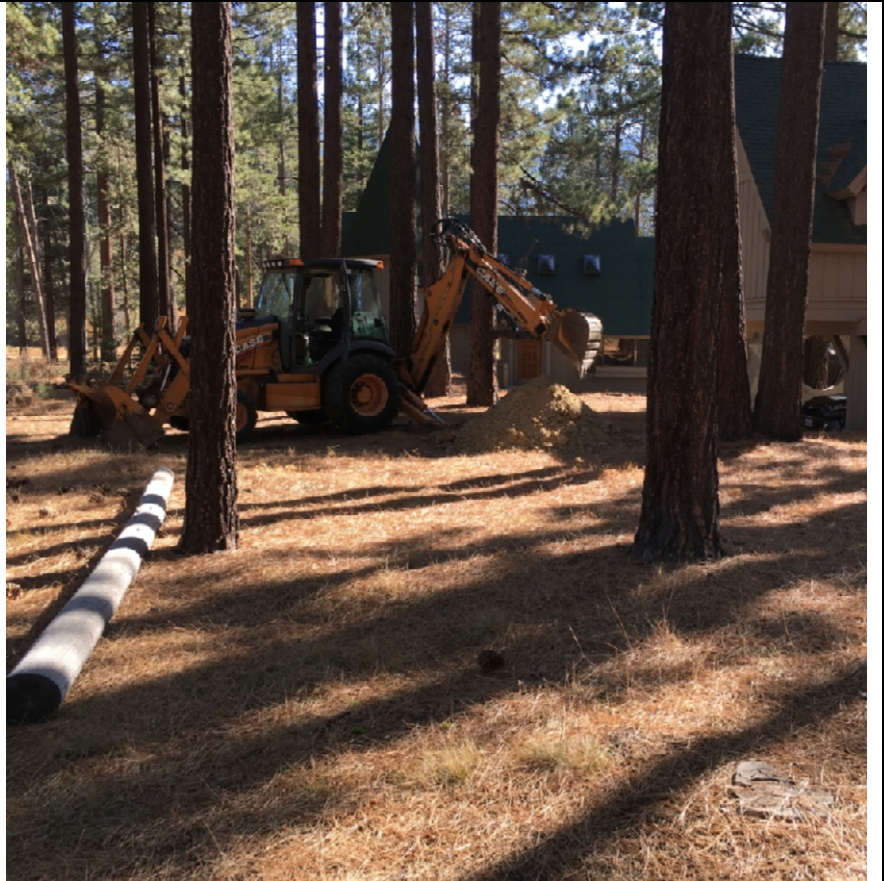
Photo 2. View east at vicinity of Soil Pit 1. 2% slope and E x SE aspect. Lake terrace landform composed of granitic outwash.

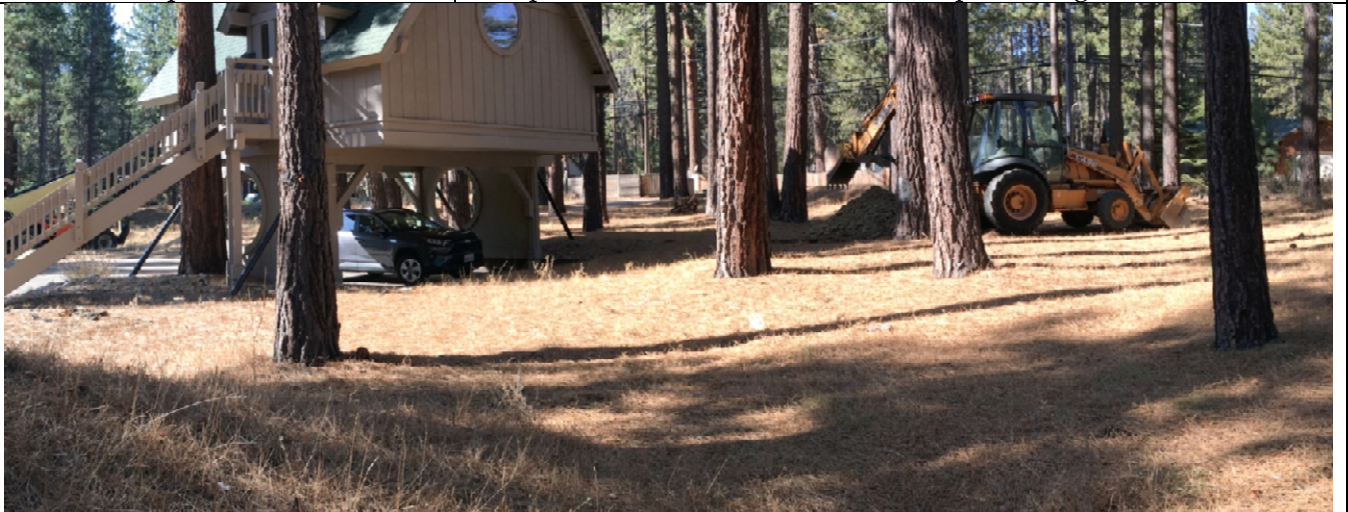
The field evaluation also found that the soil surrounding the carport/office contained small layer of fill material atop the native soil. This is most apparent at a small landscape berm parallel to Johnson Boulevard. It is assumed that the fill source was the foundation and parking area for the carport/office structure. A surface duff layer was mostly absent east of the residence, since that land was converted to a lawn. Accumulated pine needles appear regularly mowed, so it does not form the typical organic horizon at the surface.

Photo 3. View southwest to west (right) at Soil Pit 1. Carport/office at left. This portion of the parcel has a thin veneer of fill material, 2 to 6 inches thick (presumably placed during prior construction).

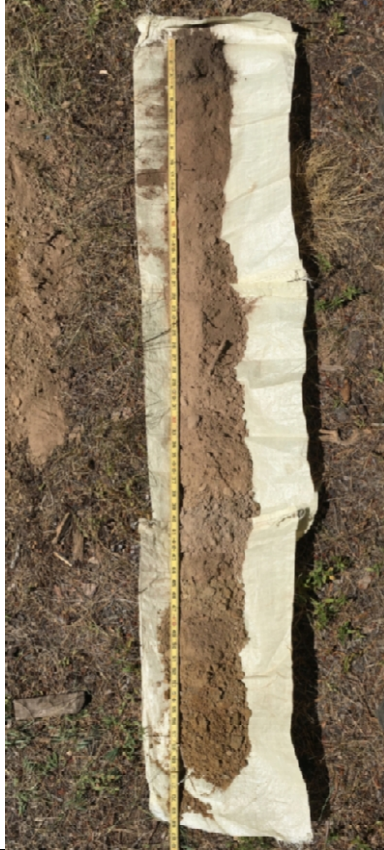
Photo 4. Auger Hole 1
(Depth = 58 in.)

Auger Hole 1 was located in the northeast (lower) part of property; about 35 feet east of the residence and 35 feet south of north property line, and 50 feet west of east property line. This soil is on lake terrace formed by glacial outwash from mixed parent material. This soil has fine sandy loam textures throughout. Redoximorphic features begin at 27 inches with 1% dark brown (7.5YR 3/4 moist) iron soft masses, which increase at 37 inches to 10% brown (7.5YR 4/4 moist) iron soft masses in the matrix. This soil is very deep, moderately well drained, and is a member of Soil Hydrologic Group B. The vegetation is a forest dominated by lodgepole pine forest with a few Jeffrey pine. The understory is open with antelope bitterbrush, vetch, and grasses.

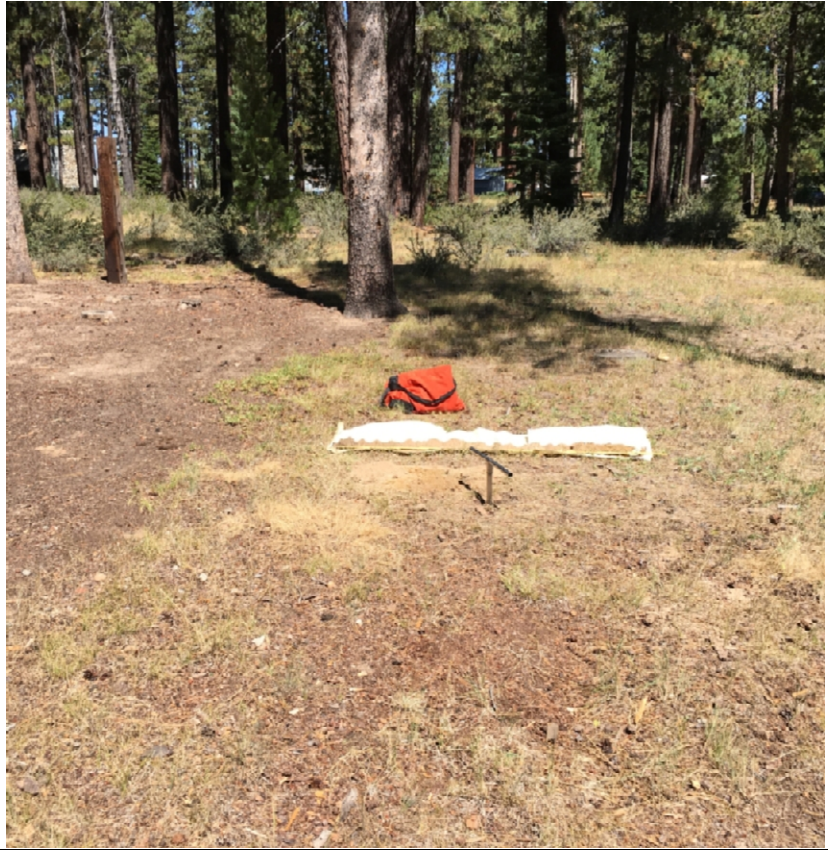
Photo 5. View north at vicinity of Auger Hole 1. 2% slope and E x SE aspect. No indication of fill material.

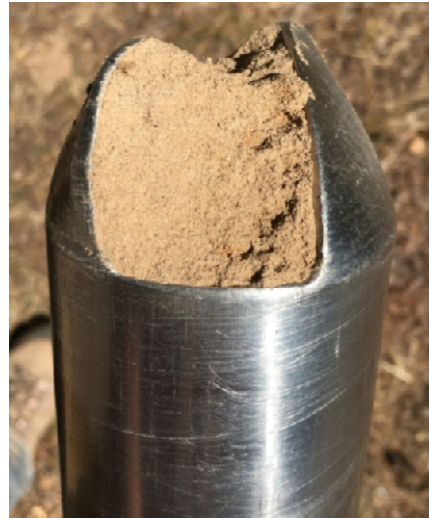
Photo 6A. Soil matrix at 32 in. with 1% Fe redox features.

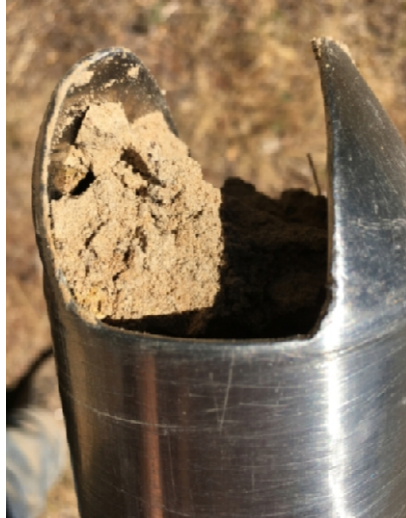
Photo 6B. Soil matrix at 37 in. with 5 to 10% Fe redox features.

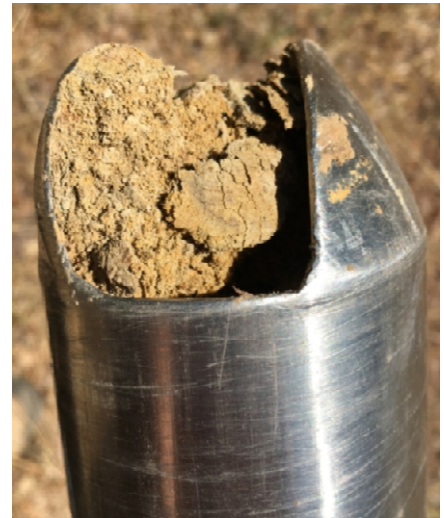
Photo 6C. Soil matrix at 52 in. with 10 to 15% Fe redox features

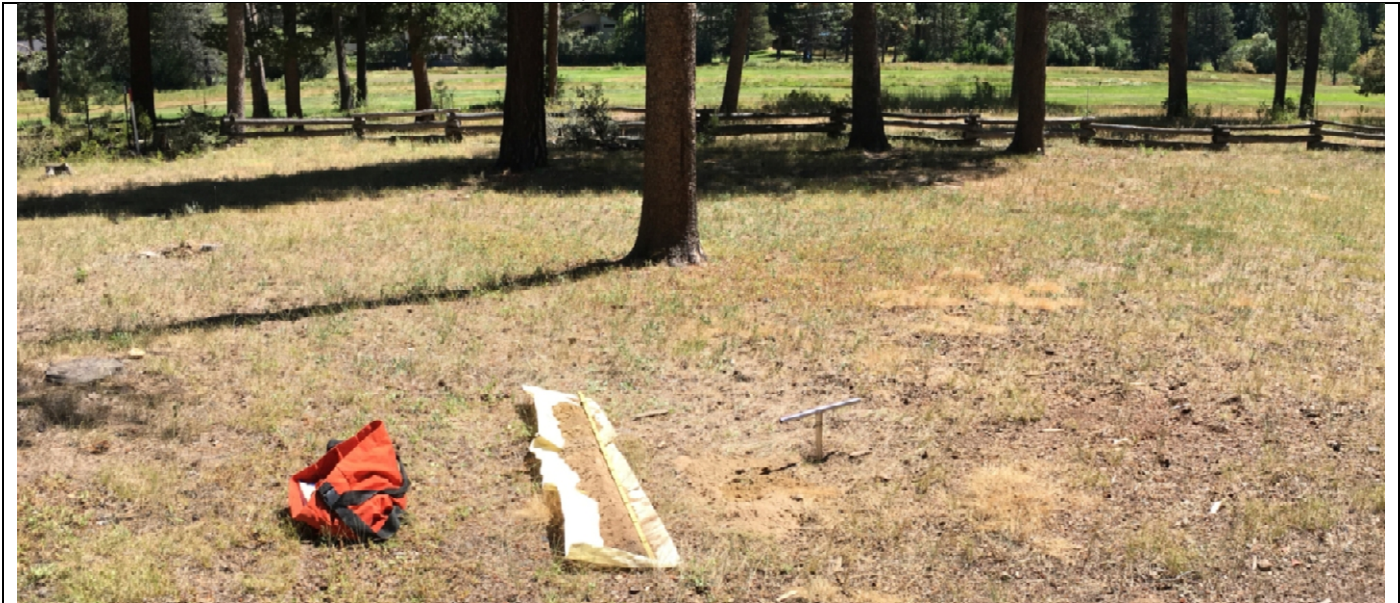
Photo 7. View east to southeast (right) at Auger Hole 1. A 2010 LCV determined the foreground area as Class 3 and background area (by fence) as Class 1B. This analysis found it qualifies as Class 6.

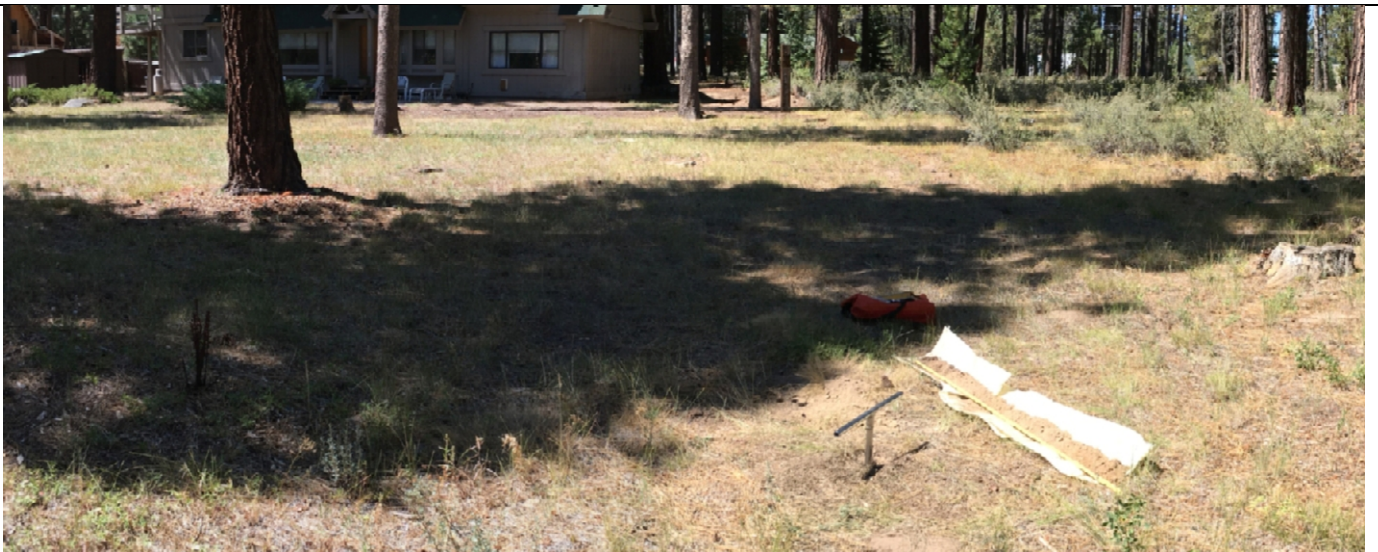
Photo 8. View west to northwest (right) at Auger Hole 2. Residence in background. Adjacent vegetation of Jeffrey pine, bitterbrush and Idaho fescue indicate non-SEZ conditions for east edge.

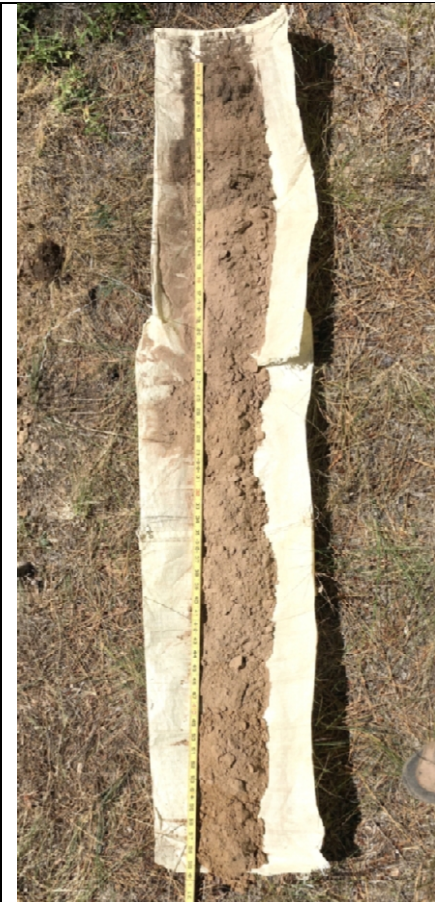
Photo 9. Auger Hole 2
(Depth = 58 in.)

Auger Hole 2 is on the northeast (lower) part of property; about 70 feet east of the residence, 10 feet south of north property line, and 20 feet west of east property line. This soil is on lake terrace formed by glacial outwash from mixed parent material. The soil has fine sandy loam textures throughout. Redoximorphic features begin at 31 inches with brown (7.5YR 4/4 moist) iron soft masses that increase at 41 inches to 10 to 15% strong brown (7.5YR 4/6 moist) iron soft masses in the matrix. This soil is very deep, moderately well drained, and is a member of Soil Hydrologic Group B. The vegetation is a forest dominated by lodgepole pine forest with a few Jeffrey pine. The understory is open with antelope bitterbrush, vetch, and grasses.

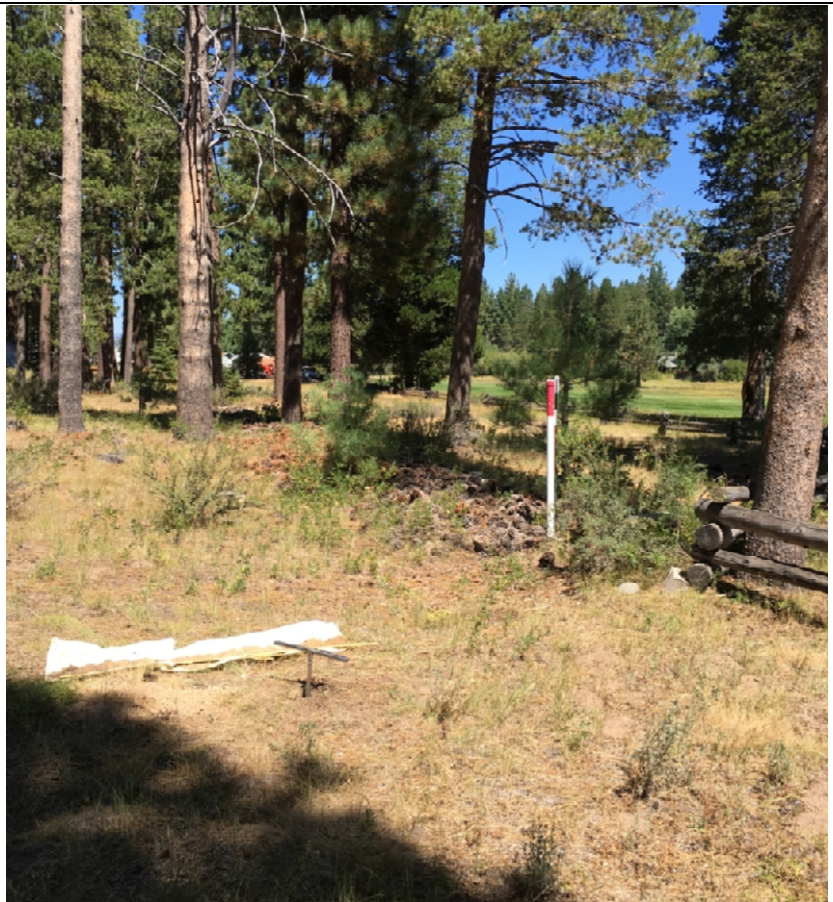
Photo 10. View north at vicinity of Auger Hole 2. The subject parcel is adjacent to Bijou Golf Course (to the east).

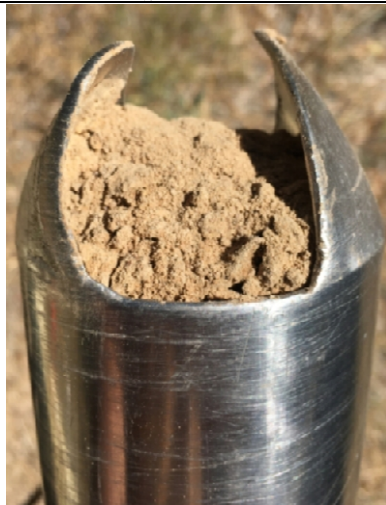
Photo 11A. Soil matrix at 31 in.
with 5% Fe redox features

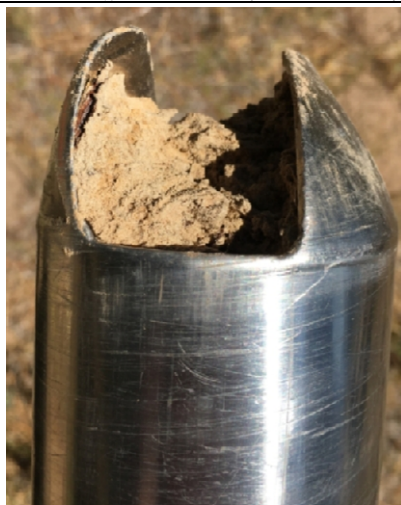
Photo 11B. Soil matrix at 41 in.
with 10 to 15% Fe redox features.

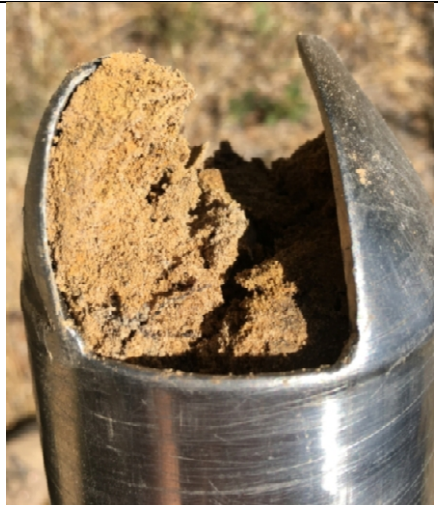
Photo 11C. Soil matrix at 54 in.
with 20% Fe redox features.

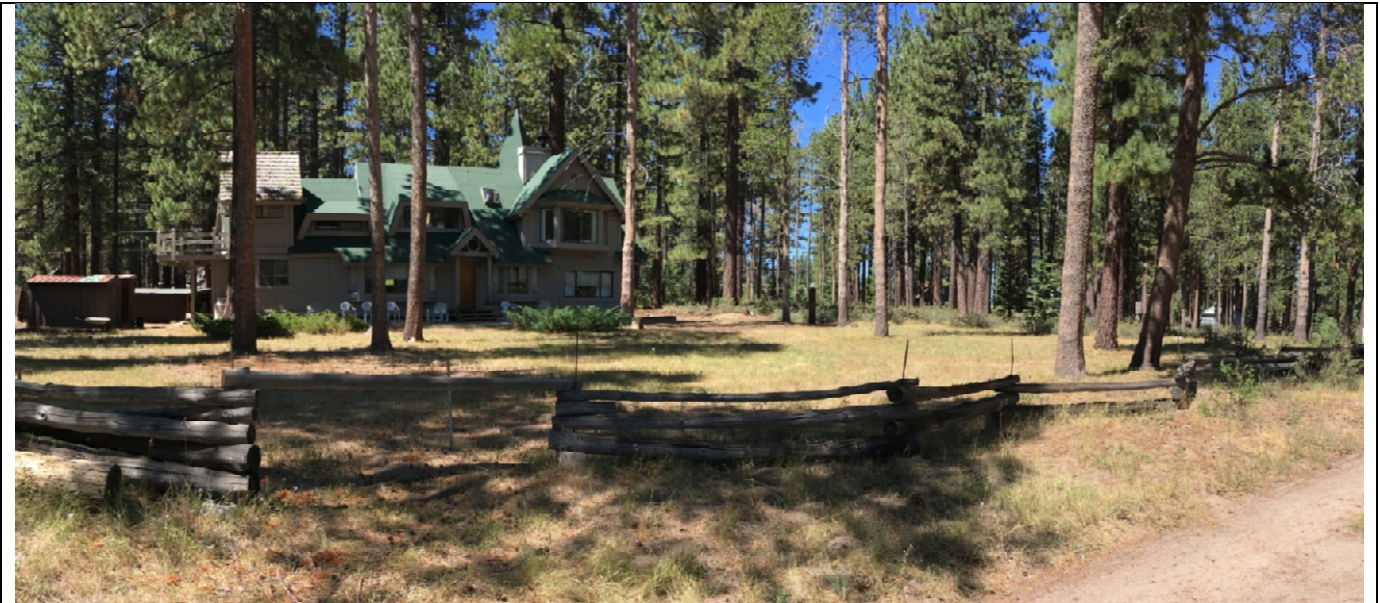
Photo 10. View northwest to north (right) at parcel backyard. Lawn of bluegrass with lesser amounts of sweet clover, lupine and aster. Lodgepole pine in foreground, Jeffrey pine in background.

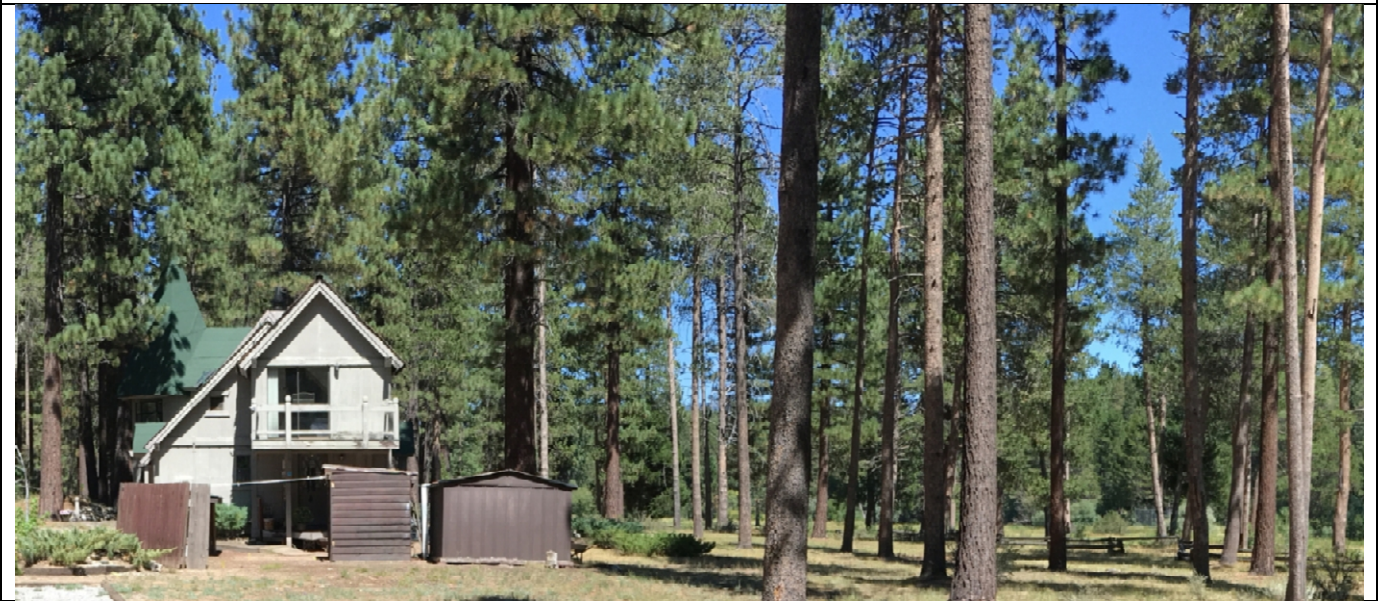
Photo 11. View north to northeast (right) at residence and backyard. This analysis found that the soil is moderately well (right) to well drained (left), which qualifies as Class 6.

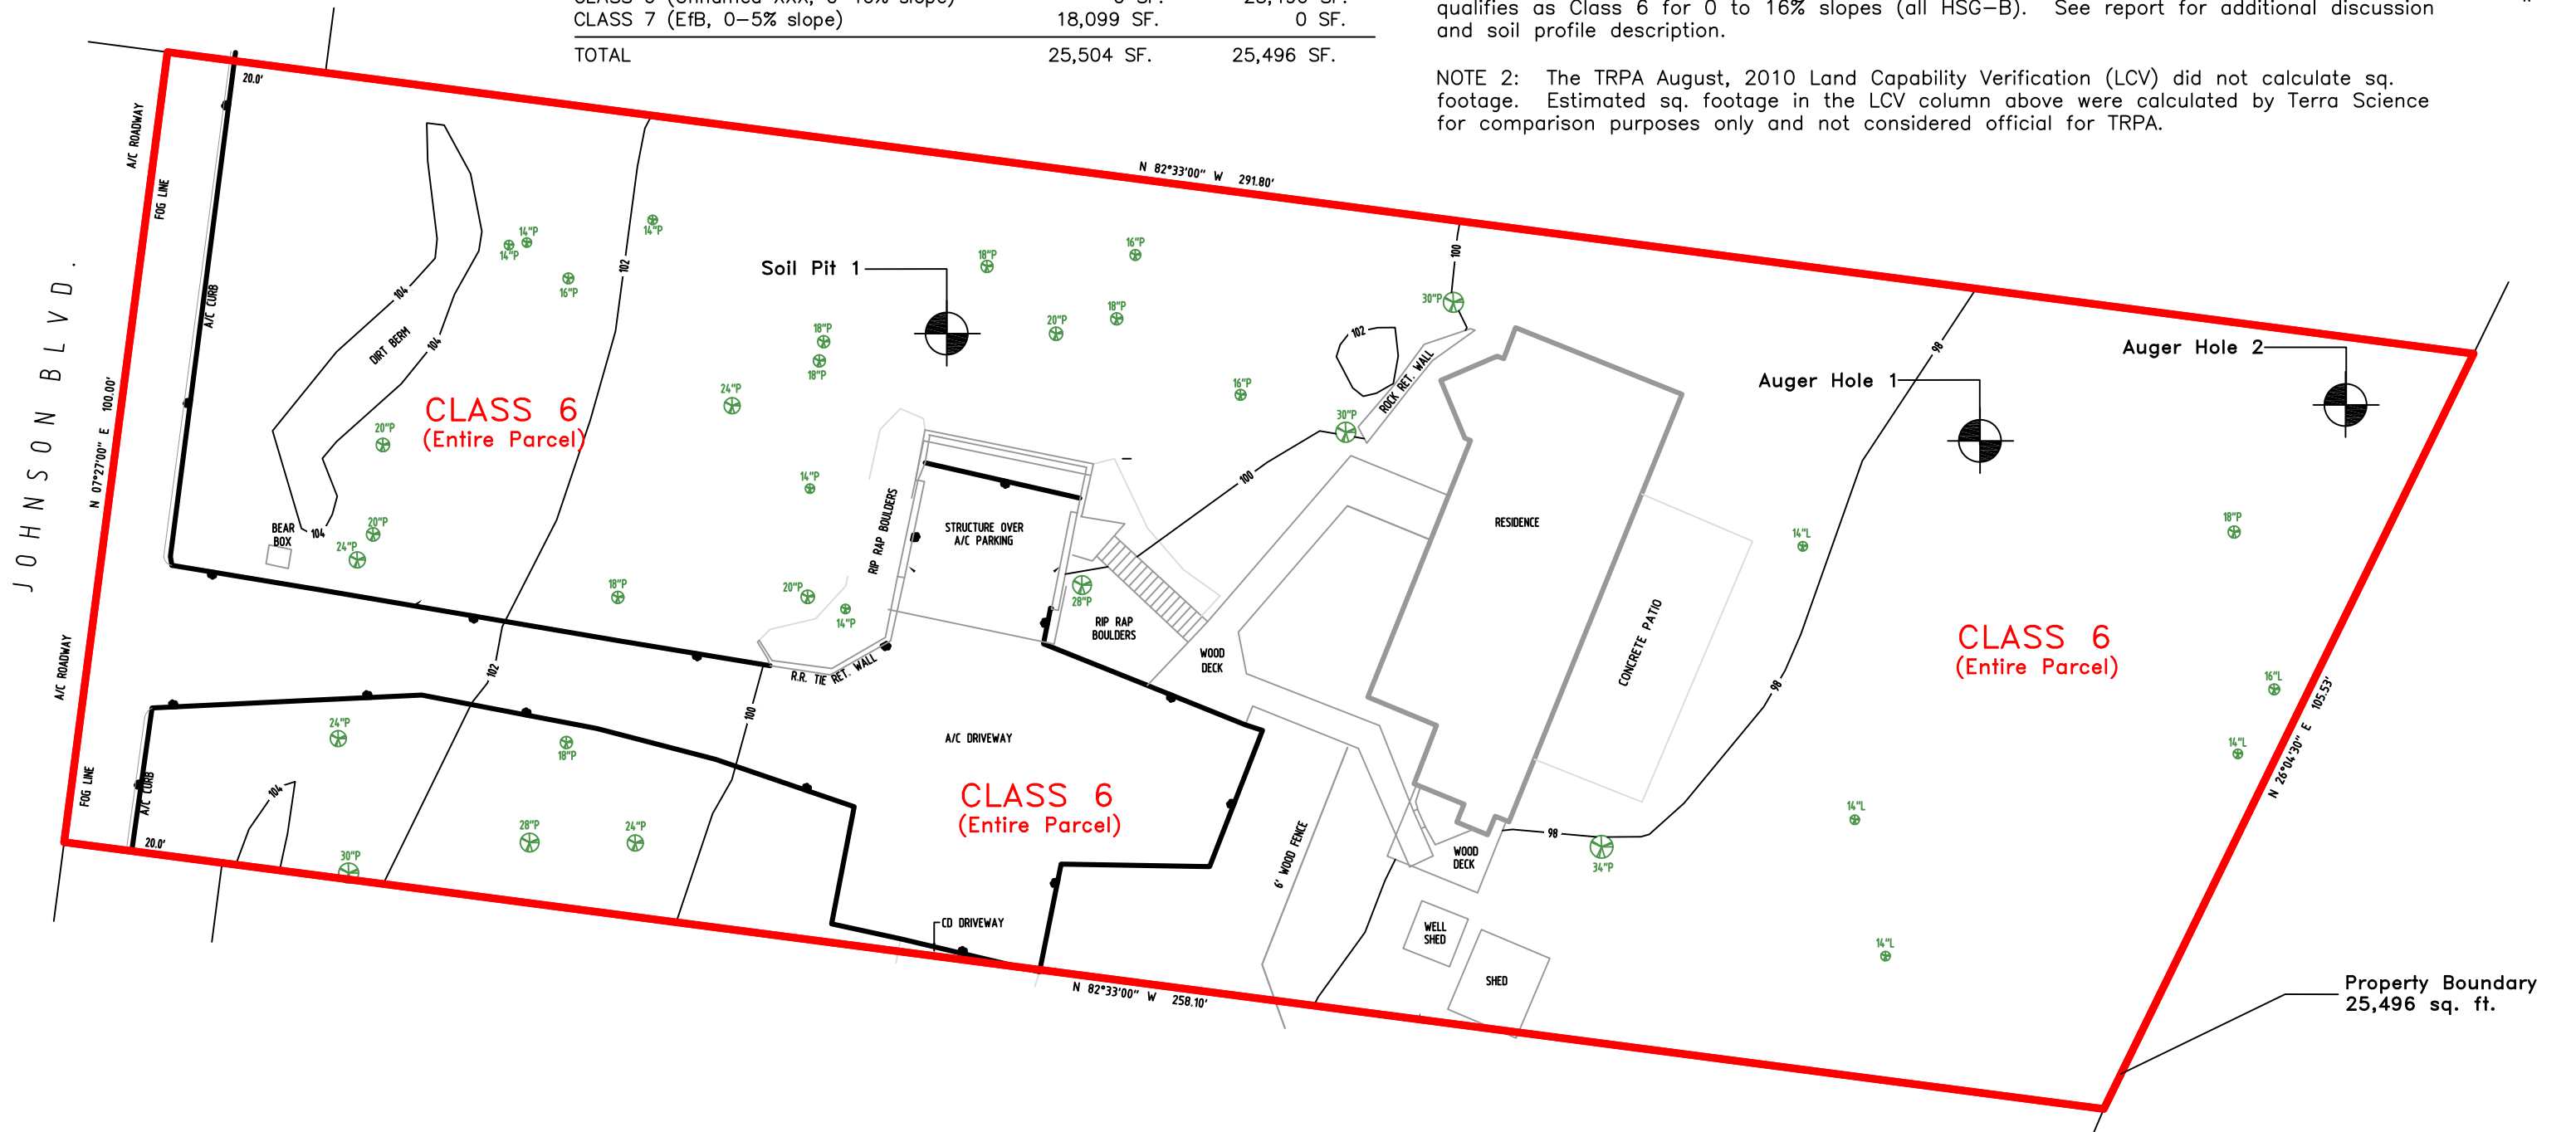
NOTE 1: Land Capability Analysis conducted by soil scientist, Phil Scoles on August 27 and November 05, 2020. The onsite soil has fine sandy loam textures throughout (lake terrace deposit from glacial outwash). Soil conditions for the subject property are similar to the mapped Efb soil (1974 soil survey), except the soil has a seasonal high water table 31 to 46 inches from the surface. Such wetness is apparent by >5% Fe redox soft masses in the matrix, which indicates the soil is moderately well to well drained. The central concept of the Efb soil does not include well drained and moderately well drained. As such, the onsite soil is unnamed (designated as XXX). In accordance with Table 4 of the Land-Capability of Lake Tahoe Basin, California-Nevada (Bailey, R.G.), this unnamed soil qualifies as Class 6 for 0 to 16% slopes (all HSG-B). See report for additional discussion and soil profile description.

NOTE 2: The TRPA August, 2010 Land Capability Verification (LCV) did not calculate sq. footage. Estimated sq. footage in the LCV column above were calculated by Terra Science for comparison purposes only and not considered official for TRPA.

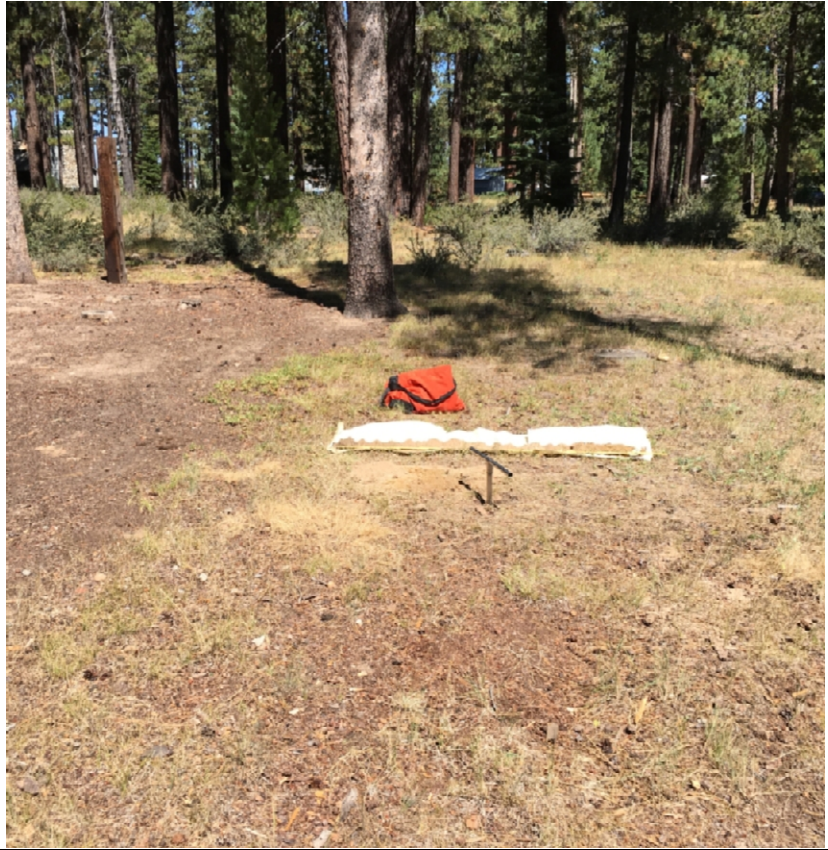
Photo 5. View north at vicinity of Auger Hole 1. 2% slope and E x SE aspect. No indication of fill material.

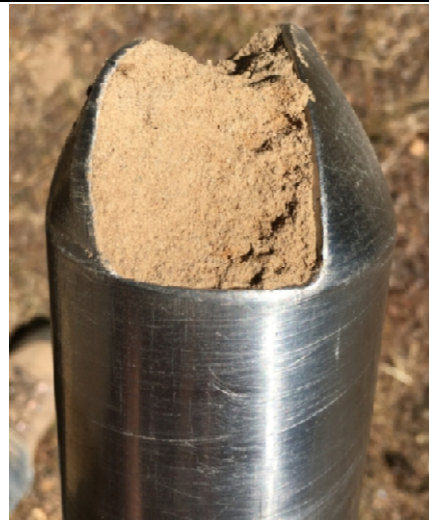
Photo 6A. Soil matrix at 32 in. with 1% Fe redox features.

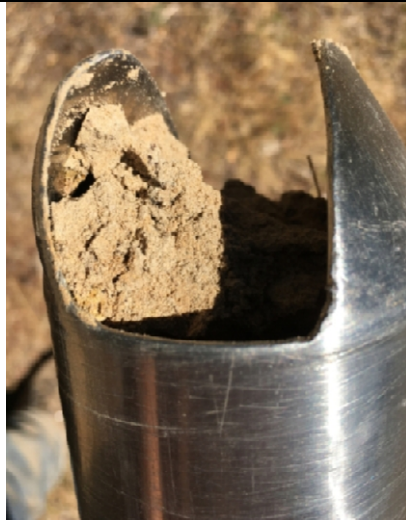
Photo 6B. Soil matrix at 37 in. with 5 to 10% Fe redox features.

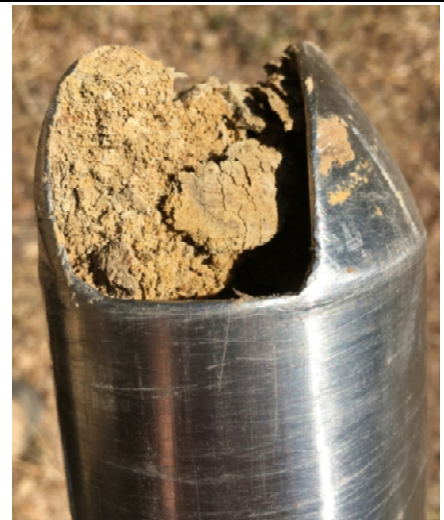
Photo 6C. Soil matrix at 52 in. with 10 to 15% Fe redox features

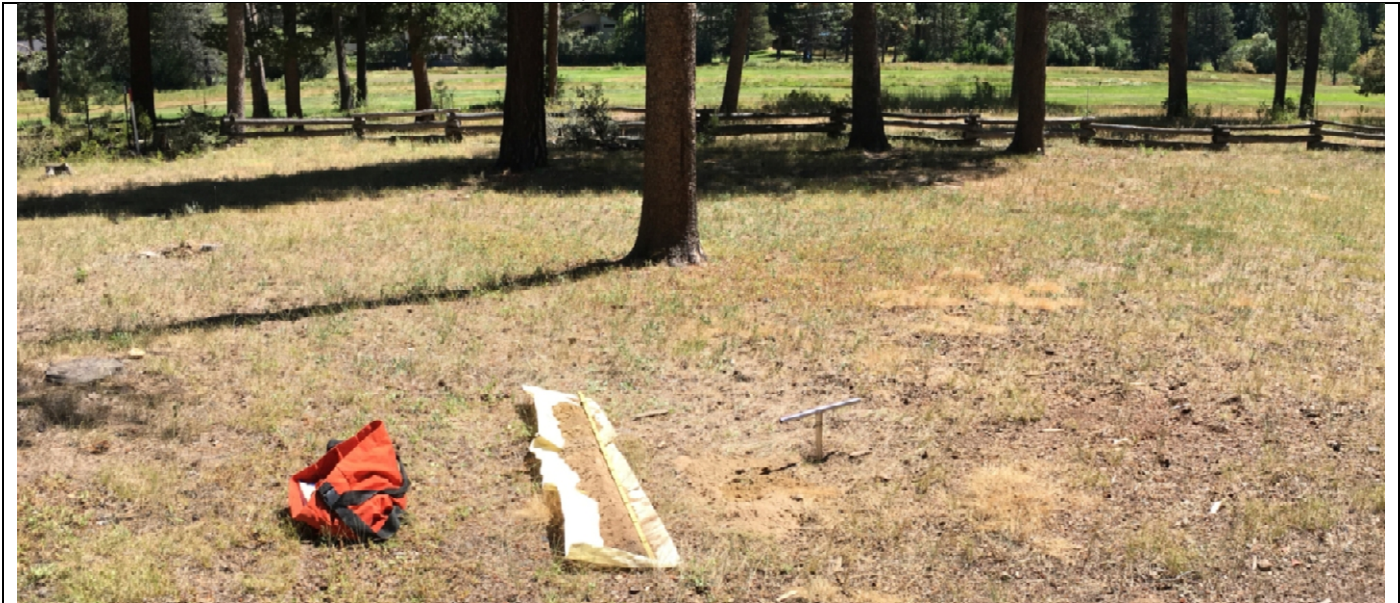
Photo 7. View east to southeast (right) at Auger Hole 1. A 2010 LCV determined the foreground area as Class 3 and background area (by fence) as Class 1B. This analysis found it qualifies as Class 6.

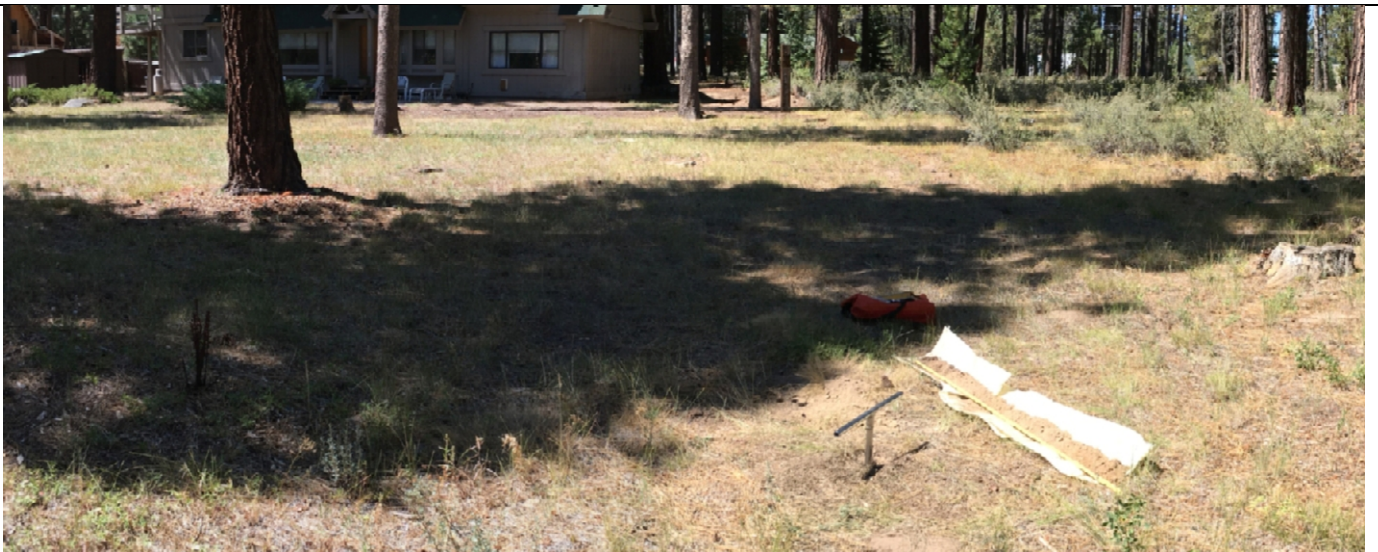
Photo 8. View west to northwest (right) at Auger Hole 2. Residence in background. Adjacent vegetation of Jeffrey pine, bitterbrush and Idaho fescue indicate non-SEZ conditions for east edge.

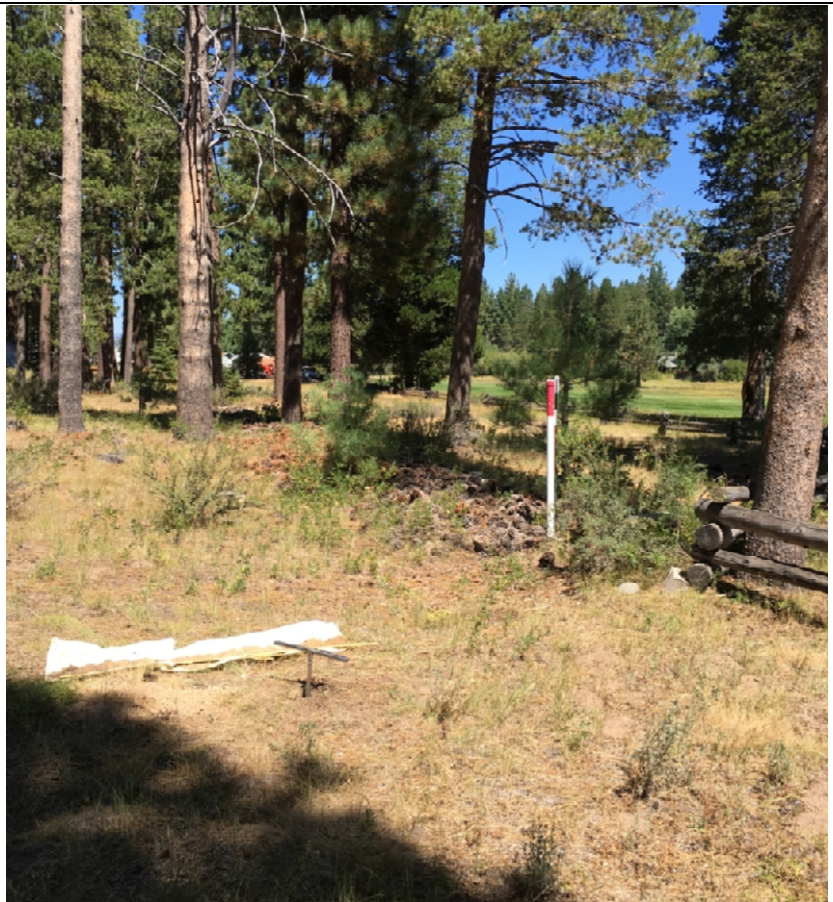
Photo 10. View north at vicinity of Auger Hole 2. The subject parcel is adjacent to Bijou Golf Course (to the east).

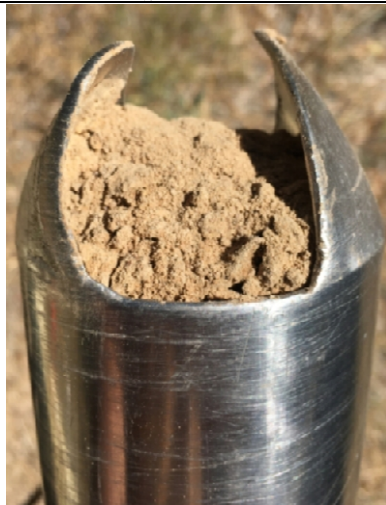
Photo 11A. Soil matrix at 31 in.
with 5% Fe redox features

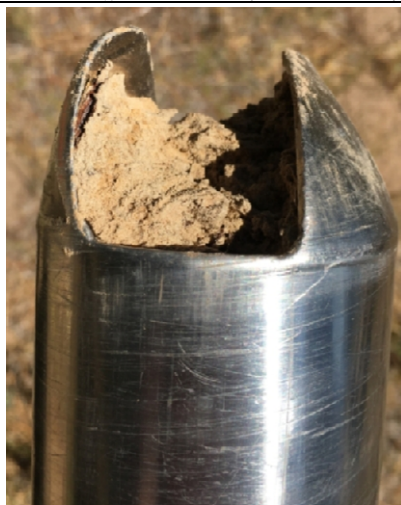
Photo 11B. Soil matrix at 41 in.
with 10 to 15% Fe redox features.

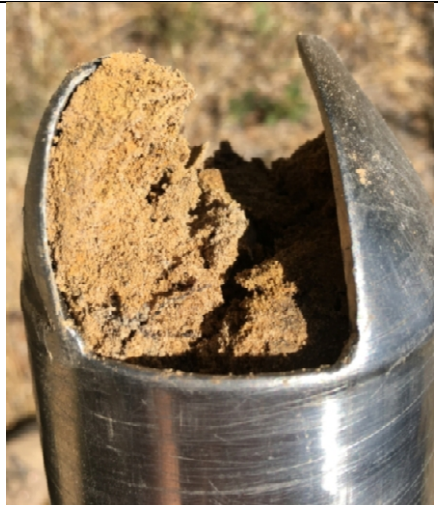
Photo 11C. Soil matrix at 54 in.
with 20% Fe redox features.

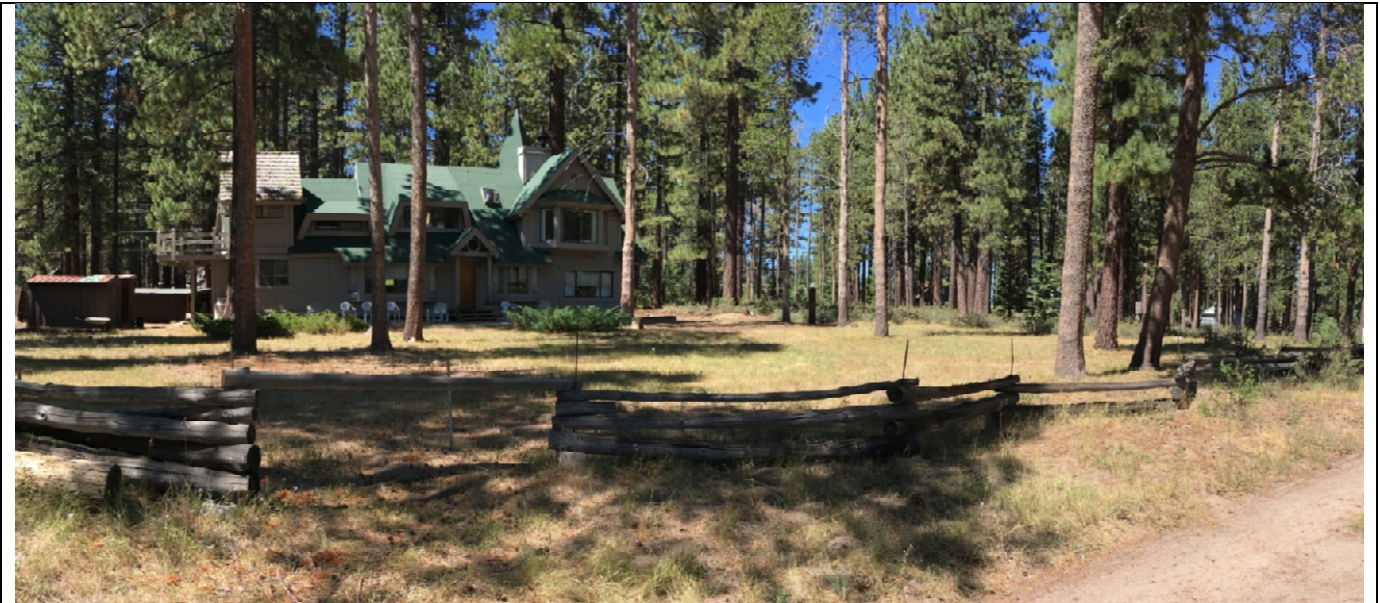
Photo 10. View northwest to north (right) at parcel backyard. Lawn of bluegrass with lesser amounts of sweet clover, lupine and aster. Lodgepole pine in foreground, Jeffrey pine in background.

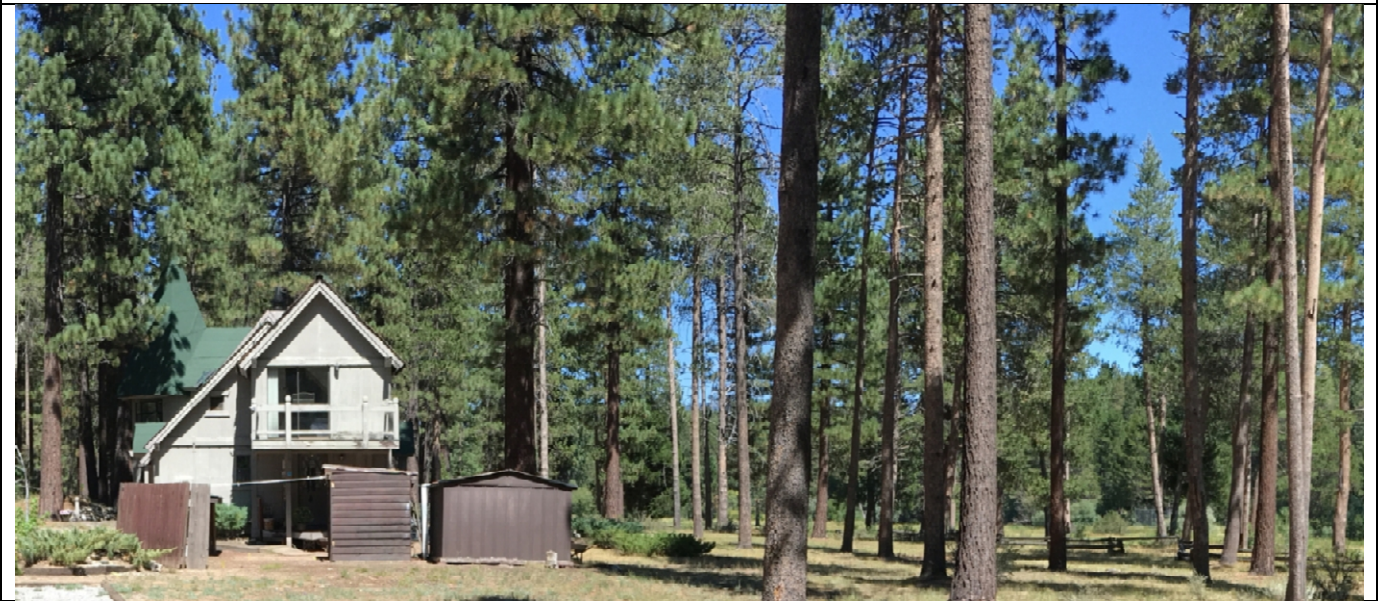
Photo 11. View north to northeast (right) at residence and backyard. This analysis found that the soil is moderately well (right) to well drained (left), which qualifies as Class 6.
