STAFF REPORT

Subject: RGB Select LLC Land Capability Challenge; 6730 West Lake Boulevard, Placer County, CA; APN 098-180-011; TRPA File Number LCAP2020-0431

Bianchina Project **Land Capability ~~and SEZ~~ Challenge** **Placer County, California** (APNs 098-180-11, ~~12 & 24~~)

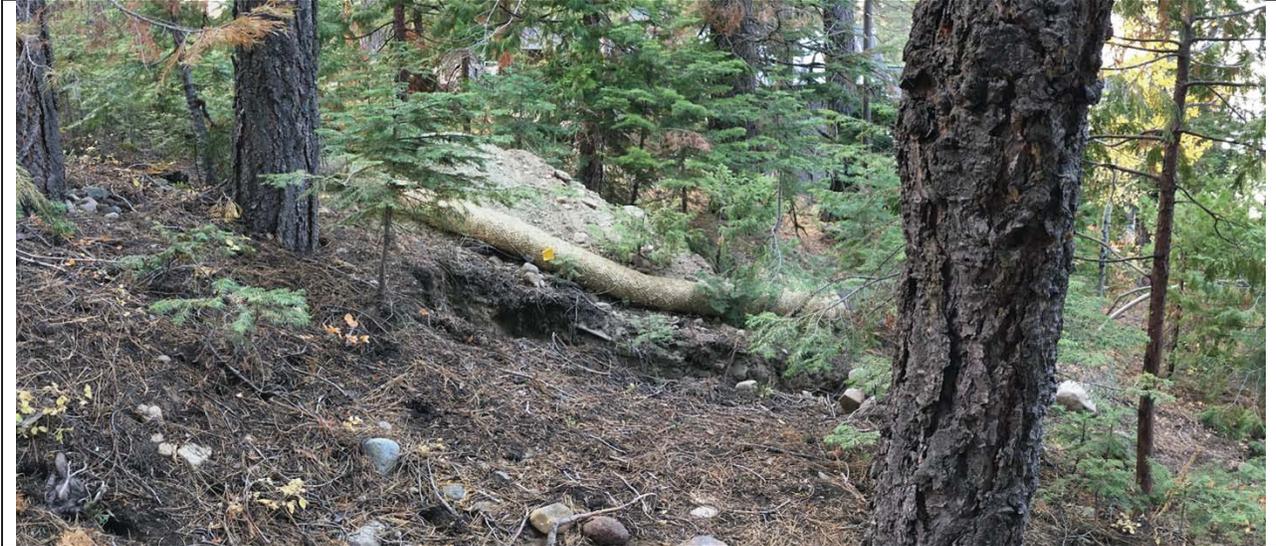
Photo 1 – View west (left) to north (right) toward “Site 3” soil pit, located in the west part of the subject parcel. This backhoe-dug pit occurs on an 18 to 28% slope of a glacial outwash terrace. Natural ground cover of fir and pine needles provides erosion protection atop sandy/gravelly soils. Soil profiles described by Davis2 Consulting Earth Scientists in September, 2020.

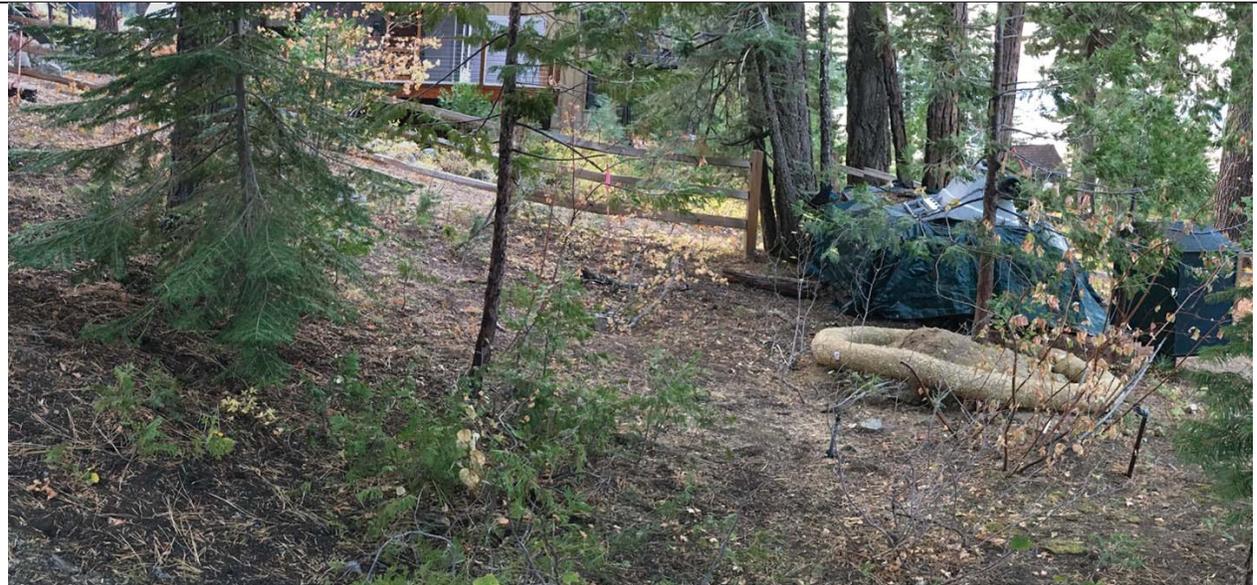
Photo 2 – View north (left) to northeast (right) toward “Site 2” hand-dug and augered soil pit. This location is part of a terrace formed from ancient lake sediment and colluvial material naturally eroded from higher ground. The soil lacks any indication of root-restricting layer or seasonally high water table.

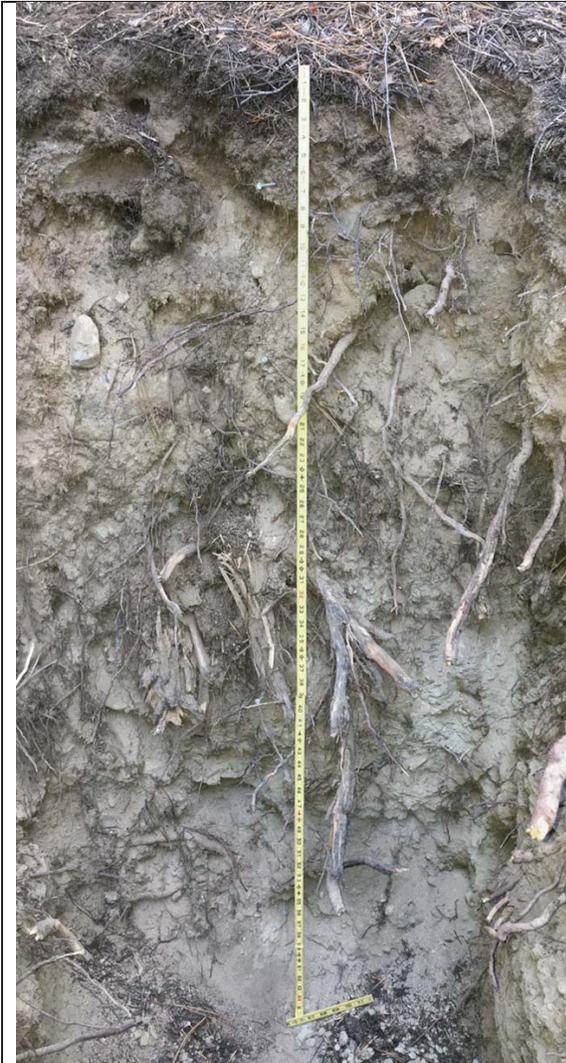
Photo 3 – Soil profile for “Site 3” – upper sampling location (west of driveway). Topsoil layer is 20 in thick and composed of gravelly loamy sand. Underlying parent material is 40+ inches thick and generally has increasing gravel content (typical for outwash terrace). The profile has minimal in-situ soil development (cambic horizon). Profile lacks root-restricting layer (such as a seasonal high water table or dense fragipan). While similar to Tallac series, this unnamed soil has more gravels, and coarser sand textures than the mapped Tallac series. As per Table 4 of Land-Capability Classification of the Lake Tahoe Basin, California-Nevada, A Guide for Planning (Rbt. Bailey, 1974), this unnamed soil qualifies as Class 4 (XXX, 16 to 30% slopes).

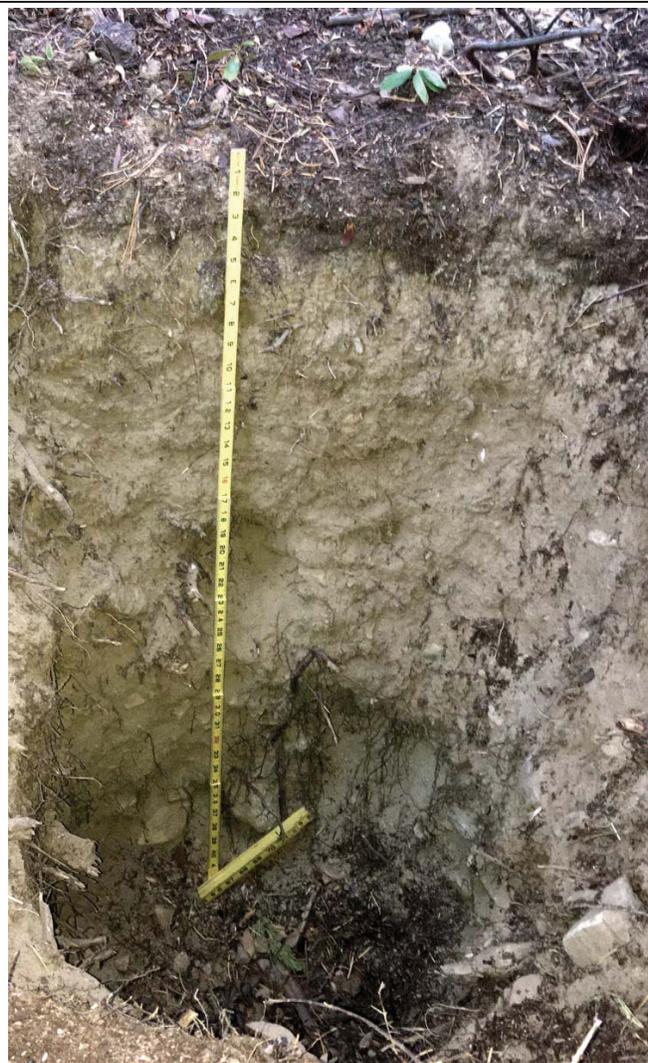
Photo 4 – Soil profile for “Site 2” – lower sampling location (west of 1.5-story residence). The topsoil layer is 8 inches thick and composed of gravelly loamy sand. The underlying layers to 45 inches have increasing amounts of sand and gravels that were deposited when Lake Tahoe was naturally higher during ancient times. This soil is dissimilar from the mapped Tallac and Gefo soils due to greater volume of gravels and coarser sand textures. It also lacks of a root-restricting layer (such as a seasonal high water table or dense fragipan). This soil occurs on 0 to 16% slopes, hence, it qualifies as Class 6 (as per Table 4 of Land-Capability Classification (Bailey, 1974).

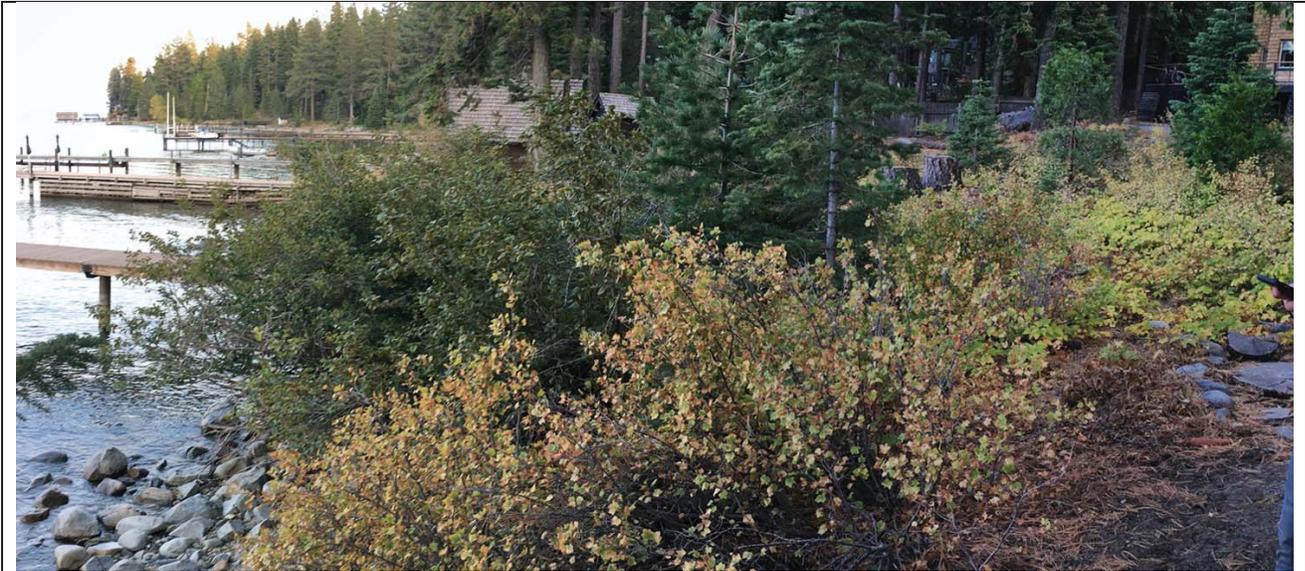
Photo 5 – View south at shoreline and backshore from north edge of study area. The backshore area includes the boulder revetment and a narrow band vegetated with mostly native trees and shrubs (mountain alder, willow, currant and thimbleberry). Soil conditions in this vicinity are mostly sandy/gravelly with cobbles and stones at depth.

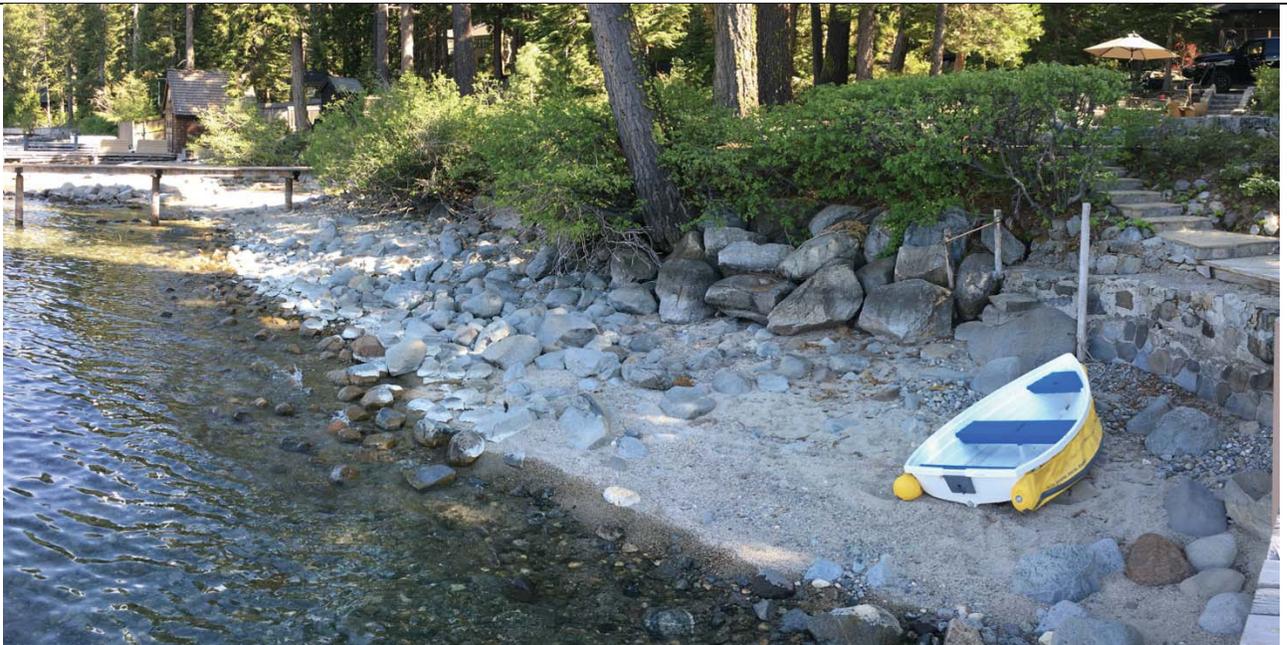
Photo 6 – View southwest along shoreline. The south segment of the shoreline has a boulder revetment with mostly native vegetation growing above/behind the boulders. The north segment of the shoreline (not shown) consists of a cemented rock seawall. The area above the retaining wall includes a patio and pathway, then the residence. The wave run-up area is just above the water lines on exposed rocks.

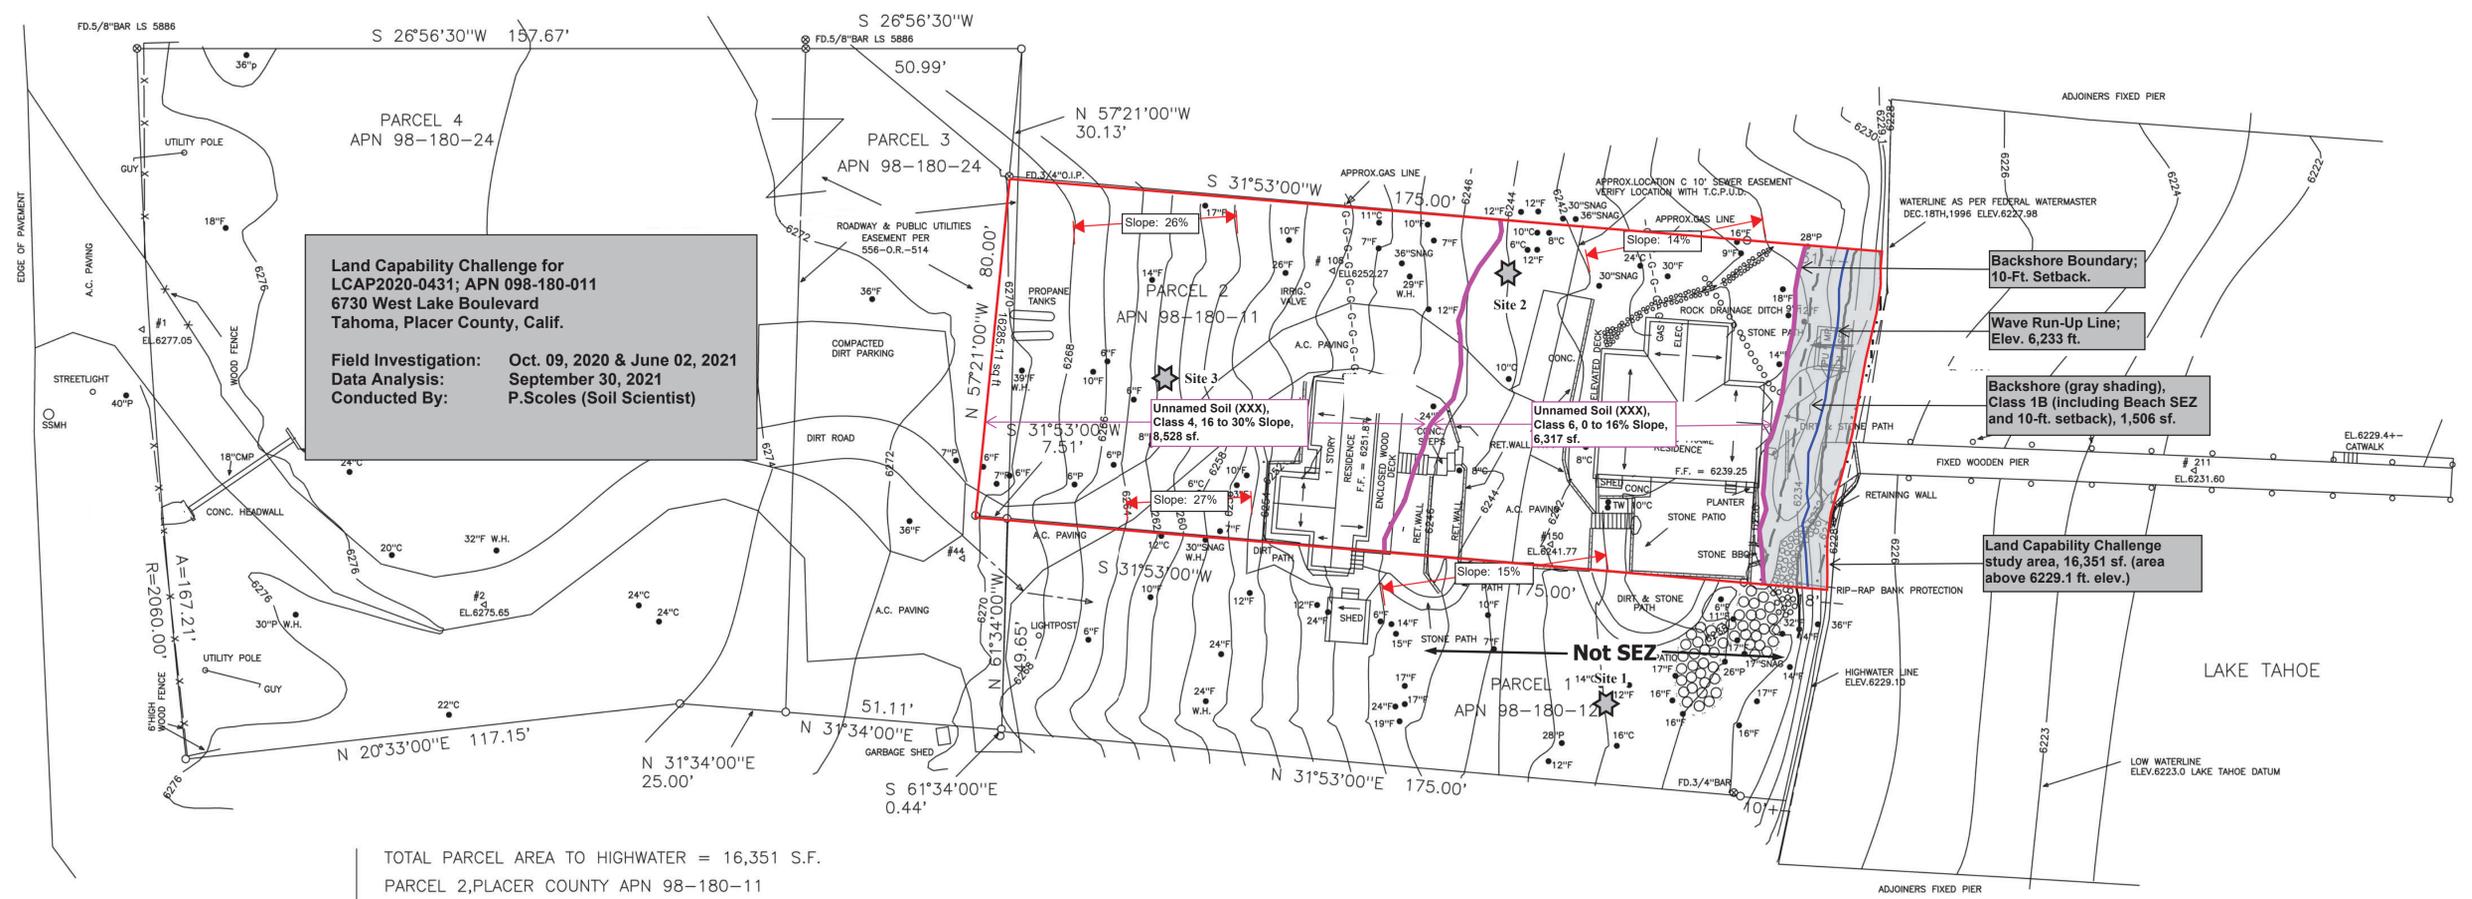
Land Capability Challenge for LCAP2020-0431; APN 098-180-011 6730 West Lake Boulevard Tahoe, Placer County, Calif.

TRPA Conclusion(s)	Backshore area (Class 1B and 10-foot setback), Class 4 Unnamed soil (XXX) for 16 to 30% slopes; Class 6 Unnamed soil (XXX) soil for 0 to 16% slopes.
Applicable Area	Entire site. 16,286 sf. (see map, Attachment C, August 2021)

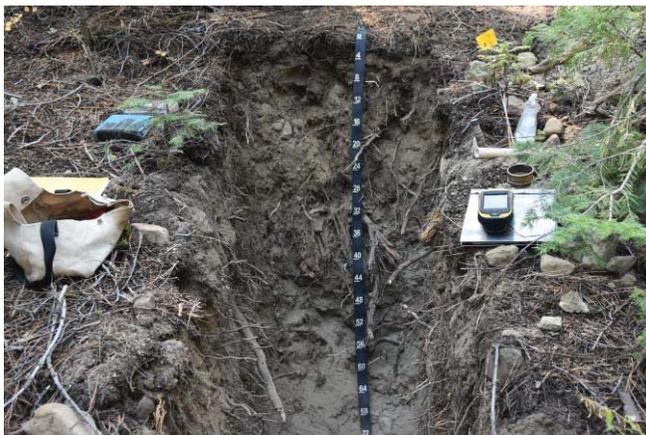
Figure 3 - Stop 2 upper landform

The upper profile (Stop 2) reflects a thin dark brown gravelly loamy sand topsoil over a weakly developed dark yellowish brown gravelly and very gravelly loamy sand to 36 inches depth, where it is underlain by olive brown extremely gravelly coarse sand.

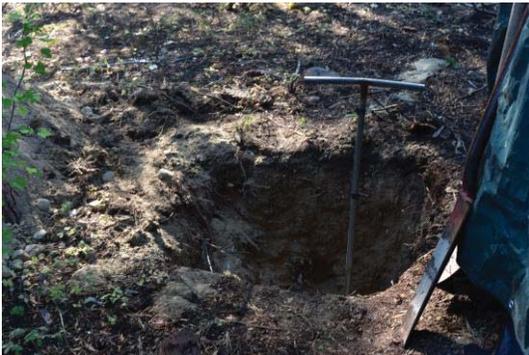
Figure 5 - Stop 3, lower terrace.

The lower profile (Stop 3) shows a thick topsoil of dark brown gravelly and very gravelly loamy coarse sand to 20 inches depth over a weakly developed subsoil consisting of dark brown and olive brown very gravelly loamy coarse sand to a depth of 60 inches. Beyond that is olive gravelly very fine sand to 72 inches depth.
