STAFF REPORT

Subject: Bock Land Capability Challenge; 1105 Tiller Drive, Washoe County, NV; APN 130-211-11, TRPA File number LCAP2021-0257

Land Capability Challenge

1105 Tiller Drive, Incline Village, Washoe County, Nevada
(APN 130-211-11)

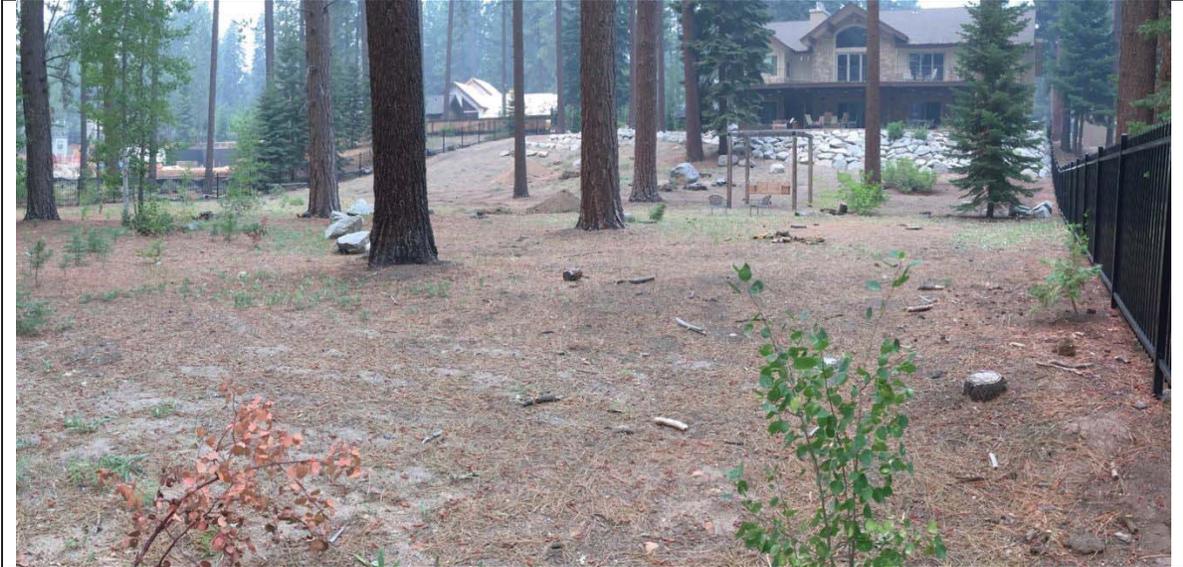
Photo 1 – View northwest from southeast property corner. Residence located in north part of somewhat pie-shaped parcel and atop lake terrace. Foreground and center part of backyard consist of gently sloping alluvial terrace – likely formed when ancient lake level receded. The understory is mostly cleared and may have been historically graded smooth (no indication of fill material).

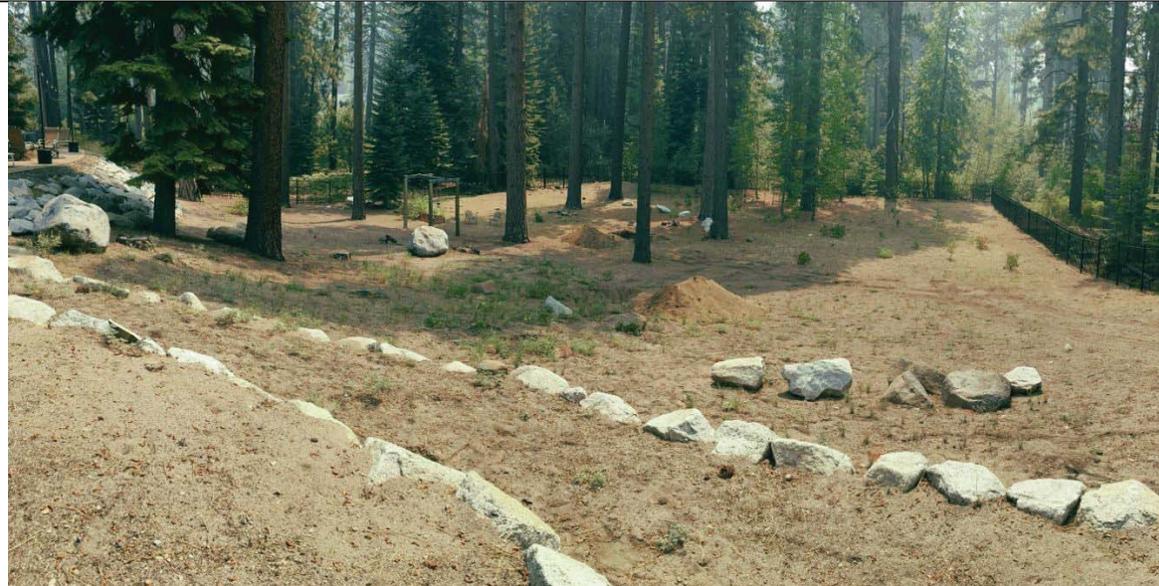
Photo 2 – View southeast across backyard (house patio at far left). The slope between the lake terrace left foreground) and alluvial terrace (center and background) has 16 to 28% slopes. The land capability challenge relied on historical contours and ignored minor terracing in foreground.

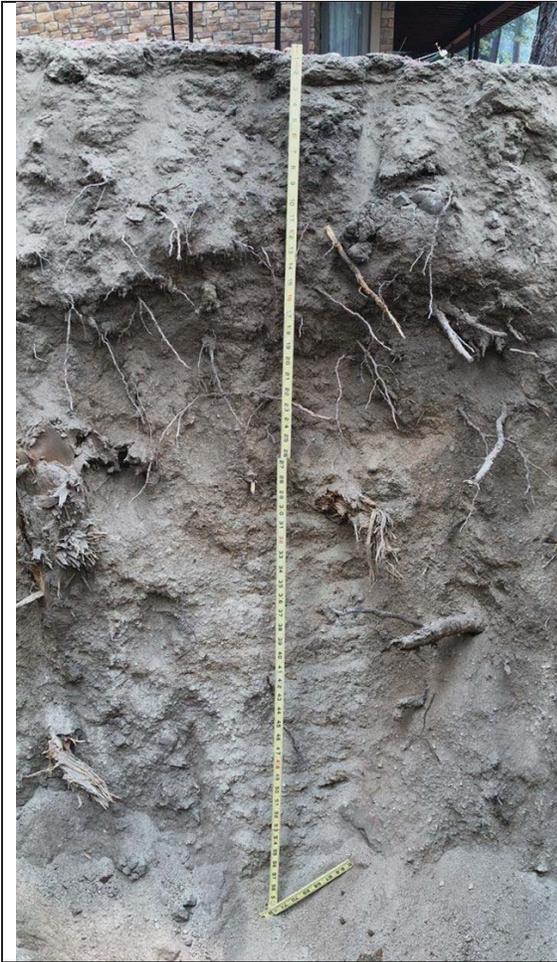
Photo 3 – Soil profile for north portion of property (aka lake terrace landform). Uppermost layers (16 inches thick) consist of dark brown loamy coarse sand. The subsoil, from 16 to 32 inches below the surface, is also loamy coarse sand, that shows little in-situ soil formation. The substratum below 32 inches (parent material) is gravelly sand. This soil is similar to Gefo and Elmira series in the 1974 soil survey; however, it shows less in-situ soil development. As per Land-Capability Classification of the Lake Tahoe Basin, California-Nevada, A Guide for Planning (Rbt. Bailey, 1974), this unnamed soil (XXX) qualifies as Class 6 (for 0 to 16% slopes).

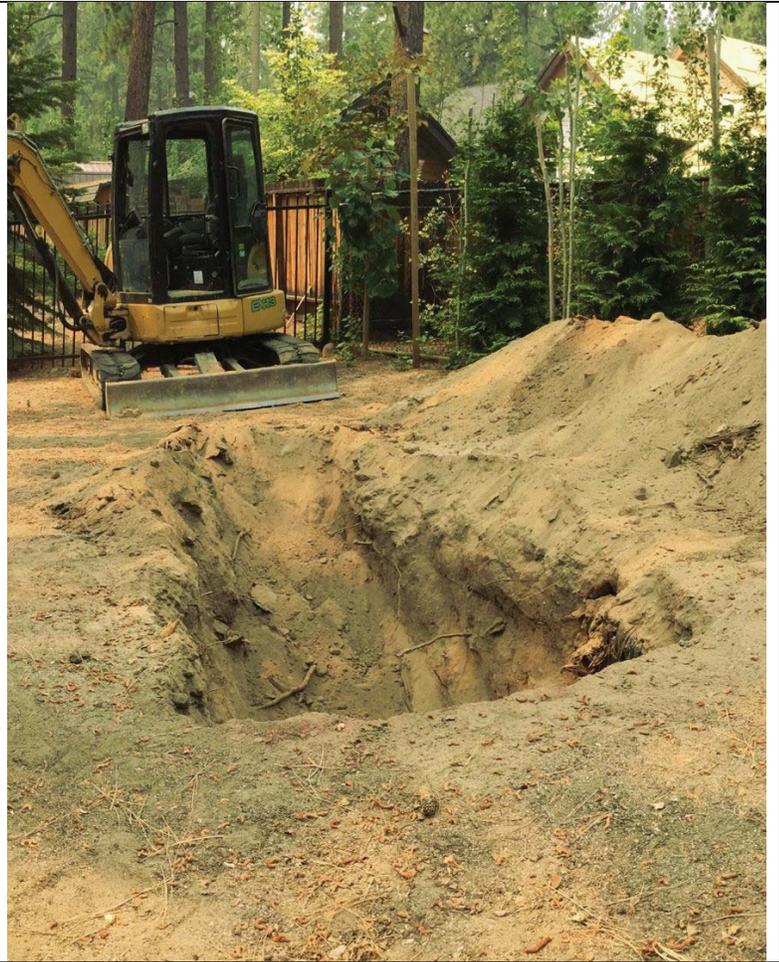
Photo 4 – View southwest toward Pit #3, situated on lake terrace (same topographic setting as existing residence). This terrace is approximately 12 feet higher than the alluvial terrace that comprises most of the backyard. Site-specific soil conditions, and soil profiles were described by Davis2 Consulting Earth Scientists in August, 2021.

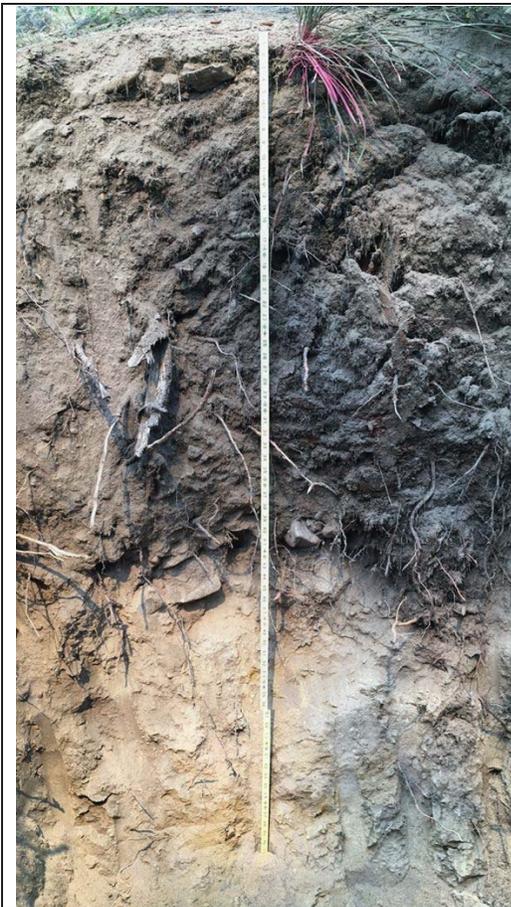
Photo 5 – Soil profile for escarpment below the lake terrace and above the alluvial terrace landform. The uppermost layers (19 inches thick) consists of dark brown gravelly loamy coarse sand. The subsoil, from 19 to 42 inches below the surface, is a sandy loam, that shows a slightly increase of illuviated iron (slightly redder tones), but not appreciable amounts of clay. The substratum below 42 inches (parent material) is a stony-gravelly sand. This soil is similar to Gefo and Elmira series in the 1974 soil survey; however, it has andesitic parent material and the substratum is more stony. As per Land-Capability Classification of the Lake Tahoe Basin, California-Nevada, A Guide for Planning (Rbt. Bailey, 1974), this unnamed soil (XXX) qualifies as Class 4 (for 16 to 30% slopes).

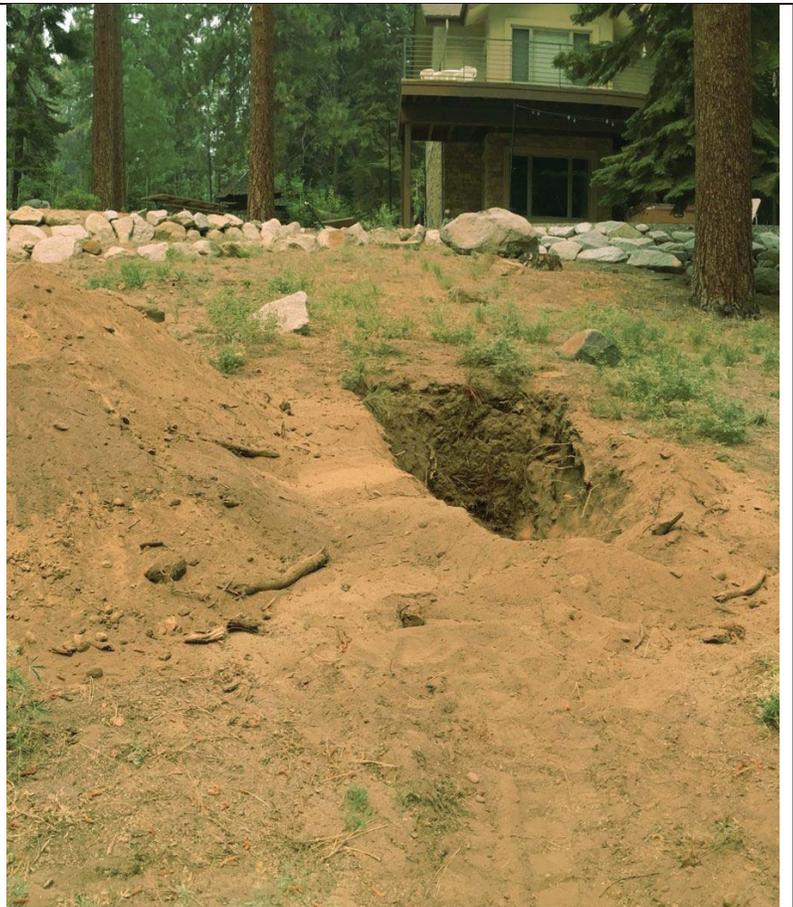
Photo 6 – View north at the transitional slope (aka natural escarpment) between upper lake terrace (older) and the alluvial terrace (opposite direction of photo). This soil at Pit #2 is deep and lacks any restricting layers, such as a fragipan or silica-cemented layer. Furthermore, no indication of seasonal groundwater was observed, such as redoximorphic features (iron staining, depleted matrix, pore linings). The slope of the escarpment ranges from 16 to 28%.

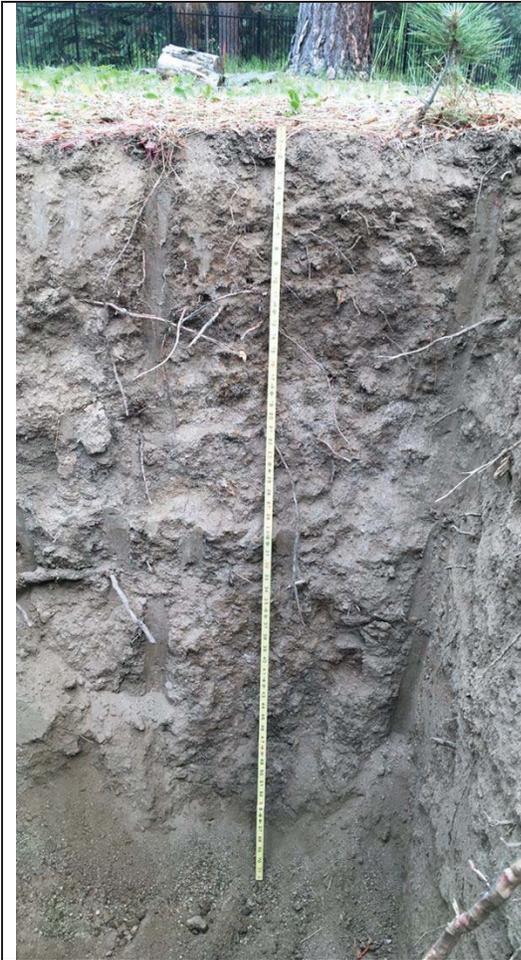
Photo 7 – Soil profile for the lower terrace (south and lowest part of parcel). The uppermost layers (16 inches thick) consists of dark brown sandy loam. The subsoil, from 16 to 30 inches below the surface, is a loamy coarse sand, that shows a slightly increase of illuviated iron (redder hue), but not appreciable amounts of clay. The substratum below 30 inches (parent material) is also loamy coarse sand. This soil is similar to Gefo and Elmira series in the 1974 soil survey; however, it has andesitic parent material. As per Land-Capability Classification of the Lake Tahoe Basin, California-Nevada, A Guide for Planning (Rbt. Bailey, 1974), this unnamed soil (XXX) qualifies as Class 6 (for 0 to 16% slopes).

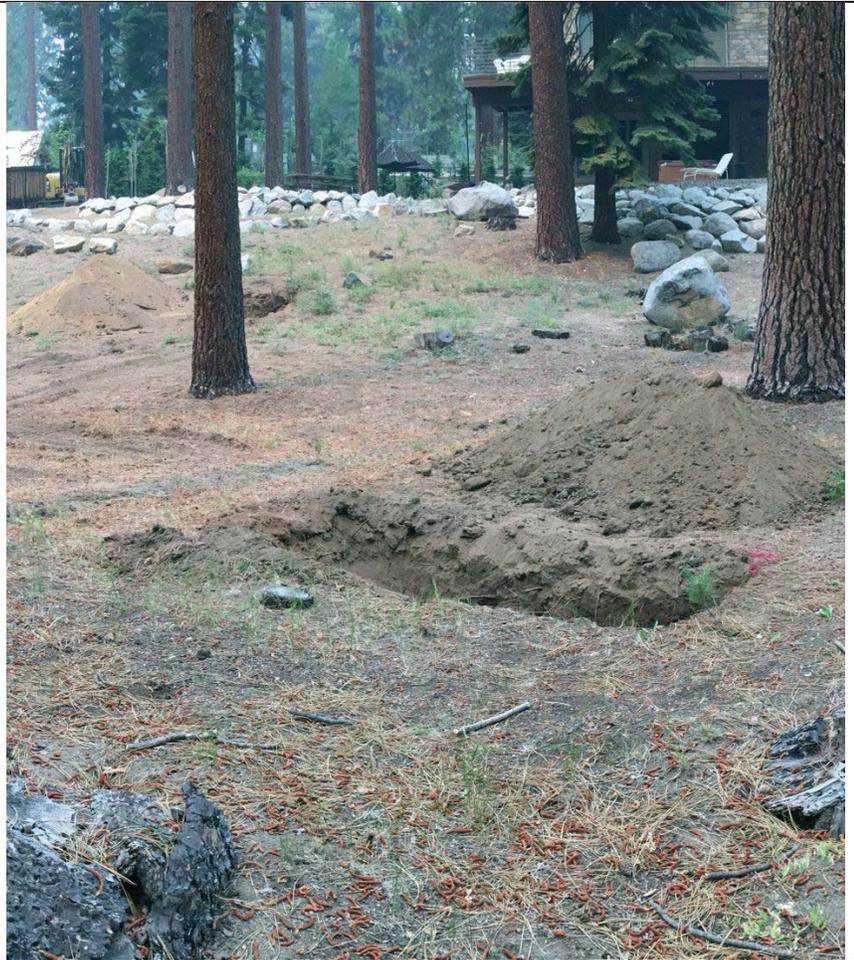
Photo 8 – View northwest toward Pit #1, situated on the alluvial terrace landform. This terrace slopes very gently to the south (2 to 16%). Like the soils on the lake terrace and escarpment, the alluvial terrace soils are deep and lack any restricting layers, such as a fragipan or silica-cemented layer. Furthermore, no indication of seasonal groundwater was observed, such as redoximorphic features (iron staining, depleted matrix, pore linings). The lack of such features is essential to the conclusion that this terrace is not, nor historically SEZ. That is, the alluvial sediments were natural flood sediments, but such area did not have a seasonal high water table.

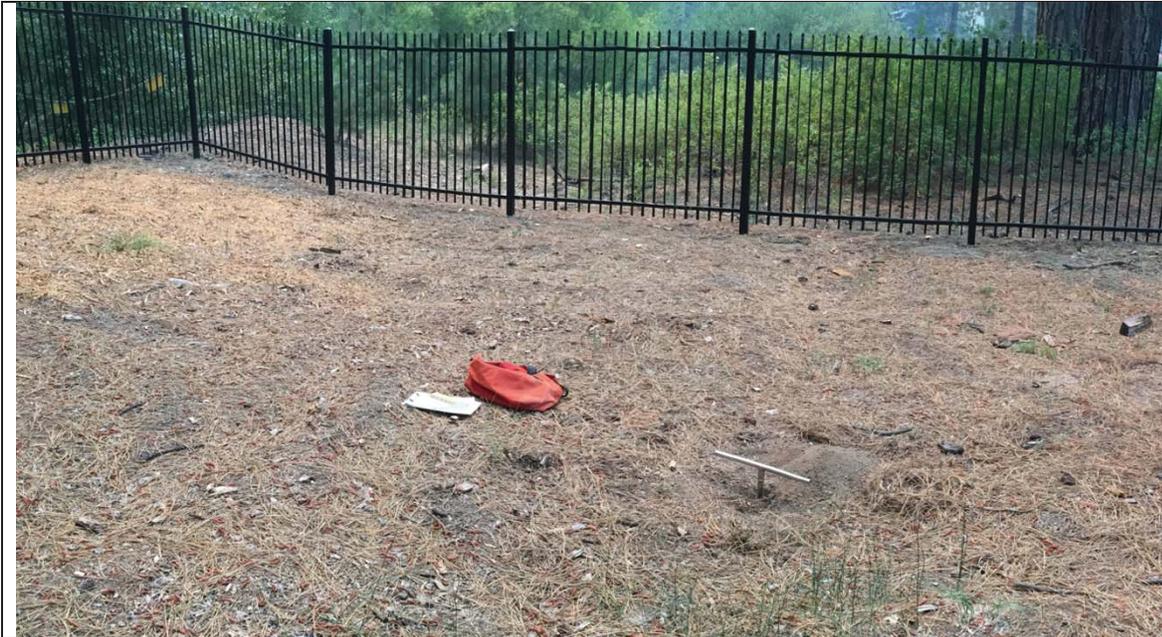
Photo 9 – View southwest toward offsite Stream Environment Zone (SEZ). Subject parcel is topographically higher and lacks SEZ plant composition; whereas, offsite SEZ (50 to 100 feet beyond fence) is dominated by willow, mountain alder, wild rose, Sierra currant, bluegrass, and Baltic rush. The onsite understory is mostly cleared, but there are small pockets of currant, bracken fern, greenleaf manzanita and lupine (all non-SEZ).

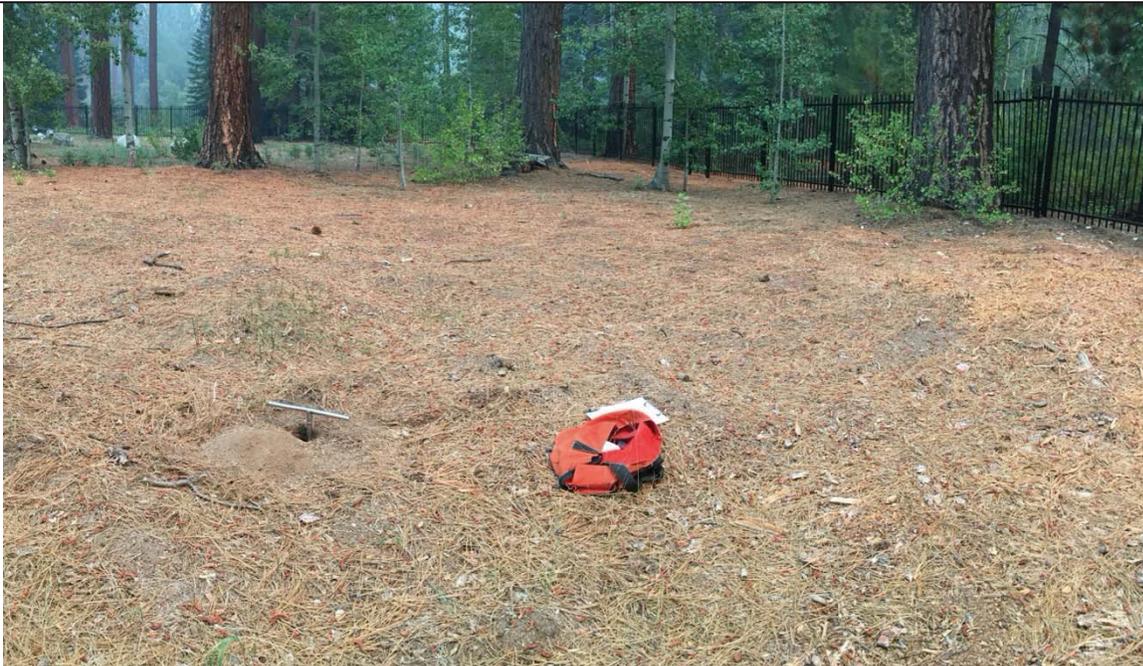
Photo 10 – View northeast from opposite position as Photo 9. This vicinity was labeled SEZ under a Land Capability Verification; however, it is dominated by large Jeffrey pines, with scattered non-SEZ shrubs in the understory. The hand-augered hole to the left of the orange field bag found deep, non-mottled and sandy soils. Also lacking any restricting layer, this soil qualifies as Class 6 (0 to 16% slopes), as per Table 4 of Bailey land capability classification system.

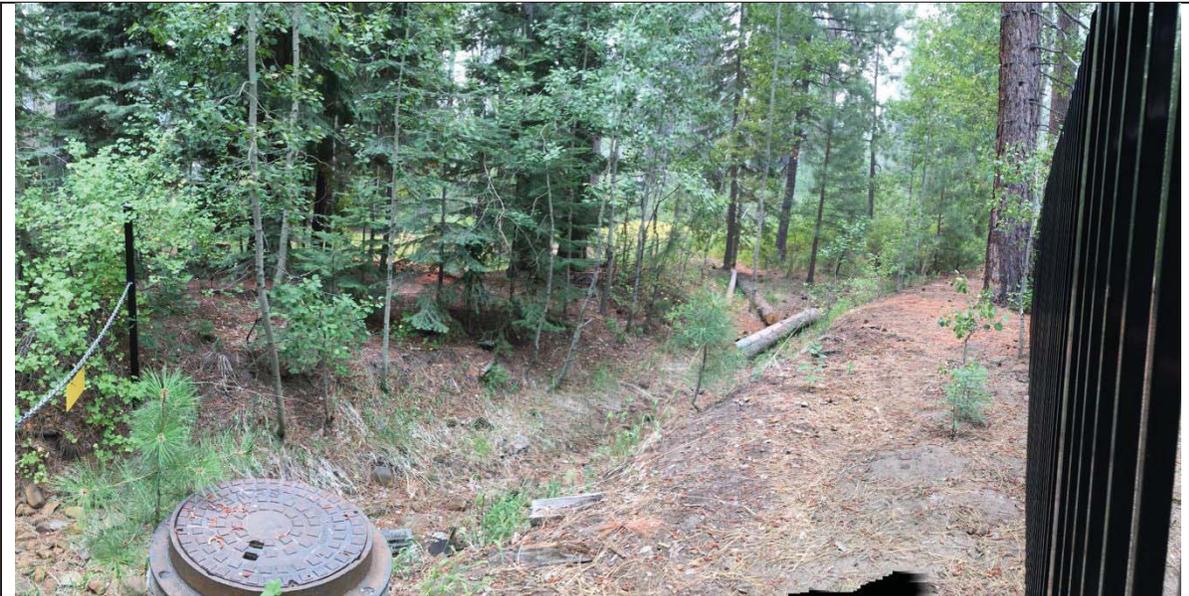
Photo 11 – View of sewer manhole located within an easement along the south property line. The sewer is set within an excavated ditch. The bottom of the ditch is about 2 feet lower than alluvial terrace described in Davis2 Consulting Earth Scientists report. The ditch was created from upland and it lacks any seasonal flow, as evident by accumulated tree needles (no scouring). It is possible the 1998 LCV interpreted the ditch as a natural feature, but the more detailed investigation for this land capability challenge found only well drained to somewhat excessively drained soils onsite.

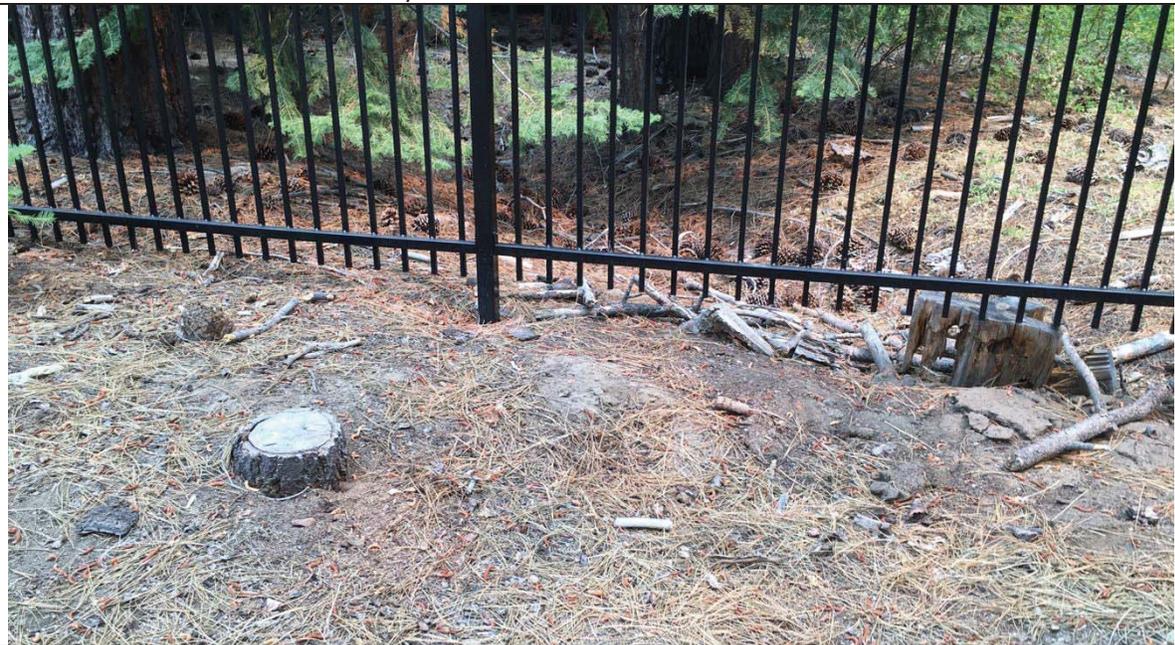
Photo 12 – View northeast from east property line. This vicinity is dominated by white fir, Sierra currant and bracken fern – all non-SEZ species. The photo shows a narrow feature that could have historically been an overflow channel or scour channel created by Mill Creek. The feature lacks any indication of flow or seasonal high water table, so it was not considered an SEZ. Instead, the feature naturally contains accumulated branches and tree needles (normal upland forest litter/ground cover).

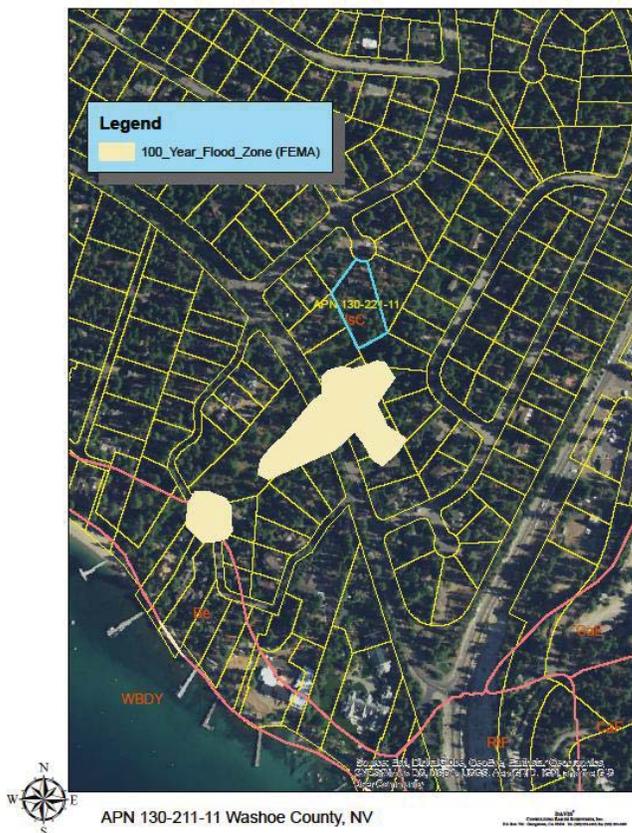
Figure 1- Flood plain in relation to subject parcel.

Soils are found to be very deep, Excessively drained, members of Hydrologic Soil Group A. Three excavations examined were all similar with respect to soil depth and texture with an intervening steeper slope that separates two terrace treads. Soils on the lower tread (Stop 1) can be characterized having a mixed topsoil consisting of dark brown loamy sand immediately above a crotovina-laced transitional (AB horizon) top soil approximately 16 inches thick, over dark yellowish brown cambic (structural Bw) loamy coarse sand subsoil to 64 inches depth. Mature Jeffrey pine occupy this surface and roots explore the soil profile to more than 60 inches. Hydrophytic vegetation is devoid of the area as well as any wetness indicators (redoximorphic features) that might be associated with wetness. A TRPA verification showing this area mapped as 1b (flood plain) is not substantiated by flood plain overlays (Figure 1).

There is no SEZ or Class 1b area on the parcel and the mapped flood plain is well offsite to the south (Figure 1).

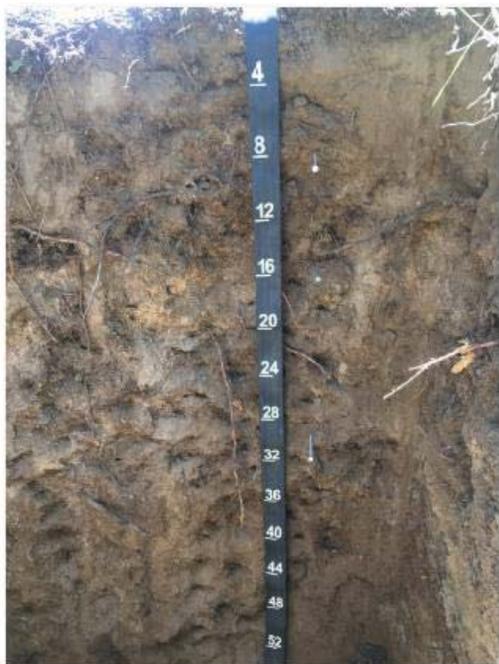
Figure 2- Stop 1 soil profile.

Notes: Crotovina in AB. Burrows filled with granitic coarse sand. Mature trees estimated at >200 years old.

Soil Series: Unnamed (XXX)

Soil Classification: Sandy, mixed, frigid, Humic Dystroxerepts

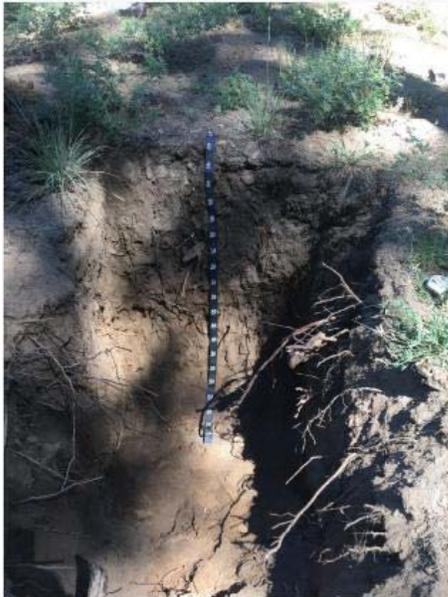
Figure 4 - Stop 2 soil profile.

Soils on the intervening slope (Stop 2) display very dark brown gravelly loamy coarse sand topsoil approximately 19 inches thick over strong brown stony sandy loam or loamy coarse sand to a depth of 68 inches. These soils display less than 35 percent coarse fragment and have a sandy control section (10-40 inches).

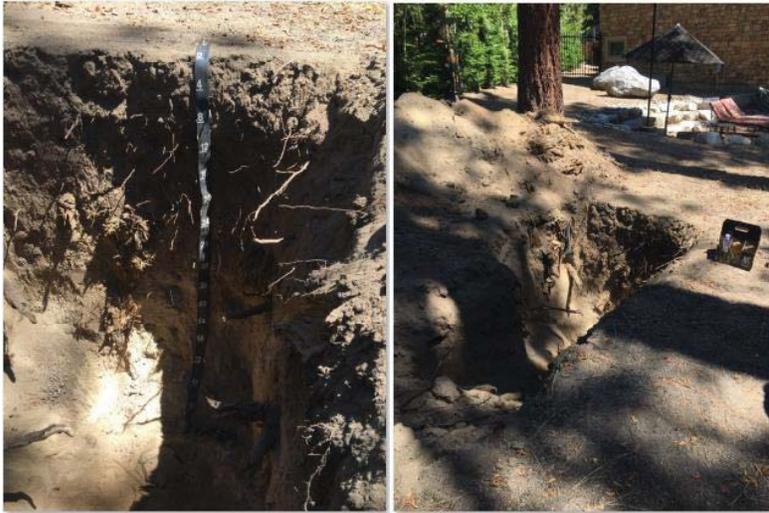
Figure 6 - Stop 3, upper terrace. Figure 7 - Upper terrace landscape.

Soils on the upper terrace (Stop 3) display dark brown loamy coarse sand topsoil about 16 inches thick over dark yellowish brown loamy coarse sand sediments to greater than 60 inches depth. These are all similar in that they are other than skeletal (< 35 percent coarse fragments by volume) in the control section.

Notes: Surface compacted by traffic.
