STAFF REPORT

Subject: Pipkin Family Trust Land Capability Challenge, 843 Stateline Avenue, South Lake Tahoe, CA; APN 029-010-013; TRPA File Number LCAP2021-0302

Pipkins Land Capability Challenge El Dorado County, California (APN 029-010-13)

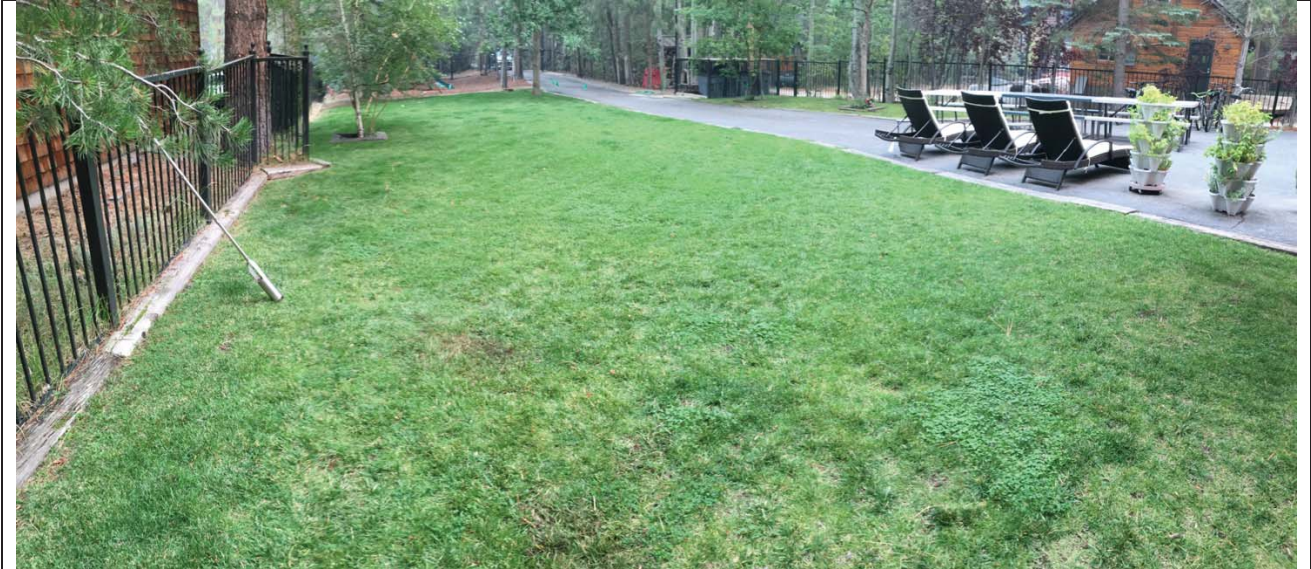
Photo 1 – View east along northern edge of parcel and east of residence (Stop no. 1). The west-center part of the parcel consists of a stabilized barrier beach ridge – half slopes towards Lake Tahoe and other half toward an SEZ. The barrier beach ridge has 0 to 2% slopes and qualifies as Class 7 (0 to 5% slopes).

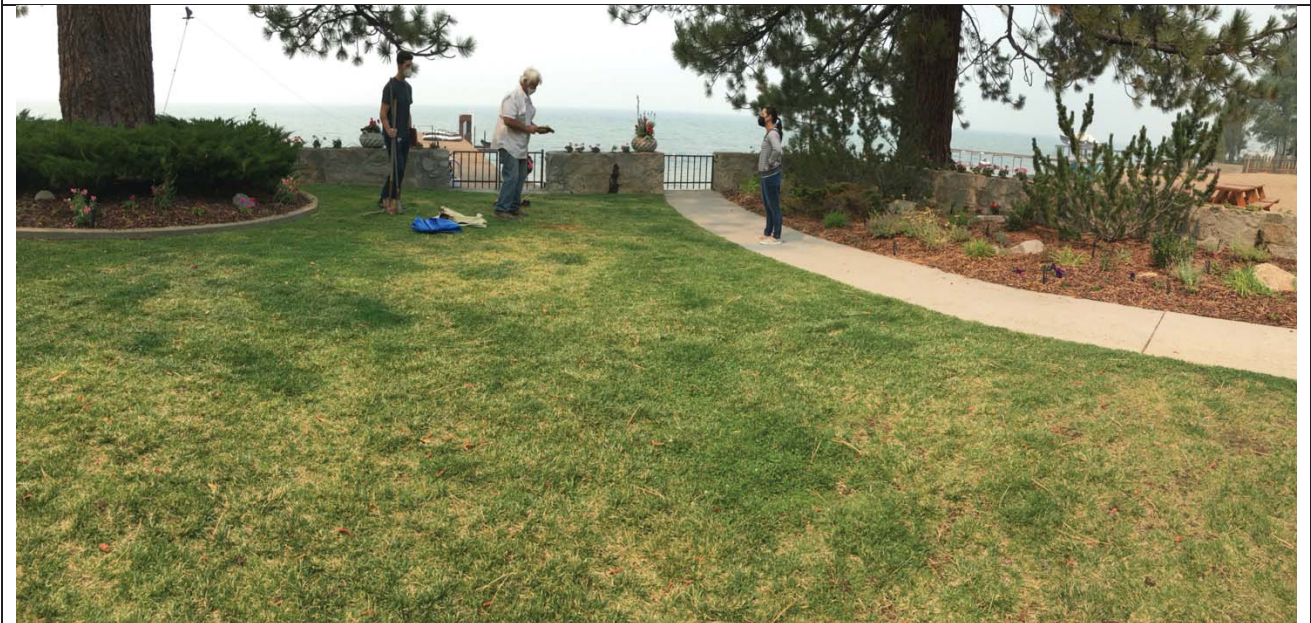
Photo 2 – View westward toward Stop 2 location (west of residence), where a hole was hand-augered to 60 inches. The profile showed no significant soil development aside from an A horizon. The soil is excessively drained due to underlying sand layers and lacks any indication of seasonal high water table. Several large Jeffrey pine trees attest this has been a stabilized barrier beach ridge for a century or more.

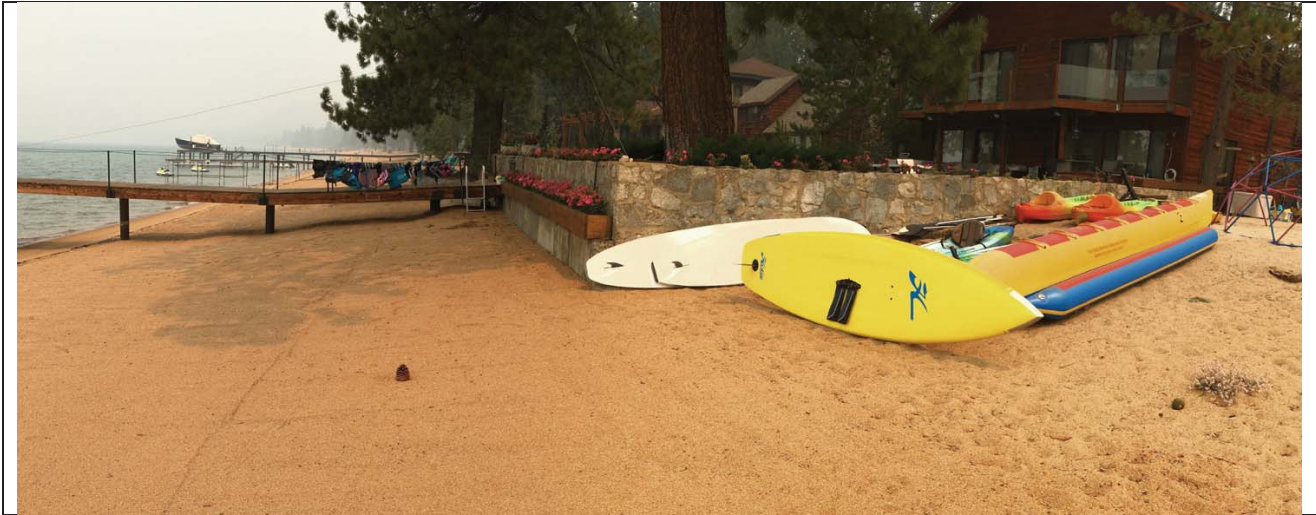
Photo 3 – View north toward southwest property corner. Subject residence located at far right and Lake Tahoe at far left. The retaining wall was built (and likely rebuilt) to prevent further erosion of the shoreline and protect several large Jeffrey pines. Without the retaining wall, the land on the adjacent parcel (foreground, right) has eroded away a portion of the stabilized barrier beach ridge.

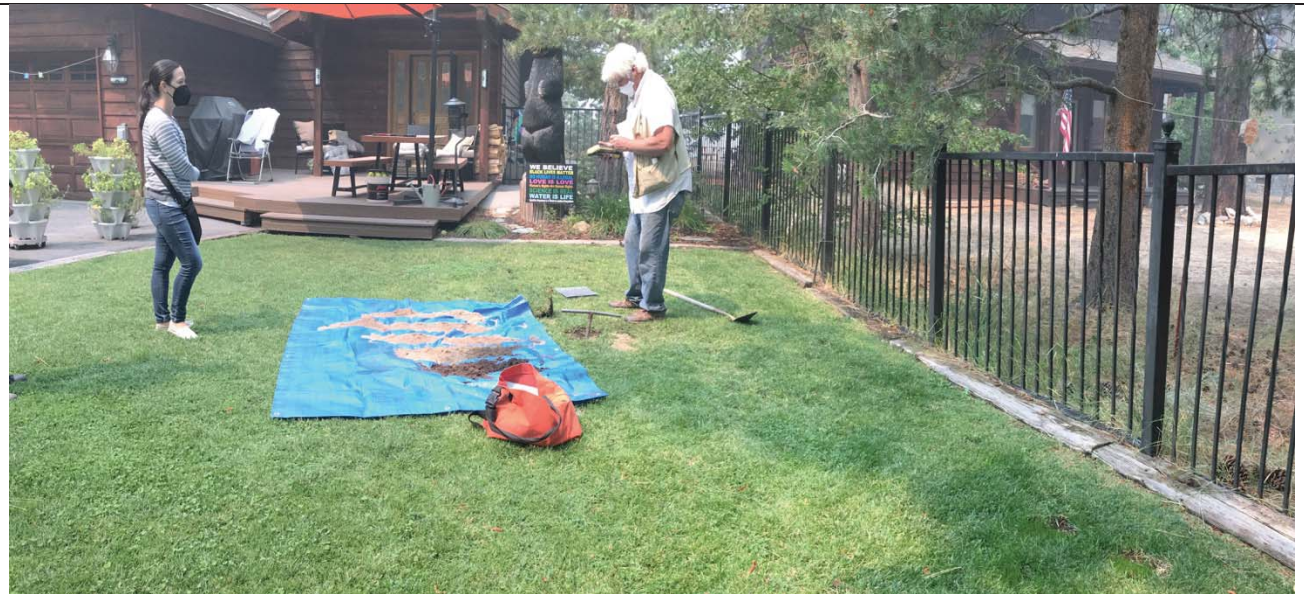
Photo 4 – View west toward west-center of parcel (residence in background). The soil consultant (Sid Davis) hand augered each hole and examined soil layers atop the blue tarp. The soils in the vicinity of the residence, front yard and back yard differ from the mapped Elmira wet variant (Ev) and Beaches (Be) on basis of no seasonal high water table. They also differ from Elmira gravelly loamy coarse sand and Gefo gravelly loamy coarse sand due to lack of gravels and no in-situ soil development.

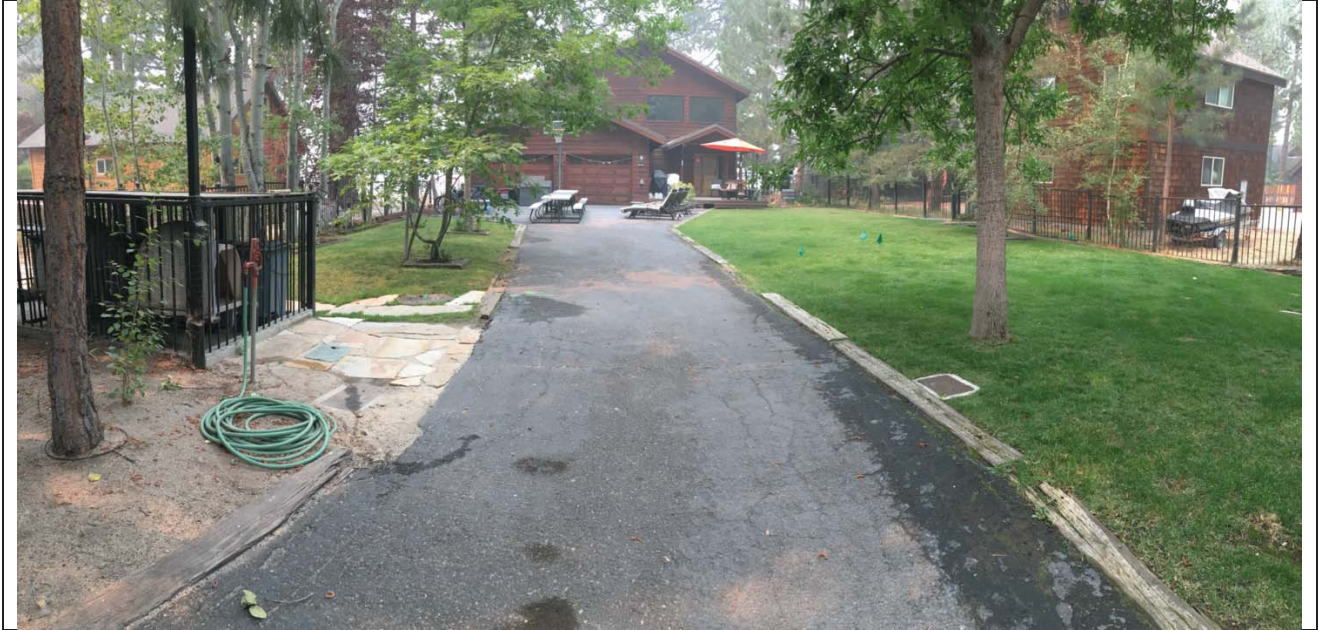
Photo 5 – View west along southern edge of parcel. The residence in background was built atop a stabilized barrier beach ridge, which has 0 to 2% slopes. As an unnamed soil inclusion (labeled XXX), it qualifies as Class 7 (0 to 5% slopes). In addition to landscaped plants, Jeffrey pine, white fir, lodgepole pine are common native trees on this parcel. This investigation findings are consistent with land capability challenges on adjacent/nearby parcels.

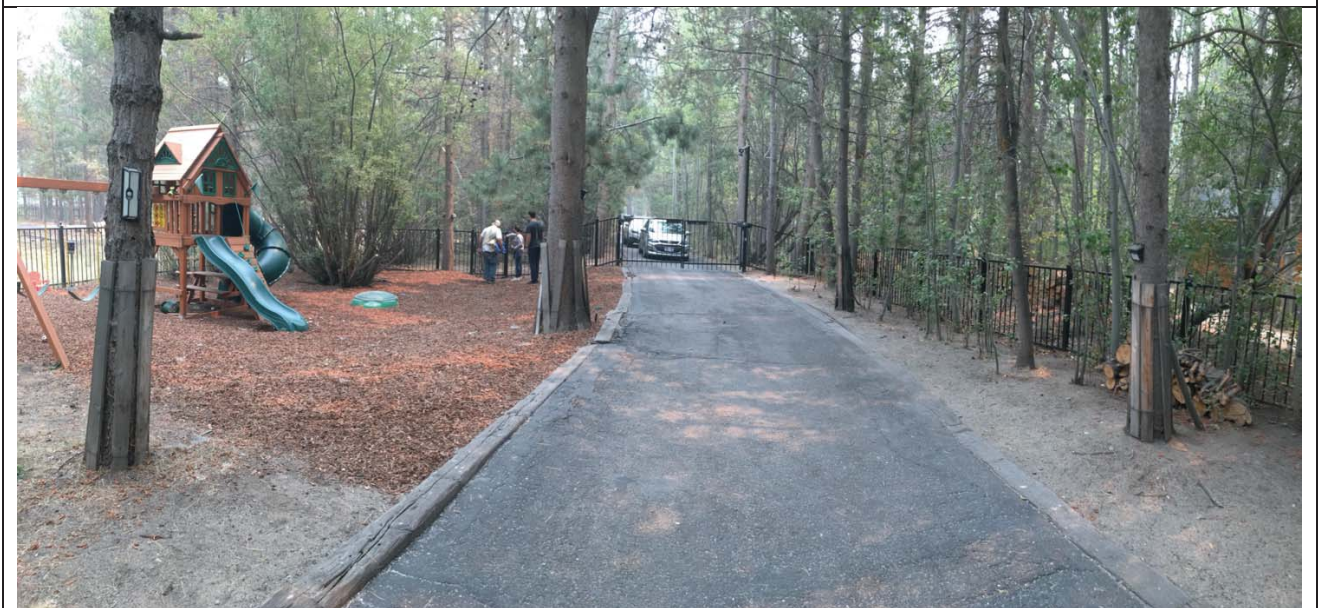
Photo 6 – View east toward SEZ area at east end of parcel. The TRPA contractor hand-augered to 40+ inches in this vicinity and confirm presence soil redox features (evidence of seasonal high water table). This area is dominated by lodgepole pine, aspen, willow, grasses and forbs. This area amounts to 3,330 sf. of Class 1B soil.

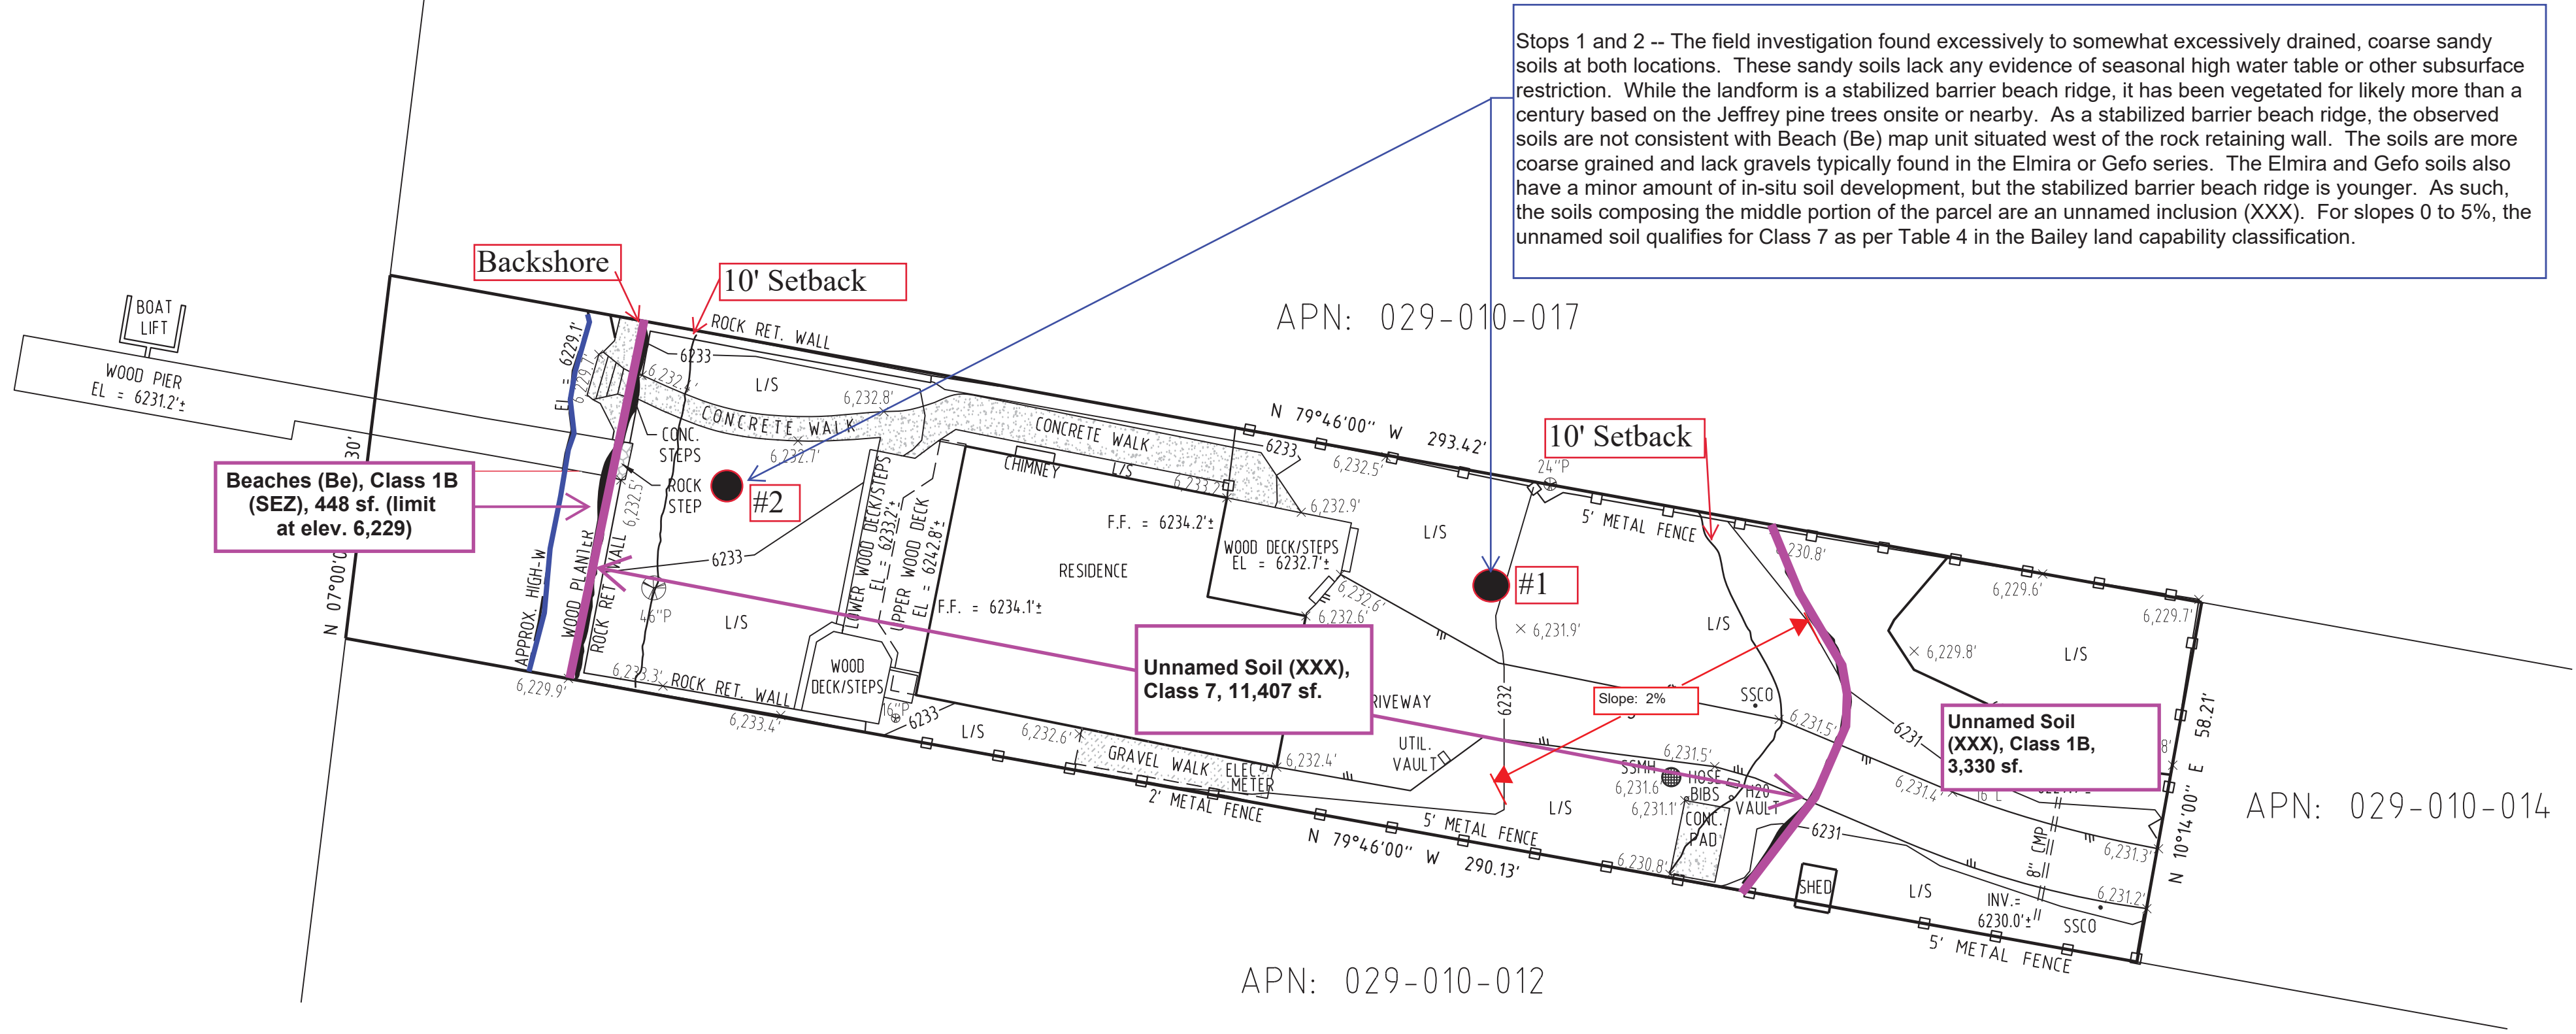
Stops 1 and 2 -- The field investigation found excessively to somewhat excessively drained, coarse sandy soils at both locations. These sandy soils lack any evidence of seasonal high water table or other subsurface restriction. While the landform is a stabilized barrier beach ridge, it has been vegetated for likely more than a century based on the Jeffrey pine trees onsite or nearby. As a stabilized barrier beach ridge, the observed soils are not consistent with Beach (Be) map unit situated west of the rock retaining wall. The soils are more coarse grained and lack gravels typically found in the Elmira or Gefo series. The Elmira and Gefo soils also have a minor amount of in-situ soil development, but the stabilized barrier beach ridge is younger. As such, the soils composing the middle portion of the parcel are an unnamed inclusion (XXX). For slopes 0 to 5%, the unnamed soil qualifies for Class 7 as per Table 4 in the Bailey land capability classification.

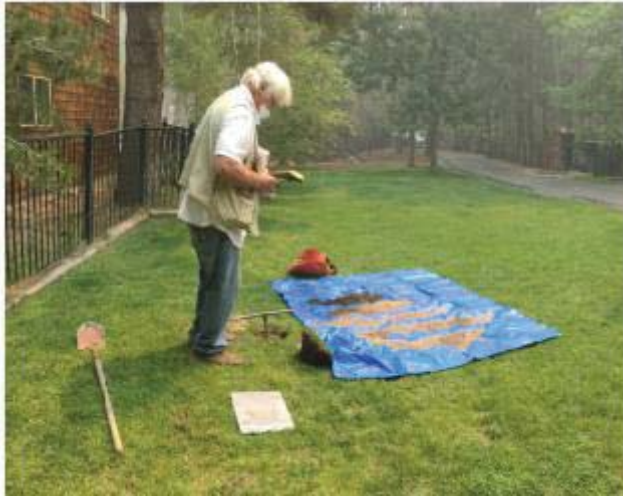
Figure 1- Stop 1

- A1 0 – 4 inches, black (10YR 2/1) moist; sandy loam; moderate fine granular structure; soft, loose, nonsticky and nonplastic; many very fine and fine roots; many very fine and fine interstitial pores; clear smooth boundary.
- A2 4 – 14 inches, very dark brown (7.5YR 2.5/2) moist; sandy loam; moderate fine granular structure; soft, loose, nonsticky and nonplastic; common fine medium roots; many very fine and fine interstitial pores; gradual smooth boundary.
- C1 14 – 36 inches, very dark grayish brown (10YR 3/2) moist; sand; single grain; soft, loose, nonsticky and nonplastic; many very fine and fine interstitial pores; gradual smooth boundary.
- C2 36 – 60 inches, brown (10YR 4/3) moist; coarse sand; single grain; soft, loose, nonsticky and nonplastic; many very fine and fine interstitial pores.

Soil Series: Unnamed (XXX)

Soil Drainage Class: Excessive

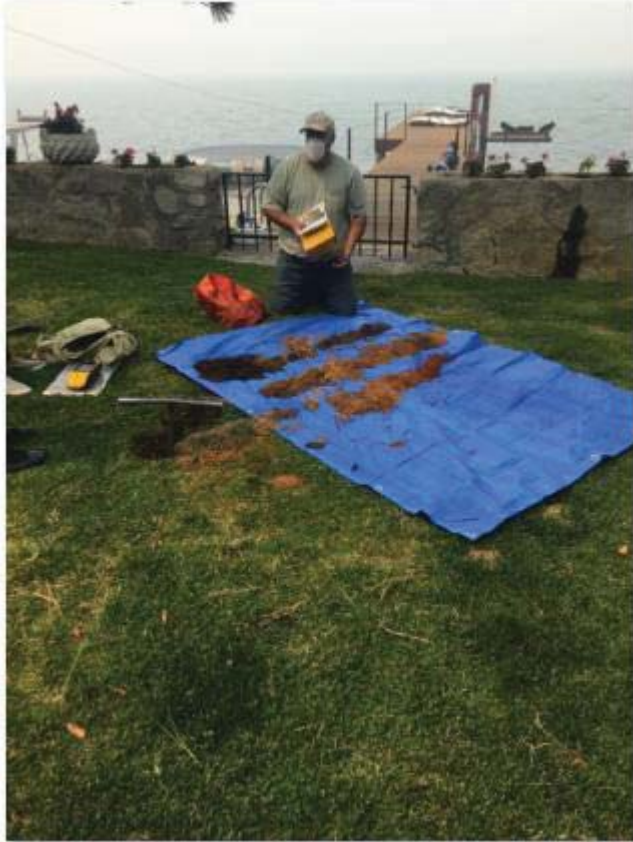
- A1 0 – 4 inches, black (7.5YR 2.5/1) moist; loamy sand; moderate fine granular structure; soft, loose, nonsticky and nonplastic; many very fine and fine roots; many very fine and fine interstitial pores; clear smooth boundary.

- A2 4 – 12 inches, dark brown (7.5YR 3/3) moist; coarse sand; single grain; soft, loose, nonsticky and nonplastic; common fine medium and few coarse roots; many very fine and fine interstitial pores; gradual smooth boundary.

- C1 12 – 24 inches, dark yellowish brown (10YR 4/4) moist; coarse sand; single grain; soft, loose, nonsticky and nonplastic; many very fine and fine interstitial pores; gradual smooth boundary.

- C2 24 – 50 inches, dark yellowish brown (10YR 3/6) moist; coarse sand; single grain; soft, loose, nonsticky and nonplastic; many very fine and fine interstitial pores; gradual smooth boundary.

- C3 50 – 60 inches, dark red (2.5YR 3/6) moist; coarse sand; single grain; soft, loose, nonsticky and nonplastic; many very fine and fine interstitial pores.

Soil Drainage Class: Excessive

Figure 2- Stop 2, convex landform.
