Staff Report

Date: October 21, 2021

Subject Hampton Land Capability Challenge, 670 Sierra Vista Avenue, Placer County, CA, APN 085-141-010, TRPA File Number LCAP2021-0250

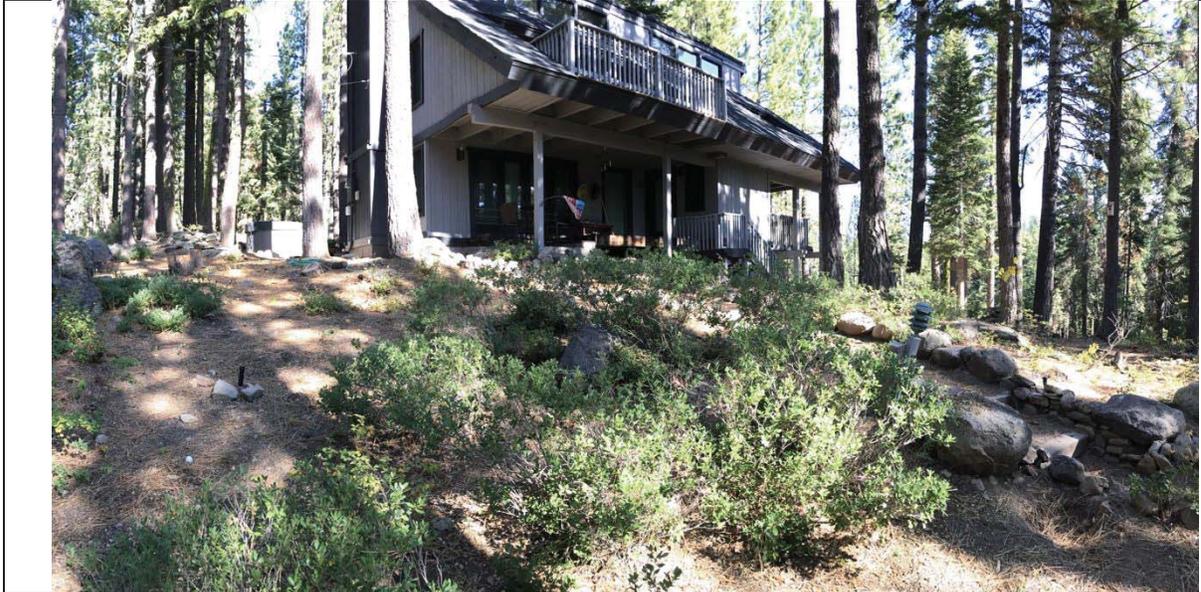
Photo 1 – View to northwest from southeast portion of property. Slopes are 24% in the left half of photograph and 15% in the right half (E and NE aspect). Sierra Vista Avenue located in opposite direction (behind photographer). Immediate foreground is artificially steepened by driveway cut.

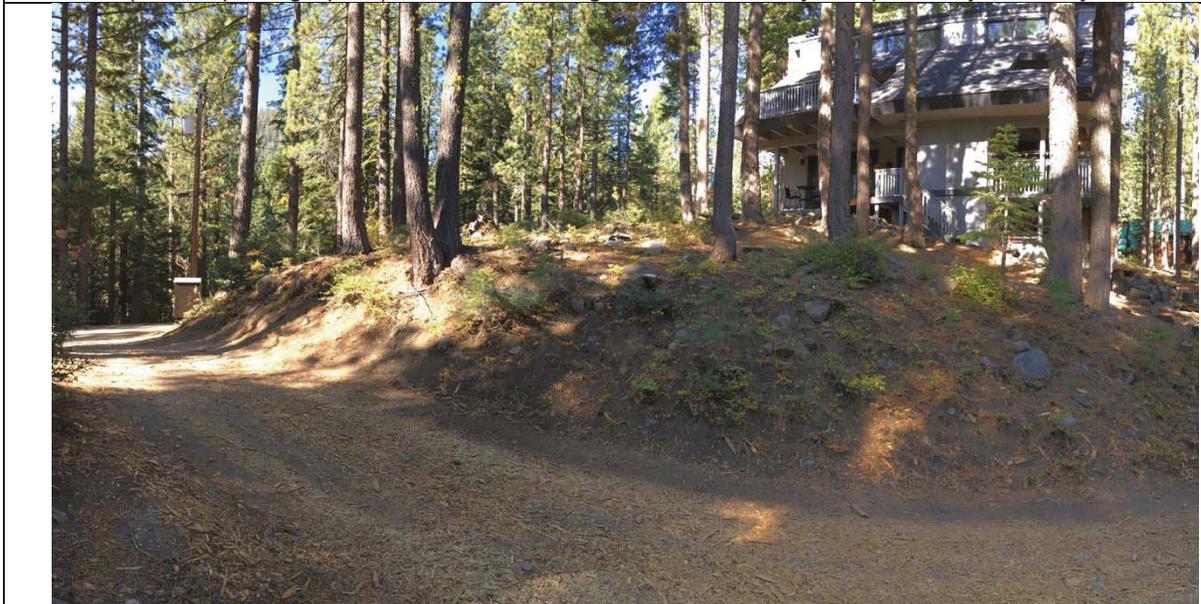
Photo 2 – View to south at southeast edge of parcel where driveway was excavated across the hillside to allow access to the residence from a less steep slope. For land capability challenges, TRPA utilizes the historical slopes, so these excavated slopes are designated as Class 4 (instead of Class 2 for slopes greater than 30%).

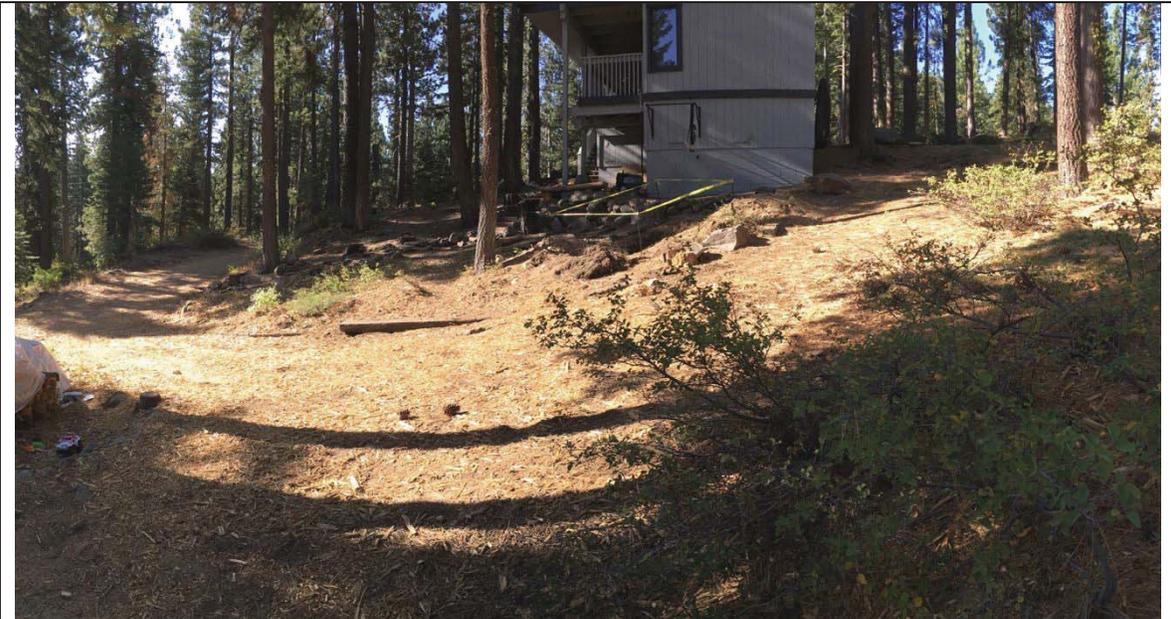
Photo 3 – View to south toward center of parcel. The driveway is located at far left and backhoe-dug pit is situated about 15 feet north of residence (yellow flagging). Pit location was relatively undisturbed and accessible by backhoe (hence appropriate for soil profile description). The natural slope is 22 to 28%; while the foreground slope is artificially flatter (part of the driveway).

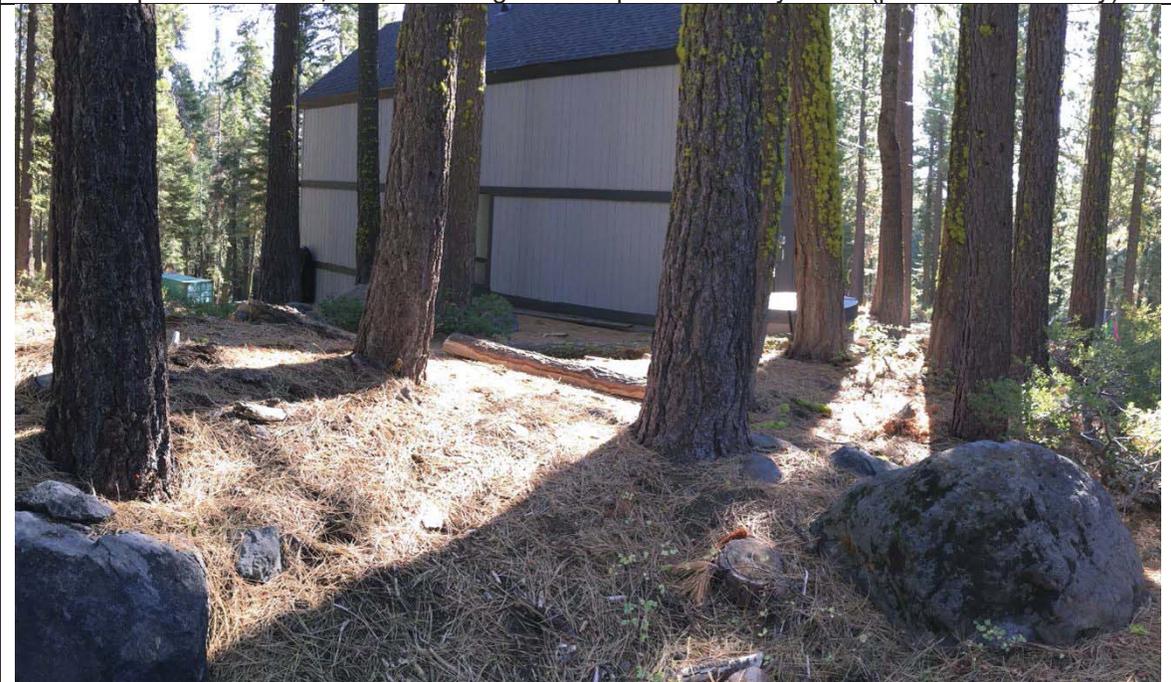
Photo 4 – View to northeast of southwest property corner (highest elevation). This vicinity has several very large boulders. These are not anchored to bedrock, which is deeper than 6 feet below the surface. Slope is roughly 18% to the northeast (left) and east (right).

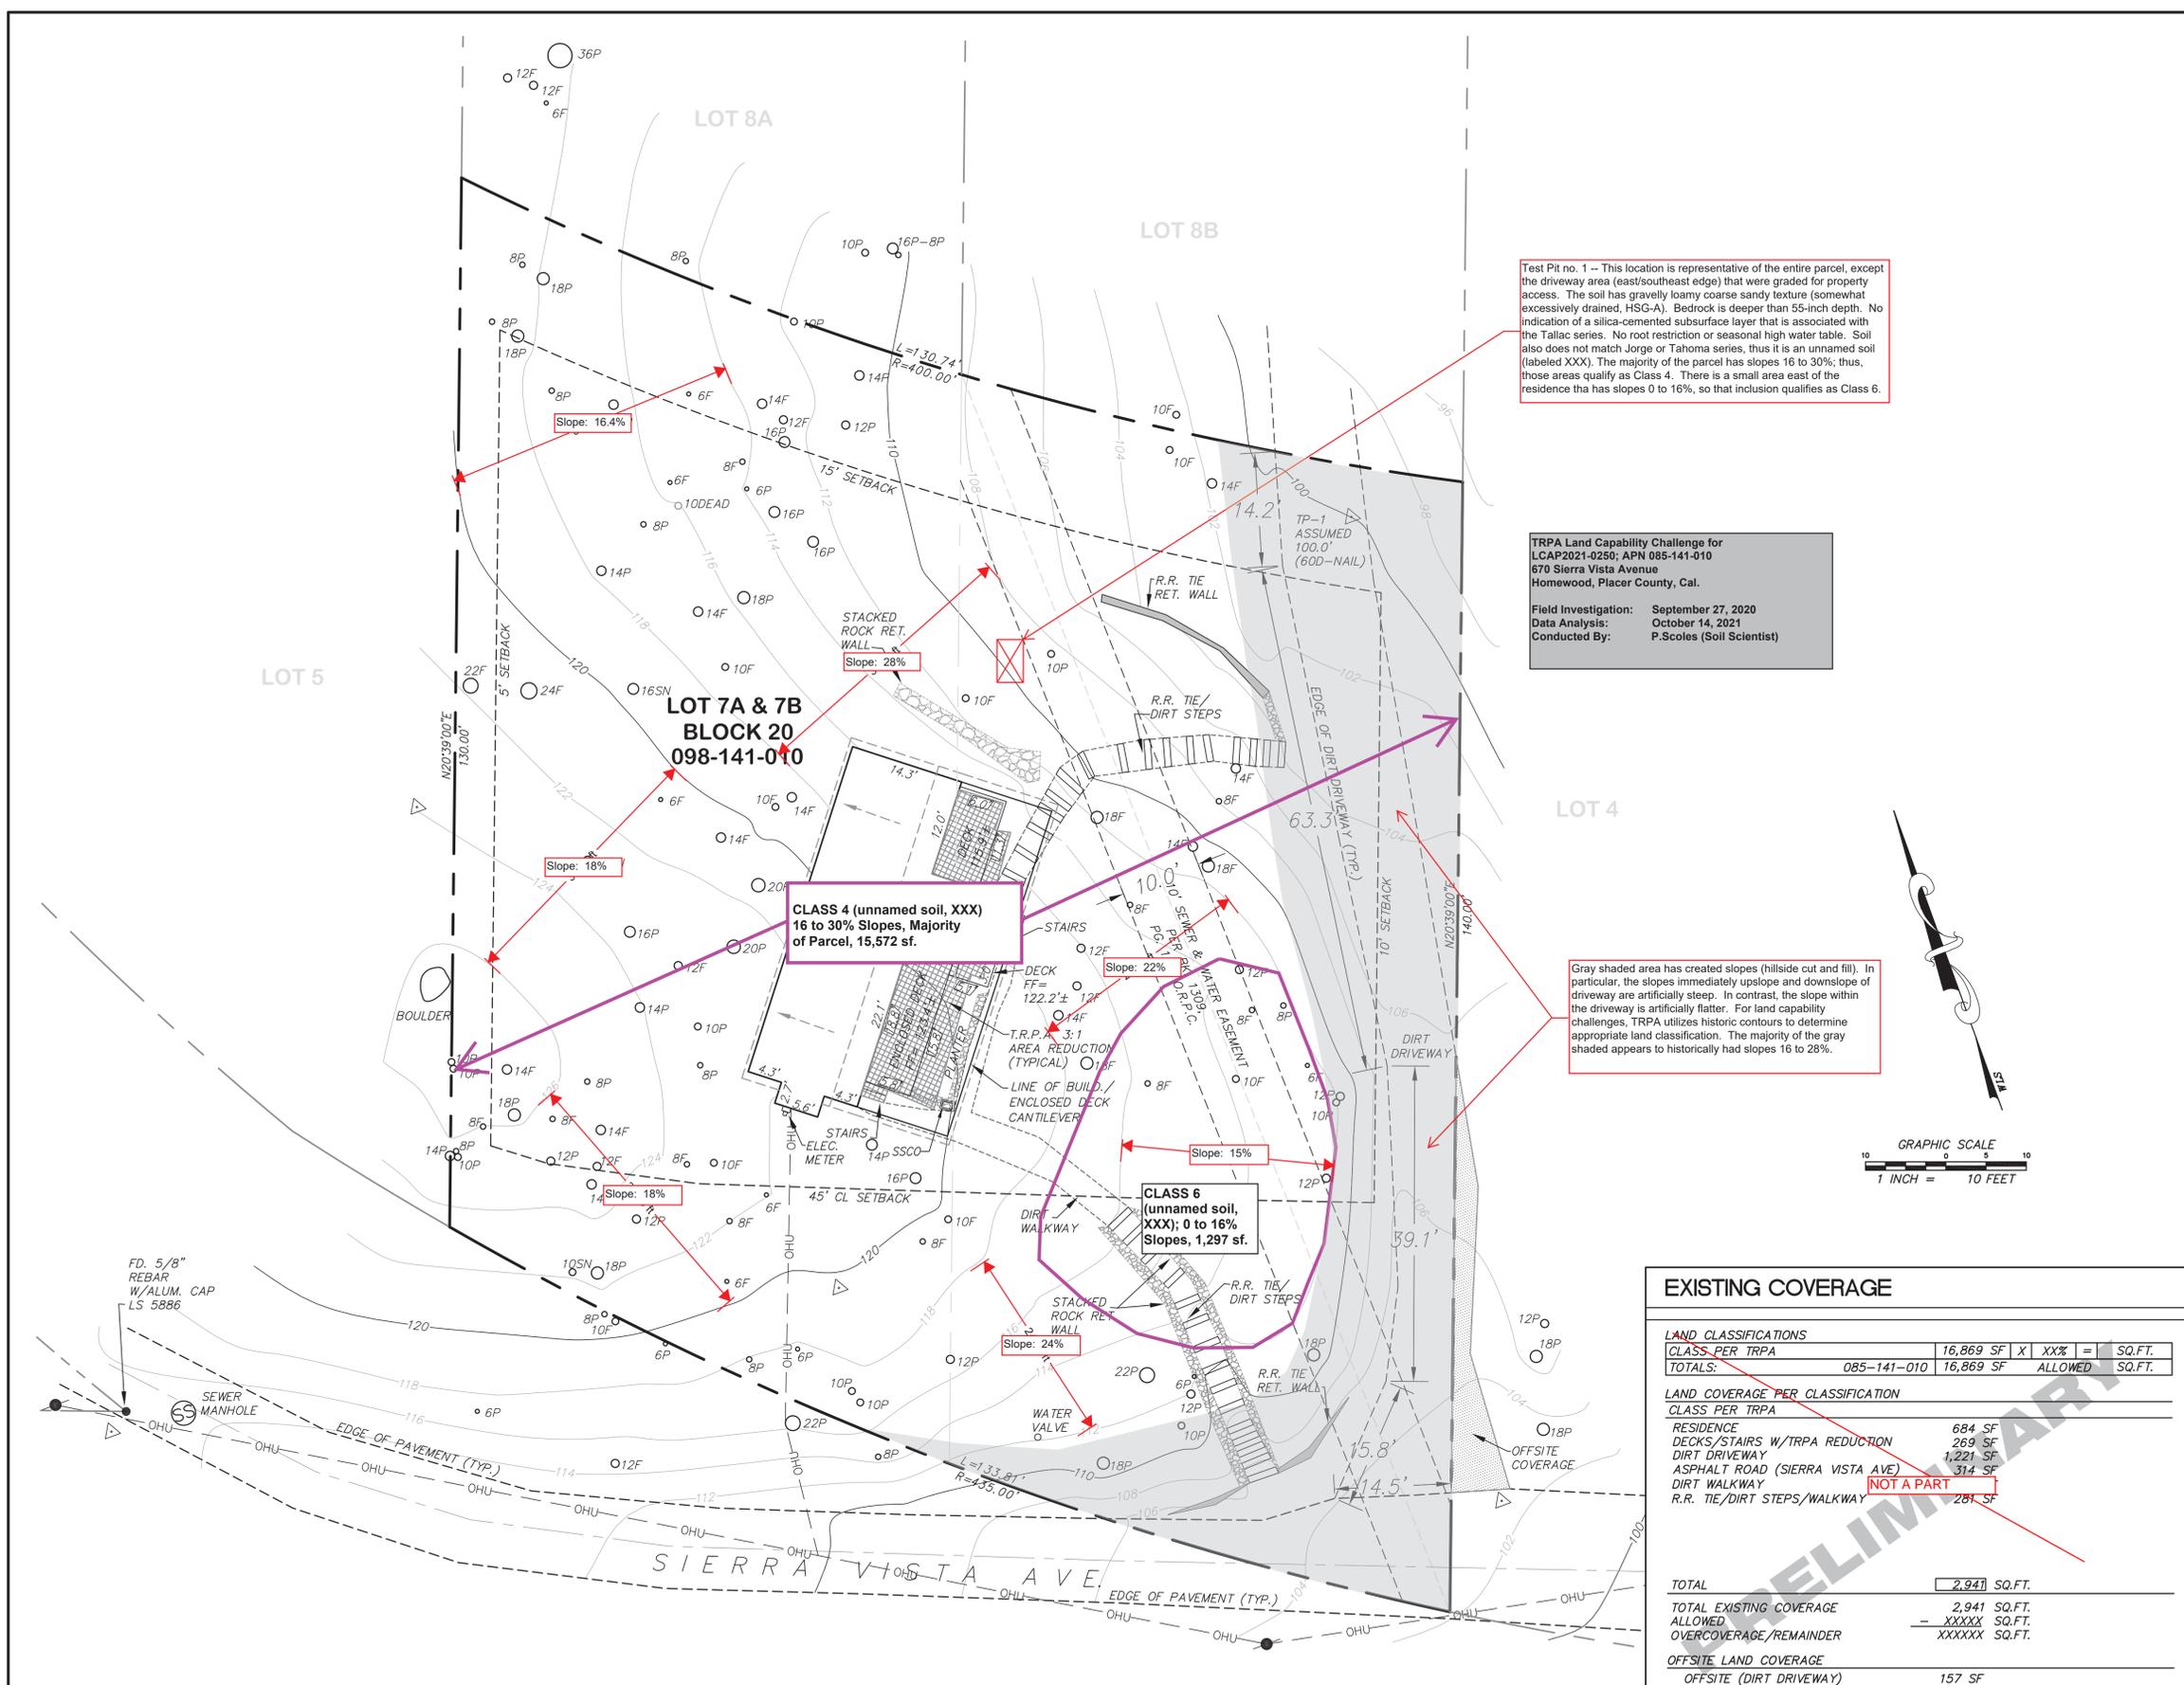
Test Pit no. 1 -- This location is representative of the entire parcel, except the driveway area (east/southeast edge) that were graded for property access. The soil has gravelly loamy coarse sandy texture (somewhat excessively drained, HSG-A). Bedrock is deeper than 55-inch depth. No indication of a silica-cemented subsurface layer that is associated with the Tallac series. No root restriction or seasonal high water table. Soil also does not match Jorge or Tahome series, thus it is an unnamed soil (labeled XXX). The majority of the parcel has slopes 16 to 30%; thus, those areas qualify as Class 4. There is a small area east of the residence that has slopes 0 to 16%, so that inclusion qualifies as Class 6.

Gray shaded area has created slopes (hillside cut and fill). In particular, the slopes immediately upslope and downslope of driveway are artificially steep. In contrast, the slope within the driveway is artificially flatter. For land capability challenges, TRPA utilizes historic contours to determine appropriate land classification. The majority of the gray shaded area appears to historically had slopes 16 to 28%.

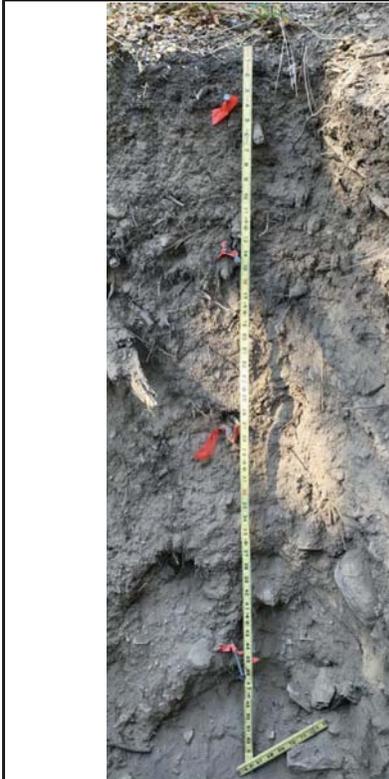
**Photo A – View of soil profile showing bottom depth of 55 inches. Root penetration to bottom and no indication of seasonal water table.**

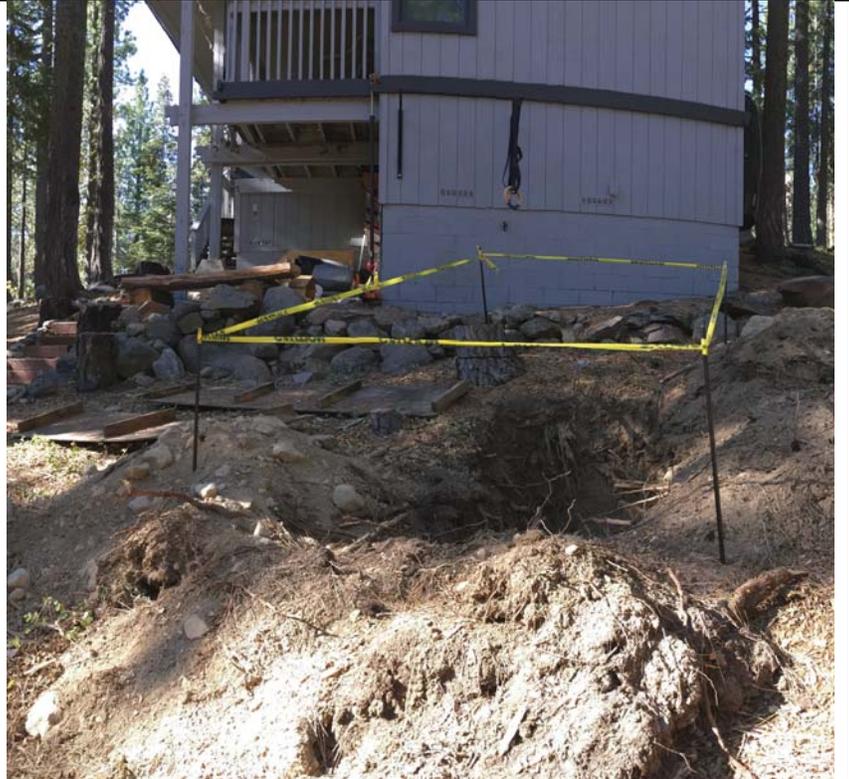
**Photo B – View southwest at Test Pit 1, located on north side of residence. This vicinity has a slope of 26% and the landform is a glacial moraine. There are several large boulders onsite (not attached to bedrock). Rock retaining wall south of pit contains rocks larger than cobbles observed in test pit.**
