STAFF REPORT

Subject: Schutte-Walton Glenbrook LLC Land Capability Challenge, 2059 Pray Meadow Road, Douglas County, NV, APN 1418-10-601-002, TRPA File Number LCAP2021-0188

BAILEY LAND CAPABILITY CHALLENGE FINDINGS

Schutte Land Capability Challenge

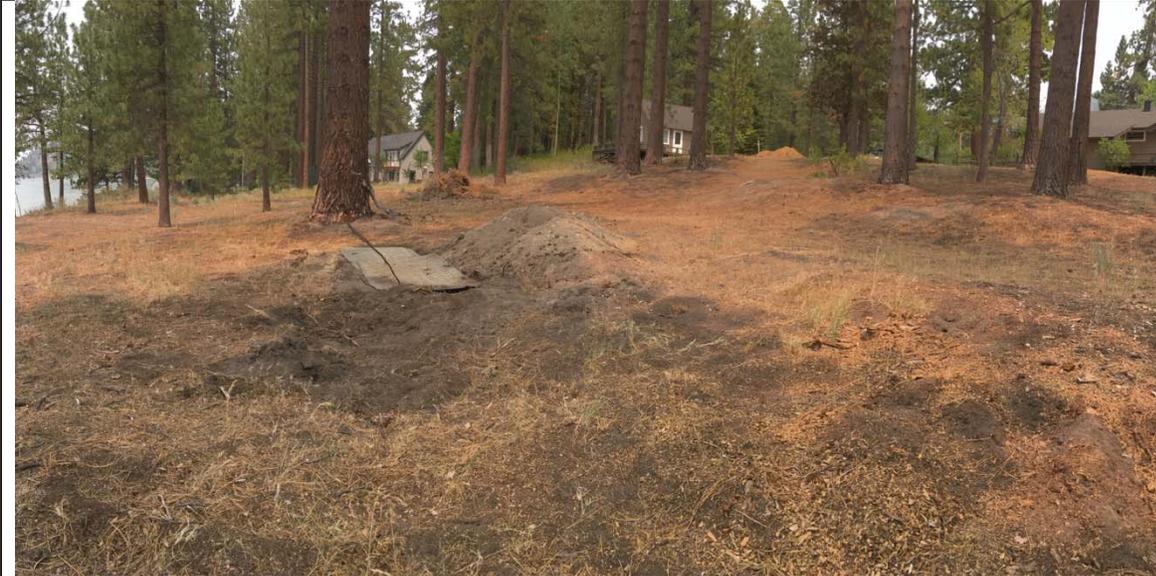
Photo 1 – View north (left) to northeast (right) of center of property. The lower terrace in foreground has slopes ranging from 5 to 16%. Small area of disturbance in center-left is the covered backhoe pit for Stop #1. Soil profile described by Davis2 Consulting Earth Scientists in June, 2021.

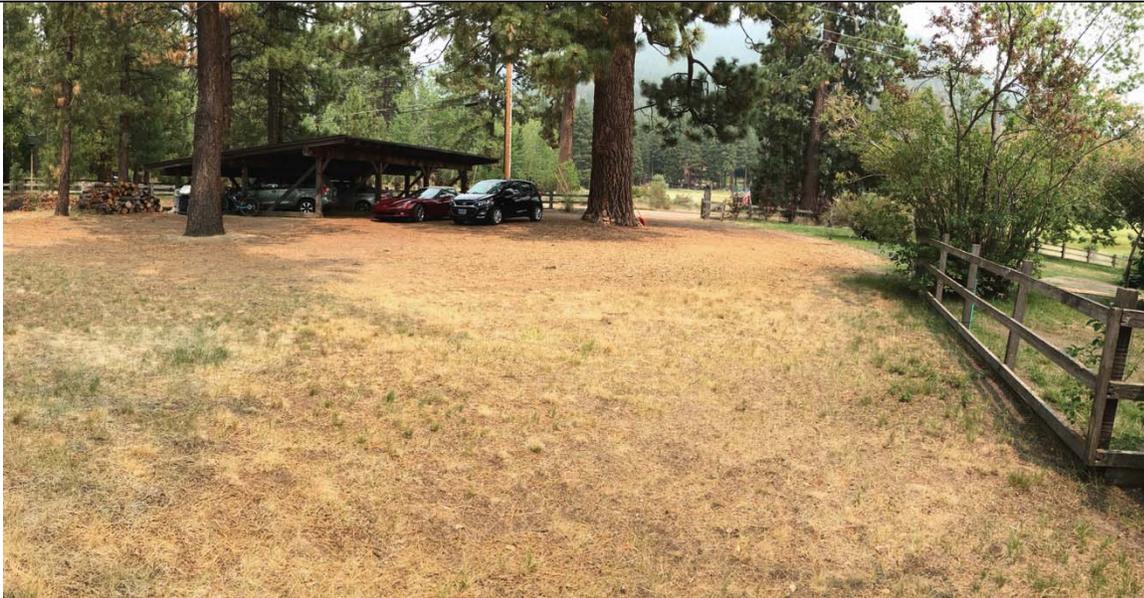
Photo 2 – View northeast (left) to east (right) of the northeast portion of the subject parcel. Backhoe pit for this upper terrace is beyond the left edge of photo and about 1 foot lower. The unpaved driveway is covered with wood chips – no tire ruts due to sufficient permeability and lack of seasonal high water table.

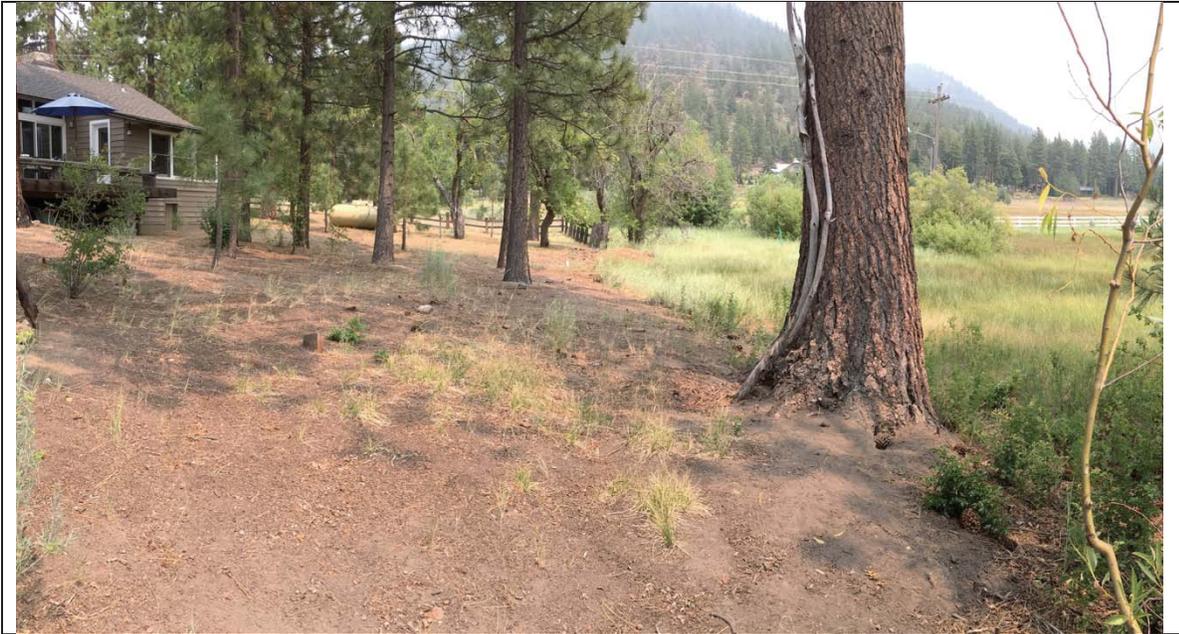
Photo 3 – View of the east edge of the subject parcel. The adjacent parcel to the south includes a wet meadow that drains runoff from the east to Lake Tahoe (opposite direction of photo). A small portion of this wetland extends into the southeast corner of the parcel. Upland to SEZ transition is mostly abrupt.

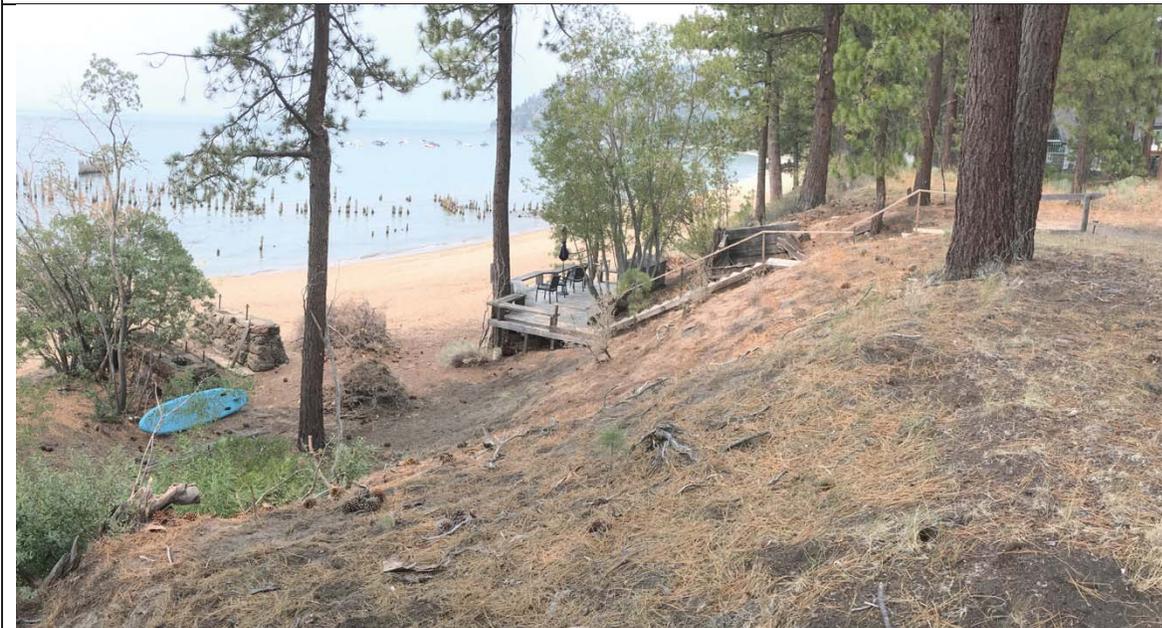
Photo 4 – View northwest (left) to north (right) along upper edge of the escarpment that parallels the shoreline. The property owner has consolidated downed branches and recent pine needles as part of their defensible space actions. The land surface still consists of an organic layer of partially decomposed pine needles, except for walking paths or areas of recent disturbance.

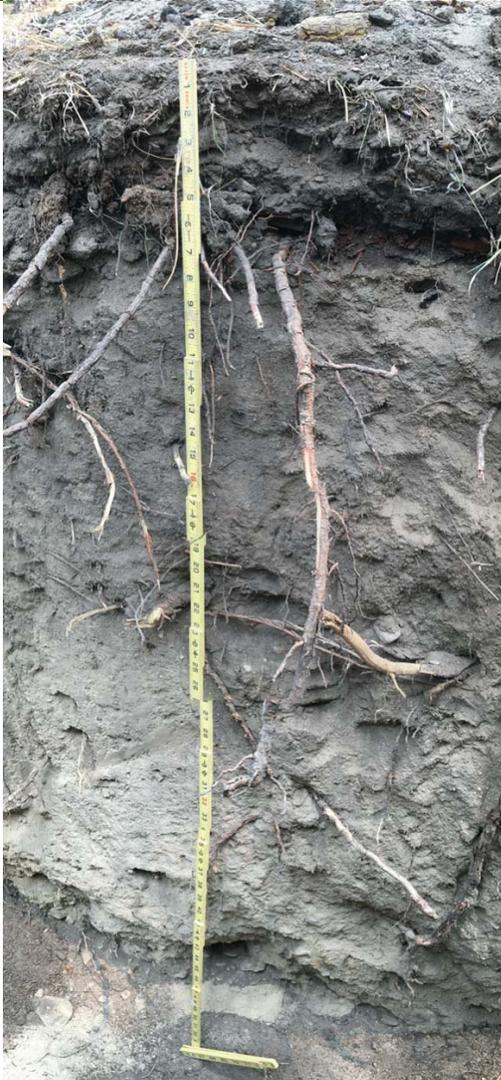
Photo 5 – Soil profile for lower terrace (Stop 1). Topsoil layer is 28 in thick and composed of loamy sand likely deposited as a dune, as apparent by the lack of gravels. Underlying parent material is 32+ inches thick and lacks in-situ soil development. Profile lacks root-restricting layer (such as a seasonal high water table or dense fragipan). While similar to Gefo series, this unnamed soil (XXX, Class 6) has substantially thicker “A” horizon, less gravels, and less soil development than that series. As per Table 4 of Land-Capability Classification of the Lake Tahoe Basin, California-Nevada, A Guide for Planning (Rbt. Bailey, 1974). There is also a small band of Class 4 soil with same conditions, but 16 to 30% slopes.

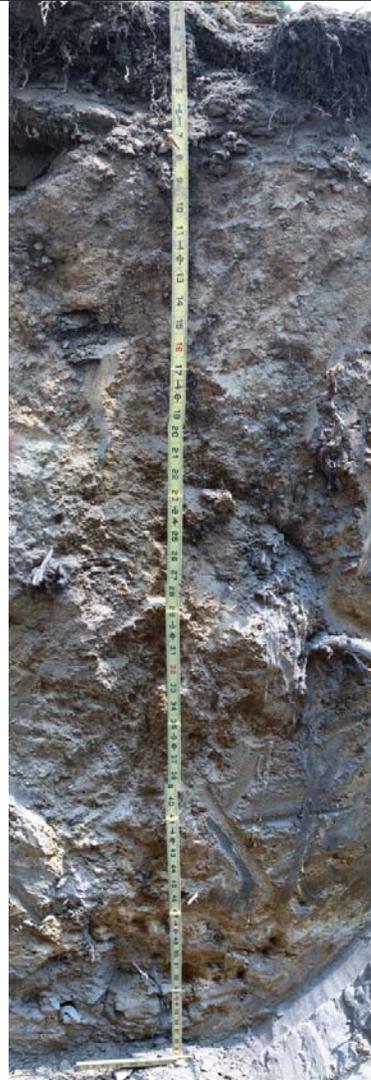
Photo 6 – Soil profile for upper terrace (Stop 2). The topsoil layer is 10 inches thick and composed of loam to sandy loam. The underlying layers to 60+ inches have increasing amounts of clay that formed in-situ. The clay naturally migrated from the upper layer down to the middle and lower layer over tens of thousands of years. Consequently, the lower layers have variegated matrix. The upper 16 inches consists of glacial outwash, while the underlying material is old lake sediments (finer texture). This soil is dissimilar from the mapped Jabu soil due to fewer gravels and lack of a root-restricting layer (such as a seasonal high water table or dense fragipan). This soil occurs on 0 to 16% slopes, hence, it qualifies as Class 6 (as per Table 4 of Land-Capability Classification (Bailey, 1974).

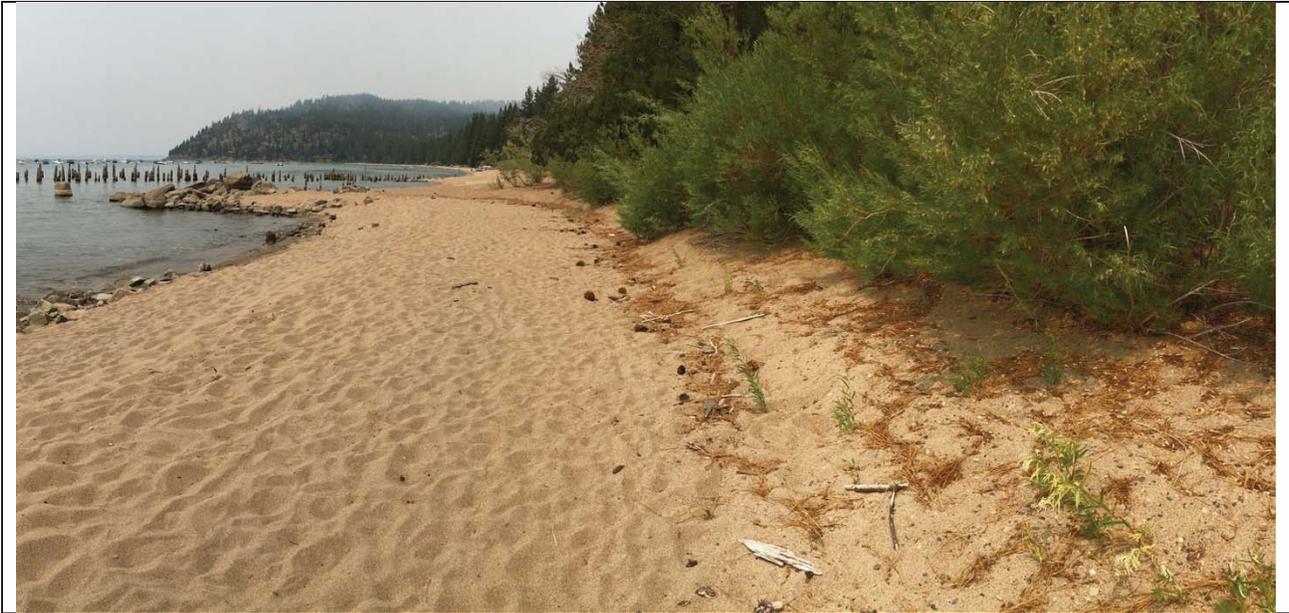
Photo 7 – View north along west edge of property. The backshore area encompasses the Beach soil (Be), upper edge of the wave run-up, and a 10-foot setback. The wave run-up area is evident by the exposed sand with only leaf litter atop the beach sand.

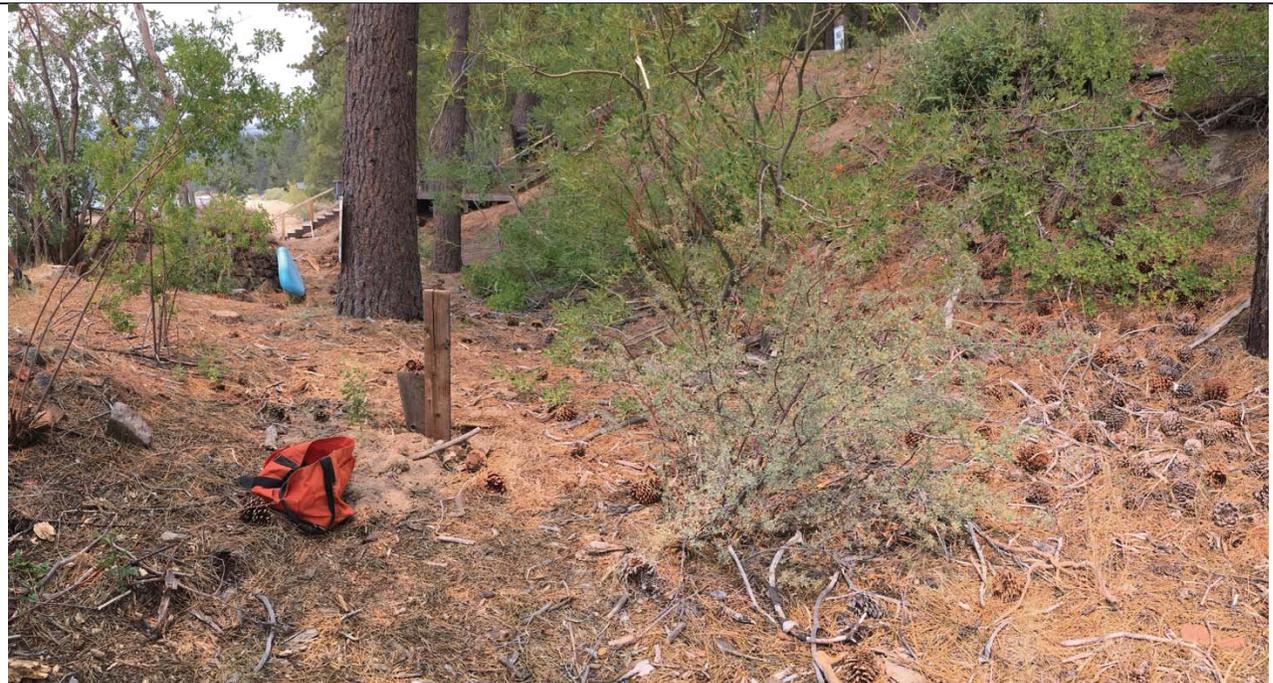
Photo 8 – View north at base of the escarpment between the backshore and low terrace (beyond right edge of photo). The soil here is a discontinuous band of stabilized sand that is deep, excessively drained. The upright wood marks soil sample location (Stop #3) . It supports Jeffrey pine, willow, rose, bitterbrush, scattered grasses and forbs.

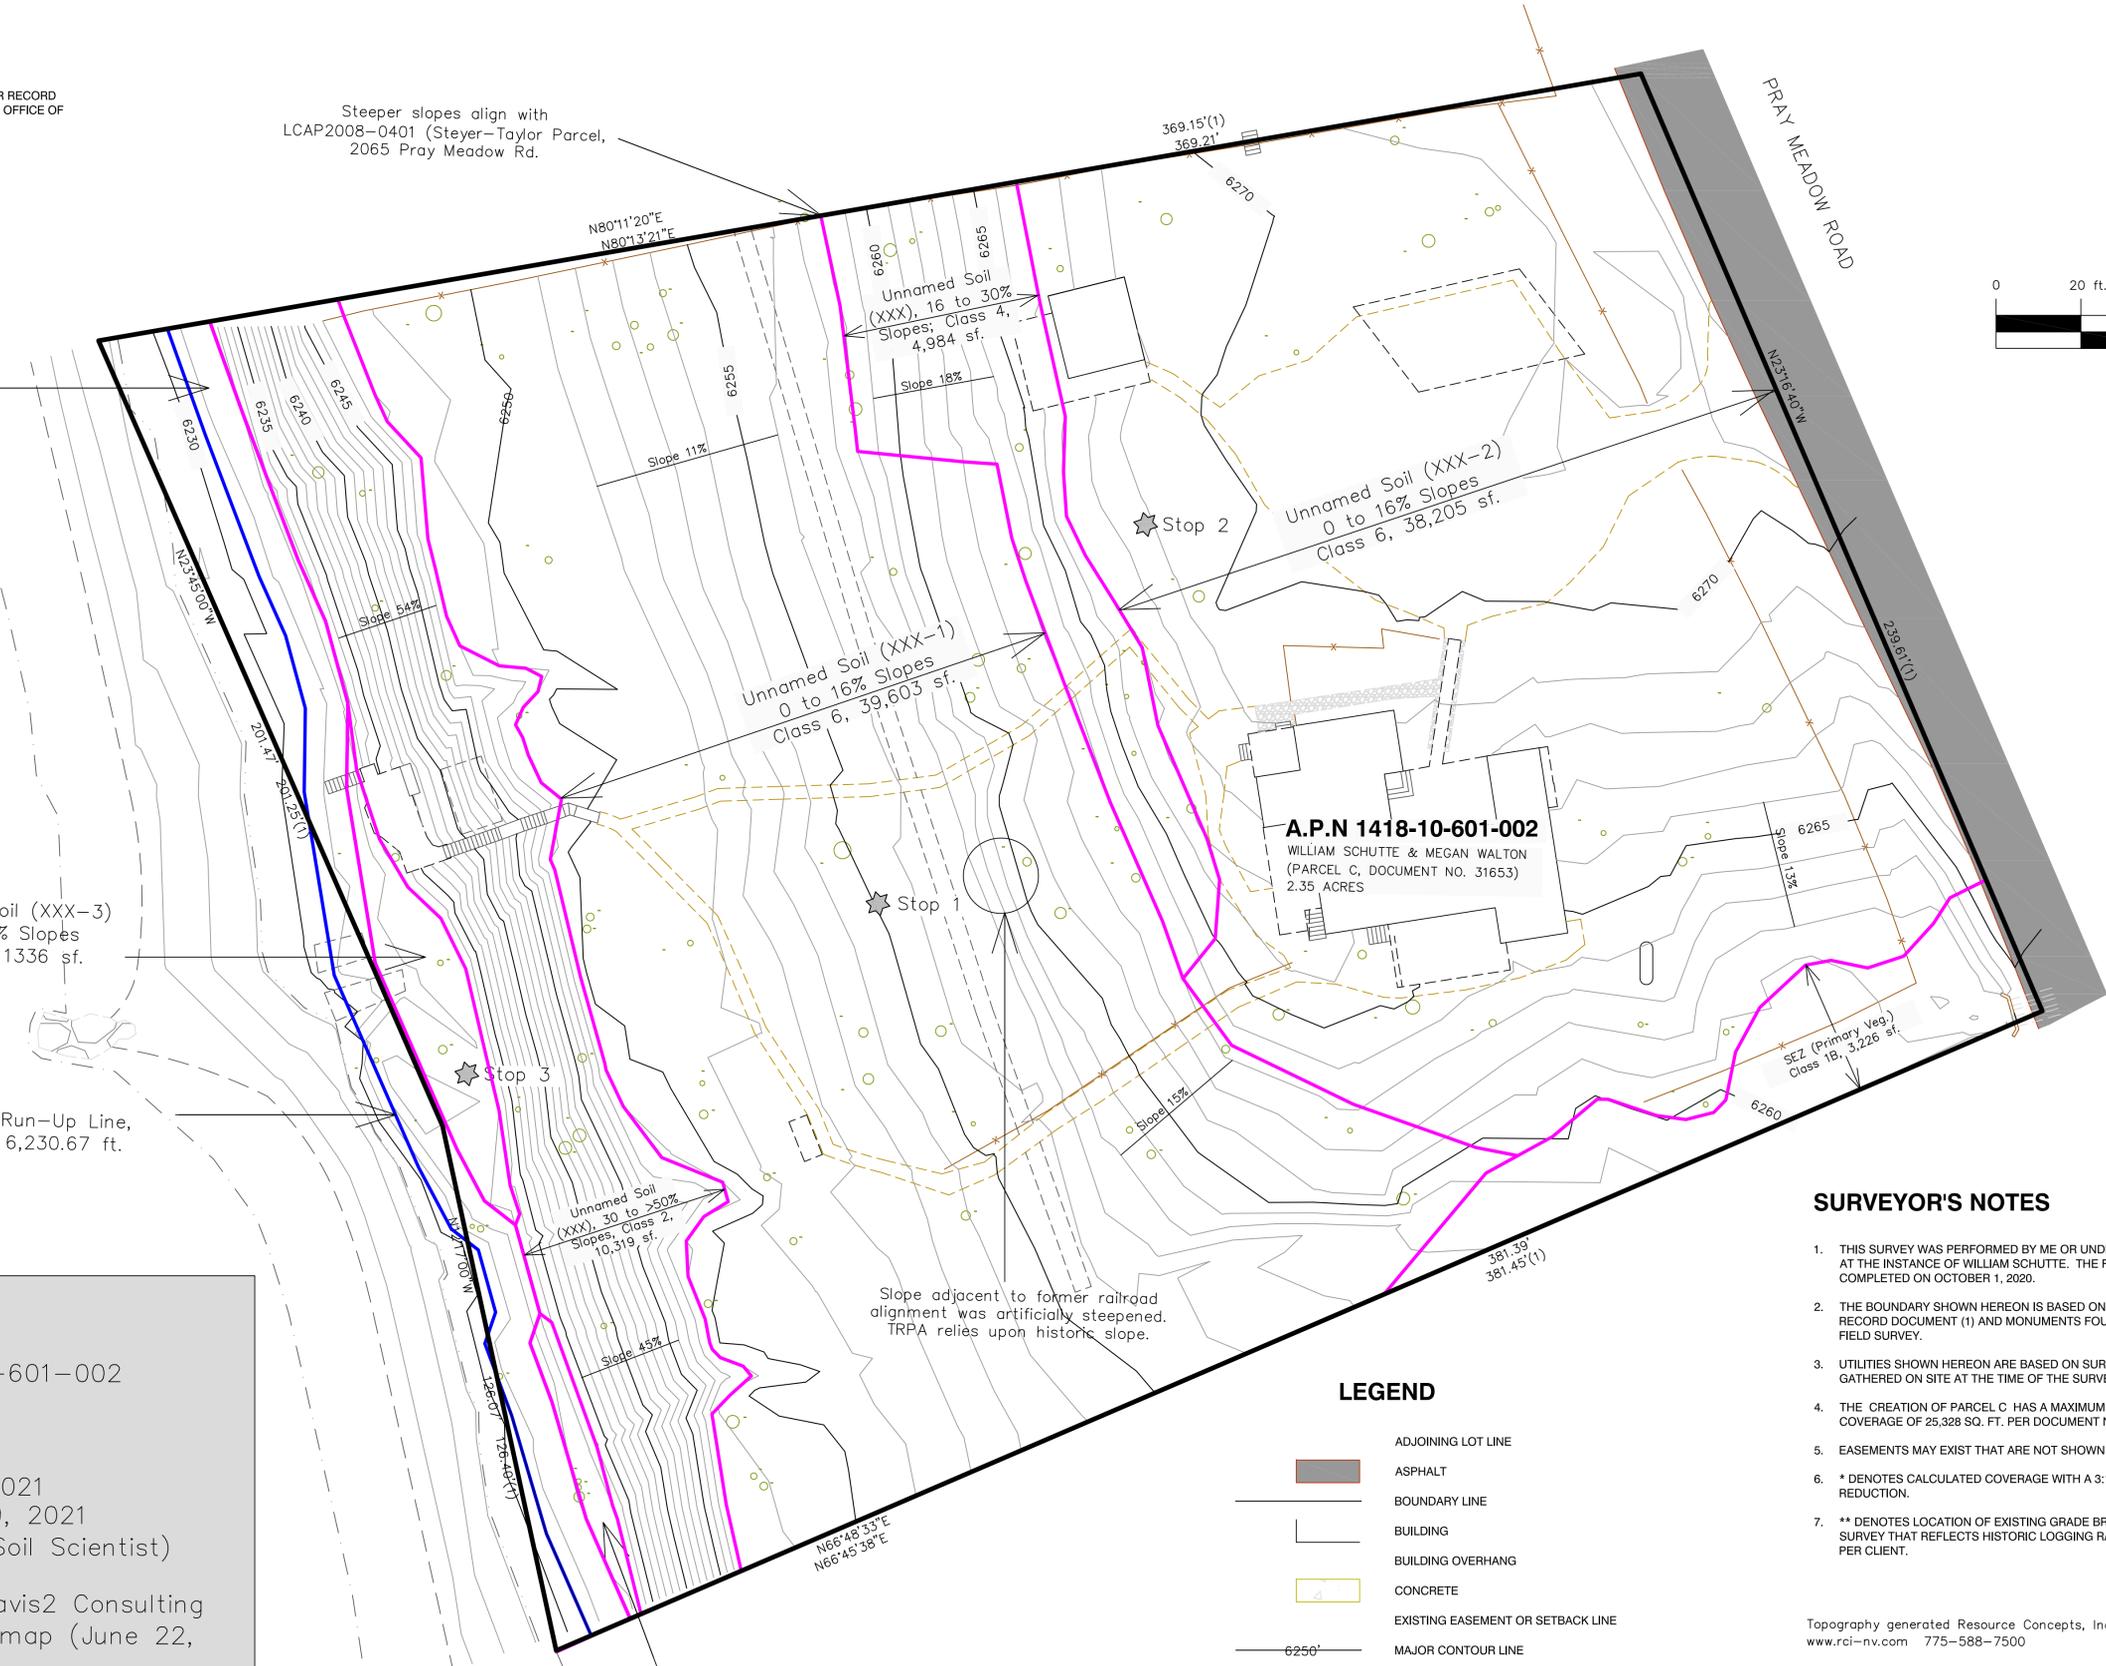
Land Capability Challenge for LCAP2021-0188; APN 1418-10-601-002 2059 Pray Meadow Road Glenbrook, Douglas County, Nev.

Land Capability Summary	
Class 1B (Backshore)	4,253 sf.
Class 1B (SEZ)	3,226 sf.
Class 2, 30-50% sl.	10,319 sf.
Class 4, 16-30% sl.	4,984 sf.
Class 6, 0-16%	79,584 sf.
Total	102,366 sf.

Slope adjacent to former railroad alignment was artificially steepened. TRPA relies upon historic slope.

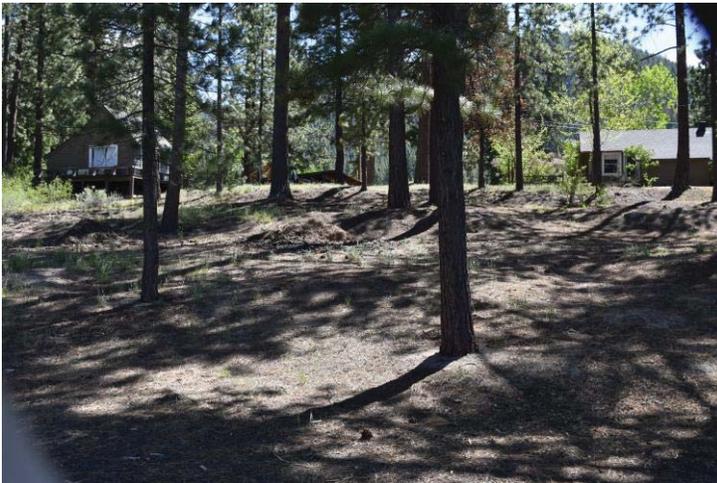
Figure 2- Landform

The parcel has a history of industrial usage and disturbance. Logging operations were centered here as part of the D. L. Bliss enterprises at the turn of the 19th century. As a result there are features such as mechanical terracing, remnant foundations at the shore line and some rubble from kilns. None of these features impact land use function.

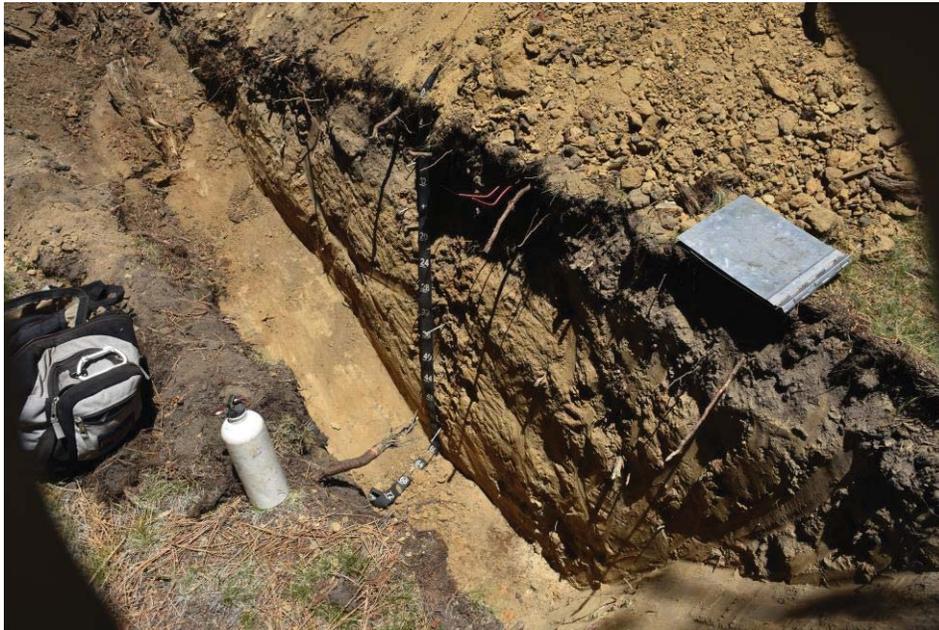
Figure 3- Stop 2, upper terrace profile

Soils found on the upper terrace (Stop 2) are generally in the concept of the Jabu series except they lack fragipan morphology or a root restrictive layer in the profile. The topsoil is dark grayish brown loam or sandy loam to approximately 10 inches over yellowish brown heavy sandy loam or light sandy clay loam at 16 inches, underlain at 32 inches by

variegated dark yellowish brown and yellowish brown coarse sandy loam and sandy loam. Color variegation is attributable to presence of clay films and is not interpreted to be associated with a seasonally fluctuating groundwater table. Roots explore to 60 inches depth, common fine and medium tubular pores are visible throughout, and the soil is interpreted to be in Hydrologic Soil Group B.

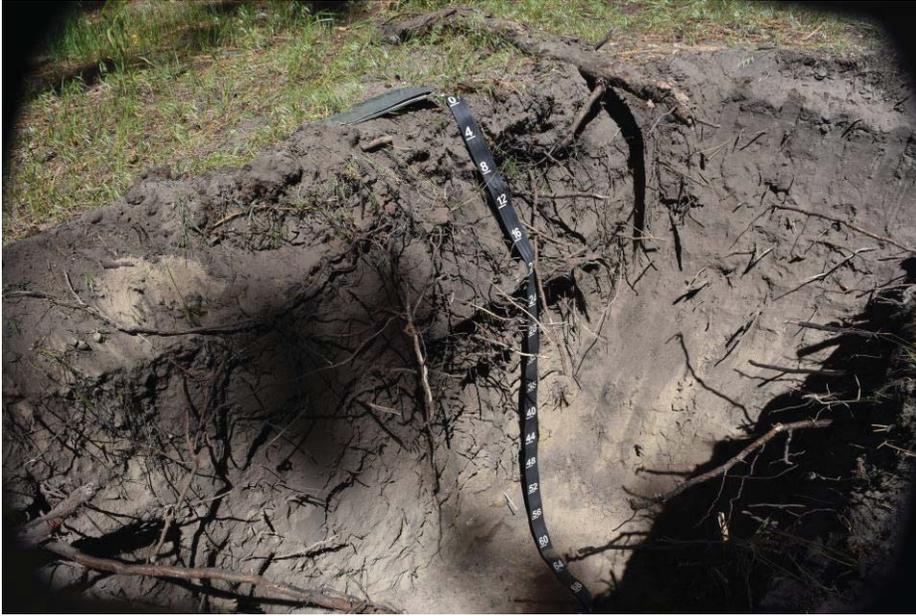
Figure 4- Stop 1, intermediate terrace

The intermediate lake terrace (Stop 1) displays a coarse grained, deep and weakly developed soil with a very thick, very dark brown, dark grayish brown and dark brown topsoil of loamy sand to approximately 28 inches, underlain by dark yellowish brown loamy sand and gravelly loamy sand at 52 inches to greater than 60 inches depth. These soils place in Hydrologic Soil Group A. Soils found differ from the Elmira and Gefo series soils because of epipedon thickness.

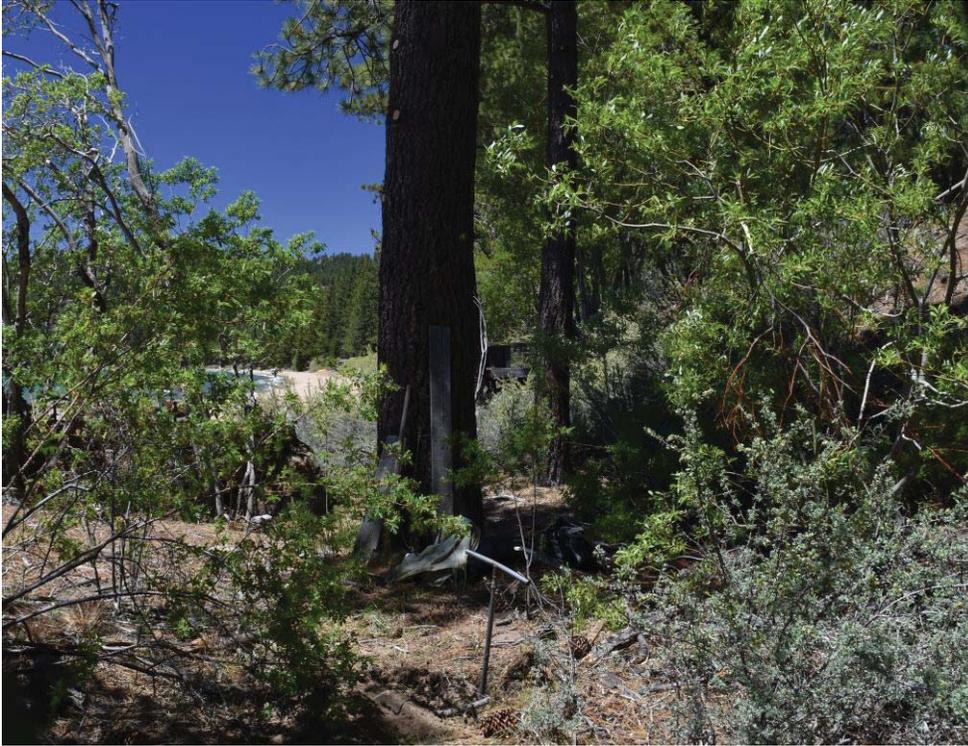
Figure 5- Stop 3, low terrace.

A terrace just above the backshore and the swash zone of the beach supports a mixture of Jeffrey pine, bitterbrush, gooseberry, rabbit brush, and scattered Scouler's willow. This has a dark brown topsoil of sand and granular structure about 4 inches thick over single grain dark yellowish brown sand, abruptly over a buried surface of very dark grayish brown sand, root laden with granular structure, and underlain by dark yellowish brown sand to 40 inches where refusal with coarse fragments was met. This area shows disturbance from prior industrial usage. These soils are unnamed and place in HSG A.
