STAFF REPORT

Subject: Schutte-Walton Glenbrook LLC Land Capability Challenge, 2059 Pray Meadow Road, Douglas County, NV, APN 1418-10-601-002, TRPA File Number LCAP2021-0188

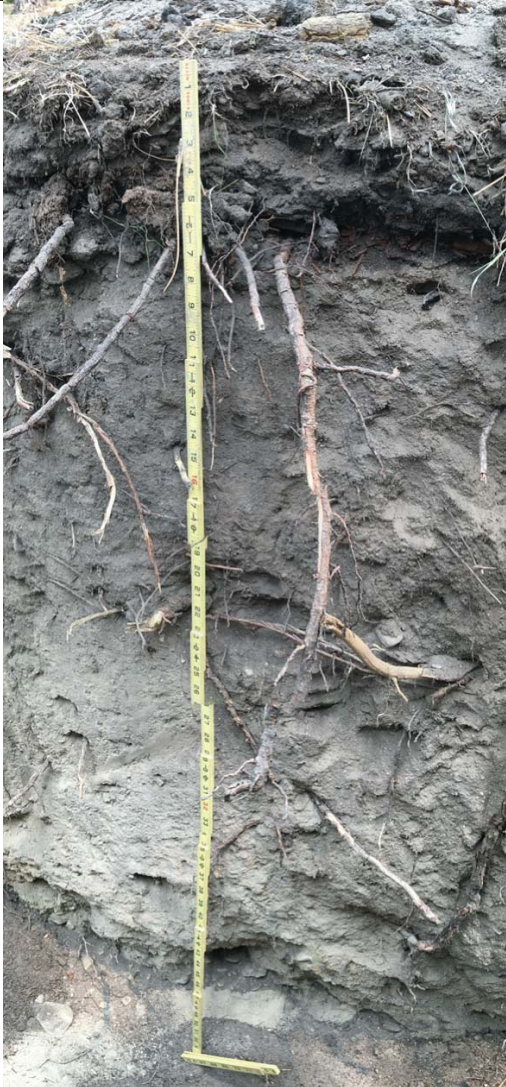
Photo 5 – Soil profile for lower terrace (Stop 1). Topsoil layer is 28 in thick and composed of loamy sand likely deposited as a dune, as apparent by the lack of gravels. Underlying parent material is 32+ inches thick and lacks in-situ soil development. Profile lacks root-restricting layer (such as a seasonal high water table or dense fragipan). While similar to Gefo series, this unnamed soil (XXX, Class 6) has substantially thicker “A” horizon, less gravels, and less soil development than that series. As per Table 4 of Land-Capability Classification of the Lake Tahoe Basin, California-Nevada, A Guide for Planning (Rbt. Bailey, 1974). There is also a small band of Class 4 soil with same conditions, but 16 to 30% slopes.

Photo 6 – Soil profile for upper terrace (Stop 2). The topsoil layer is 10 inches thick and composed of loam to sandy loam. The underlying layers to 60+ inches have increasing amounts of clay that formed in-situ. The clay naturally migrated from the upper layer down to the middle and lower layer over tens of thousands of years. Consequently, the lower layers have variegated matrix. The upper 16 inches consists of glacial outwash, while the underlying material is old lake sediments (finer texture). This soil is dissimilar from the mapped Jabu soil due to fewer gravels and lack of a root-restricting layer (such as a seasonal high water table or dense fragipan). This soil occurs on 0 to 16% slopes, hence, it qualifies as Class 6 (as per Table 4 of Land-Capability Classification (Bailey, 1974).

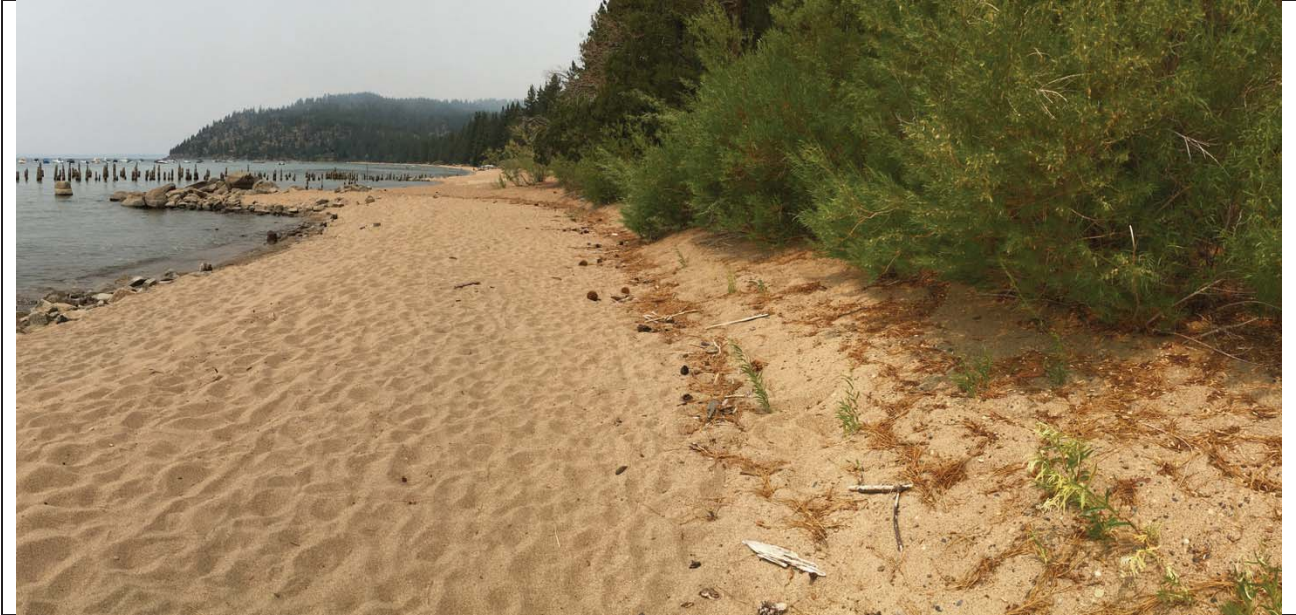
Photo 7 – View north along west edge of property. The backshore area encompasses the Beach soil (Be), upper edge of the wave run-up, and a 10-foot setback. The wave run-up area is evident by the exposed sand with only leaf litter atop the beach sand.

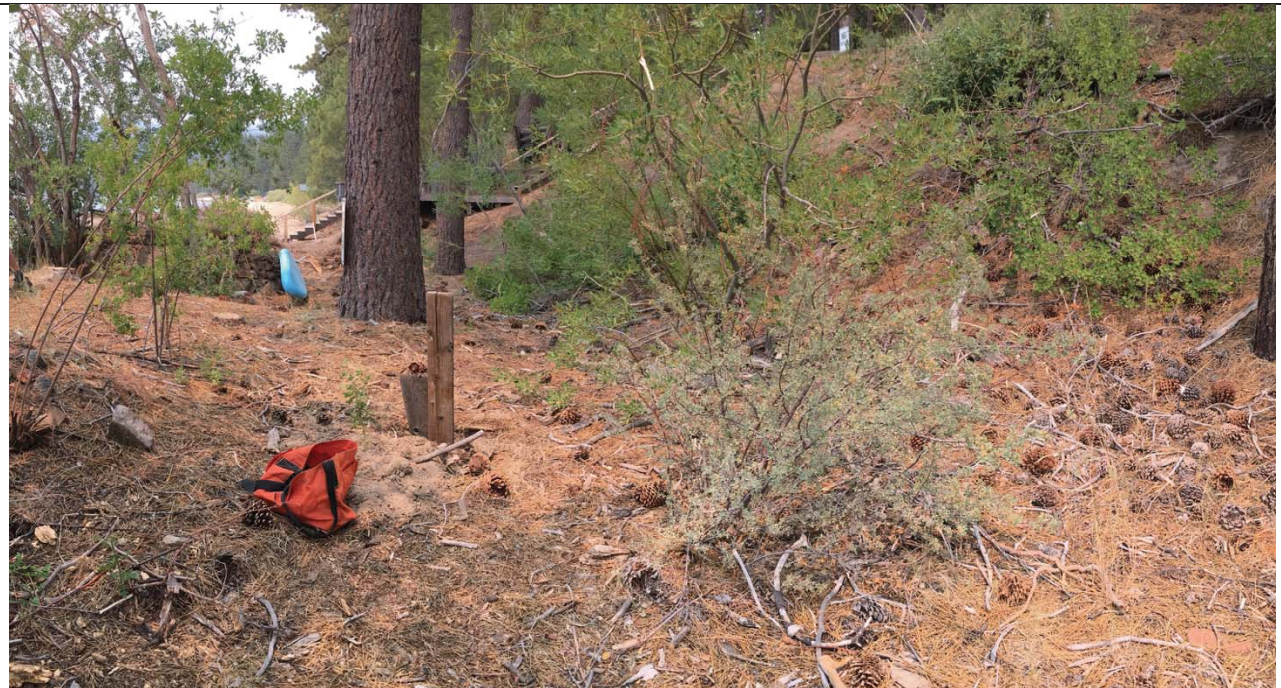
Photo 8 – View north at base of the escarpment between the backshore and low terrace (beyond right edge of photo). The soil here is a discontinuous band of stabilized sand that is deep, excessively drained. The upright wood marks soil sample location (Stop #3) . It supports Jeffrey pine, willow, rose, bitterbrush, scattered grasses and forbs.
