STAFF REPORT

Subject: MJD Development/Boatworks at Tahoe LLC Land Capability Challenge; 740, 760, and 790 North Lake Boulevard, Placer County, California; APNs 094-090-001, 094-090-029, 094-090-042; TRPA File Nos. LCAP2020-0067, LCAP2020-0068, LCAP2020-0069

BAILEY LAND CAPABILITY CHALLENGE FINDINGS

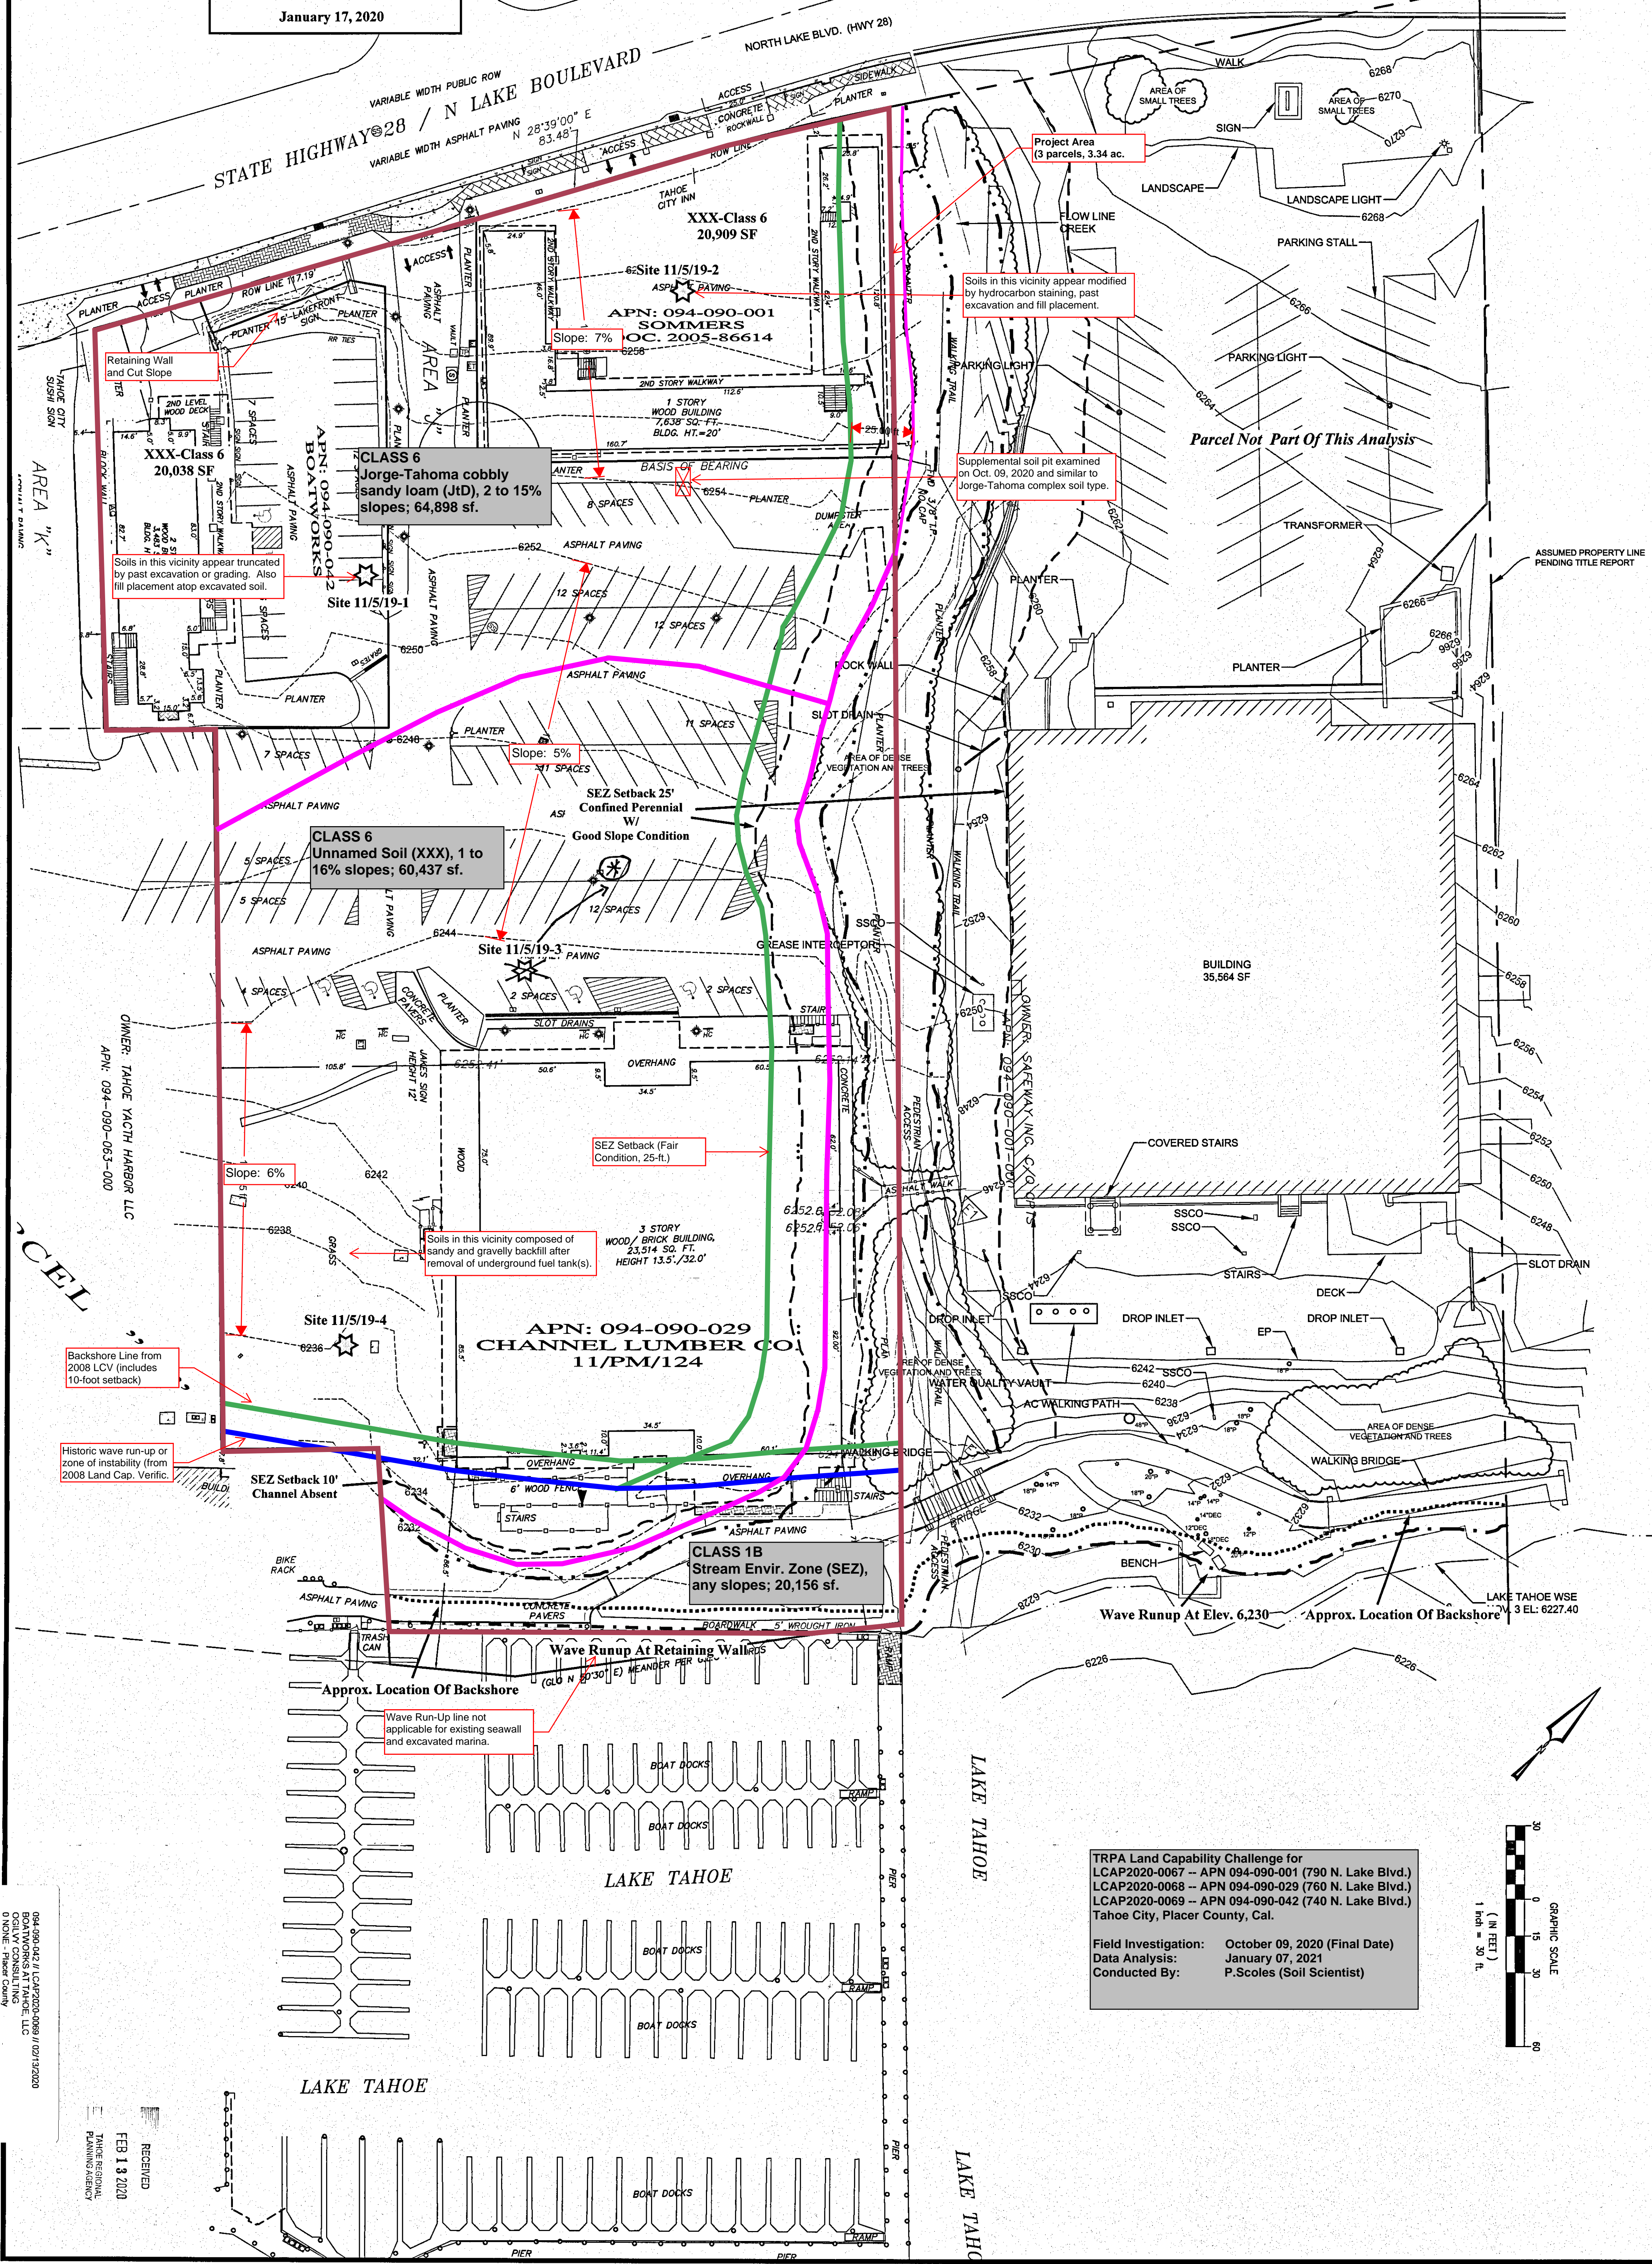
Retaining Wall and Cut Slope
Soils in this vicinity appear truncated by past excavation or grading. Also fill placement atop excavated soil.

CLASS 6
Jorge-Tahoma cobbly sandy loam (JtD), 2 to 15% slopes; 64,898 sf.

CLASS 6
Unnamed Soil (XXX), 1 to 16% slopes; 60,437 sf.

CLASS 1B
Stream Env. Zone (SEZ), any slopes; 20,156 sf.

Soils in this vicinity appear modified by hydrocarbon staining, past excavation and fill placement.

Supplemental soil pit examined on Oct. 09, 2020 and similar to Jorge-Tahoma complex soil type.

Wave Run-Up line not applicable for existing seawall and excavated marina.

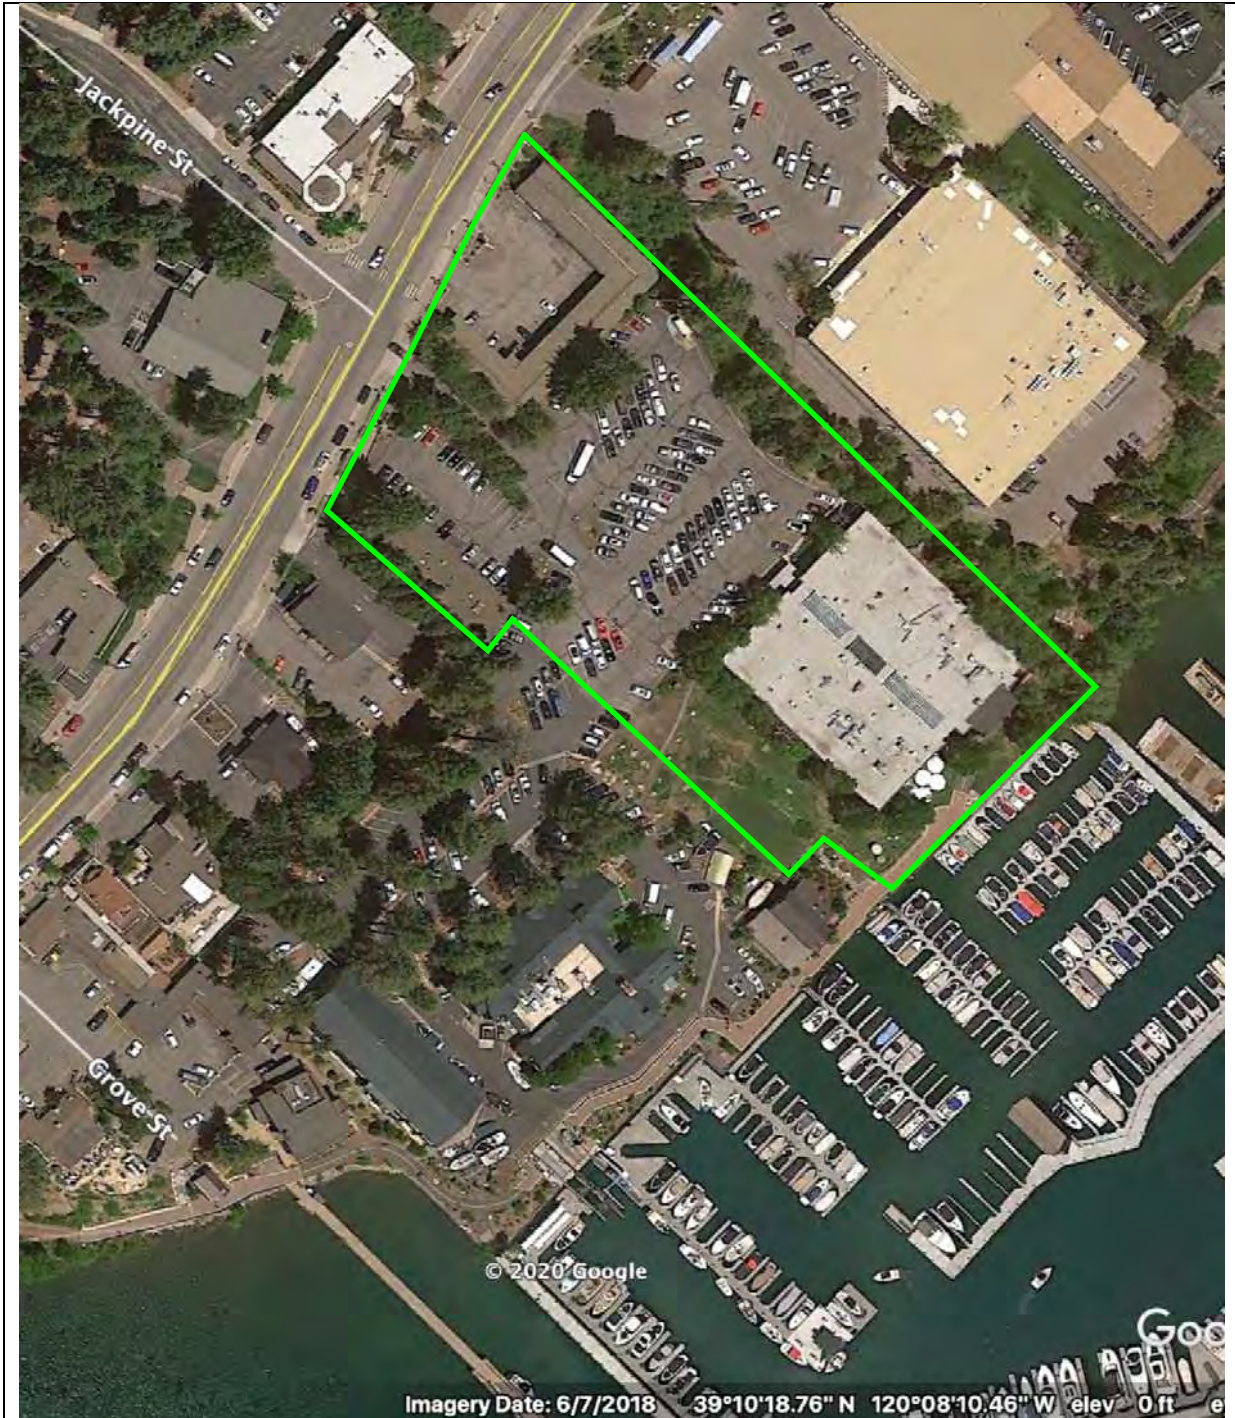
Photo 1 – Aerial view of project area, which consists of 3 parcels. The hotel is situated in the northeast corner; city library in the northwest corner; Boatworks building in the south; and the unnamed creek along the east edge. Paved land and buildings compose majority of project area.

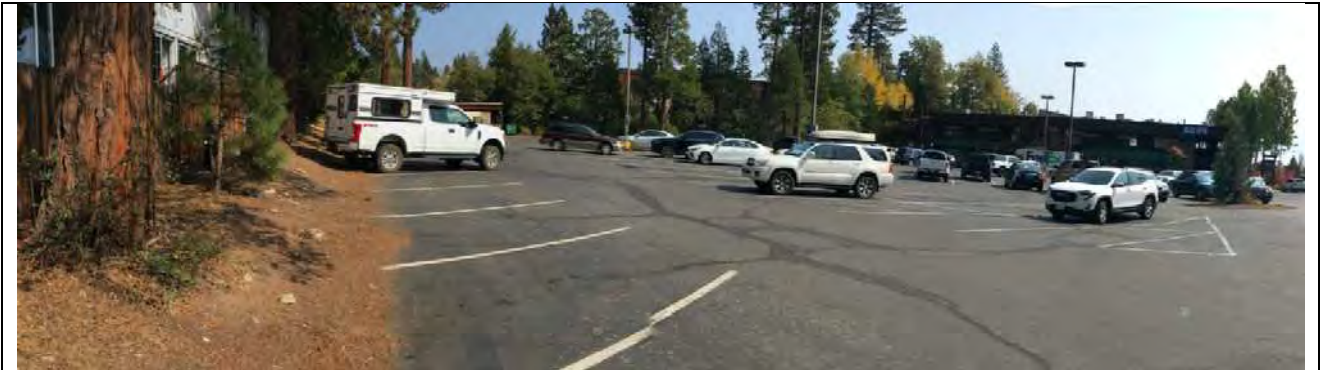
Photo 2 – View east to southeast from northwest corner of APN 094-090-029 (760 North Lake Blvd). Inn at Boatworks hotel at far left edge of photo. This vicinity of the parking lot is glacial outwash and alluvial fan.

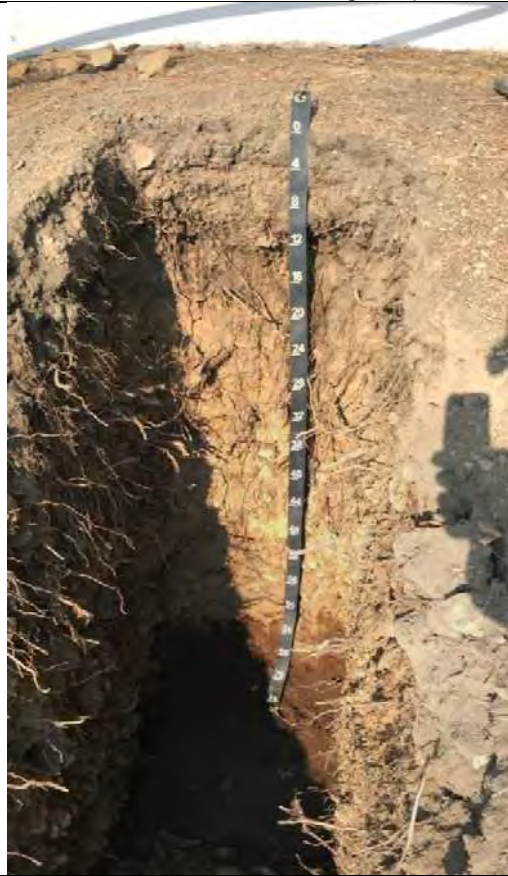
Photo 3 – Soil profile for supplemental soil pit located on south side of hotel. This soil is similar to 11/19/19-1 and best resembles the Jorge-Tahoma soils in the 1974 soil survey.

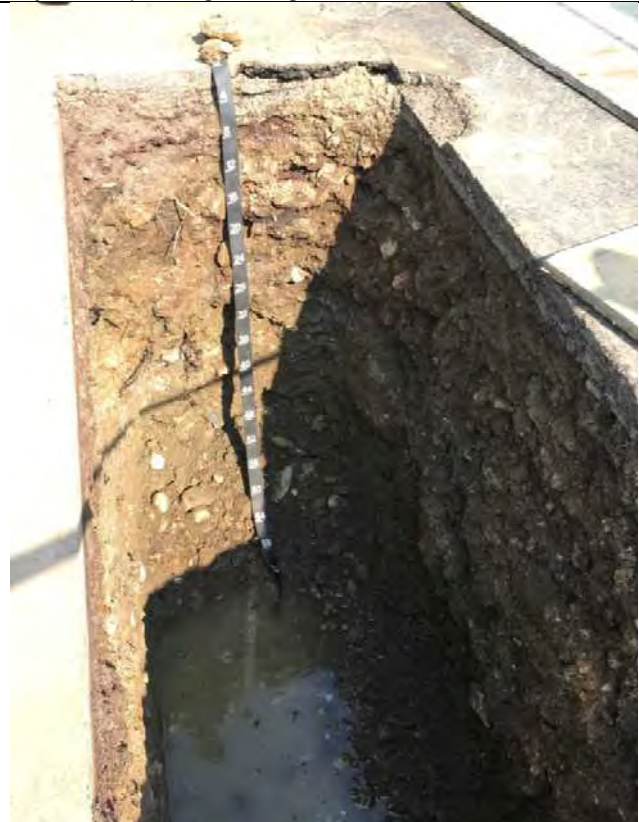
The center and south portion of the project area was evaluated using soil pit 11/5/19-3 located north of the Boatworks building. The upper two feet of this soil is fill material that has variable colors, texture, and gravel content. The underlying soil has olive gray to gray matrix colors with common to many iron stains (aka redoximorphic concentrations). These colors and staining form over hundreds of years when the soil is waterlogged for many months each year. These colors become permanent when the waterlogging ceases. For this location, it appears the unnamed creek along the east property line naturally downcut into the alluvial deposits and slowly lowered the water table. Consequently, this natural downcutting converted an ancient marsh to a drained marsh. The observed water table was approximately five feet below the surface during two separate site visits by the applicant's soil consultant and TRPA contractor. The importance of such observation is that the soil colors and staining could not have formed if the water table were historically at five feet – the water level would need to be closer to two feet below the surface. Such condition is unusual, but it has been observed in the Kings Beach area by the TRPA contractor. This condition is too infrequent and variable to have been mapped by the 1974 soil survey, so this vicinity is considered an unnamed soil (XXX) for land capability purposes. Although a relict hydric soil, this soil qualifies as Class 6.

Photo 4 – Soil profile for soil pit 11/15/19-3 that was re-excavated on October 09, 2020. The upper 2 feet consists of fill material and subsoil has hydric soil characteristics. Water table just below 5-foot depth.

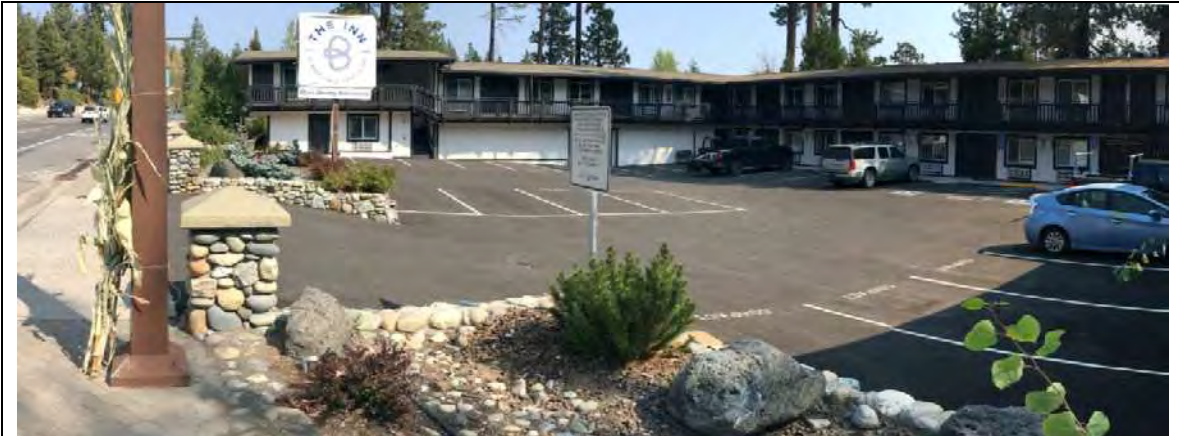
Photo 5 – View east to southeast from northwest corner of APN 094-090-001 (790 N. Lake Blvd.). This parcel is essentially 100% covered with paved land, buildings and landscaping.

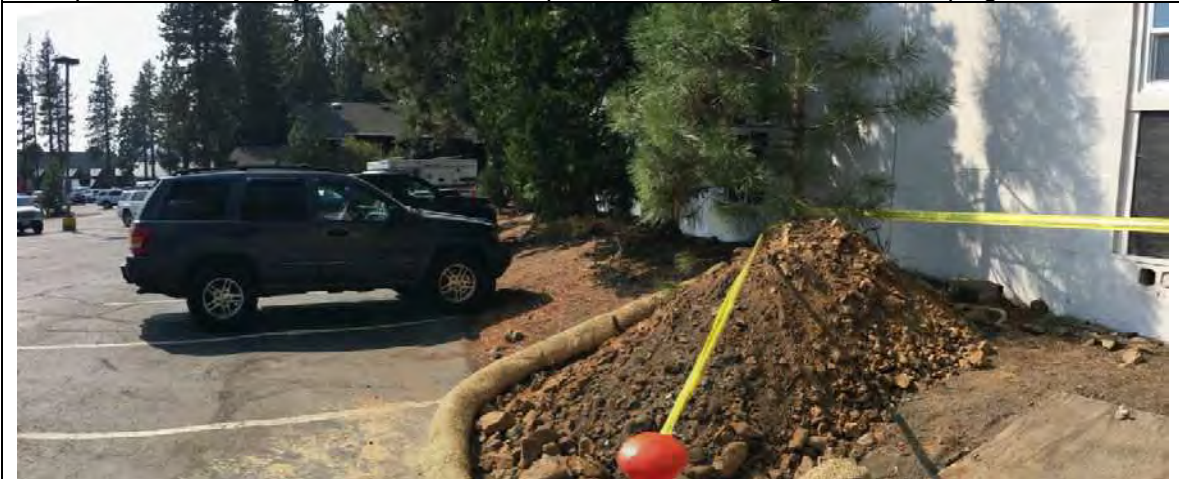
Photo 6 – View west along south side of hotel (property line between 094-090-001 and 094-090-029). This soil pit is partially disturbed, but to a lesser degree than other soil pits.

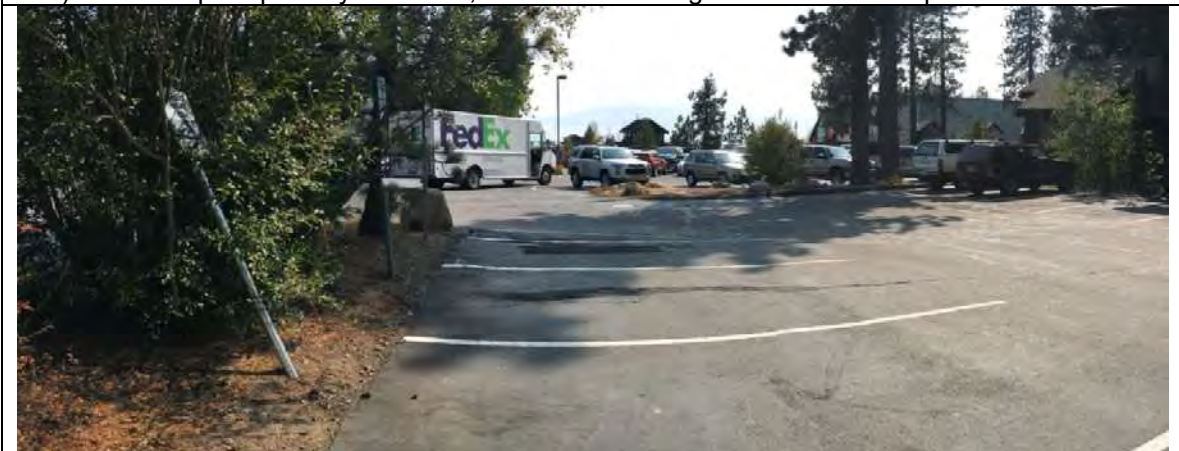
Photo 7 – View south to southwest from northeast corner of APN 094-090-042 (740 N. Lake Blvd.). The north edge of this parcel has a 10-foot high retain wall; parking lot excavated.

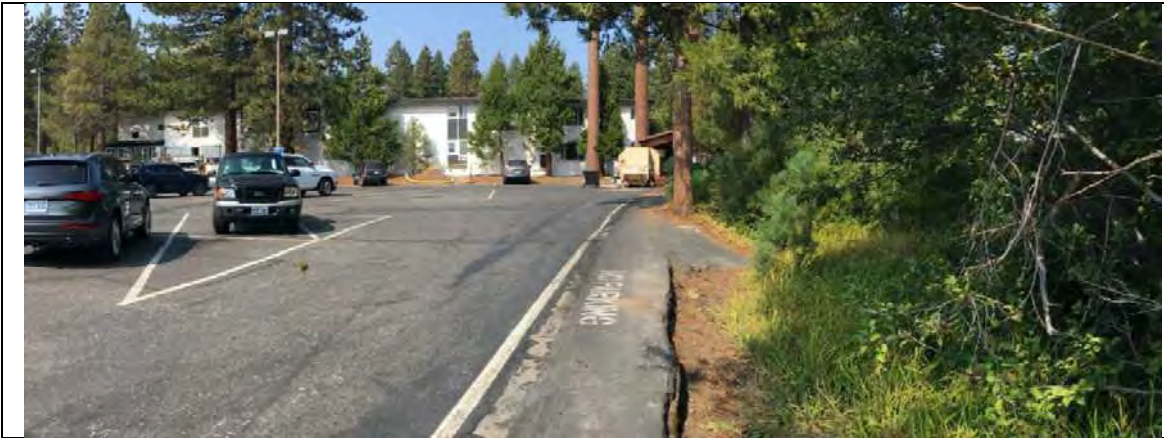
Photo 8 – View north to northwest from east edge of APN 094-090-029 (760 N. Lake Blvd.). Unnamed creek at far right, which appears naturally downcut and effectively draining adj. land.

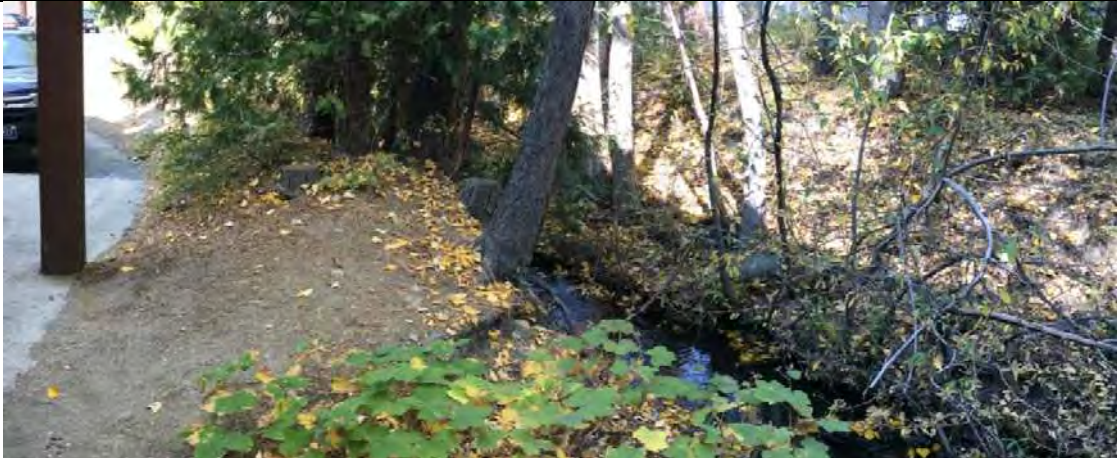
Photo 9 – View north from northeast corner of Boatworks building (post at far left). The creek in this vicinity is channelized and likely had a wider riparian area than present day.

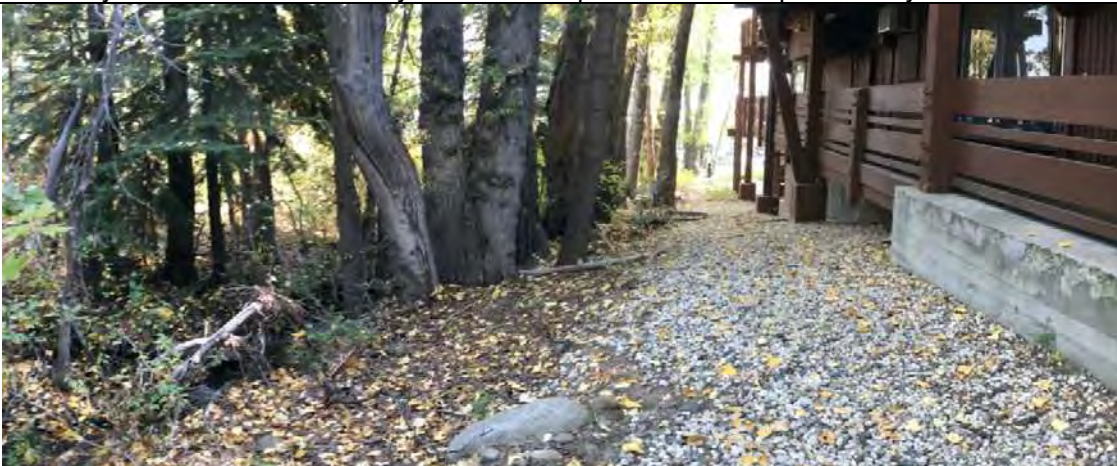
Photo 10 – View south from east property line and mid-point of Boatworks building. The historic soil and SEZ could not be investigated due to past encroachment (fill material placement).

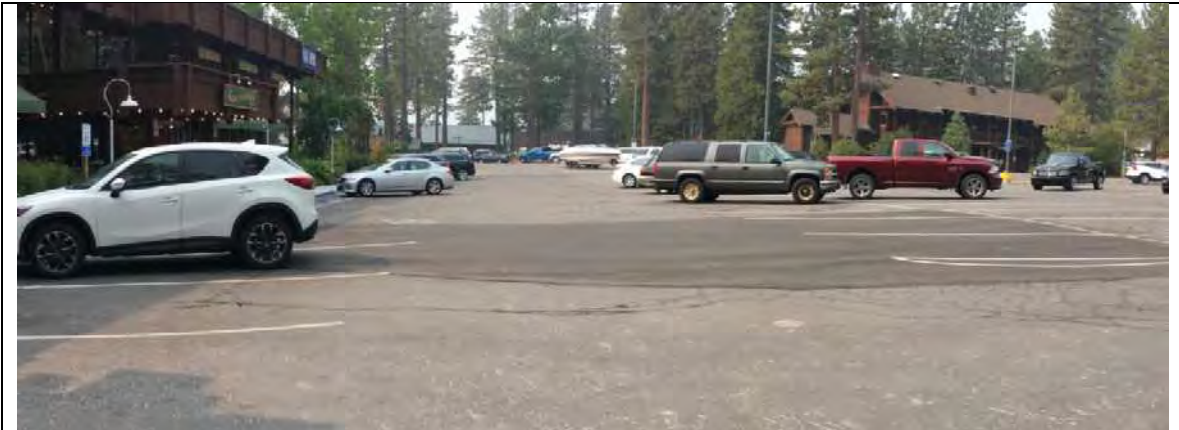
Photo 11 – View west to northwest from northeast corner of Boatworks building. Soil pit 11/15/19-3 was excavated in parking lot, approximately near burgundy colored truck.

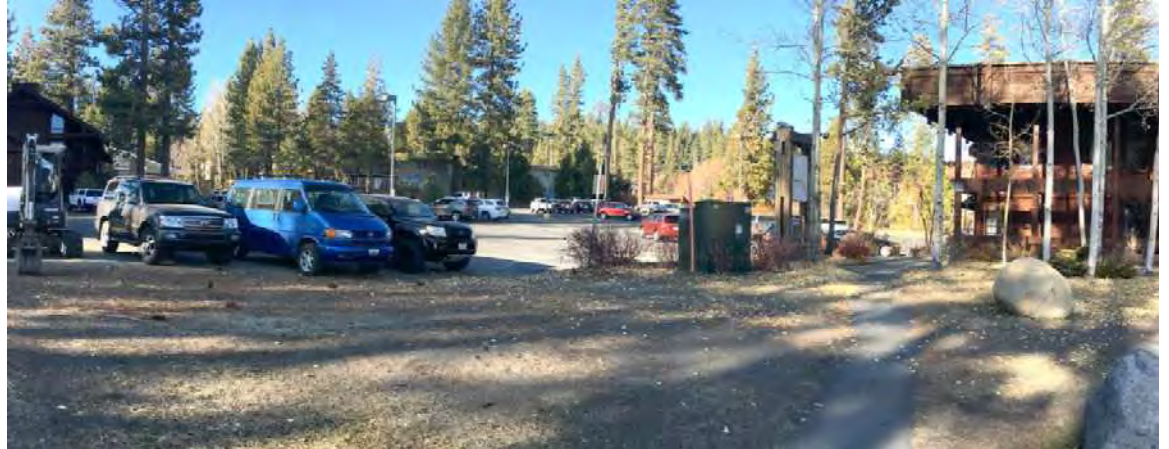
Photo 12 – View northwest to north from pedestrian path along south edge of APN 094-090-029. This vicinity was extensively altered when originally developed and later when fuel tank removed.

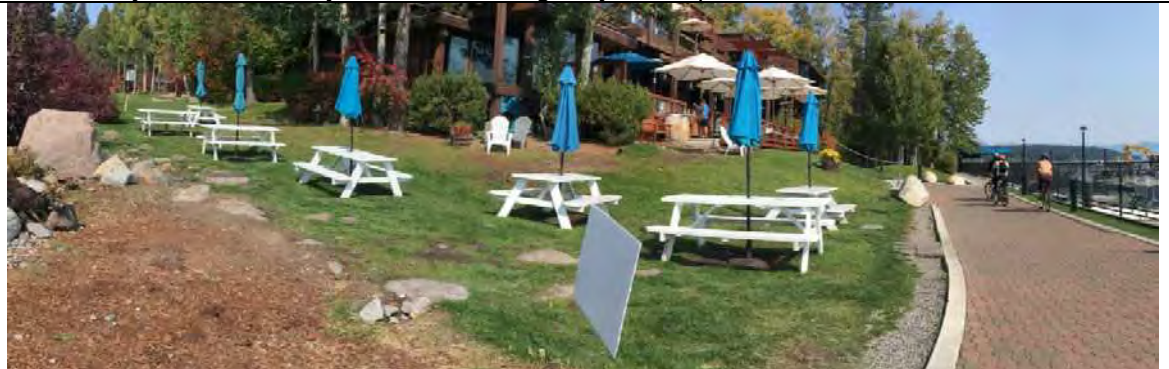
Photo 13 – View east from southwest corner of APN 094-090-029. The original shoreline of Lake Tahoe was filled decades ago and replaced by seawall, pedestrian path and landscaping.

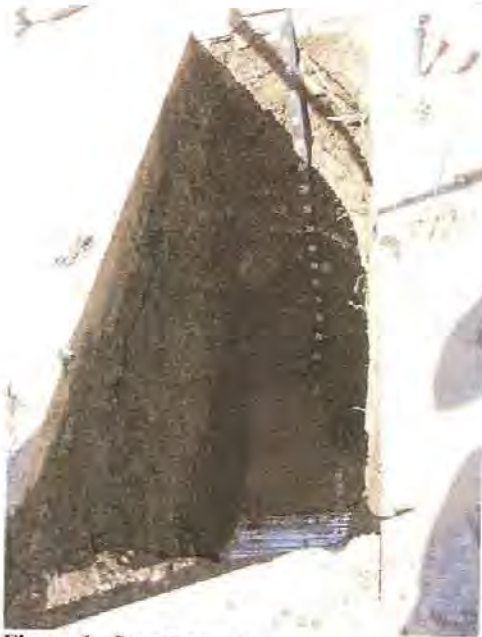
Figure 6 - Stop 3 profile.

Notes: 20 inches of paving and engineered fill. Beheaded subsoil. Darkness of color due to former hydrocarbon impregnation (?). GW at 70 inches. Noticeable petrochemical odor.

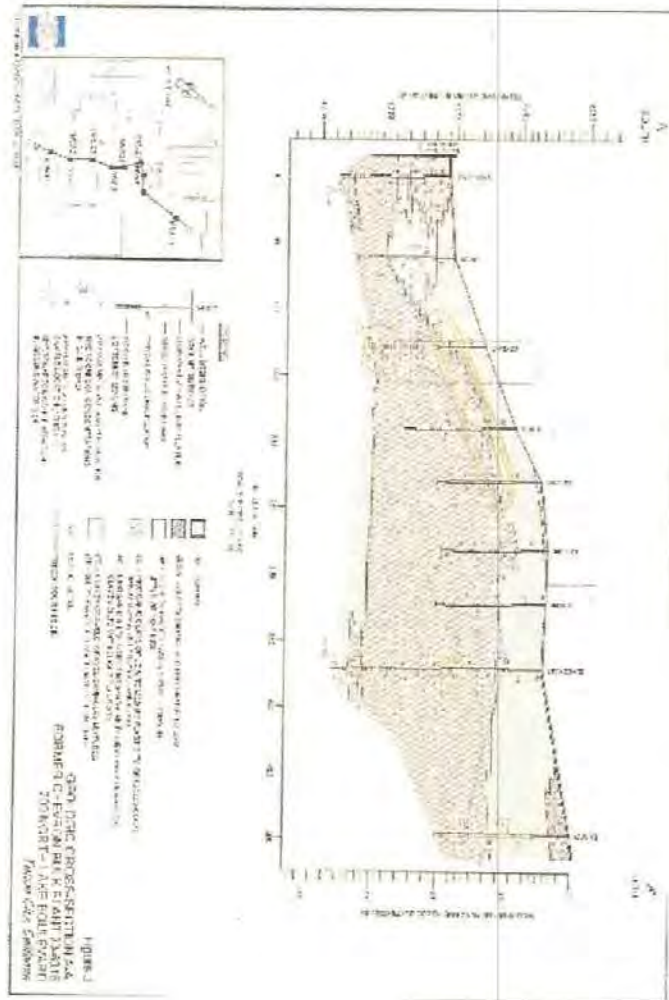
Figure 12 - Groundwater Monitoring graphic (GHD Services, 2016)

Two years of groundwater monitoring in 1994 and 1995, reported by GHD (Fig. 12), shows similar results as what is seen onsite in November 2019, groundwater below 5 feet depth across the site.
