Heavenly Mountain Resort Mitigation and Monitoring Plan Annual Report (October 2010 - September 2011)

May 1, 2012

Prepared For Tahoe Regional Planning Agency

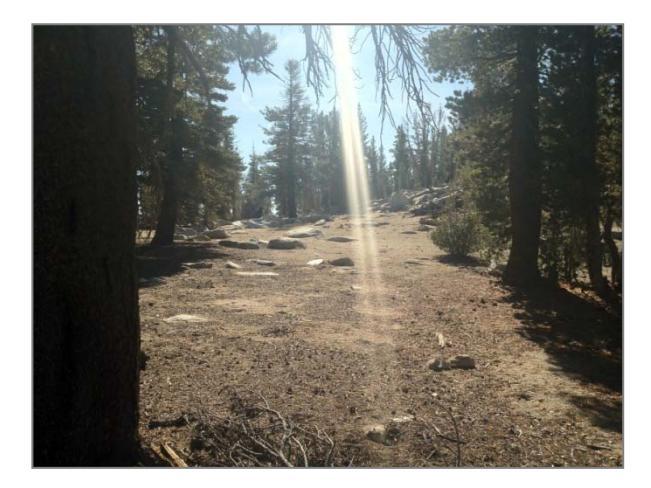
Figure 2. Little to no understory vegetation and no evidence of erosion in an undisturbed area at Heavenly.

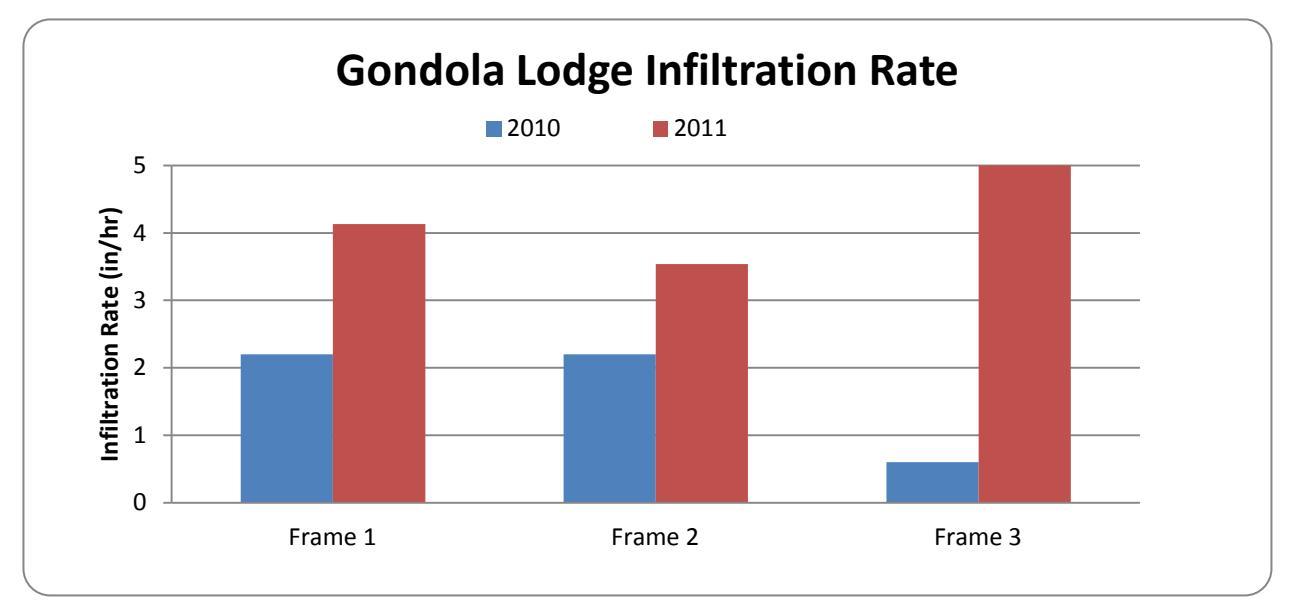
The slope at the Gondola Lodge fill area is relatively flat, which precluded runoff sample collection. Instead, the rainfall simulator was used to measure the steady state infiltration rate. In 2010, steady state infiltration rates ranged from 0.6 to 2.2 in/hr, with an average infiltration rate of 1.6 in/hr. In 2011, steady state infiltration rates ranged from 3.5 to 5.3 in/hr, with an average infiltration rate of 4.3 in/hr (Figure 27). This data indicates that the average infiltration rate increased 2.7 times from pre-treatment to post-treatment conditions, since the spoils material was placed without being compacted.

Figure 27. Gondola Lodge Infiltration Rate for 2010 and 2011. Each of the 3 rainfall frames are presented here. Pre-treatment infiltration monitoring was conducted in 2010.

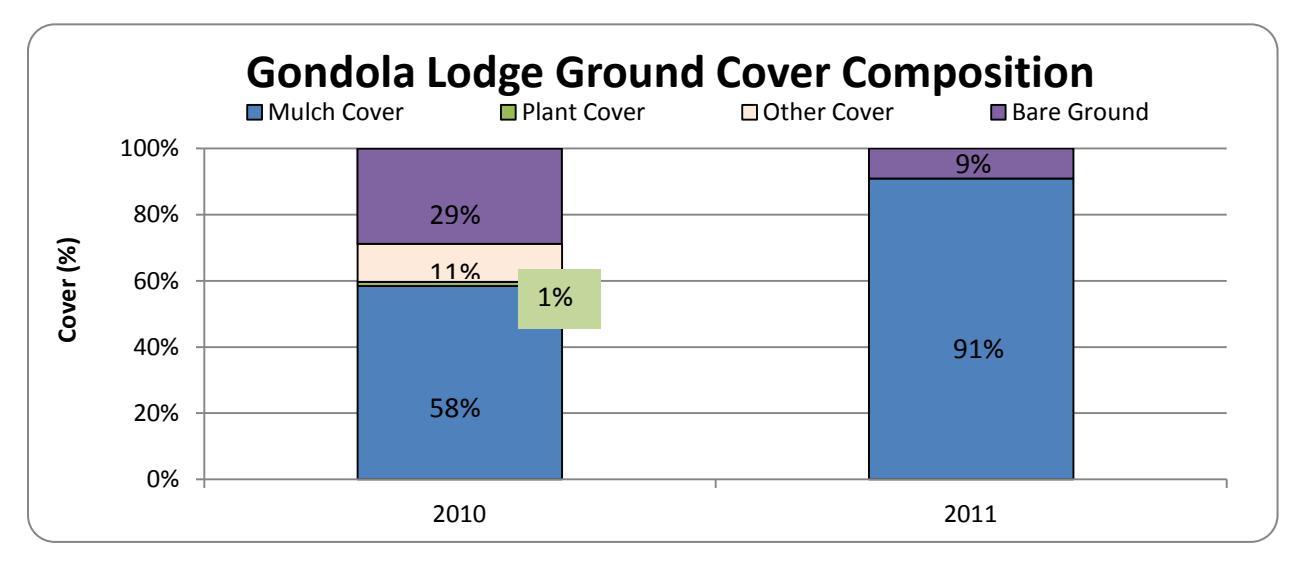
In 2010, total cover at the fill area was71%, with 58% mulch cover, 11% other cover, and 1% understory plant cover (Figure 29). Bare soil was 29% of the ground composition. Overstory (or foliar) plant cover was 14% (no graph). In 2011, total cover was 91%, with 91% mulch cover, 9% bare ground and 0% plant cover in the sampling area. However, ocular estimates of vegetation cover for the entire treatment area averaged 5%, with pockets of vigorous, well-established grasses. Compared to pre-treatment conditions, total ground cover increased 28% following treatment in the sampling area. It is also worth noting that post-treatment monitoring in 2011 was conducted prior to the planting of approximately 250 seedlings throughout the fill area, which likely contributed to an overall increase in plant cover at the fill area.

Figure 29. Gondola Lodge Ground Cover Composition for 2010 and 2011.

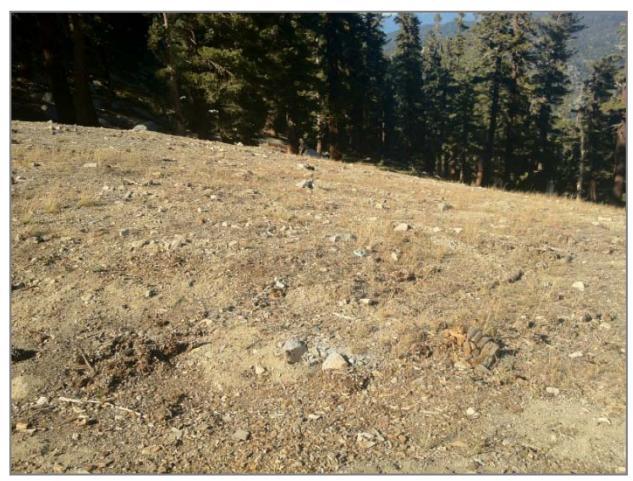
Figure 41. Olympic lift bottom, treatment area C, October 2011. Widespread vegetation establishment observed. Soil investigation planned for 2012.

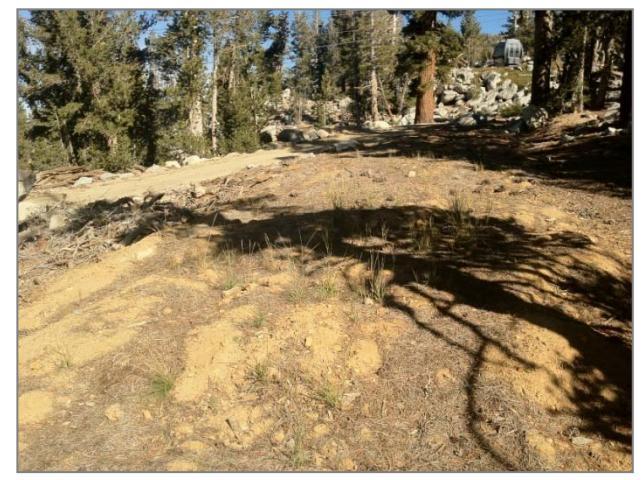
Figure 57. Mid Station Road, July 2011. Bare areas and rodent activity observed, as well as grasses beginning to establish.

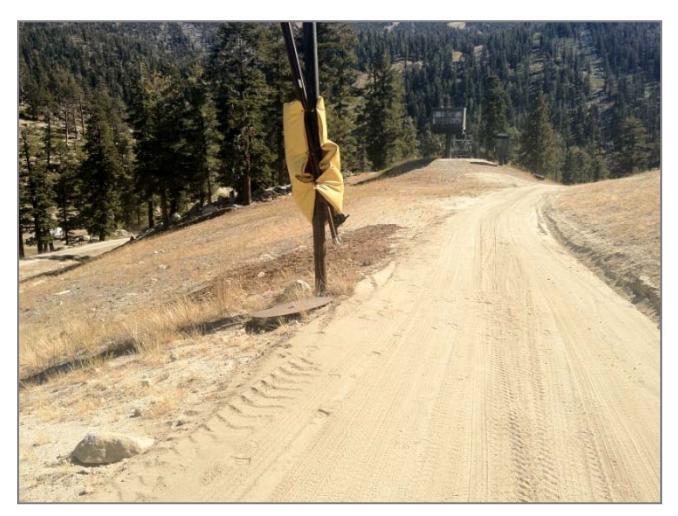
Figure 71. Road drainage improvements were implemented in 2011 to direct road drainage away from the treated slope below

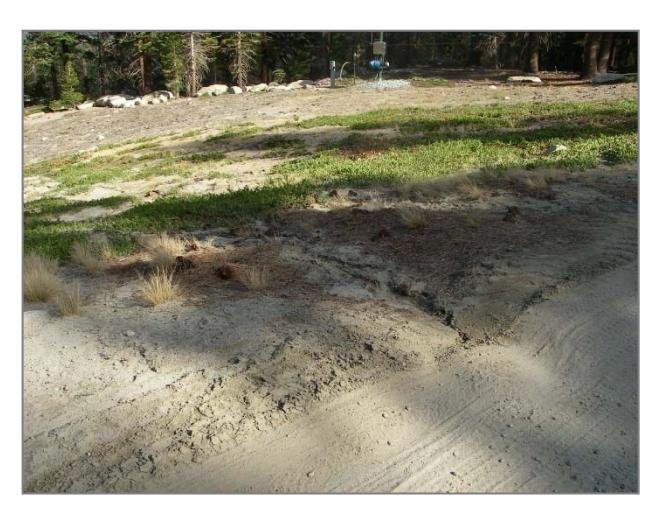
Figure 82. Concentrated road drainage initiating causing erosion at the top of the Stagecoach lower slope, October 2010.

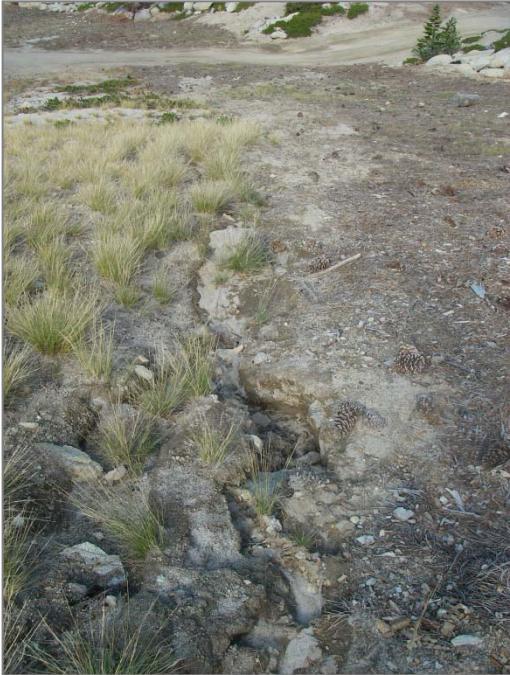
Figure 84. Gully along Stagecoach lower treatment area, August 2010. This gully was caused by concentrated drainage from the road upslope.

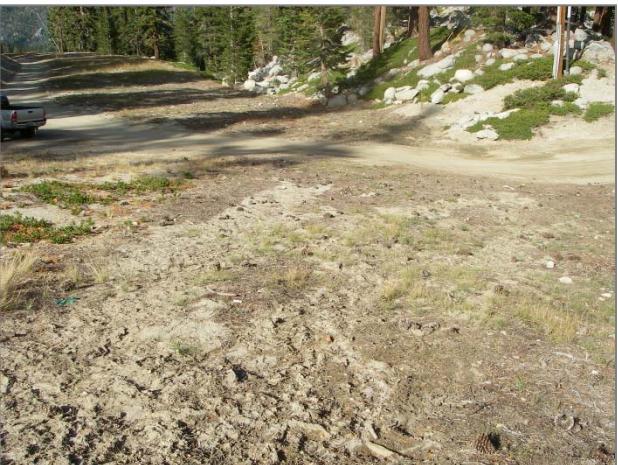
Figure 85. Deposition near the bottom of the Stagecoach lower treatment area, August 2010.
