Tahoe Keys Lagoons Aquatic Weed Control Methods Test Project Update

TRPA Governing Board May 24, 2023 Dennis Zabaglo, TRPA Pete Wolcott, TKPOA Dr. Lars Anderson, TKPOA Jesse Patterson, League to Save Lake Tahoe

Tahoe Keys Lagoons Aquatic Weed Control Methods Test

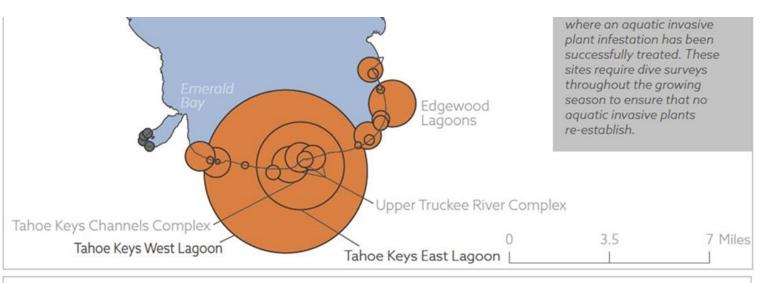
The Tahoe Keys Challenge

Based on acreage, the Tahoe Keys comprise 70 percent of all aquatic plant infestations in Lake Tahoe. The size of these infestations and the complexity associated with the geography of the Tahoe Keys make identifying and implementing control treatments a challenge. Although most marinas contain one or two embayments, the Tahoe Keys complex contains a myriad of connected waterways equalling approximately 170 acres.

Map produced by S.Matthews, Tahoe RCD 2019.

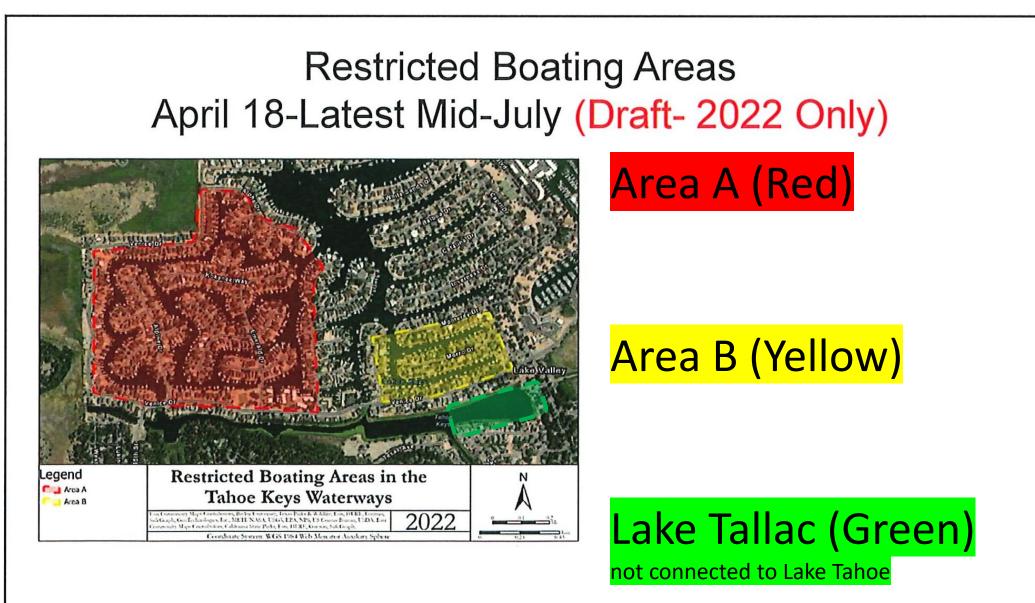
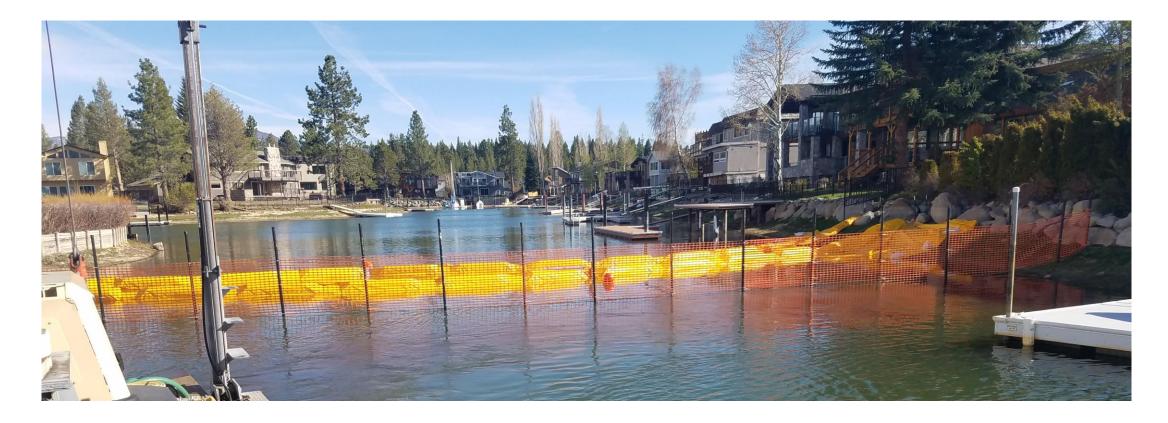
#5: Boating Restriction, Curtains, Barriers

Boat Closure from: April 18 April 25 May 9

Test Area B: Turbidity Curtains and Boat Barrier Installed 5/16

One week before Scheduled Start of Test

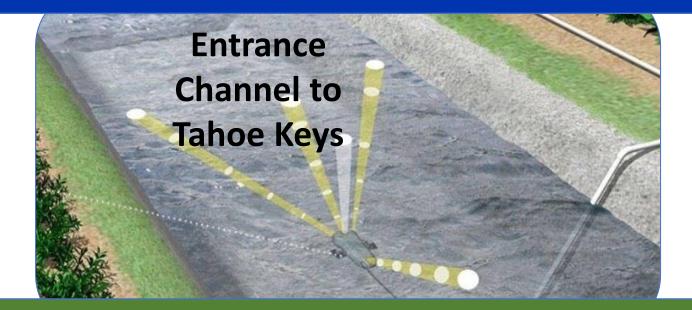
#7: Revised Flow Monitoring Spec @ 11th Hour

The Lake – cold, clean and clear

The Lagoon – warm, turbid, sediment-laden

Simple Fix:

- Manual Meter (in stock)
- Mounted on a pole to the bottom
- Measuring @ 3 depths
- From Anchored Barge

5/23 Doppler Flow Meter Not Working

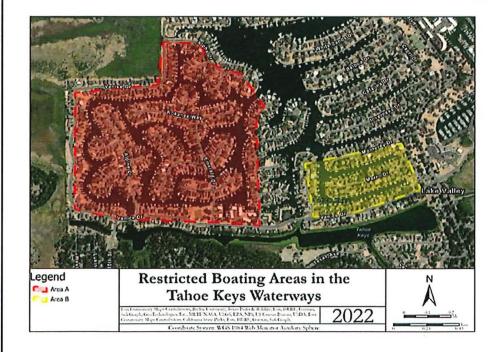
Restricted Boating Areas April 18-Latest Mid-July (Draft- 2022 Only)

Boat Closure to: 3-5 weeks Mid-July August 19 Sept 2 for Area B Sept 23 for Area A

Treatment Area A (Red) Barrier Placement will impact all homeowners on the following streets:

• All streets off Emerald Drive (Garmish Court, Marconi Way, Lido Way, Kokanee Drive)

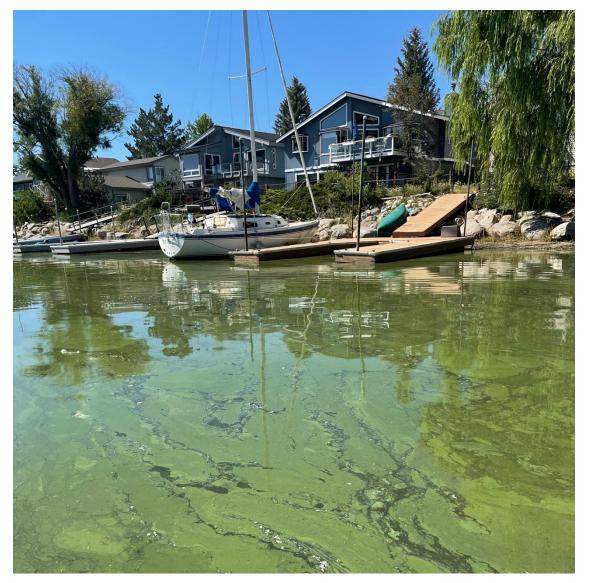
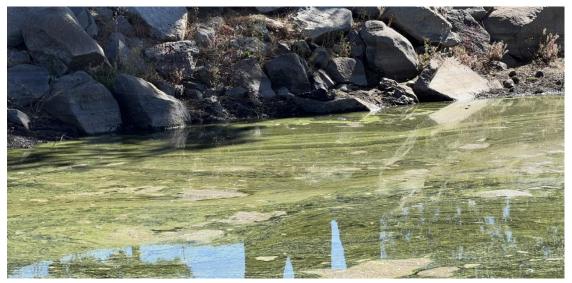
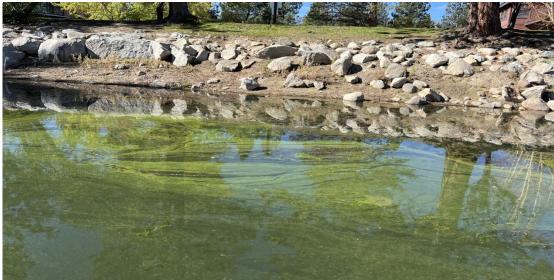
Significant Algae Bloom behind curtains

- Non-detect for Triclopyr set @ 1PPB, a high bar
 - Turbidity Curtains remain in place until late September
 - Water Quality behind the curtains erodes markedly in August

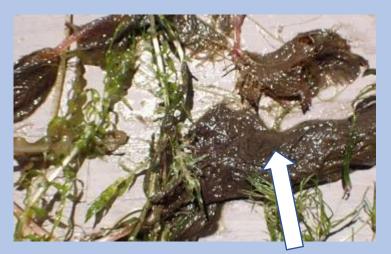
Triclopyr 14 days after treatment: **Only Eurasian watermilfoil is affected**

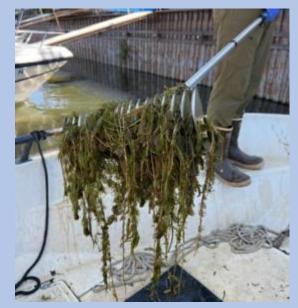
Controls (untreated) (July 6, 2022) All plants are robustly growing

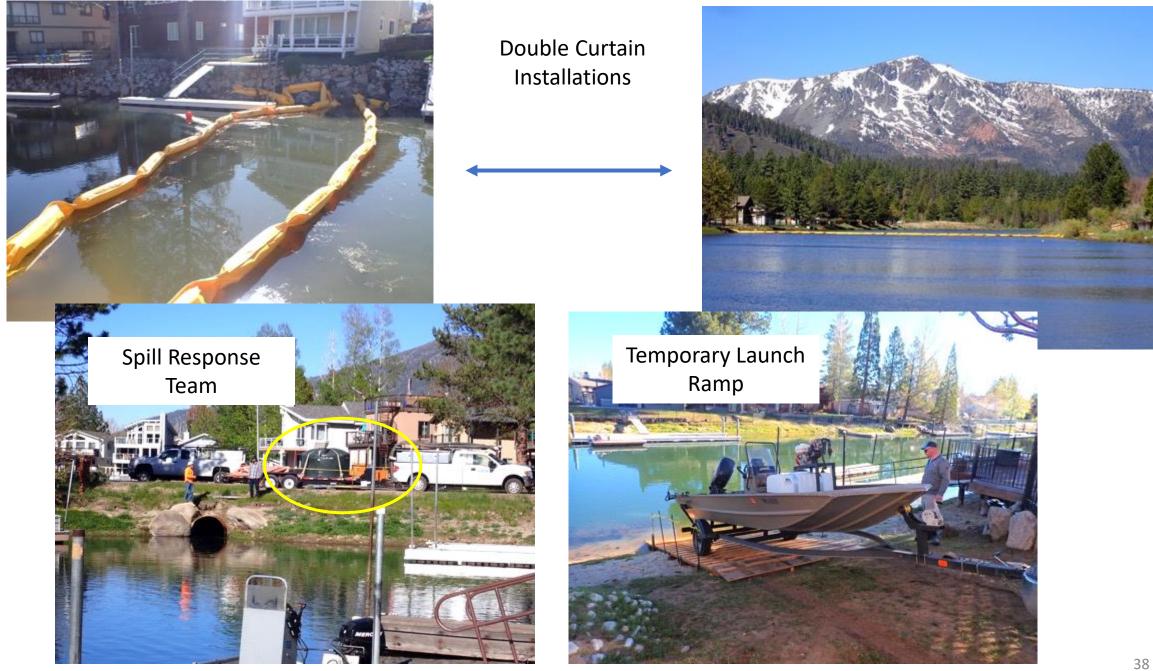
Pumped /Dropline Application of Liquid Endothall Herbicide Mixed with Rhodamine Dye Tracer May, 2022

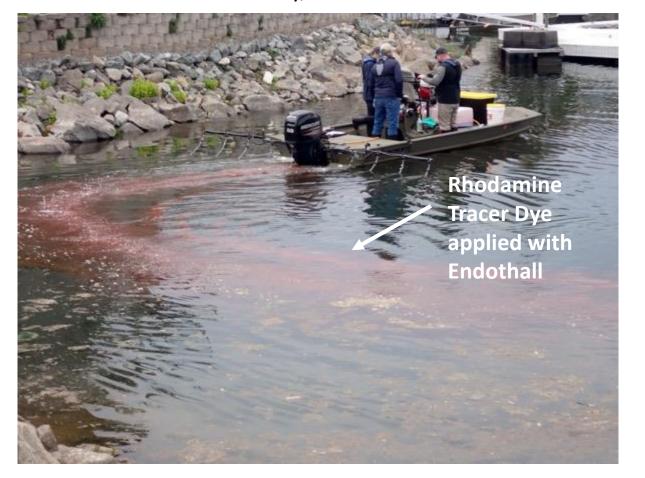
Blower Application of Pelleted Triclopyr Herbicide Rhodamine Dye Was Applied Immediately afterword May 2022

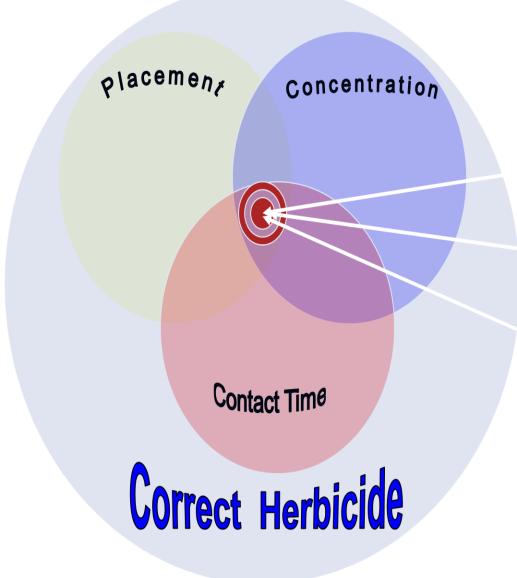
Obtaining Optimal Effectiveness of Aquatic Herbicides

CMT Used "Selective" Aquatic Herbicides: >They do not harm desirable native plant Elodea canadensis watermilfoil Endothall (2 ppm): Controls All three target plants Curlyleaf ("Mainly Contact" = shorter control) pondweed

Coontail (Hornwort)

Eurasion

Triclopyr (1 ppm): Controls Eurasian watermilfoil ("Systemic"=longer control)

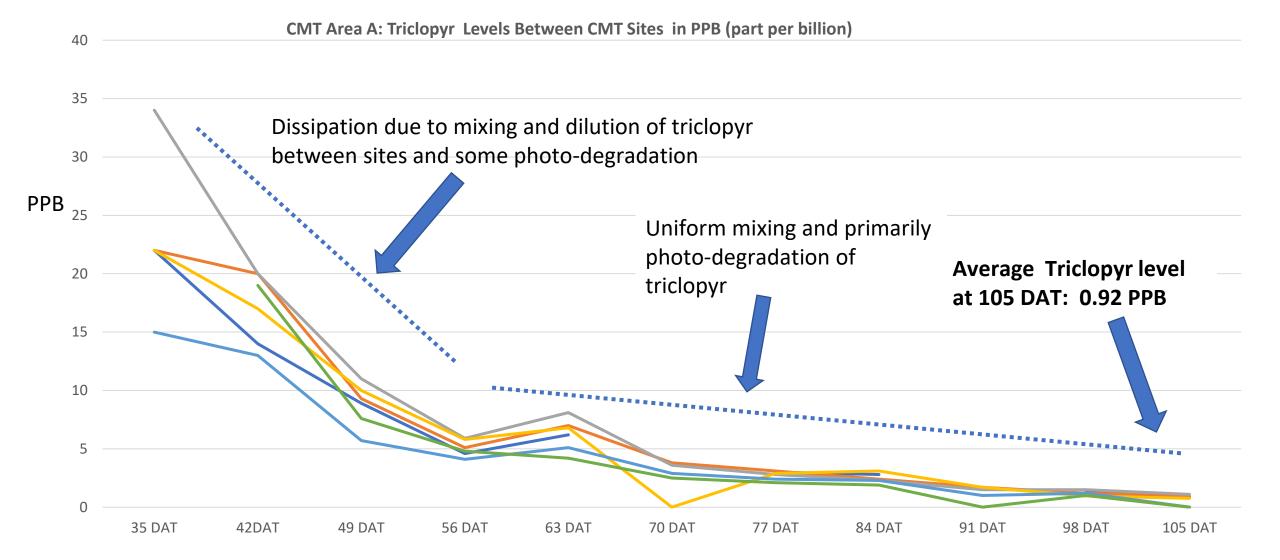
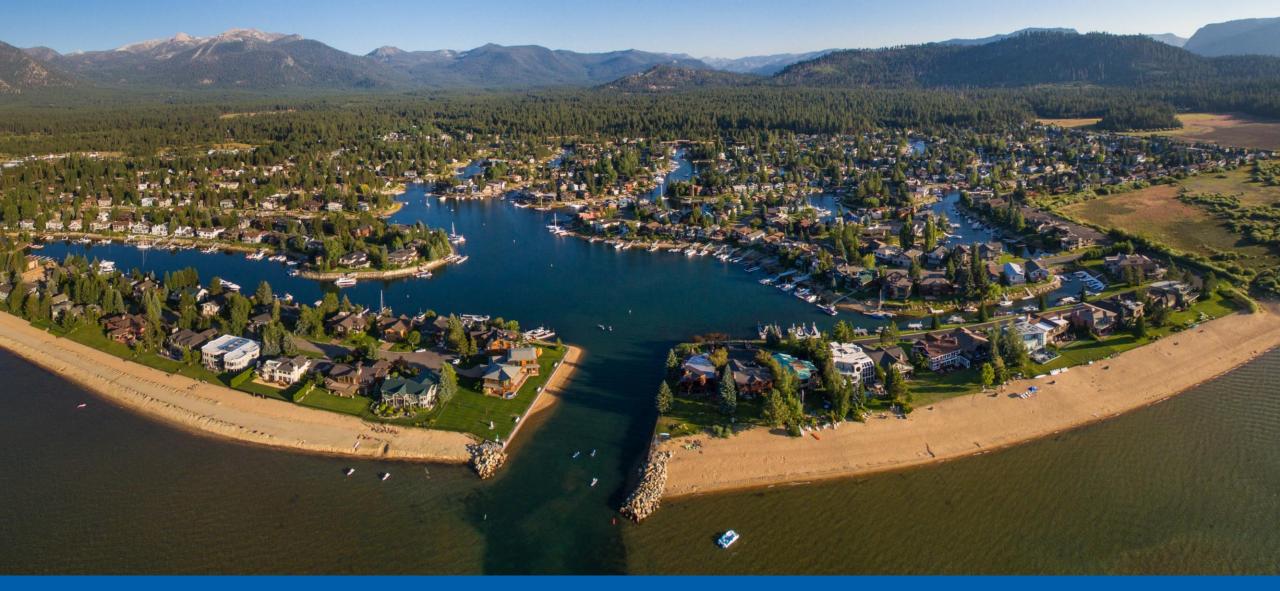
Triclopyr Degradation in Area A (Different lines are from separate monitoring stations in Area A)

- Herbicides never entered Lake Tahoe and never reached the West Channel.
- Rhodamine dye worked well to indicate likely presence of herbicides.
- Endothall became "non-detect" (5 μg/L) by 45 Days after treatment.
- Triclopyr was above "non-detect" levels (1 μg/L) until >100 DAT.
 This prevented removal of turbidity curtains until September.

NOTE: Triclopyr is photo-degraded (light dependent) and high turbidity in Area A probably greatly impeded normal photodegradation.

- PH was above regulatory ranges in Controls
- Herbicide treatments brought pH into regulatory range in many sites.
- Dissolved oxygen was depressed in all sites near the bottom <u>and in</u> <u>mid-depth in Endothall and some Triclopyr sites</u>
- <u>Turbidity was very high in Endothall only sites</u> (generally in all of "Area A")
 >This probably slowed degradation of Triclopyr
- Temperature was not affected by UV treatments.

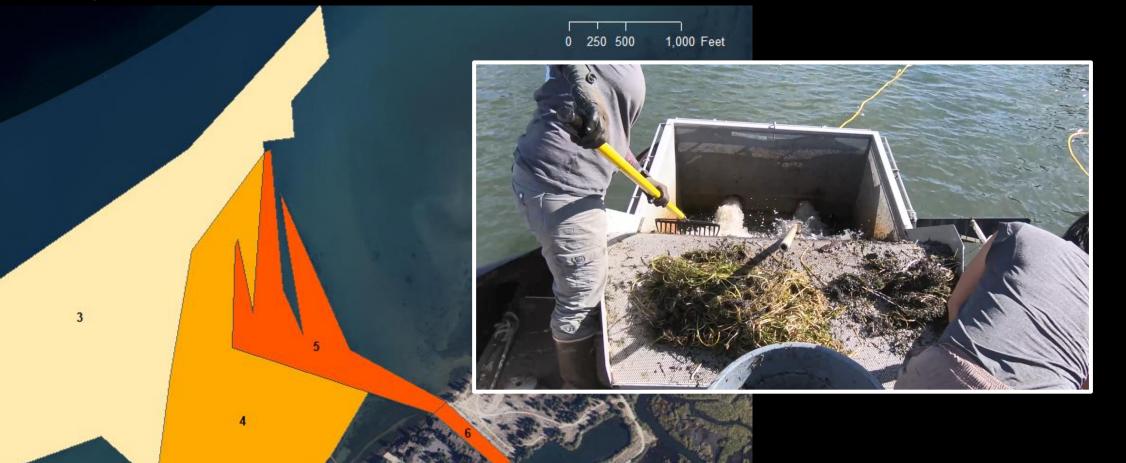
Tahoe Keys Offshore

Infestation Characteristics

High Density EWM & CLP (approximately 16 acres) Patchy EWM & CLP (approximately 35 acres) Sparse EWM (approximately 53 acres)
