**MEMORANDUM**

Subject: Strauss Land Capability Challenge;  
910 Snowshoe Road, Placer County, California  
APN: 083-032-006, TRPA File #: LCAP2022-0749

**BAILEY LAND CAPABILITY CHALLENGE FINDINGS**

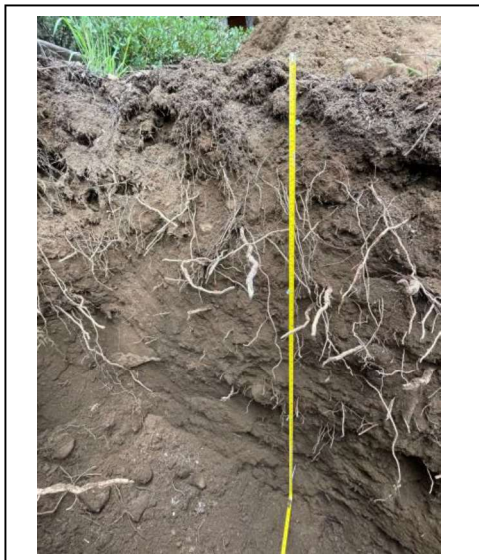
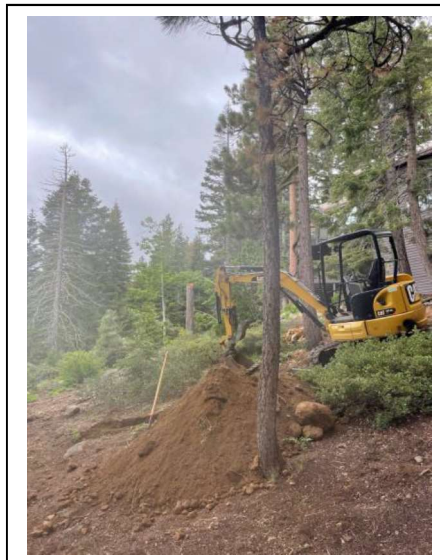
**Pit 083-032-006:**

**Soil Classification:** Loamy-skeletal, isotic, frigid Andic Haploxeralfs. A laboratory test would be needed to verify if this soil has enough volcanic ash to be an Andisol. If so, the taxonomy would be medial, mixed, frigid, Humic Vitrixerands. Soils in this area in the 2007 Soil Survey were mapped as andisols.

**Soil Series:** JwE- 15 to 30 percent slopes, Capability Class 4.

**Parent Material:** Colluvium and residuum from volcanic parent material over volcanic bedrock.

**Slope:** 25 %     **Aspect:** South- Southeast

- Oi 0 to 3 inches; shrub leaves and pine needles; clear smooth boundary.
- A 3 to 10 inches; gravelly sandy loam, dark brown (7.5YR 3/2) moist; strong medium granular structure; soft, very friable, nonsticky and nonplastic; many very fine to fine roots; many very fine to fine irregular pores; 10 percent gravels; gradual, smooth boundary.

- Bt1 10 to 20 inches; gravelly sandy loam, dark brown (7.5YR 3/3) moist; moderate medium subangular blocky structure; soft, very friable, nonsticky and nonplastic; many very fine to coarse roots; many very fine to fine irregular pores; 20 percent gravel and 10 percent cobbles; gradual wavy boundary.

- Bt2 20 to 39 inches; very gravelly sandy loam, brown (7.5YR 4/3) moist; moderate medium subangular blocky structure; soft, very friable; slightly sticky and slightly plastic; many very fine to coarse roots; many very fine and fine irregular pores; 40 percent gravel and 5 percent cobbles; gradual wavy boundary.

- Bt2 39 to 51 inches; very gravelly sandy clay loam, brown (10YR 4/3) moist; moderate medium angular blocky structure; soft, very friable, moderately sticky and moderately plastic; common fine to medium roots; many very fine and fine irregular pores; 45 percent gravel; gradual wavy boundary.

- Cr 51 to 58+ inches; weathered volcanic bedrock, with few fine roots.

One soil pit was excavated by a backhoe to 56 inches. The pit was in the southwest portion of the parcel, approximately 30 feet southwest of the southwest corner of the residence. The soil formed in volcanic colluvium and residuum over weathered volcanic bedrock. This soil is characterized by a sandy loam surface texture, with gravelly sandy loam, very gravelly sandy loam, very gravelly sandy clay loam sand subsurface textures. Weathered bedrock is present

below 51 inches. A silica cemented horizon was not observed in the pit. This soil is classified as a Loamy-skeletal, isotic, frigid Andic Haploxeralfs. This soil is deep, well drained, and is a member of Soil Hydrologic Group B. The vegetation on this parcel is a white fir and Jeffrey pine forest with an understory of mixed montane shrubs including huckleberry oak, snowberry, mountain whitethorn, Sierra wax current, and prostrate ceanothus.

In the *Soil Survey of Tahoe Basin Area, California-Nevada* (Rogers, 1974), the Tallac soil is described as having a root restrictive silica cemented layer between 40 to 60 inches. A silica cemented layer was not observed in this soil. This soil has argillic soil development and has weathered bedrock below 51 inches. The Tallac soil does not have argillic soil development, forms in glacial outwash, and does not have bedrock near the surface. Mapunit MxF, Meiss cobbly loam, 30 to 60 percent slope is mapped to the east of this parcel. The Meiss soil is a shallow soil (10 to 20 inches deep) over hard bedrock. The presence of bedrock is similar to this soil, but this soil is deeper (51 inches to weathered bedrock) and has argillic soil development. This soil falls into the range and characteristics of the Jorge soil. The 2007 soil survey maps the soils in this area as Andisols. Laboratory analysis is required to determine if this soil is an Andisol. In the absence of lab data, this soil is determined to be the Jorge soil, and based on slopes, places in the JwE, Jorge-Tahoma very stony sandy loam, 2 to 15 percent slopes mapunit.

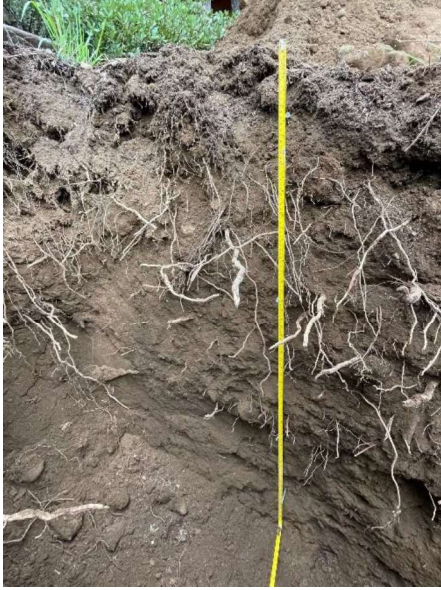
Photo 1 – a. Soil pit. Photo 1- b. Looking north across pit towards Snowshoe Road.
