STAFF REPORT

Subject: Nelson Land Capability Challenge
5647 Rhodesia Road, Placer County, CA
APN: 116-210-024, TRPA File #: LCAP2023-0121

BAILEY LAND CAPABILITY CHALLENGE FINDINGS

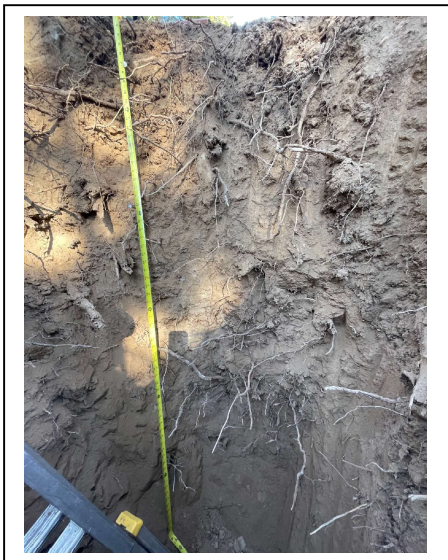
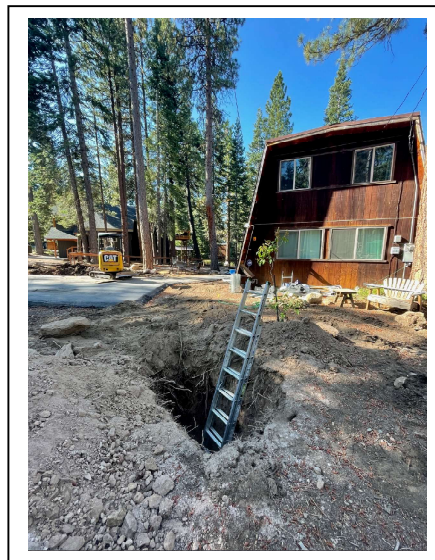
Pit 116-210-024:

- A1 0 to 2 inches; sandy loam, brown (10YR 4/3), very dark grayish brown (10YR 3/2) moist; moderate fine granular structure; loose, loose, nonsticky and nonplastic; many very fine to very coarse roots; many very fine and fine irregular pores; 10 percent gravels; clear smooth boundary.

- A2 2 to 7 inches; gravelly sandy loam, brown (10YR 4/3), dark brown (7.5YR 3/3) moist; moderate medium granular structure; soft, very friable, slightly sticky and slightly plastic; many fine to medium roots and common very fine and very coarse roots; many very fine and fine irregular pores; 10 percent gravel and 15 percent cobbles; gradual wavy boundary.

- Bw 7 to 24 inches; gravelly sandy loam, yellowish brown (10YR 5/4), brown (10YR 4/3) moist; weak medium subangular blocky structure; soft, very friable, slightly sticky and slightly plastic; many very fine to medium roots; many very fine and fine irregular pores; 15 percent gravel, and 5 percent cobbles; gradual wavy boundary.

- Bt1 24 to 41 inches; sandy clay loam, brown (10YR 5/3), brown (7.5YR 4/3) moist; strong very thick platy structure; slightly hard, friable, moderately sticky and moderately plastic; many very fine to medium roots; common clay films bridging sand grains; many very fine and fine irregular pores; 10 percent gravels; clear wavy boundary.

- Bt2 41 to 62 inches; gravelly sandy clay loam, light brownish gray (10YR 6/2), brown (7.5YR 4/2) moist; strong medium subangular blocky structure; hard, very firm, moderately sticky and moderately plastic; common medium, distinct redox concentrations in the matrix, common fine to medium roots; many clay films on ped faces; common very fine and fine irregular pores; clear wavy boundary.

- CR 62 to 75+ inches; Highly weathered volcanic mud flow. Hard, but with effort, breaks up into clayey gravel sided pieces.

Note: Bt2 horizon colors described appear to be natural color variation in the weathered parent material.

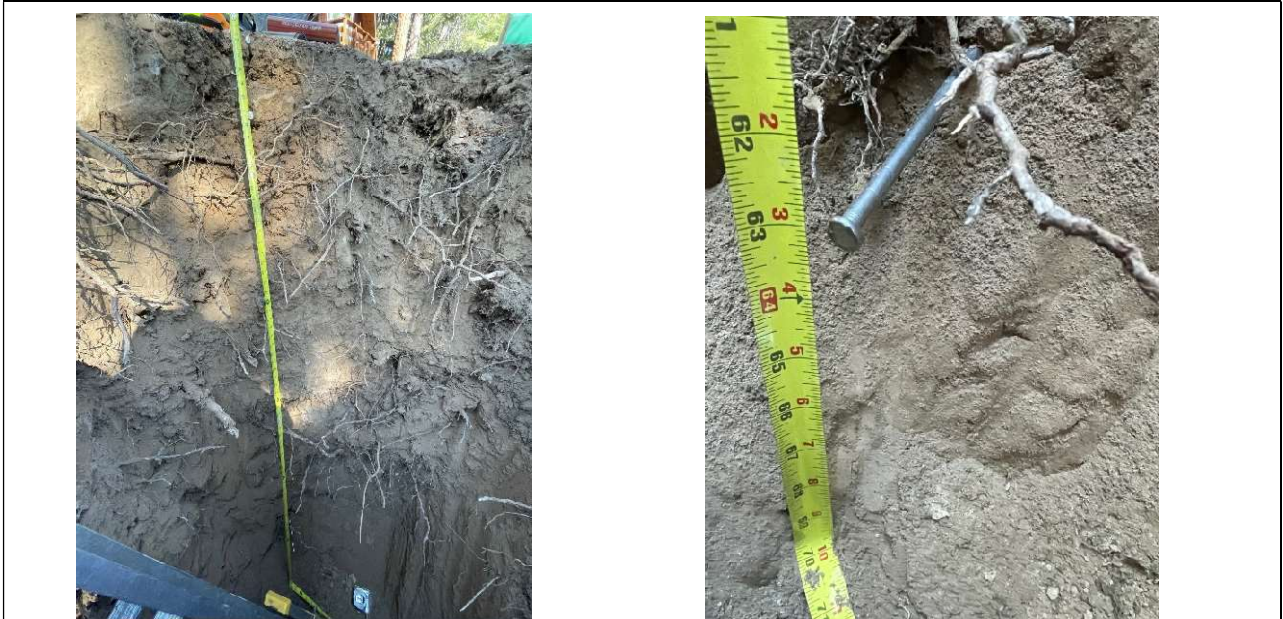
One soil pit was excavated by backhoe to 75 inches. The pit was located northeast of the residence, approximately 15 feet north of the driveway. The soil is characterized by a sandy loam surface texture, with gravelly sandy loam, sandy clay loam, and gravelly sandy clay loam, subsurface textures. Hard, weathered bedrock was present at 62 inches. This soil formed in volcanic colluvium over residuum from volcanic mud flows. This soil has less than 35 percent rock fragments in the particle control section, and classifies as Finel-loamy, isotic, frigid, Ultic Haploxeralfs. This soil is very deep, well drained, and is a member of Hydrologic Soil Group B. The vegetation is a white fir and Jeffrey pine forest with huckleberry oak, antelope bitterbrush, creeping snowberry, and greenleaf manzanita occasional in the understory. The forb and grass layers are very sparse, with pine and fir needles covering the surface.

Photo 1 – a. Pit 1. Photo 1- b. Bottom of pit.
