STAFF REPORT

Subject: Ralston Land Capability Challenge;
1560 North Lake Blvd., Placer County, CA
APN: 094-160-007; TRPA File #: LCAP2023-0167

Attachment A
Parcel Map with Soil Map Units Delineated

**Land Capability Challenge
Ralston Project
1560 N. Lake Boulevard
Tahoe City, Placer County, California
(APN 094-160-007)**

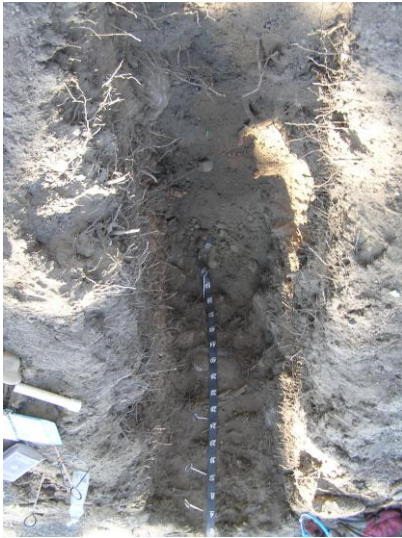
Figure 1. Stop 1 profile

- A1 0 to 4 inches, grayish brown (10YR 5/2) gravelly loamy sand, very dark grayish brown (10YR 3/2), moist; moderate fine granular structure; soft, loose, nonsticky and nonplastic; many fine and medium roots; many very fine and fine interstitial pores; 20 percent gravel; clear smooth boundary.
- A2 4 to 12 inches, grayish brown (10YR 5/2) very gravelly loamy coarse sand, very dark grayish brown (10YR 3/2), moist; moderate fine granular structure; soft,

- Bw1 12 to 25 inches, yellowish brown (10YR 5/4) very gravelly sandy loam, dark yellowish brown (10YR 3/4), moist; weak fine subangular blocky structure; soft, very friable, nonsticky and nonplastic; many fine, medium and coarse roots; many fine, medium and common tubular pores; 40 percent gravel; clear smooth boundary.

- 2Bw2 25 to 56 inches; yellowish brown (10YR 5/4) extremely bouldery sandy loam, dark yellowish brown (10YR 3/4), moist; moderate fine subangular blocky structure; soft, very friable, nonsticky and nonplastic; many very fine and fine interstitial pores; 60 percent boulders and 20 percent gravel; clear smooth boundary.

- 3C 56 plus inches; color as above, very gravelly loamy coarse sand; weak fine granular structure; common fine, medium and few coarse roots; many very fine and fine interstitial pores; 50 percent gravel.

Notes: Water rounded gravels below 25 inches depth. HSG B. Not Rx.

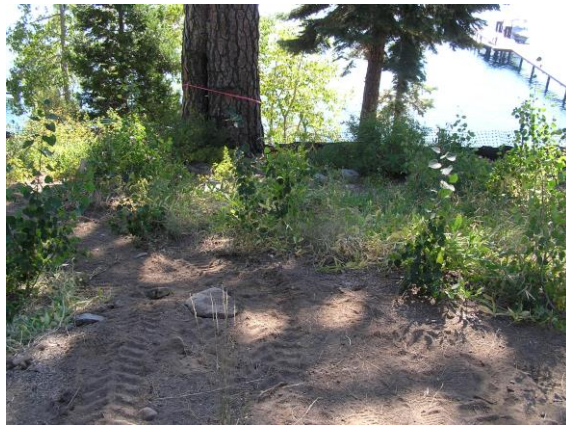
Figure 2. Stop 1 landscape.

Two soil pits were excavated by backhoe to 56 and 64 inches. Stop 1 was located approximately 20 feet south southwest of the residence and stop 2 was located around the back of the residence approximately 8 feet to the north northeast of the center of the residence. These soils formed in volcanic colluvium and alluvium from old lake deposits. The soil at Stop 1 is characterized by a gravelly loamy sand surface texture, with very gravelly loamy coarse sand, very gravelly sandy loam, and extremely bouldery sandy loam subsurface textures. Hard or weathered bedrock was not encountered in the pit. This soil is classified as a Sandy-skeletal, mixed, frigid, Humic Dystrocherepts. This soil is very deep, well drained, and is a member of Soil Hydrologic Group B. The soil at Stop 2 is characterized by a gravelly loamy sand surface texture, with very gravelly sandy loam, very cobbly sandy loam, and extremely gravelly loamy coarse sand subsurface textures. Hard or weathered bedrock was not encountered in the pit. This soil is classified as a Sandy-skeletal, mixed, frigid, Humic Dystrocherepts. This soil is very deep, well drained, and is a member of Soil Hydrologic Group B. The native vegetation on this parcel is an open forest of Jeffrey pine, white fir and incense-cedar, with an understory of greenleaf manzanita, huckleberry oak and bitter cherry. Along the backshore there are a few black cottonwood trees, and a few quaking aspens are by the house in an irrigated area.

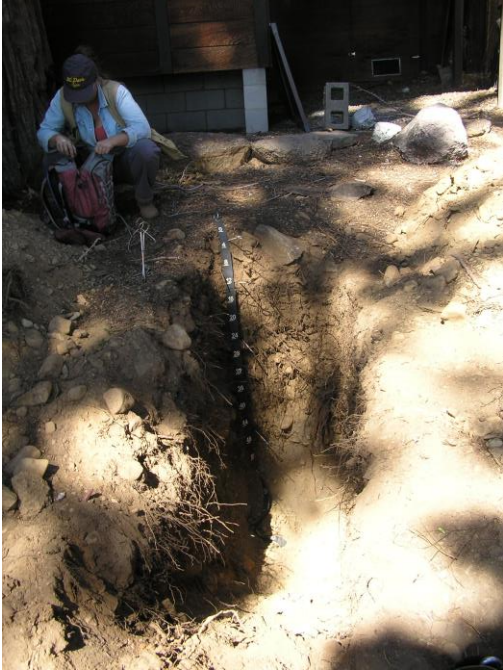
Figure 3. Stop 2 profile.

- A1 0 to 3 inches; dark gray (10YR5/2) gravelly loamy sand, dark brown (10YR 3/3), moist; fine platy parting to weak fine subangular structure; soft, loose, nonsticky and nonplastic; many fine and medium roots; many very fine and fine interstitial pores; 15 percent gravel; clear smooth boundary.

- A2 3 to 12 inches, brown (10YR 5/3) gravelly sandy loam (near loamy sand) dark brown (10YR 3/3), moist; soft, loose, nonsticky and nonplastic; many fine, medium and coarse roots; 25 percent gravel; gradual wavy boundary.

- Bw1 12 to 24 inches; yellowish brown (10YR 5/4) gravelly sandy loam, dark yellowish brown (10YR 3/4), moist; weak fine granular structure; soft, loose, nonsticky and nonplastic; many fine, medium and coarse roots; many very fine and fine interstitial pores; 30 percent gravel; gradual wavy boundary.

- 2Bw2 24 to 46 inches, brown (7.5YR 5/4) very cobbly sandy loam, dark brown (7.5YR 3/4), moist; single grain; soft, loose, nonsticky and nonplastic; common fine and medium, few coarse roots; 30 percent cobble and 40 percent gravel; clear smooth boundary.

3C 46 to 64 inches, pinkish gray (7.5YR 6/3) extremely gravelly loamy coarse sand, brown (7.5YR 4/3); single grain; soft, loose, nonsticky and nonplastic; common fine and medium, few coarse roots; 60 percent gravel.

Notes: Surface has been slightly compacted. Many roots to depth. HSG B.

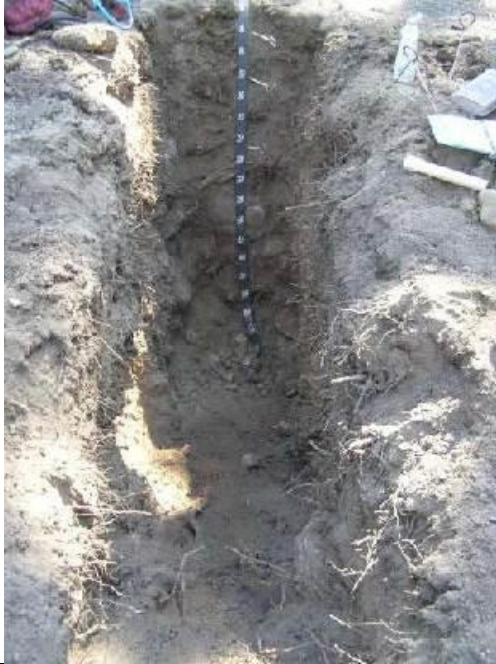
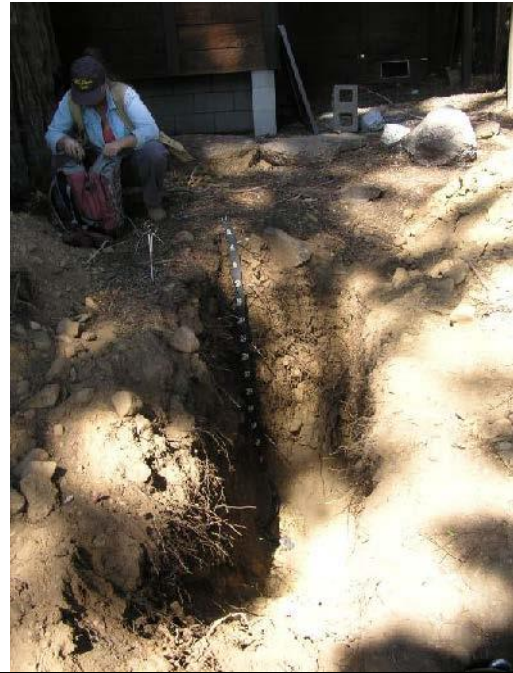
Photo 1 – a. Stop 1 pit. Photo 1- b. Stop 2 pit.

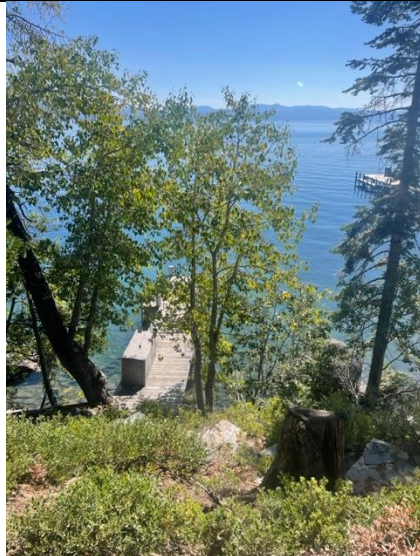
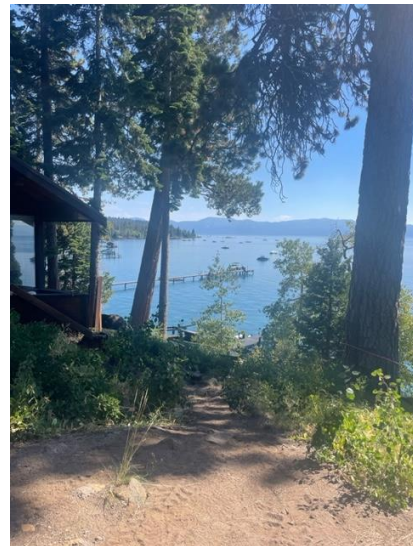
Photo 2 – a. View of Class 2 towards backshore and Lake Tahoe. Photo 2 – b. View from near Stop 1 towards the east.

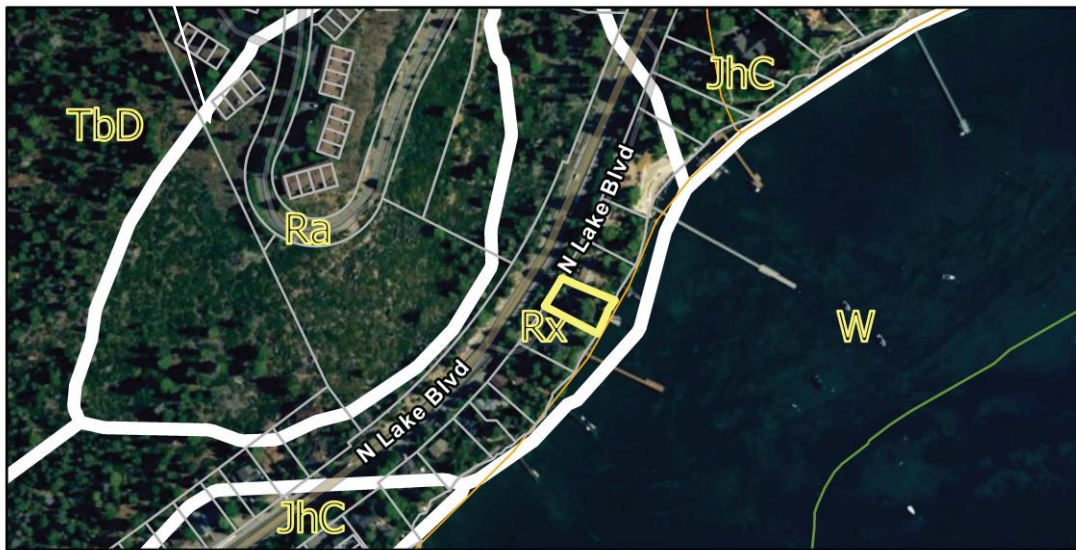
Image 4 – ArcGIS map of parcel area, showing the 1974 Soil Survey delineations in white (Mapunits labeled in Yellow).
