STAFF REPORT

Subject: Taylor Land Capability Challenge
545 Alpine View Drive, Washoe County, NV
APN: 131-212-03; TRPA File #: LCAP2023-0309

BAILEY LAND CAPABILITY CHALLENGE FINDINGS

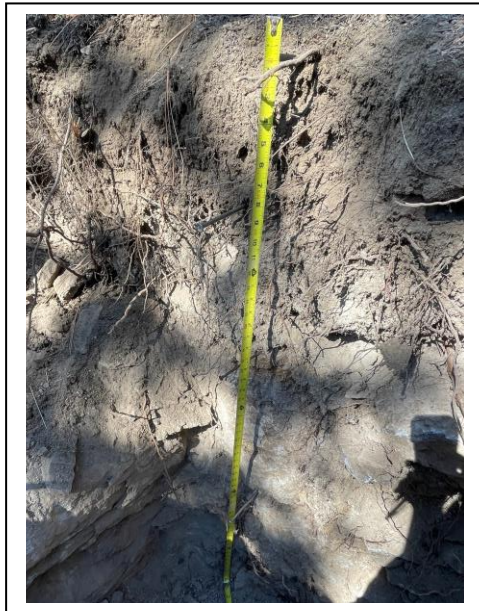
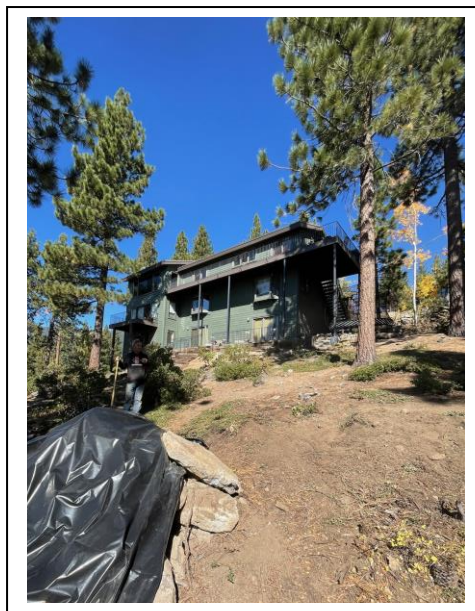
Soil Profile Description

Pit 131-212-03:

Soil Classification: Loamy-skeletal, isotic, frigid Andic Dystrocherepts

- Oe 0 to 0.5 inch; shrub leaves and pine needle duff
- A1 0.5 to 8 inches; sandy loam, dark grayish brown (10YR 4/2), very dark brown (10YR 2/2) moist; weak fine granular structure; soft, very friable, nonsticky and nonplastic; many very fine and fine roots; many very fine and fine irregular pores; 5 percent gravels; gradual smooth boundary.

- A2 8 to 20 inches; sandy loam, grayish brown (10YR 5/2), brown (10YR 4/3) moist; moderate medium granular structure; soft, very friable, slightly sticky and slightly plastic; many very fine to very coarse roots; many very fine and fine irregular pores, 10 percent gravel; gradual smooth boundary.

- Bw 20 to 38 inches; very stony sandy clay loam, light gray (10YR 7/1), grayish brown (10YR 5/2) moist; moderate medium subangular blocky structure; hard, very firm, slightly sticky and slightly plastic; common very fine to medium roots; many very fine and fine irregular pores, 15 percent gravel, 20 percent cobbles, and 15 percent stones, gradual wavy boundary.

- C 38 to 56+ inches; extremely gravelly clay loam, light brownish gray (10YR 6/2), grayish brown (10YR 5/2) moist; massive; soft, very friable, slightly sticky and slightly plastic; many fine to coarse roots; many very fine and fine irregular pore, 55 percent gravel and 5 percent stones.

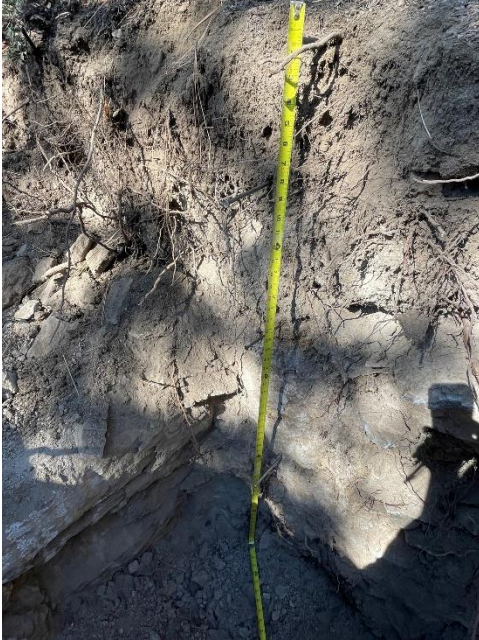
Photo 1 – a. Pit. Photo 1- b. View looking north across parcel toward the residence.

One soil pit was excavated by hand to 56 inches. The soil pit was located approximately 35 feet south of the southeast corner of the residence. This soil formed in colluvium and residuum from volcanic parent material over old lake influenced deposits. This parcel ranges in elevation from 6,730 to 6,790 feet. In the report, *Pleistocene volcanism and shifting shorelines at Lake Tahoe, California*, the shoreline of Lake Tahoe was determined to reach elevations of 6,700 to 6,840 feet at specific times in the past due to volcanic flows plugging of the Truckee River outlet. This parcel is in the elevation band affected by the high lake levels. In many areas of the lake a “stone line” can be found around this elevation where submersion by the lake has caused erosion and deposition. The somewhat jumbled arrangement of the soil and rock fragments in this pit is likely a result of this process. The soil at this pit is characterized by a sandy loam surface texture, with sandy loam, very stony sandy clay loam, and extremely gravelly clay loam subsurface textures. This soil is deep, well drained, and is a member of Soil Hydrologic Group B. The soil taxonomy is Loamy-skeletal, isotic, frigid, Andic Dystroxerepts. The vegetation is an open Jeffrey pine forest with a few incense cedar and landscaped plants. Greenleaf manzanita, huckleberry oak, prostrate ceanothus, antelope bitterbrush, and creeping snowberry are present in the openings.

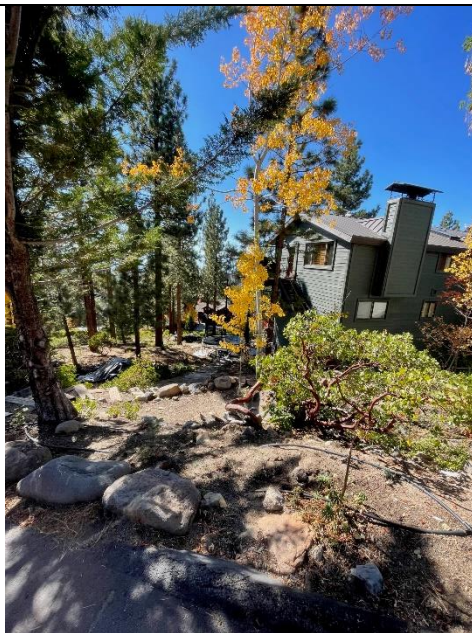
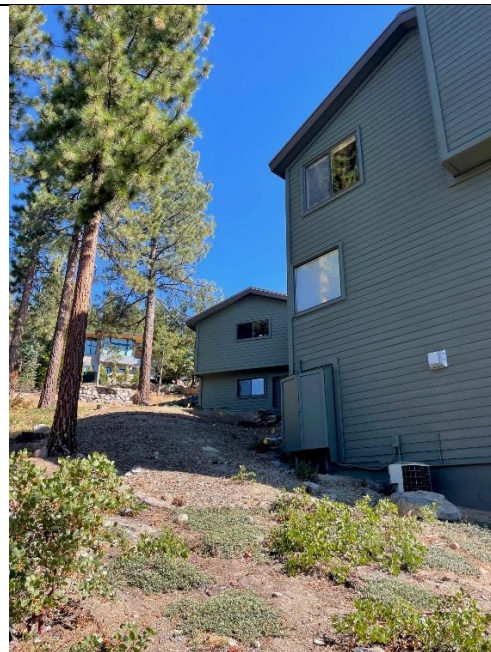
Photo 2 – a. View from road at east corner of parcel looking to the west. Photo 2 – b. View from west to east.

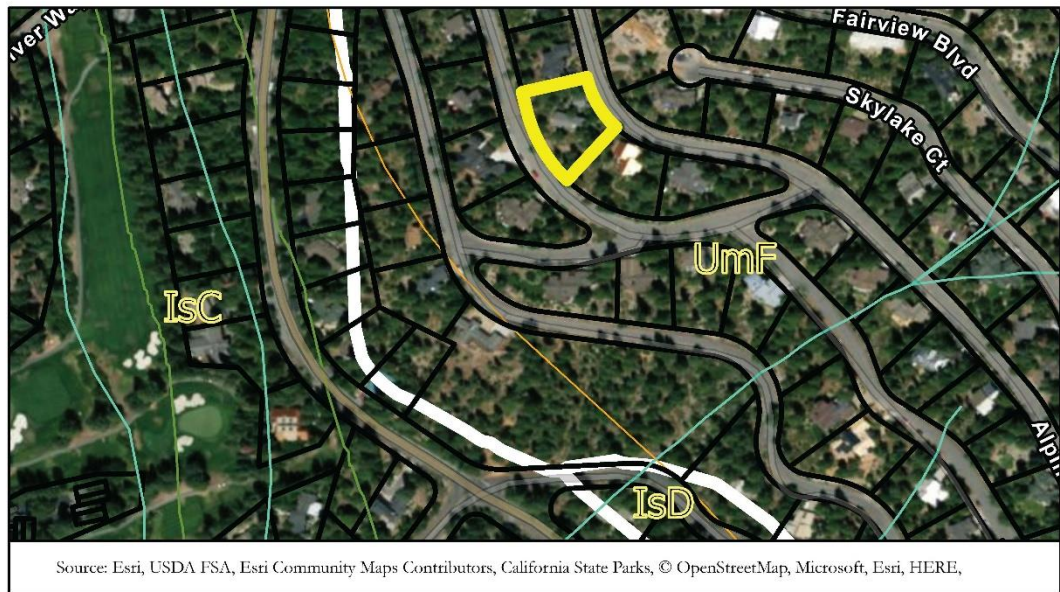
Image 4– ESRI Map, 1974 Soil Survey delineations in white, mapunit in yellow/black, and parcel in bold yellow.

The subject parcel is shown as Class 1a on TRPA Land Capability Overlay Maps (aka Bailey Land Capability maps). The Soil Conservation Service *Soil Survey of Tahoe Basin Area, California-Nevada* (Rogers, 1974) places the subject parcel in the UmF, Umpa very stony sandy loam, 30 to 50 percent slope mapunit. A land capability verification completed in 2023 (LCAP2023-0309) verified the entire parcel as Class 3-UmE, Umpa very stony sandy loam, 15 to 30 percent slope mapunit. The updated *Soil Survey of Tahoe Basin Area, California and Nevada* (NRCS, 2007) maps this parcel as mapunit 7152- Jorge very cobbly fine sandy loam, 15 to 30 percent slopes. This parcel has a geomorphic mapping of D2 for Streamcut Volcanic Flowlands; Headlands (Moderate hazard lands). The Umpa soils formed in colluvium and residuum over andesitic bedrock. Umpa soils have a very stony sandy loam A-horizon, with gravelly sandy loam subsurface textures in the upper 40 inches. Hard, fractured andesite is encountered between 20 and 40 inches below ground surface. The Jorge soils formed in colluvium and residuum over andesitic bedrock. Jorge soils have a stony sandy loam A-horizon, with gravelly sandy loam or very gravelly sandy loam subsurface textures in the upper 50 inches. An argillic horizon is present at 33 inches to a depth of 50 inches, where a C horizon is present. Depth to weathered andesitic bedrock is below 60 inches.
