STAFF REPORT

Subject Nolan Land Capability Challenge
4001 Manzanita Avenue, South Lake Tahoe, California
APN: 029-081-003, TRPA File #: LCAP2023-0298

BAILEY LAND CAPABILITY CHALLENGE FINDINGS

4001 Manzanita Ave.,
South Lake Tahoe, El Dorado County, CA 96150
APN 029-081-003, LCAP2023-0298

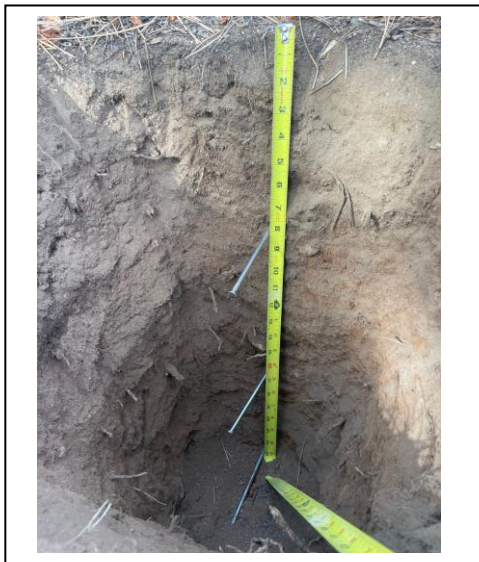
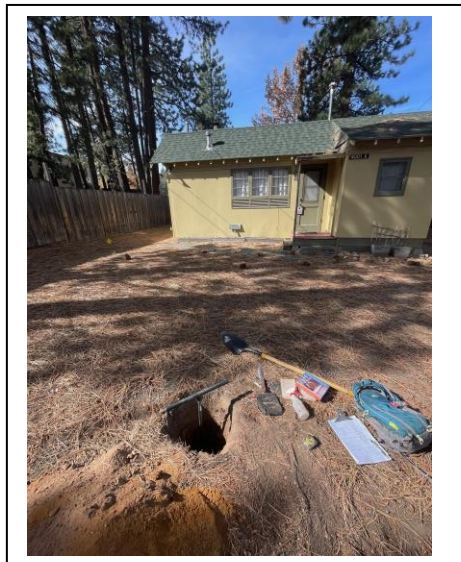
Pit 029-081-003:

- A1 1 to 8 inches; gravelly loamy coarse sand, dark brown (10YR 3/3), very dark grayish brown (10YR 3/2) moist; moderate fine granular structure; soft, very friable, nonsticky and nonplastic; common very fine to medium roots; many very fine to fine irregular pores; 15 percent gravels; gradual wavy boundary.

- AB 8 to 18 inches; loamy coarse sand, dark yellowish brown (10YR 4/3), dark brown (7.5YR 3/2) moist; moderate medium subangular blocky structure; slightly hard, friable, nonsticky and nonplastic; many very fine to medium roots; many very fine to fine irregular pores; 5 percent gravels; gradual wavy boundary.

- Bw 18 to 23 inches; loamy coarse sand, pale brown (10YR 6/3), dark yellowish brown (10YR 3/4) moist, with common, medium, yellowish brown (10YR 5/6) iron masses in matrix; moderate medium platy structure; slightly hard, friable; nonsticky and nonplastic; common fine roots; many very fine and fine irregular pores; 5 percent gravel; gradual wavy boundary.

- C1 23 to 33 inches; loamy coarse sand, brown (10YR 5/3), dark yellowish brown (10YR 4/4) moist with few, medium, light brownish gray (10YR 6/2) iron depletions, and many, medium, dark yellowish brown (7.5YR 4/6) iron masses in matrix; massive; moderately hard; firm, nonsticky and nonplastic; few fine roots; many very fine and fine irregular pores; 45 percent gravel; clear wavy boundary.

- C2 33 to 54 inches; very gravelly loamy coarse sand, strong brown (7.5YR 4/6), reddish brown (5YR 4/4) moist with few, medium, yellowish brown (10YR 6/2) iron depletions and many, medium; strong brown (7.5YR 5/8) iron masses in matrix; massive; slightly hard, friable, nonsticky and nonplastic; 30 percent gravel.

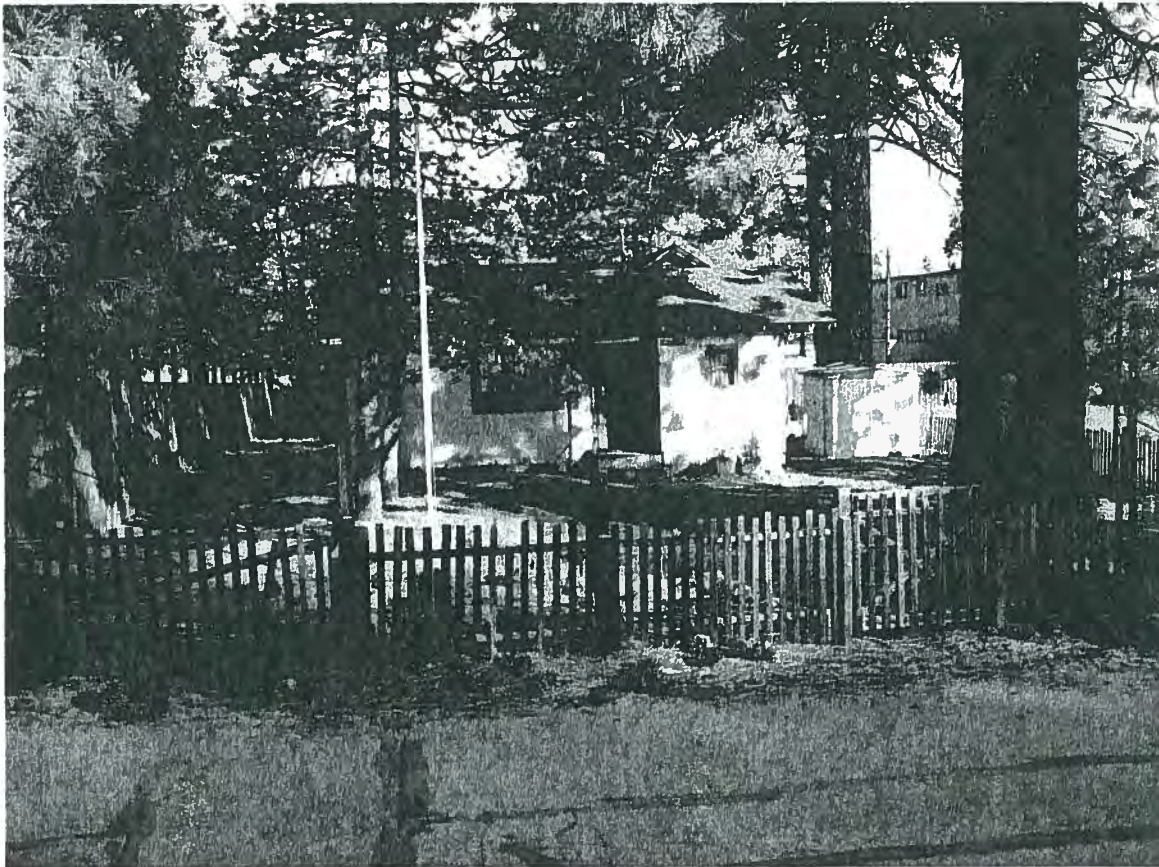
Fig. 3 - APN 029-081-03, looking north from Manzanita Ave

The vegetation community type found is *Type 17: Mixed Conifer*, consisting of dominantly Jeffrey pine (*Pinus jefferyii*), with few lodgepole pine (*P. contorta var. murrayana*) and an understory of dominantly blue wild rye (*Ilymus glaucus*). This is not an SEZ indicator community according to Chapter 37 (Figs. 3 – 5).

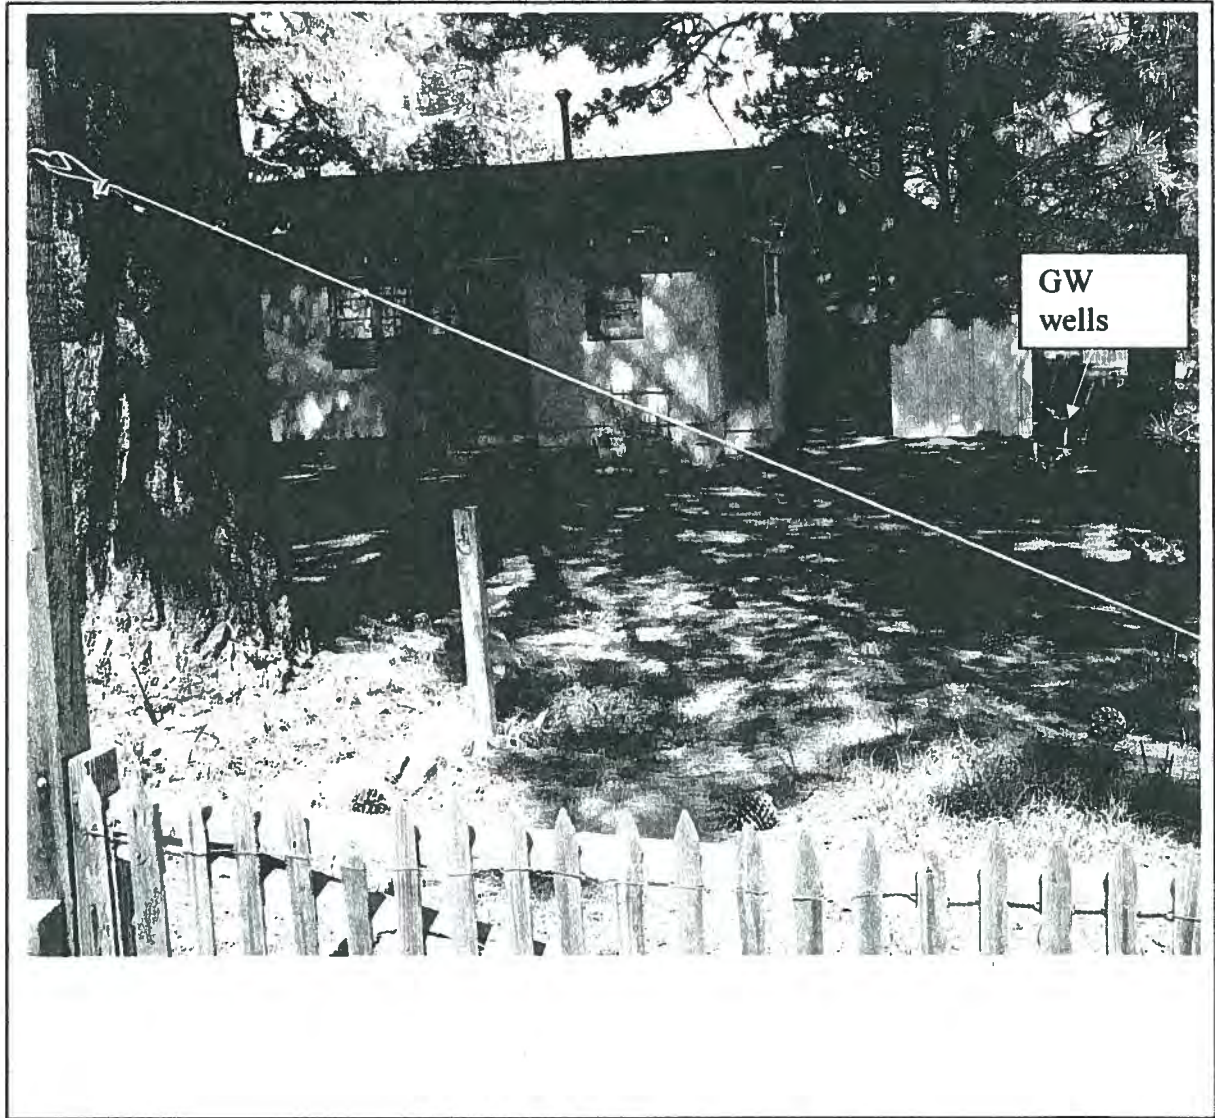
Fig. 4 - Location of groundwater monitoring wells

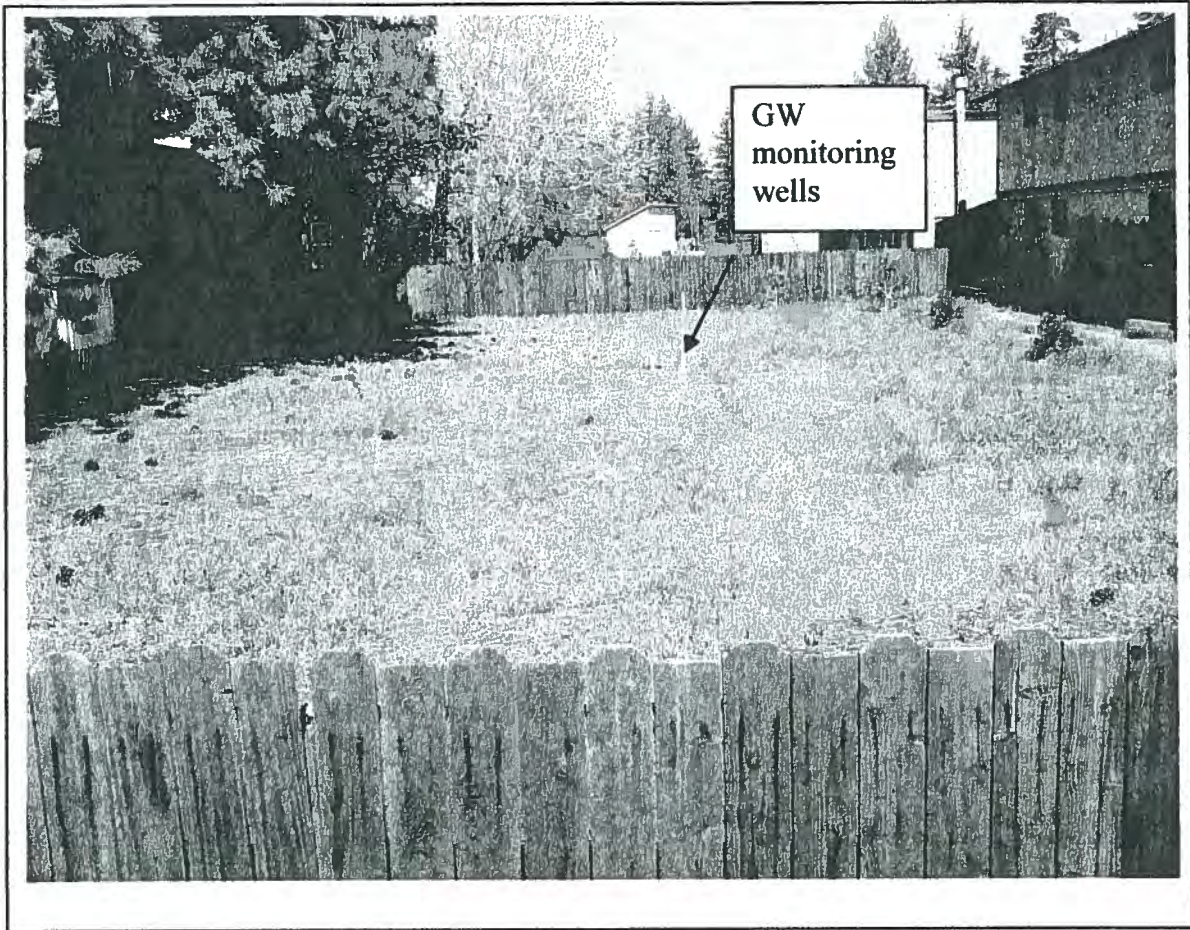
Fig. 5 - Parcel 029-081-15 – groundwater monitoring wells near center of parcel.

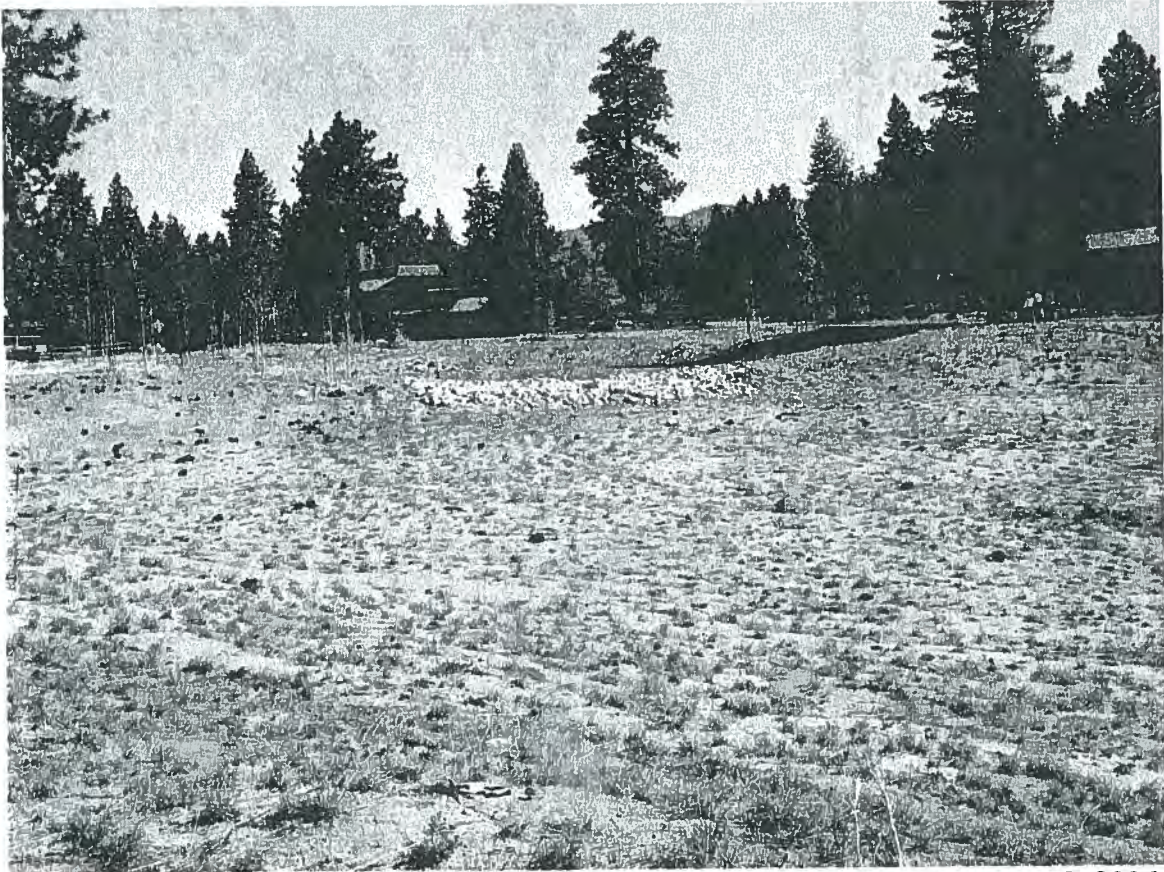
Fig. 6 - Sedimentation basin located between Pine Road and L. Tahoe – dry May 2, 2006

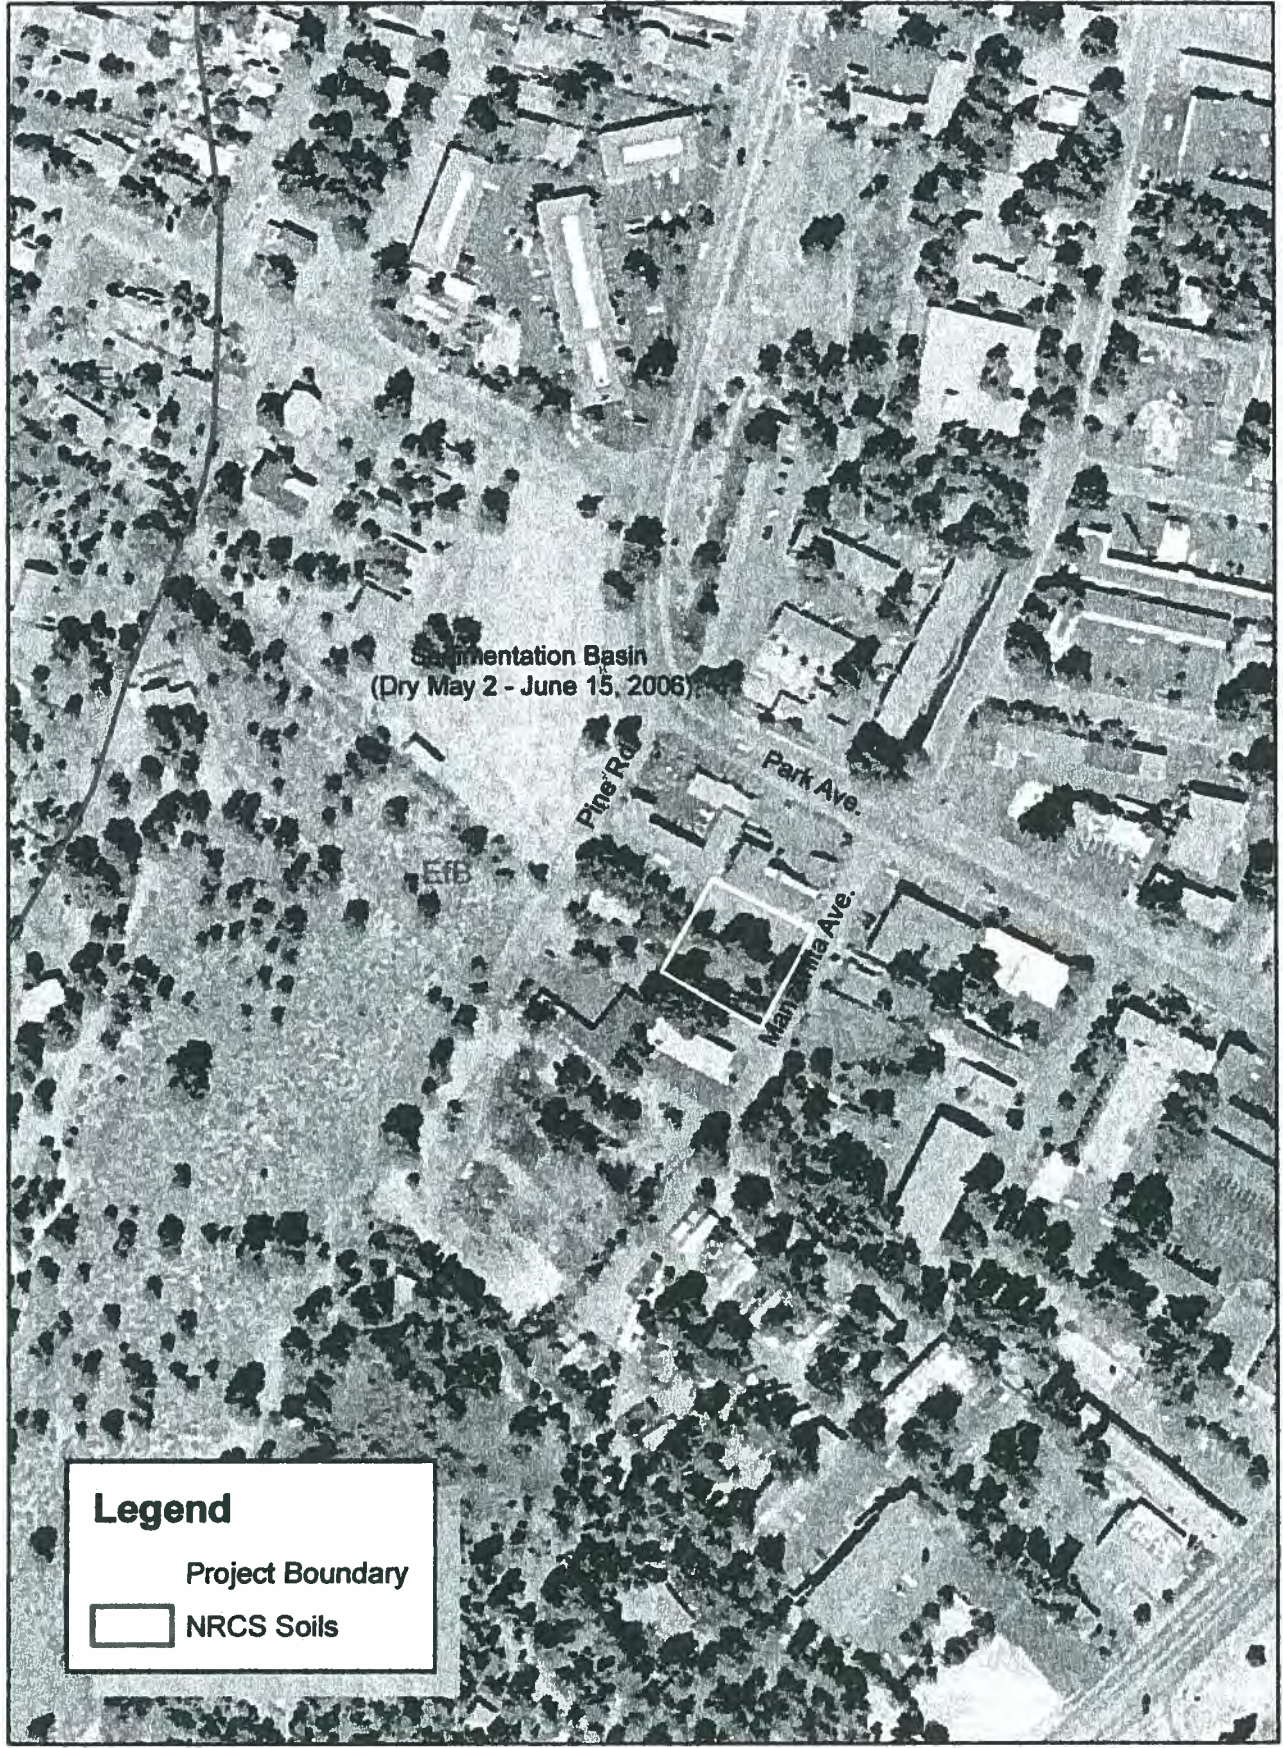
Nolan Project Site

El Dorado County APNs 029-081-03 & 15

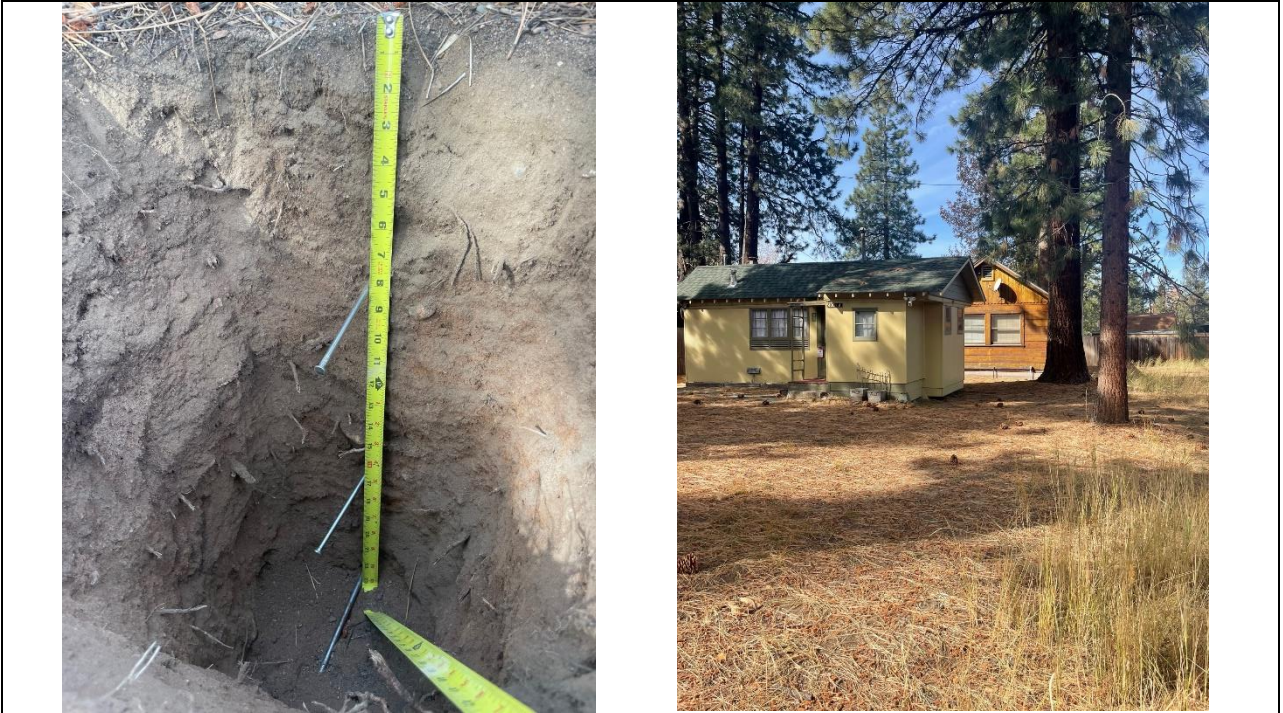
One soil pit was excavated by hand to 24 inches and hand augured to 54 inches. The pit was located in the east side of the parcel, approximately 15 feet southeast of the easternmost structure. This soil formed in mixed alluvium and is characterized by a loamy coarse sand surface texture, with loamy coarse sand and gravelly loamy coarse sand subsurface textures. Redoximorphic features begin at 18 inches and continue to the bottom of the pit. This soil is classified as a Sandy, mixed, frigid, Humic Dystroxerepts. This soil is very deep, somewhat excessively drained, and is a member of Soil Hydrologic Group A. The vegetation on this parcel is an open Jeffrey pine forest with a barren understory with uniform cover of pine needle litter and duff.

Photo 1 – a. Soil pit. Photo 1- b. Looking west from Manzanita Avenue towards residence.

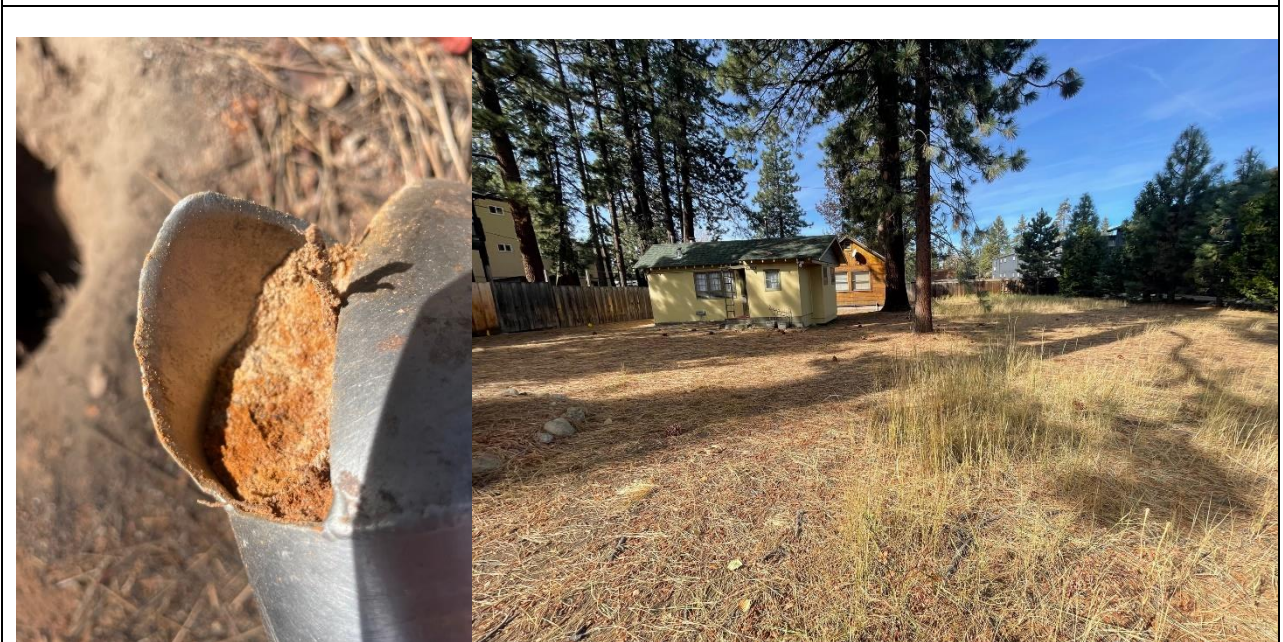
The water table observations from the groundwater monitoring wells indicate that the redoximorphic features are relict. Since ground water was not observed above 40 inches, and no other primary or secondary SEZ indicators are present, this site does not qualify as SEZ. The current upland vegetation composed of mature Jeffrey pine forest and google earth historic imagery suggest this site has been dry since 1969. The hydrology on this parcel may have changed with the development of the Stateline area or possibly much farther in the past.

Photo 2 – a. Soil sample from 45 inches. Photo 2- b. View of LCC parcel and adjacent IPES parcel (on right) which was part of the original soil investigations.
