STAFF REPORT

Subject: Brodsky Land Capability Challenge, 767 Charles Court, Washoe County, Nevada, Assessor's Parcel Number 125-254-06, TRPA File Number LCAP2022-0219

BAILEY LAND CAPABILITY CHALLENGE FINDINGS

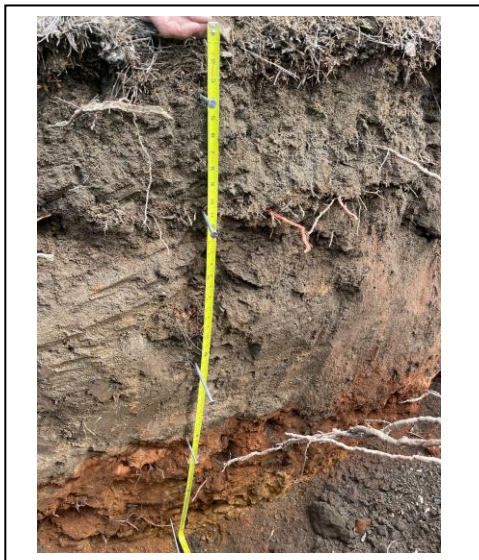
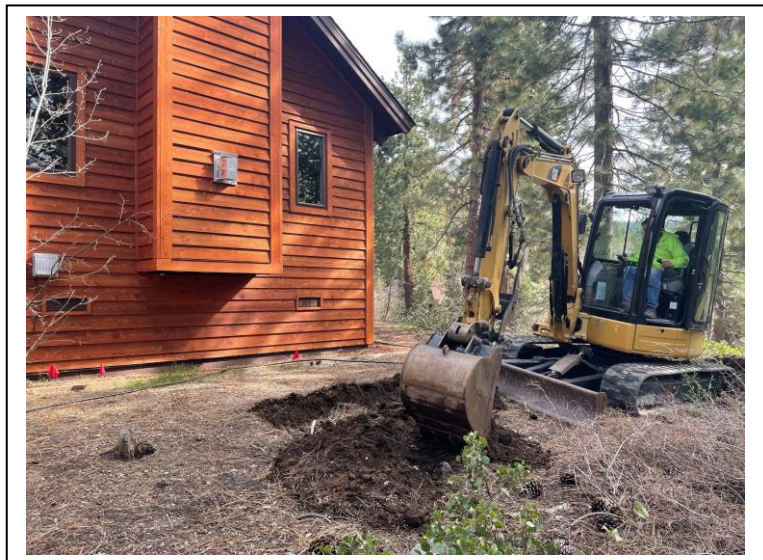
Pit 125-254-06:

Soil Classification: Fine-loamy, isotic, frigid Ultic Haploxeralfs

Soil Series: Tahoma soil, Jwe- Jorge- Tahoma ,very stony sandy loam, 2 to 15 percent slopes, Capability Class 6.

Parent Material: Colluvium from volcanic parent material over volcanic flow deposits.

- Oi 0 to 3 inches; mulch and pine needles; clear smooth boundary.
- A1 3 to 10 inches; coarse sandy loam, very dark grayish brown (10YR 3/2) moist; moderate medium granular structure; soft, very friable, nonsticky and nonplastic; many very fine to fine, and common medium roots; many very fine to fine irregular pores; 5 percent gravels; clear smooth boundary.

- Bt1 10 to 24 inches; coarse sandy loam, very dark grayish brown (10YR 3/2) moist; moderate thick platy structure; moderately hard, firm, nonsticky and nonplastic; many very fine to coarse roots; many very fine to fine irregular pores; common thin clay films bridging sand grains; 5 percent gravel; gradual smooth boundary.

- Bt2 24 to 37 inches; sandy loam, dark brown (7.5YR 3/2) moist; moderate thick platy structure; soft, very friable, slightly sticky and slightly plastic; common very fine to fine roots; many very fine and fine irregular pores; few thin clay films bridging sand grains; 5 percent gravel; clear smooth boundary.

- Bt3 37 to 56 inches; gravelly sandy clay loam, yellowish red (5YR 4/6), reddish brown (5YR 4/4) moist; moderate medium subangular blocky structure; slightly hard, friable, slightly sticky and slightly plastic; many very fine to medium roots; many very fine and fine irregular pores; many thick clay films coating sand grains and on ped faces; 15 percent gravel, 2 percent cobbles and 2 percent stones; gradual smooth boundary.

- Bt4 56 to 63+ inches; gravelly sandy clay loam, strong brown (7.5YR 5/6), brown (7.5YR 4/4) moist; moderate medium subangular blocky structure; slightly hard, friable, slightly sticky and slightly plastic; few fine roots; many very fine and fine irregular pores; many thick clay films coating sand grains and on ped faces; 25 percent gravel, 5 percent cobbles.

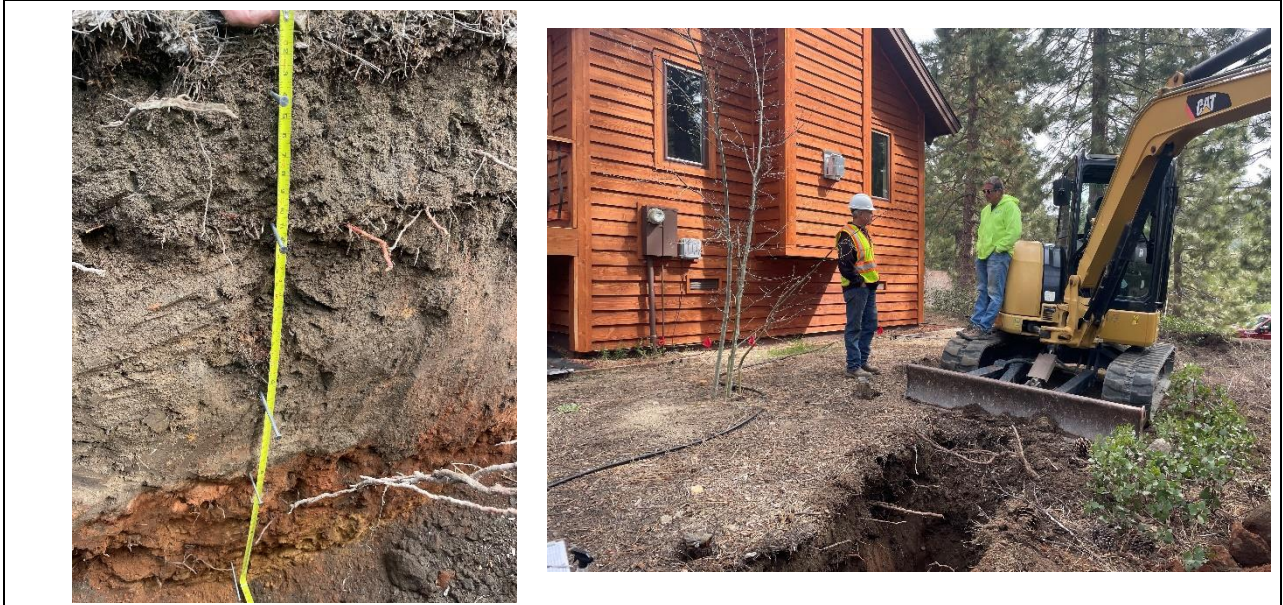
One soil pit was excavated by backhoe to 63 inches. The pit was located approximately 15 feet south of the of the southwest corner of the residence. This parcel is situated on a small, broad, ridge within a concave side slope. The ridge is dry with upland vegetation, but there are areas with willows and wetter vegetation in the swales to either side of the ridge.

The closest stream environment zone (SEZ) is approximately 70 feet north of this parcel in a swale with subsurface flow. The soil pit has distinct layers of volcanic colluvium, over a possible alluvial layer, over reddish volcanic flow deposits. This soil is characterized by a coarse sandy loam surface texture, with coarse sandy loam, sandy loam, and gravelly sandy clay loam subsurface textures. Argillic horizons begin at 10 inches below the surface and continue to the depth of the pit. Below 37 inches is highly weathered, yellowish red volcanic mud flow material. Very fine to medium sized roots are common to 56 inches, with few roots extending to the depth of the pit. This soil is very deep, well drained, and is a member of Soil Hydrologic Group B. The vegetation on this parcel is primarily Jeffrey pine with a few white fir trees and patches of greenleaf manzanita and snowbrush ceanothus in open areas. The groundcover is relatively sparse with sticky cinquefoil, blue-eyed Mary, and other native and landscaped vegetation.

Photo 1 – a. Stop 1 pit. Photo 1- b. View from south of residence looking north east.

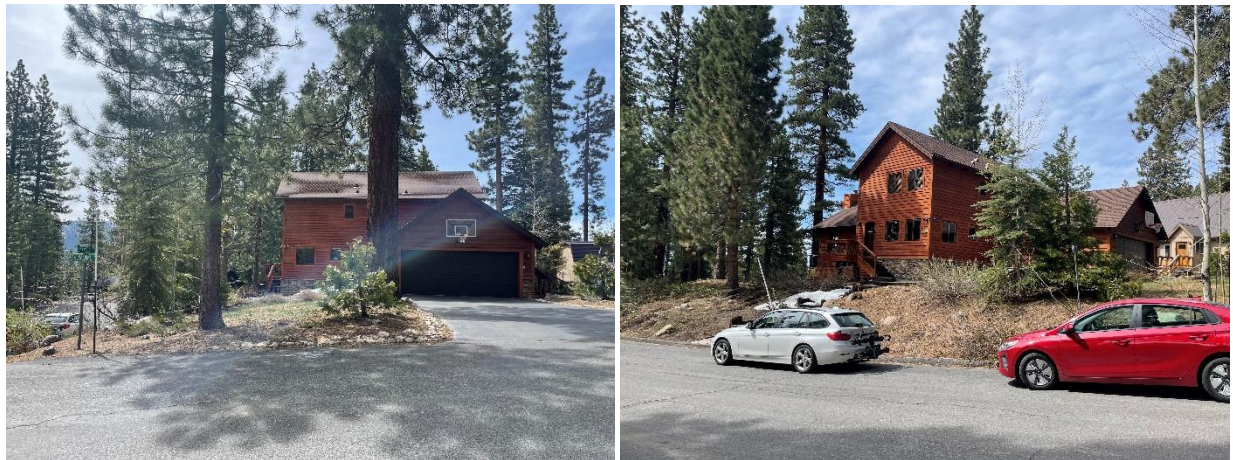
Photo 2 – a. View of house from Geraldine Drive. Photo 2 – b View of house from Charles Court.

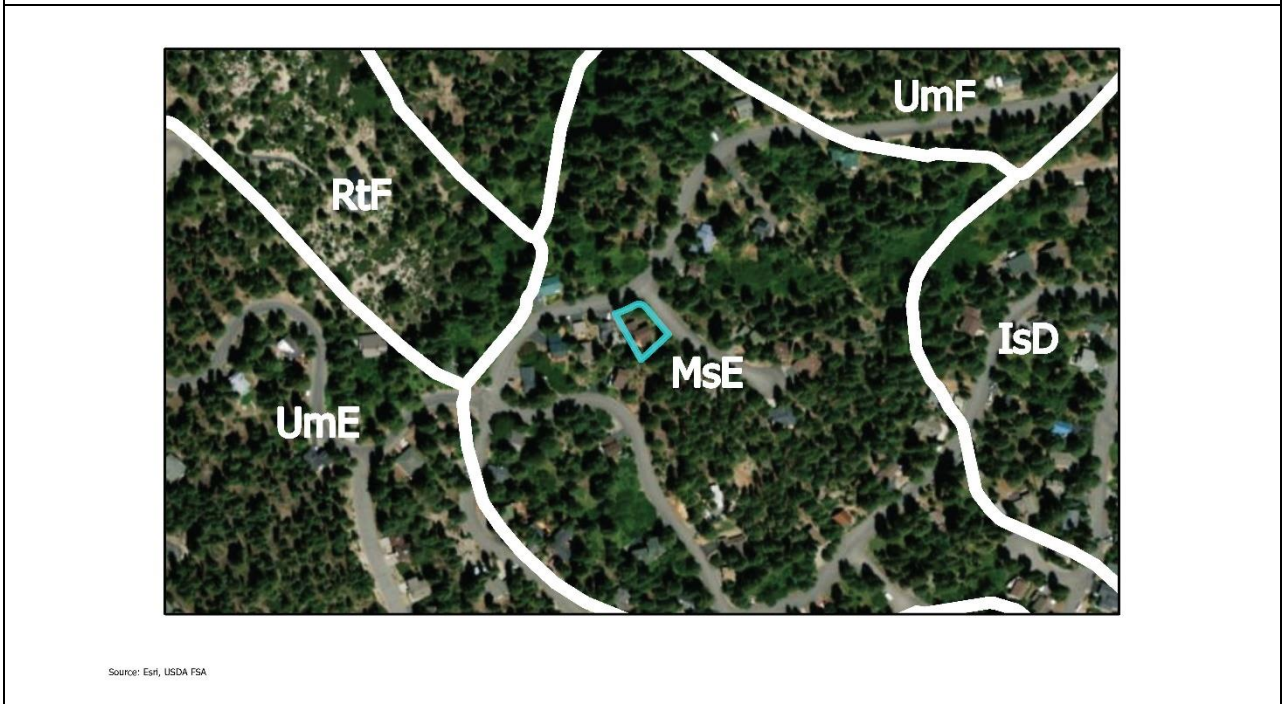
In the Soil Conservation Service *Soil Survey of Tahoe Basin Area, California-Nevada* (Rogers, 1974), the Meeks soils are described as forming primarily in granitic parent material, and the soil on this parcel formed in volcanic parent material. The Meeks soils have greater than 35 percent rock fragments and lack argillic soil development, whereas this soil has less than 35 percent rock fragments, and has an argillic soil development. The Meeks soils have a thin silica cemented layer at depths of 40 to 70 inches, which was not observed in this soil. The Umpa, Jorge and Tahoma soils are mapped in this area and occur on volcanic soils. This soil is dissimilar to the Umpa soil because they are deeper than 40 inches, and dissimilar to the Jorge soils because it has less than 35 percent rock fragments. This soil is within the range and characteristics of the Tahoma soil. Based on the natural slopes of this parcel, it is mapped as JwD- Jorge – Tahoma very stony sandy loam, 2 to 15 percent slope mapunit, land capability Class 6.

Image 4– 1974 Soil Mapping with parcel 125-254-06 shown in blue.
