STAFF REPORT

Subject O’Grady Revocable Trust Land Capability Challenge; 2220 Lands End Drive,
Douglas County, NV; APN 1418-03-401-010, TRPA File Number LCAP2021-0447

BAILEY LAND CAPABILITY CHALLENGE FINDINGS

LAND CAPABILITY CHALLENGE FOR APN 1418-03-401-010
 2220 LANDS END DR., GLENBROOK, DOUGLAS CO., NV
 Owners: Standish & Anne O'Grady (P.O. Box 286, Glenbrook, NV 89413)

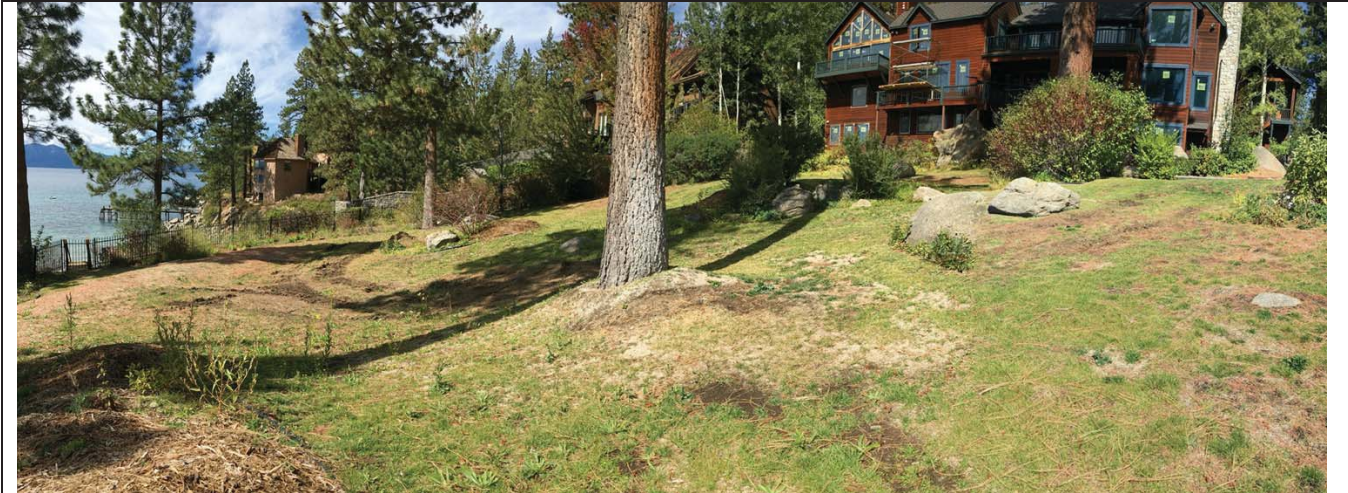
Photo 1 – View west (left) to north (right) of south (lower) part of parcel. The land in this vicinity has shallow soils in the lower part, and deeper soils near the residence. The shallow soils qualify as Class 1A and Class 2. The deeper soils qualify as Class 4 (16 to 30% sl.) and Class 6 (0 to 16% sl.)

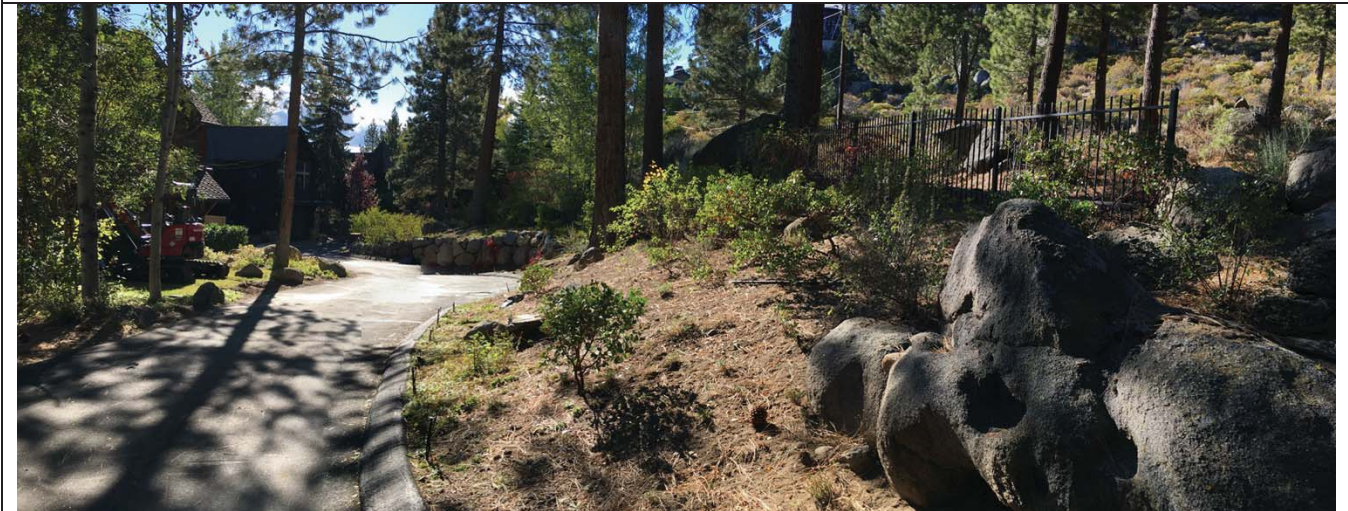
Photo 2 – View west along easement axis that is situated immediately north of residence. The slopes at far right are natural slopes, while graded slopes in the center and left part of photo. Historic slopes estimated by soil consultant using older trees and non-graded surfaces. A nearby soil pit had deep soils that qualified this vicinity as Class 4 (for slopes 16 to 30%).

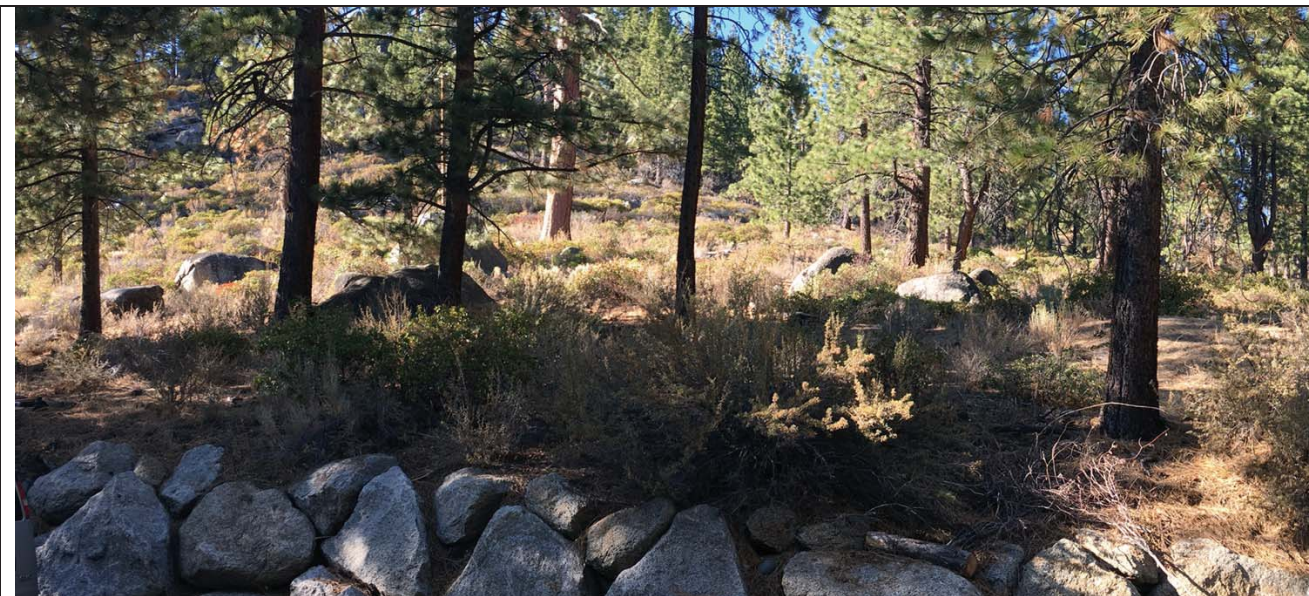
Photo 3 – View north (left) to northeast (right) of hillside above Lands End Road, which dissects the south part of the parcel. Lands above the road have a natural condition, albeit forest fuels treatments. This land is often greater than 30% slopes, which results in Class 1A and Class 2 designations.

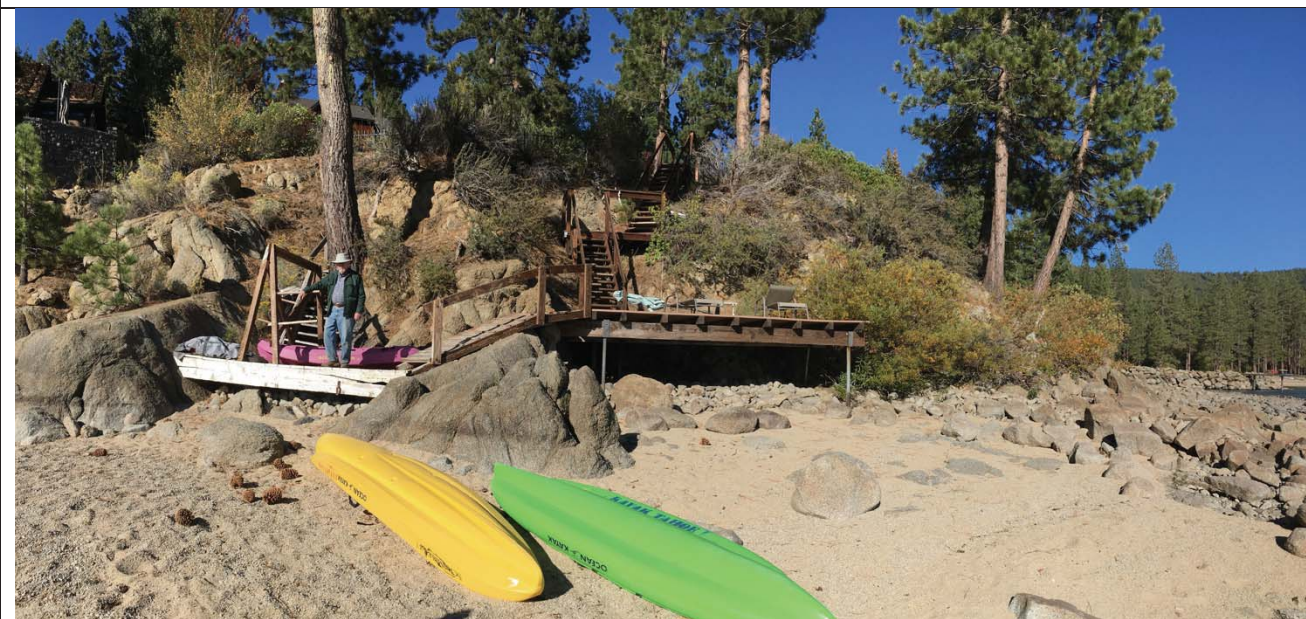
Photo 4 – View northeast at Lake Tahoe shoreline. Rocky bluff adjacent to the lake is partially vegetated, but also has many bedrock exposures. This bluff qualifies as Rock outcrop-Rubble land (Rx) in the 1974 soil survey (Class 1C). Beach area situated below elevation 6229.1 ft., so not included in land cap. challenge.

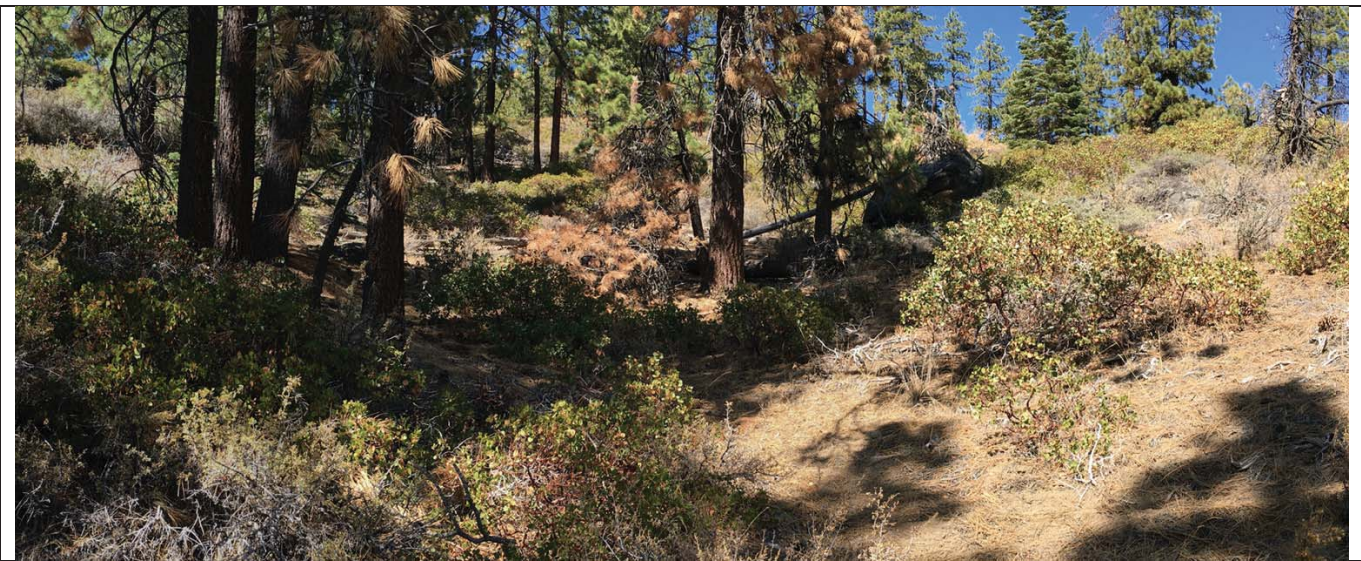
Photo 5 – View northwest (left) to north (right) at hillside near center of property. Typical hillside condition is vegetated with Jeffrey pine, Greenleaf manzanita, bitterbrush and scattered grasses. The hillsides have unchanneled hollows that accumulate eroded sediments, but do not generate runoff.

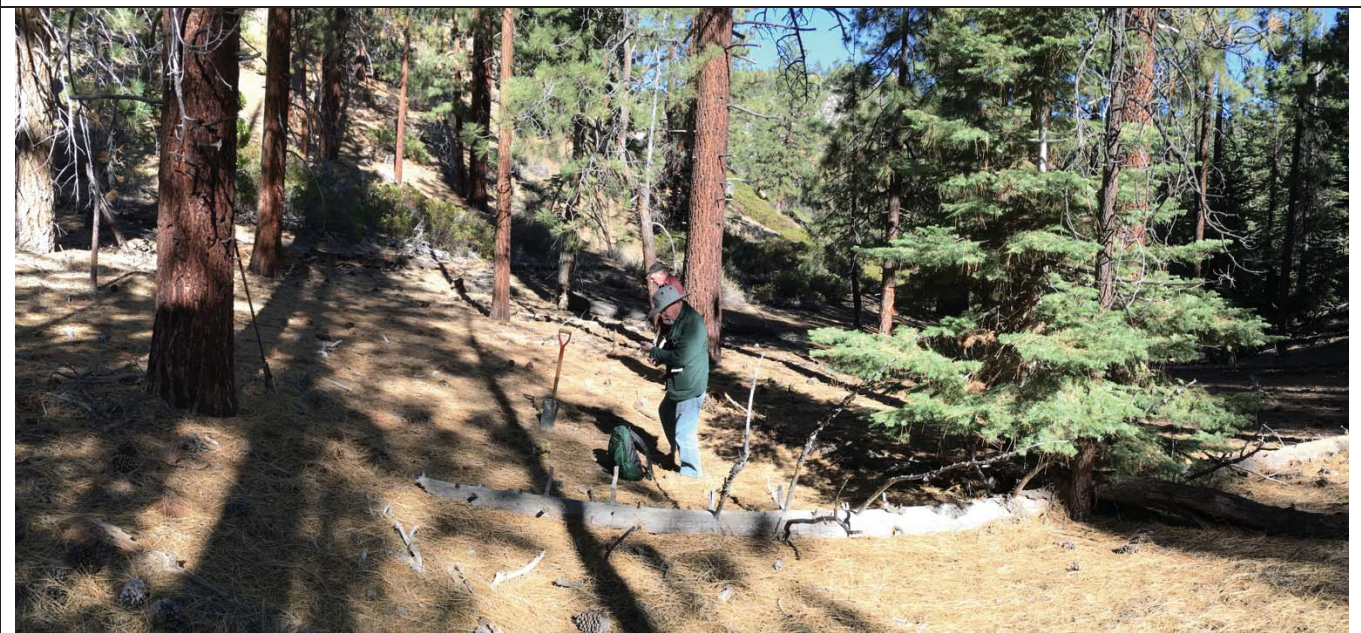
Photo 6 – View northeast (left) to east (right) of small area of Class 6 near the north edge of the subject parcel. The soil auger was able to core to more than 55 inches, and the soil lacks any indication of seasonal high water table. See Photo 10 for profile.

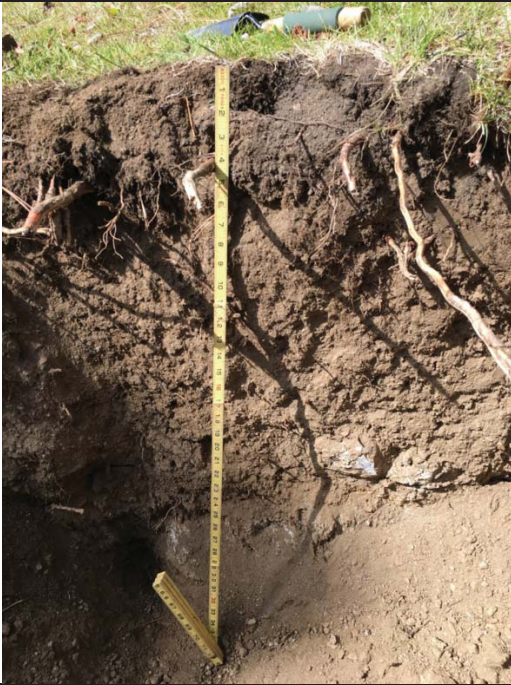
Photo 7 – Close-up view of shallow soil located in south-west part of property (about 125 feet south of residence). Bedrock at approximately 35 inches (Class 1A).

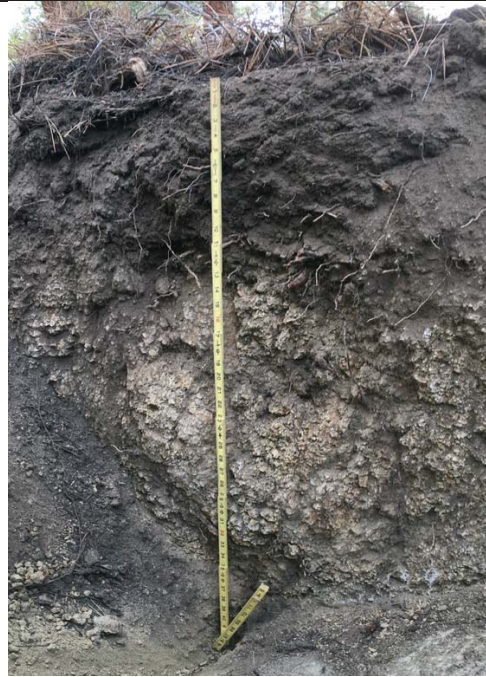
Photo 8 – Close-up view of deep soil with highly weathered bedrock with roots extending deeper than 40 inches.

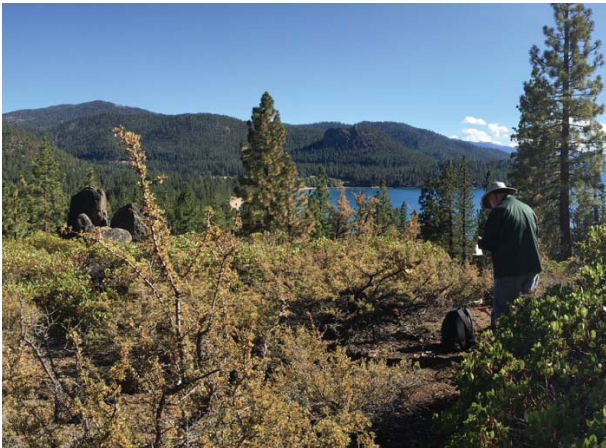
Photo 9. View southwest at hillside knob with very shallow soils that best resemble the Toem series.

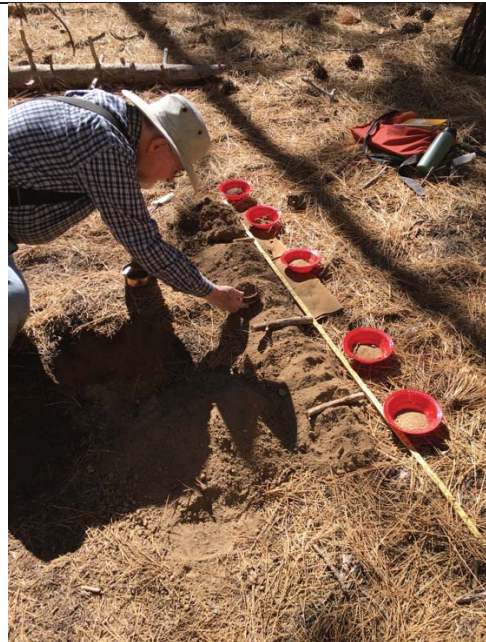
Photo 10. View of soil profile at Pit no. 1 (north part of parcel).

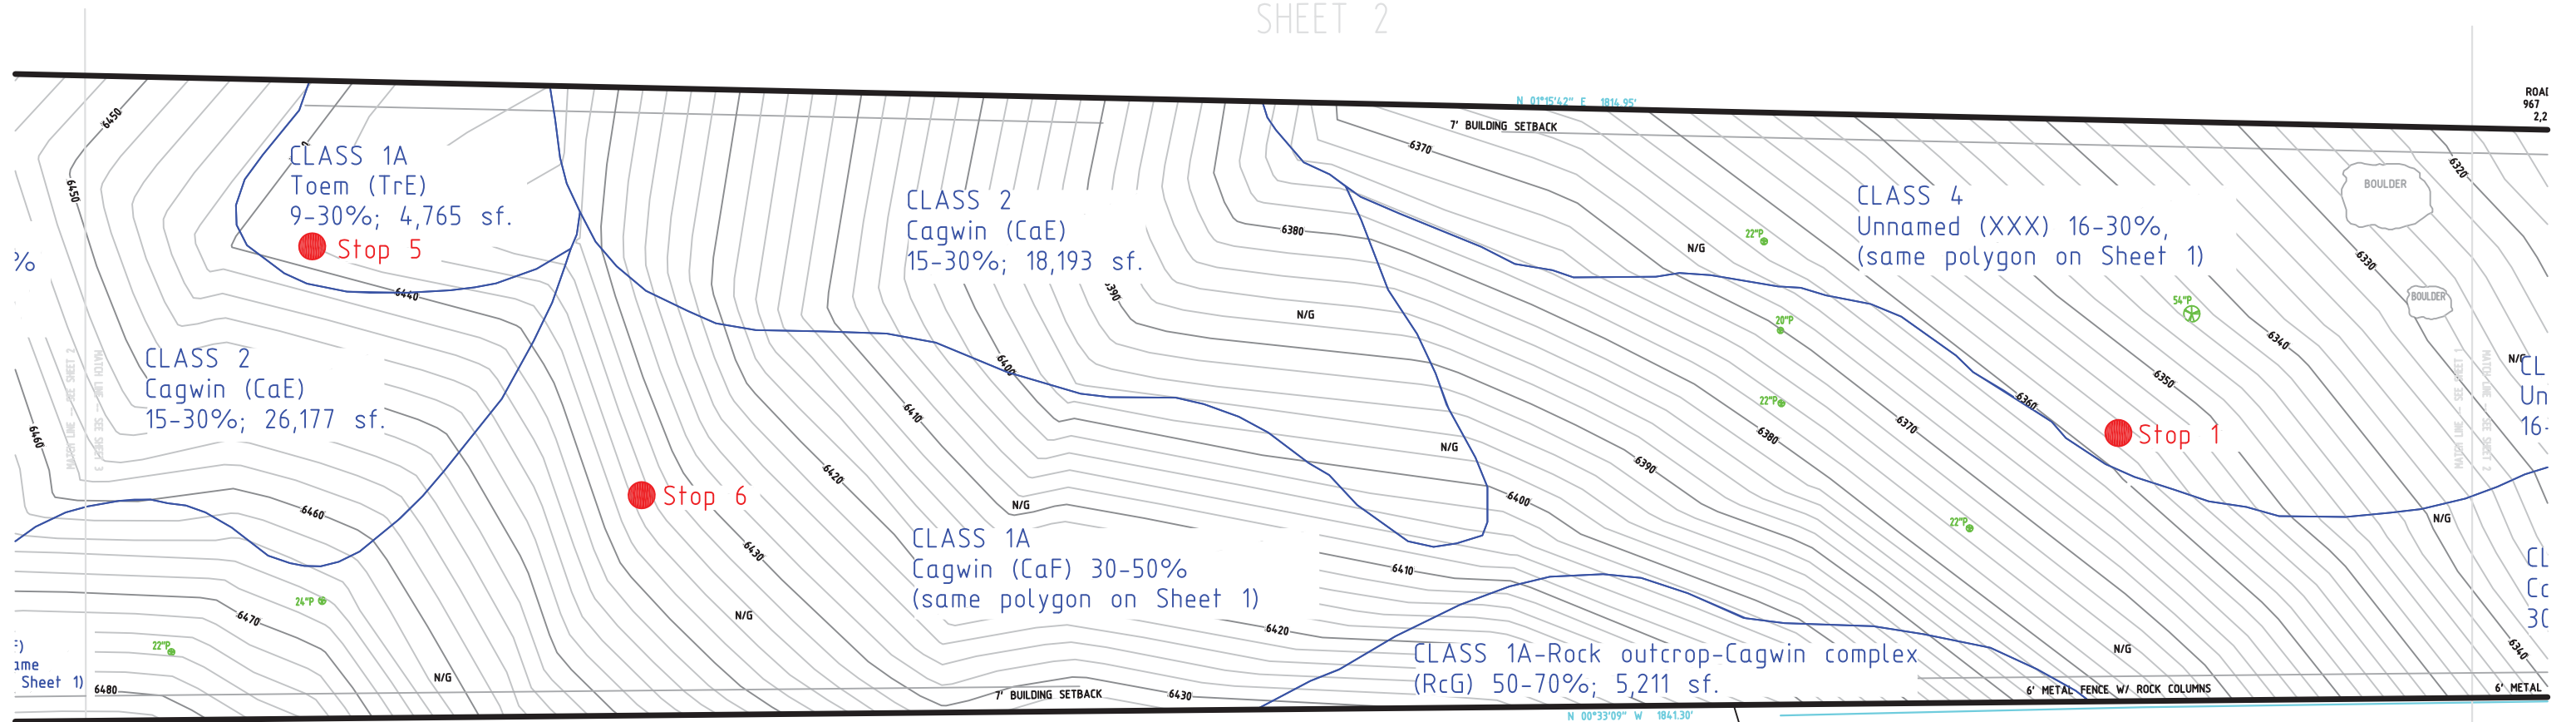
SHEET NO. 2

NOTE: Land Capability Linework Added To Surveyor's Topographic Map;
No Changes To Property Boundaries, Structures or Contour Lines.
Utility and Infrastructure Layers Turned Off to Simplify Exhibit.

307,654 SQUARE FEET (GROSS)
304,425 SQUARE FEET (NET, excludes road easement)
Land Area from Turner & Associates, Inc. topo. survey (June 2021)

The boundaries of the soils we observed are shown in Appendix 1, Sheets 1, 2, and 3.

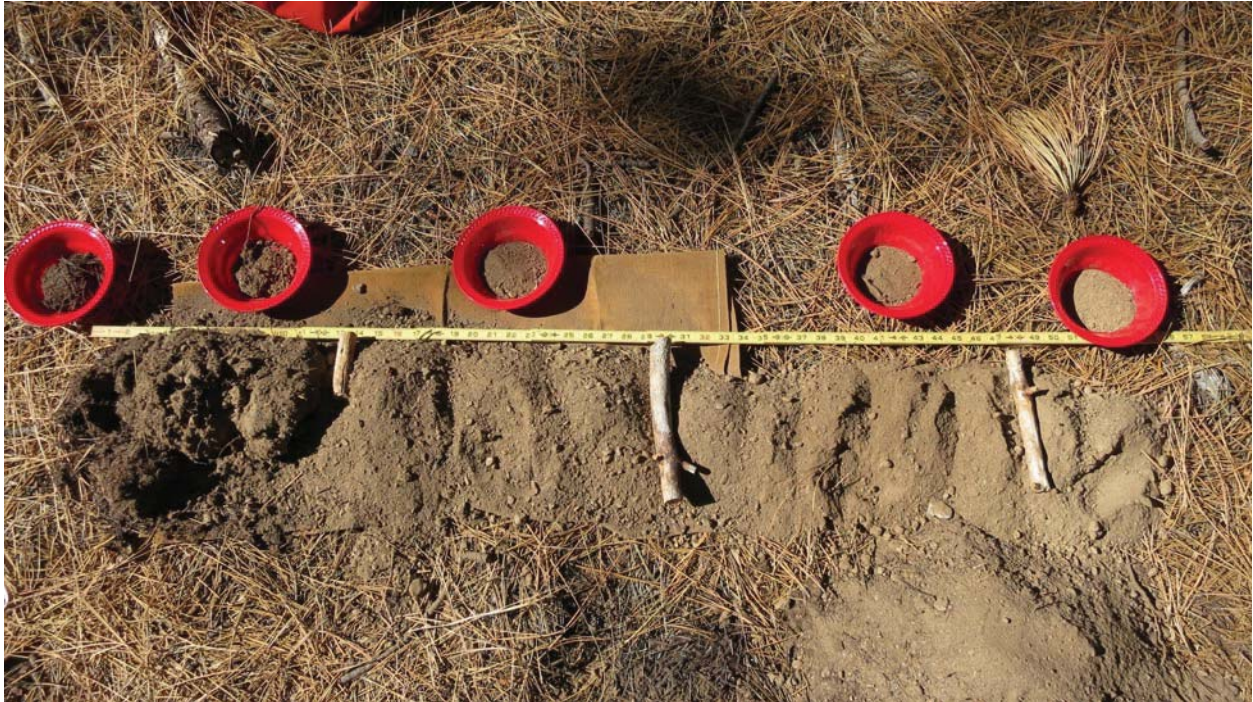
Photo 1. Soil Pit 1, Profile (Depth to bedrock >60 inches)

A—1 to 13 inches; dark grayish brown (10YR 4/2) **gravelly coarse sand**, very dark brown (10YR 2/2) moist; weak, medium and fine granular structure; loose, friable, non-sticky, non-plastic; many fine and common medium roots; common, very fine interstitial pores; 15% fine gravels; gradual smooth boundary.

AB—13 to 34 inches; dark grayish brown (10YR 4/2) **gravelly coarse sand**, very dark brown (10YR 2/2) moist; very weak fine granular structure; loose, friable, non-sticky; non-plastic; very many medium and fine, and common coarse roots; common, very fine interstitial pores; 20% fine gravels; gradual smooth boundary.

Bw—34 to 47 inches; brown (10YR 4/3) **gravelly coarse sand**, very dark grayish brown (10YR 3/2) moist; very weak fine and very fine granular structure; loose, very friable, non-sticky, non-plastic; 22% fine gravels; diffuse smooth boundary.

C—47 to 58 inches; brown (10YR 4/3) **gravelly coarse sand**, dark brown (10YR 3/3) moist; single grain structure; loose, very friable, non-sticky, non-plastic; 15% fine gravels.

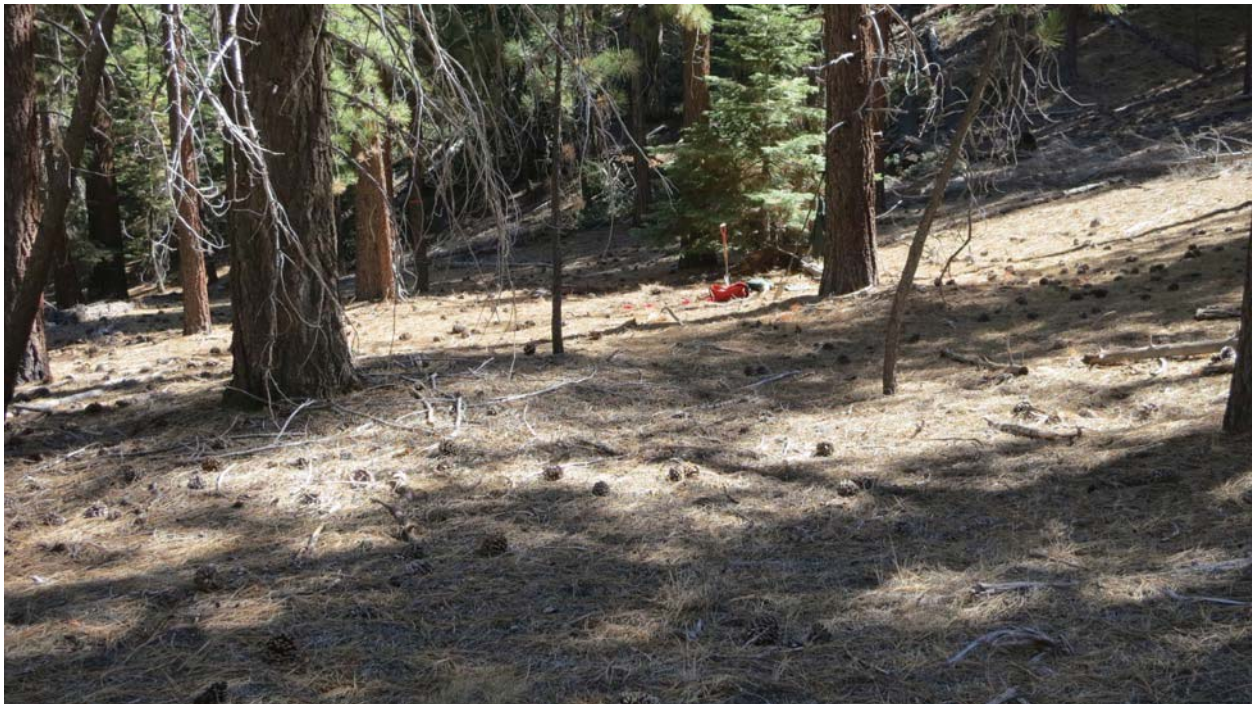
Photo 2. Soil Pit 1, Landscape

North of Lands End Drive, ground cover is about 95 percent in the open shrub areas. In areas with a forest canopy the ground cover is 100 percent with a thick carpet of needles, cones, and twigs (see Appendix 4, photo 2). In the area mapped as Toem (TrE) ground cover is about 80 percent, and the erosion hazard high (see Appendix 4, Photo 12). The very northern part of the parcel that is mapped RcG also has less ground cover. Erosion hazard is moderate to high on slopes less than 30 percent, and very high on the steeper slopes. The many deer trails on the steep sideslopes have disturbed the duff and litter and exposed bare soil.

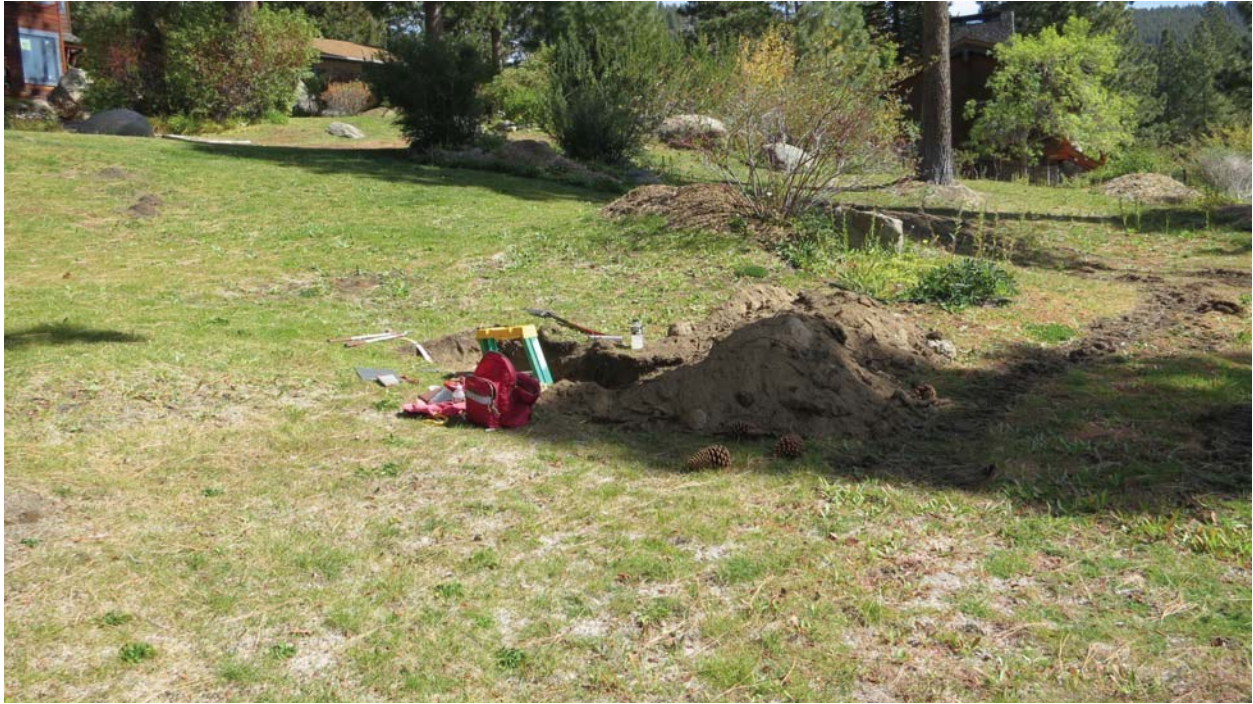
Photo 3. Soil Pit 2, Landscape

Described by Roger Poff on September 29, 2021 from a backhoe pit on aN 18 percent, south-southwest facing slope (196°) at 39°6'3"N, 119°56'58"W. Slope has been landscaped. Somewhat excessively drained. Developed in colluvium weathered from granodiorite. Depth to firm bedrock without root penetration varies from 30 to 38 inches across the site. Profile contains about 25 percent stones 8 to 12 inch in diameter. Vegetation is lawn and landscaping plants with scattered legacy Jeffrey Pine. When described, soil was moist throughout from lawn irrigation. Photos of the soil pit and site are in Appendix 4, page 2.

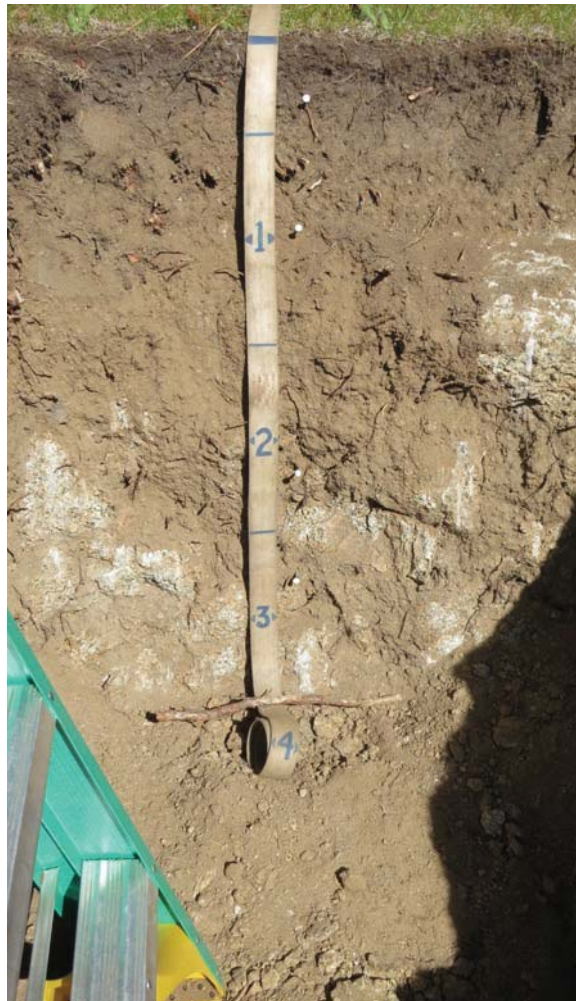
Photo 4. Soil Pit 2, Profile (Weathered bedrock at 32 inches)

Ap—0 to 2 inches; dark grayish brown (10YR 4/2) **sandy loam**, very dark brown (10YR 2/2) moist; moderate fine and very fine granular structure; soft, very friable, slightly-sticky; non-plastic; many fine and very fine, and common medium roots; few fine interstitial pores; 10% fine gravels; pH 7.0; abrupt smooth boundary.

A—2 to 10 inches; brown (10YR 5/3) **loamy sand**, dark brown (10YR 3/3) moist; moderate medium and fine granular structure; soft, very friable, non-sticky, non-plastic; common medium and few fine roots; few fine interstitial pores; 15% fine gravels; pH 6.5; gradual smooth boundary.

Bw—10 to 25 inches; yellowish brown (10YR 5/4) **light loamy sand**, dark yellowish brown (10YR 4/4) moist; moderate medium and fine granular structure; soft, very friable, non-sticky; non-plastic; common medium and few fine and very fine roots; 15% fine gravels; pH 6.5; clear irregular boundary.

C—25 to 32 inches; pale brown (10YR 6/3) **gravelly sand**, dark yellowish brown (10YR 4/4) moist; single grain structure; loose, loose, non-sticky, non-plastic; common medium and very few fine roots; 25% fine gravels; pH 6.0; clear wavy boundary.

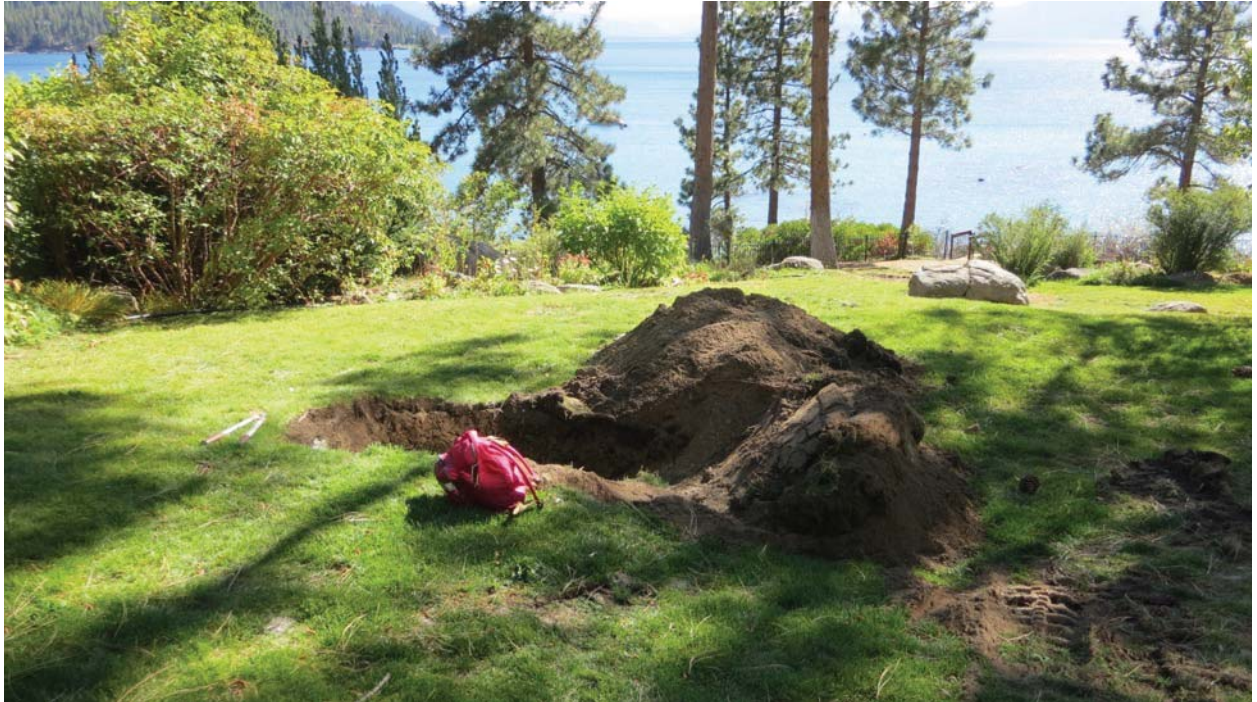
Photo 5. Soil Pit 3, Landscape

Described by Roger Poff on September 29, 2021 from a backhoe pit on a 12 percent, south-facing slope (202°). 39°6'4"N, 119°56'57"W. Slope has been terraced and landscaped. Well-drained. Developed in shoreline colluvium weathered from granodiorite. Vegetation is lawn and landscaping plants. When described the soil was moist throughout from irrigation. The Ap is a mixture of native and 15 percent imported soil and contains one 8-inch imported stone. This

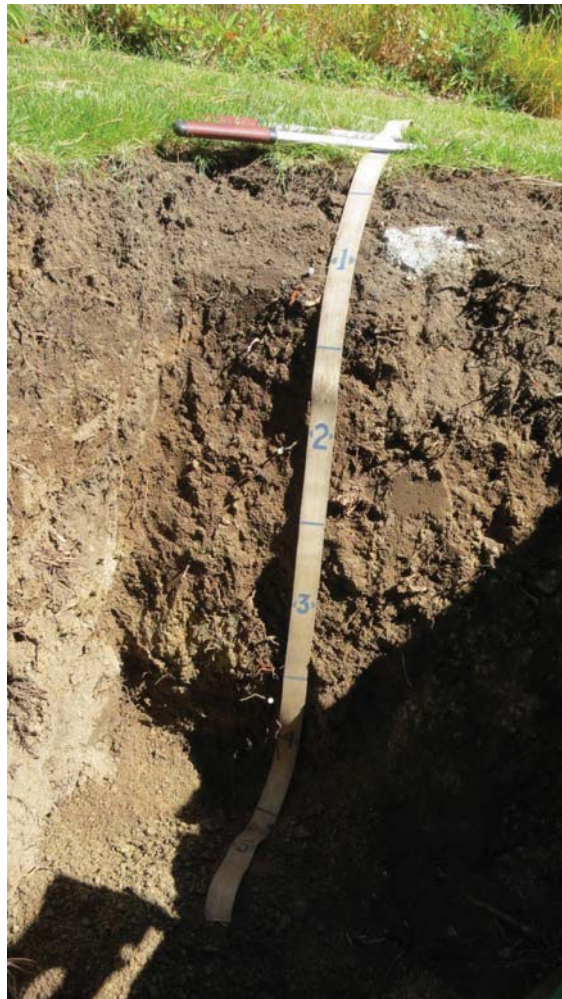
Photo 6. Soil Pit 3, Profile (Depth to weathered bedrock 52 inches)

Ap—0 to 7 inches; dark grayish brown (10YR 4/2) **sandy loam**, very dark grayish brown (10YR 3/2) moist; moderate fine and very fine granular structure; soft, very friable, slightly sticky; non-plastic; very many fine and very fine roots; many fine interstitial pores; 15% fine gravels; pH 7.0; clear smooth boundary.

Bw1—7 to 19 inches; brown (10YR 5/3) **gravelly loamy coarse sand**, dark brown (10YR 3/3) moist; moderate very fine granular structure; soft, very friable, slightly sticky, non-plastic; common medium and fine roots; common, very fine interstitial pores; 25% fine gravels; slightly hydrophobic; pH 6.0; gradual smooth boundary.

Bw2—19 to 38 inches; pale brown (10YR 6/3) **gravelly loamy coarse sand**, dark brown (10YR 4/3) moist; weak fine granular structure; soft, very friable, non-sticky; non-plastic; common medium and fine roots; 30% fine gravels; pH 5.5; clear wavy boundary.

Cr—38 to 52 inches; brown (10YR 5/3) **gravelly loamy coarse sand**, dark brown (10YR 4/3) moist; single grain structure; loose, loose, non-sticky, non-plastic; few fine and very fine roots throughout; 30% fine gravels; pH 5.5; gradual irregular boundary.

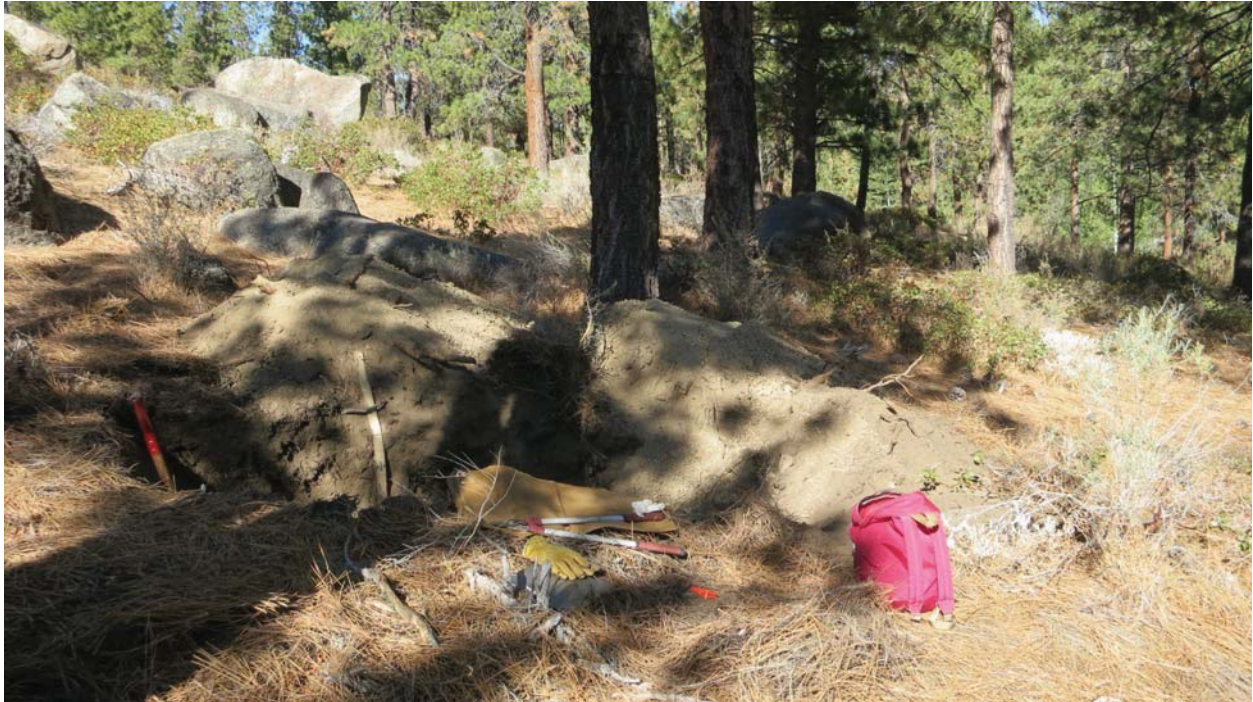
Photo 7. Soil Pit 4, Landscape

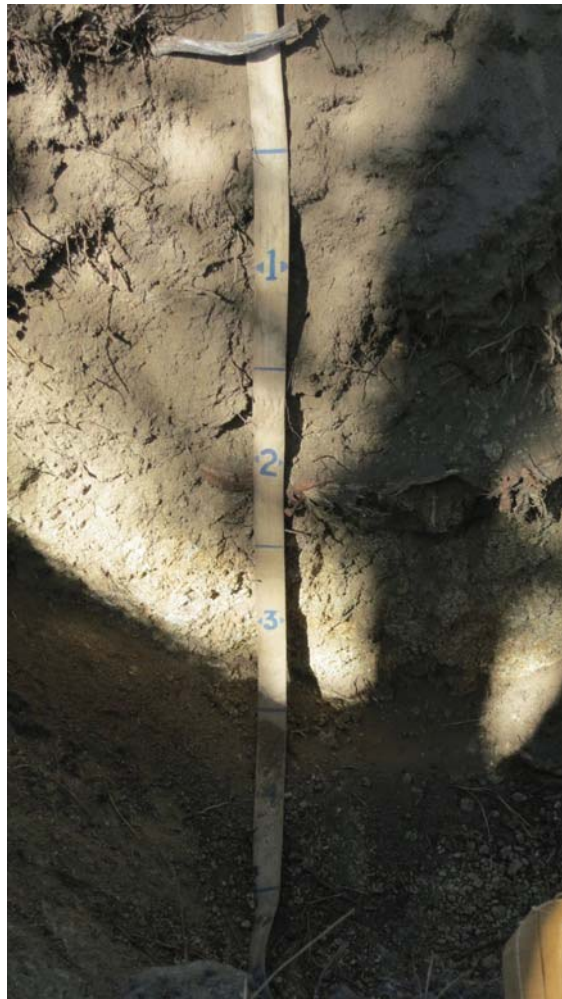
Photo 8. Soil Pit 4, Profile (Depth to weathered bedrock 43 inches)

A—4 to 20 inches; brown (10YR 5/3) **loamy sand**, dark brown (10YR 3/3) moist; very weak fine granular structure; soft, very friable, slightly sticky, non-plastic; common fine and medium, and few coarse roots; horizon is in highly stratified colluvium; 15% fine gravels; pH 7.5; gradual smooth boundary.

Bw—20 to 29 inches; very pale brown (10YR 7/4) **gravelly loamy coarse sand**, brown (10YR 5/3) moist; very weak, very fine granular structure; firm, very friable, slightly sticky, non-plastic; common fine and medium, and few large roots; 20% fine gravels; pH 6.5; gradual wavy boundary.

Cr—29 to 43 inches; pale brown (10YR 6/3) **gravelly coarse sand**, dark brown (10YR 4/3) moist; single grain structure; loose, loose, non-sticky, non-plastic; very few medium and fine roots; 25% fine gravels; pH 6.5; abrupt wavy boundary.

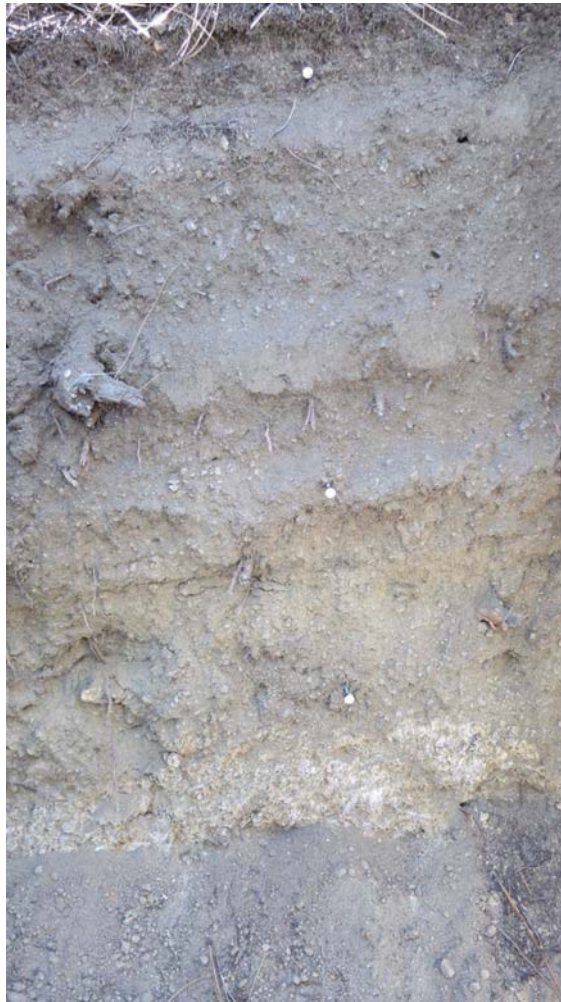
Photo 9. Soil Pit 4, Profile showing stratification in upper horizons

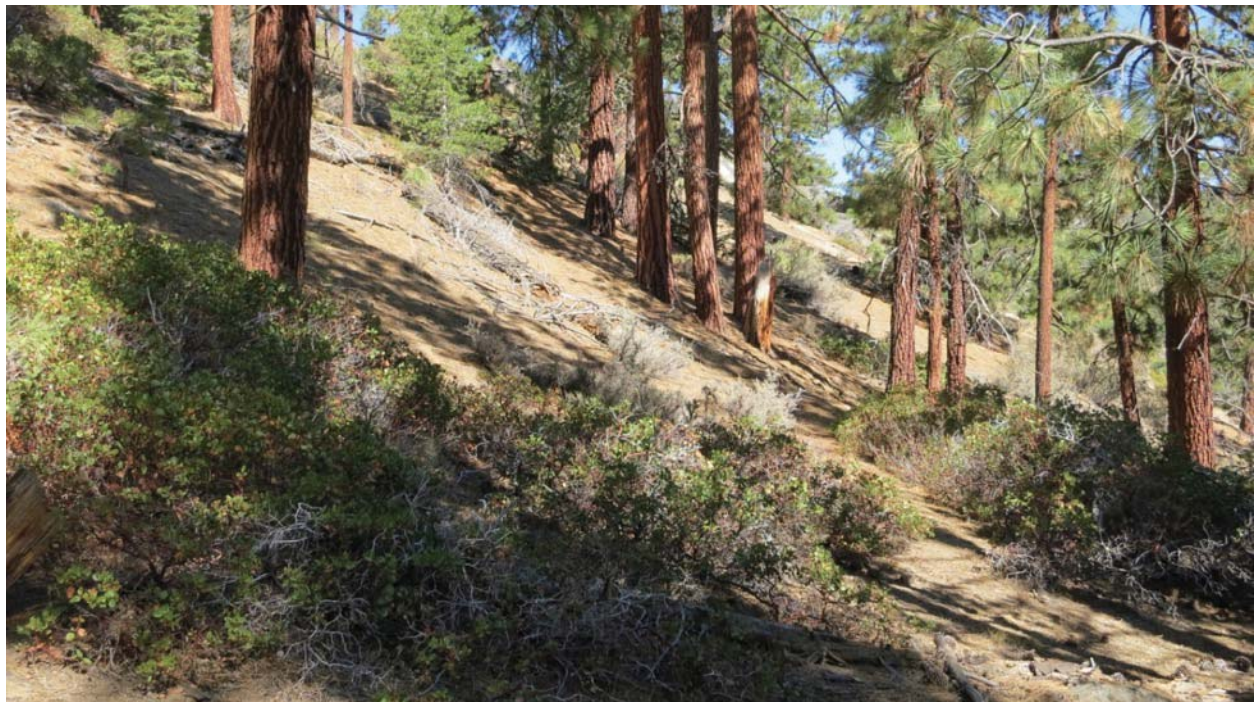
Photo 10. Stop 4, Steep slope not traversed; view to NE

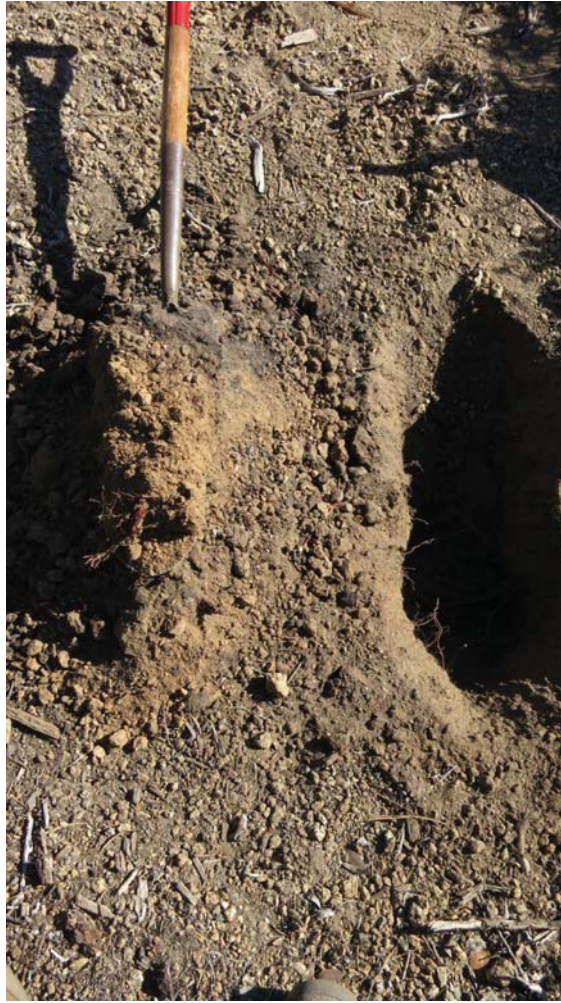
Photo 11. Stop 5, Profile (Toem soil; depth to bedrock 16-18 inches)

- Stop 5 (9-28-21) Toem soil 16-18 inches deep; very dense manzanita and bitterbrush, with scattered saplings and stunted old dwarf white fir and Jeff Pine; 15-20% bare soil in places; Photos 0796-0800; rock outcrop knob to E just outside parcel boundary

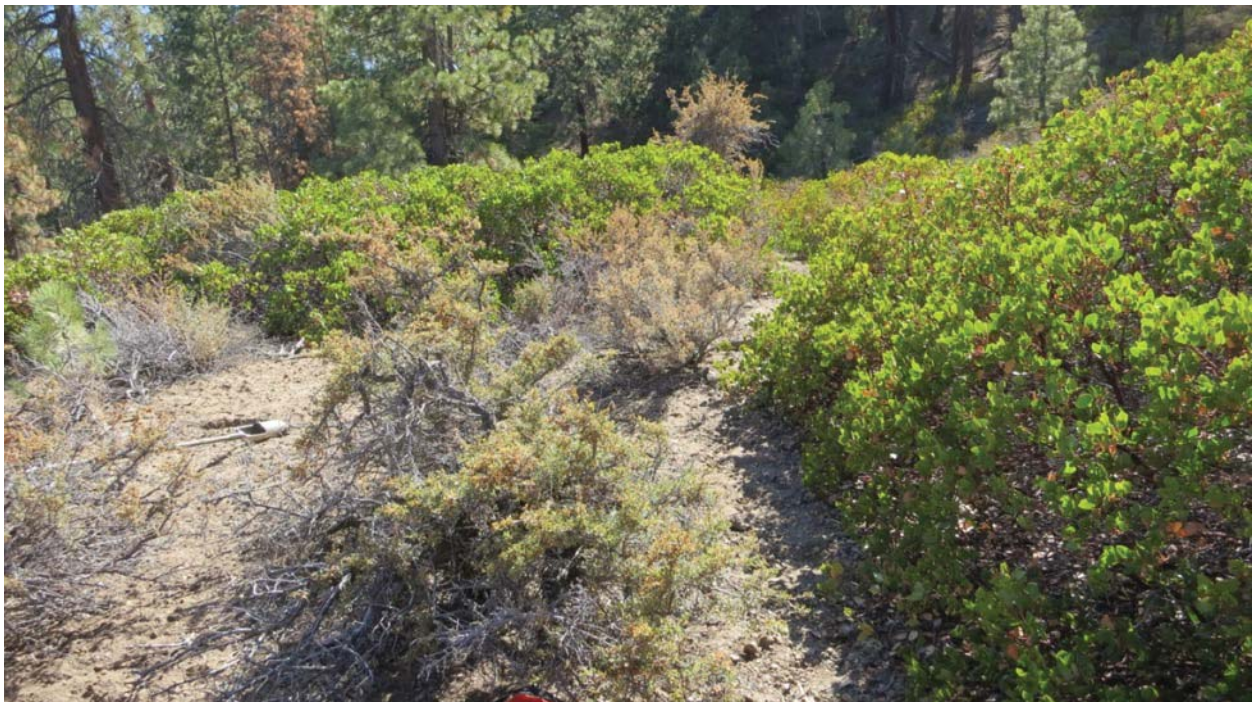
Photo 12. Stop 5, Landscape
