STAFF REPORT

Subject: Deep Blue Trust Land Capability Challenge, 751 Champagne Road, Washoe County, Nevada, Assessor's Parcel Number 126-262-09, TRPA File Number LCAP2021-0420

Land Capability Assessment
For
Washoe APN 126-262-009
751 Champagne Way, Incline Village, NV

Land Capability Challenge
For
Myers Project
751 Champagne Way, Incline Village
Washoe County, Nevada
(APN 126-262-009)

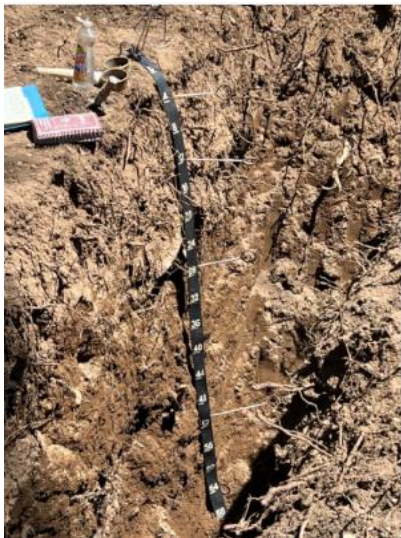
Figure 1 - Stop 1 profile.

Stop No. 1

- Oi 0 – 1 inch, conifer needles, duff and wood chips.
- A1 1 – 4 inches, dark yellowish brown (10YR 3/4) moist; coarse sandy loam; moderate fine granular structure; soft, loose, nonsticky and nonplastic; many very fine and few medium roots; many very fine and fine interstitial pores; fifteen percent gravel; clear smooth boundary.

- A2 4 – 12 inches, dark yellowish brown (10YR 3/4) moist; gravelly sandy loam; moderate medium granular structure; soft, loose, nonsticky and nonplastic; many fine medium roots; many very fine and fine interstitial pores; twenty percent gravel; gradual smooth boundary.

- Bt1 12 – 28 inches, dark yellowish brown (10YR 4/4) moist; gravelly sandy loam; weak fine subangular blocky structure; slightly hard, very friable, slightly sticky and slightly plastic; many fine medium and coarse roots; many fine tubular pores; few thin colloid in bridges between mineral grains; fifteen percent gravel; gradual smooth boundary.

- Bt2 28 – 50 inches, dark yellowish brown (10YR 4/4) moist; gravelly sandy clay loam; moderate medium subangular blocky structure; slightly hard, very friable, sticky and plastic; common fine medium coarse roots; many fine tubular pores; common thin colloid in bridges between mineral grains; twenty percent gravel; gradual smooth boundary.

- 2Bt3 50 – 65 inches; dark yellowish brown (10YR 4/6) moist; very gravelly coarse sandy loam; moderate medium angular blocky structure; hard, friable, sticky and plastic; few fine medium roots; common fine tubular pores; common medium thick clay films on face of peds and line pores; forty percent gravel.

Notes: Buried surface below 50 inches. HSG B.

Soil Series: Tahoma

Soil Classification: Fine-loamy, mixed, frigid, Ultic Haploxeralfs

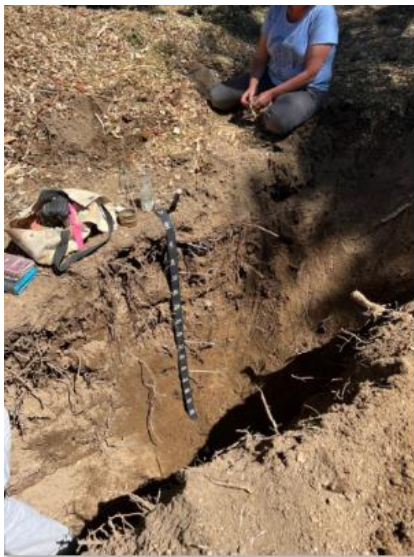
Figure 3 - Stop 2 profile.

Stop No. 2

- Oi 0 – 1 inches, Conifer needles and duff.
- A1 1 – 4 inches, dark yellowish brown (10YR 4/4) moist; gravelly coarse sandy loam; strong medium granular structure; soft, loose, nonsticky and nonplastic; common very fine and fine roots; many very fine and fine interstitial pores; medium acid; fifteen percent gravel; clear smooth boundary.

- A2 4 – 10 inches, dark yellowish brown (10YR 4/4) moist; gravelly coarse sandy loam; moderate medium subangular blocky structure; soft, loose, nonsticky and nonplastic; many fine medium and few coarse roots; many very fine and fine interstitial pores; medium acid; twenty percent gravel; clear wavy boundary.

- Bt1 10 – 30 inches, dark yellowish brown (10YR 4/4) moist; gravelly sandy clay loam near clay loam; moderate medium subangular blocky structure; slightly hard, very friable; slightly sticky and slightly plastic; common fine medium coarse roots; common fine medium tubular pores; common thin clay films occur on faces of peds and colloid in bridges between mineral grains; slightly acid; thirty percent gravel; clear wavy boundary.

- Bt2 30 – 42 inches, dark yellowish brown (10YR 4/4) moist; gravelly clay loam; strong medium subangular blocky structure; hard, friable, sticky and plastic; common fine medium and few coarse roots; common fine medium tubular pores; many medium thick clay films on face of peds and line pores; slightly acid; twenty percent gravel; clear smooth boundary.
- 2Bt3 42 – 60 inches, olive brown (2.5Y 4/4) moist; very gravelly sandy clay loam; strong medium angular blocky structure; hard, friable, sticky and plastic; few fine medium coarse roots; few fine medium tubular pores; many medium thick clay films on face of peds and line pores; slightly acid; forty percent gravel.

Note: Thick clay films at base.

Soil Series: Tahoma

Soil Classification: Fine-loamy, mixed, frigid, Ultic Haploxeralfs

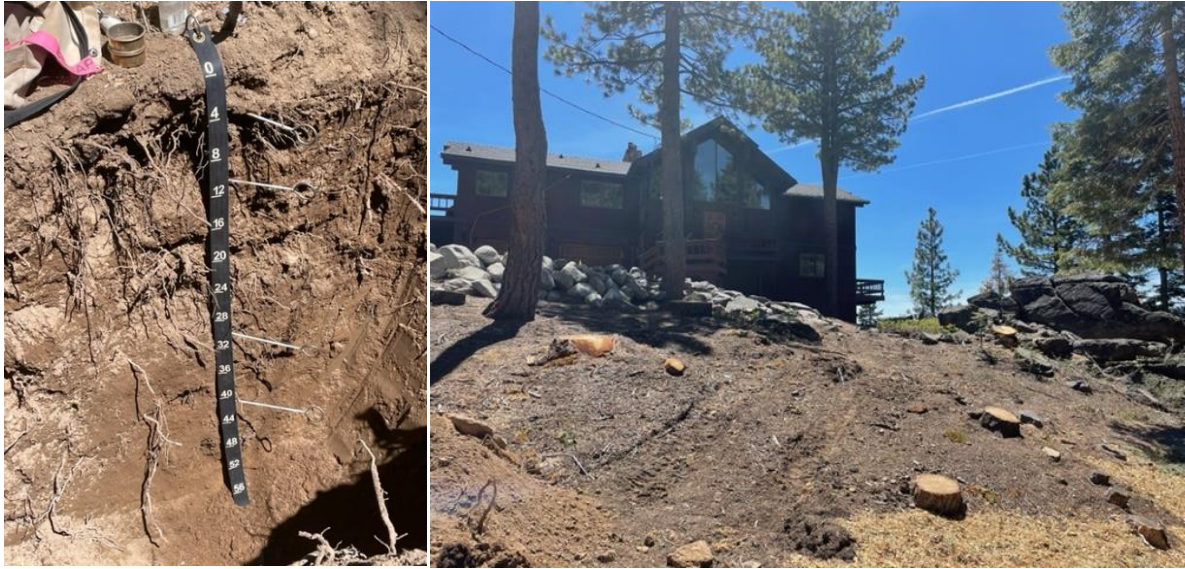
Two soil pits were excavated by backhoe to 65 and 60 inches. Site 1 was located approximately 4 feet north of the driveway and northeast of the residence. Site 2 was located approximately 22 feet south of the driveway on the southeast corner of the parcel. The soils at the two pits are very similar. They formed in colluvium and residuum from volcanic parent material. The soil at Site 1 is characterized by a coarse sandy loam surface texture, with gravelly sandy loam, very gravelly sandy clay loam, and very gravelly coarse sandy loam subsurface textures. Hard or weathered bedrock was not encountered in the pit. This soil has argillic horizons beginning at 12 inches and is classified as a Fine-loamy, mixed, frigid, Ultic Haploxeralfs. This soil is very deep, well drained, and is a member of Soil Hydrologic Group B. The soil at Site 2 is characterized by a gravelly coarse sandy loam surface texture, with gravelly coarse sandy loam, gravelly sandy clay loam, gravelly clay loam subsurface textures. Hard or weathered bedrock was not encountered in the pit. This soil is non-skeletal with argillic horizons beginning at 10 inches. This soil is classified as a Fine-loamy, mixed, frigid, Ultic Haploxeralfs. This soil is very deep, well drained, and is a member of Soil Hydrologic Group B. The vegetation in this upper area an open forest of Jeffrey pine, red fir and huckleberry oak.

Photo 1 – a. Site 1 pit. Photo 1- b. Site 1 looking west toward residence.

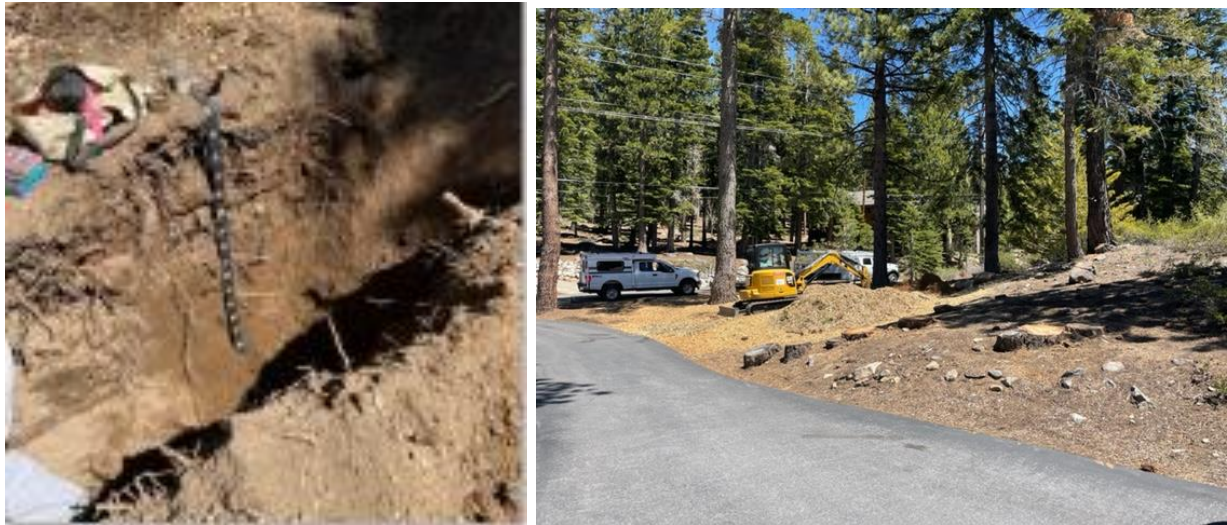
Photo 2 – a. Site 2 pit. Photo 2- b. From road looking south toward Site 2 area.
