STAFF REPORT

Date: :	March 31, 2022
То:	TRPA Hearings Officer
From:	TRPA Staff
Subject	Eget Land Capability Challenge; 45 East Tuscarora Road, Washoe County, NV; APN 123-136-02, TRPA File Number LCAP2020-0422

Land Capability Challenge Eget Project Incline Village, Nevada APN 125-136-02

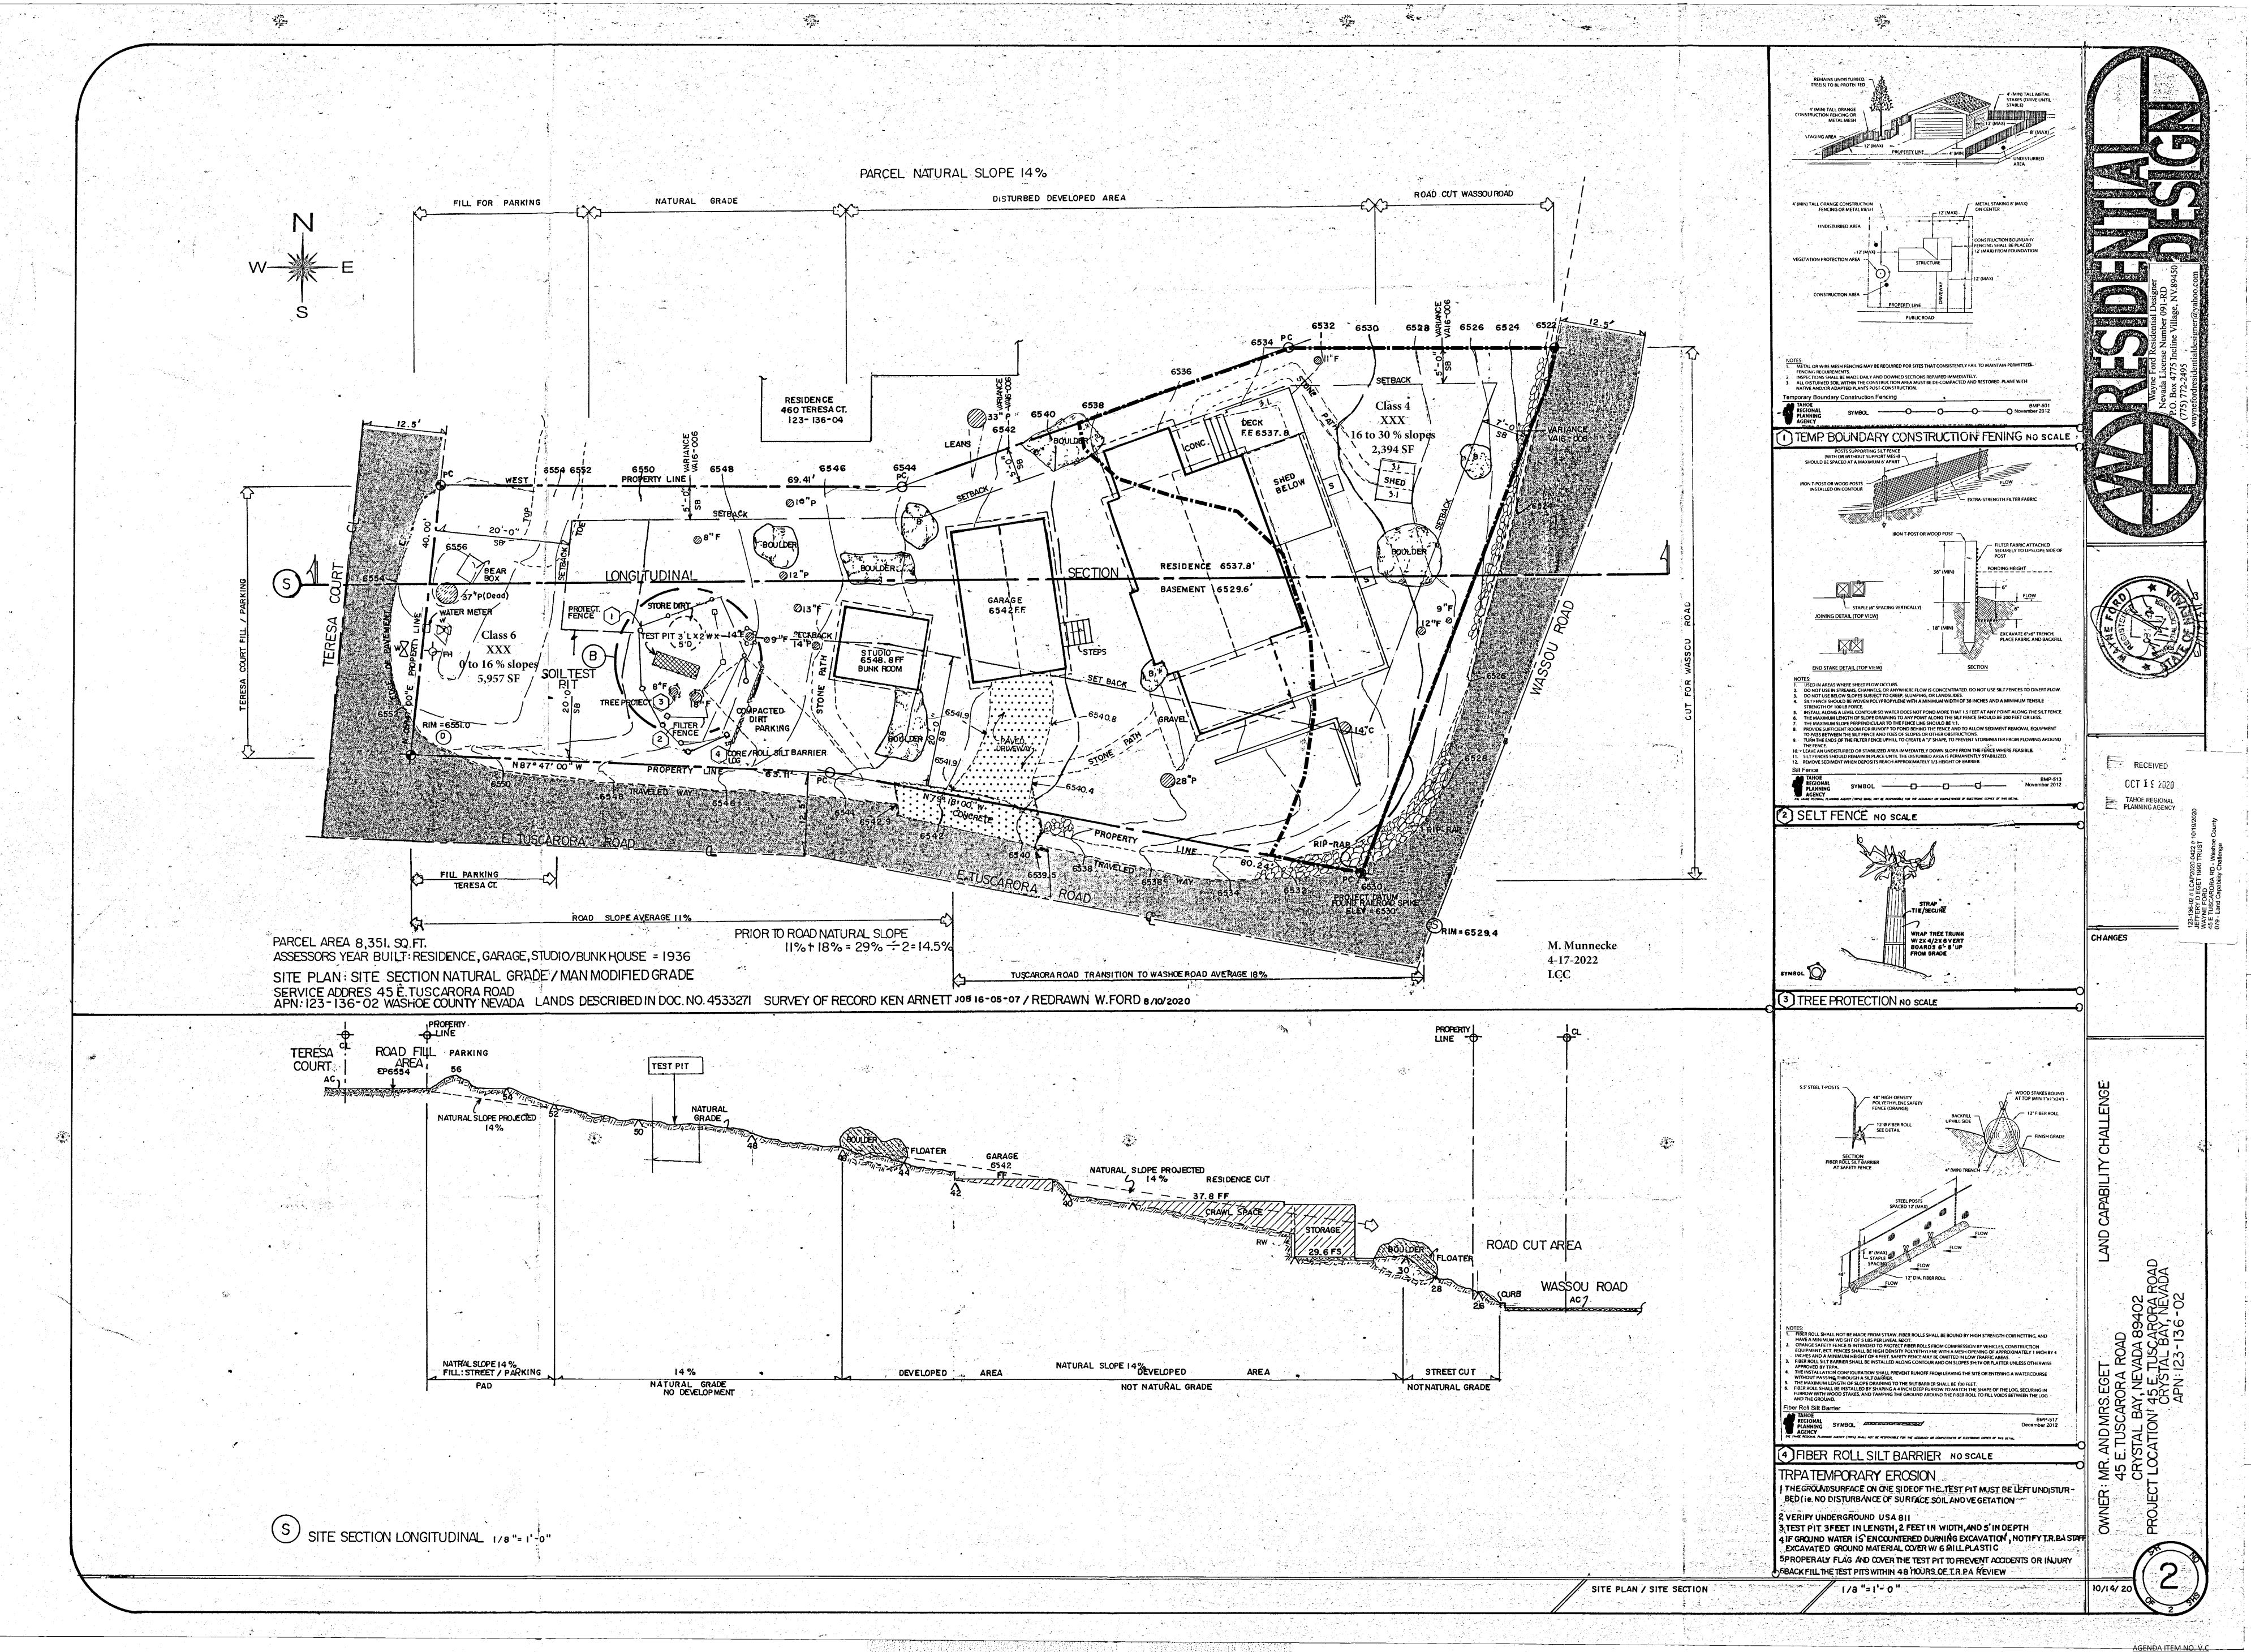
Attachment A

Site Plan with Proposed TRPA Land Capability Delineations

Staff recommends the TRPA Hearings Officer approve the land capability challenge on the subject parcel. The challenge changes Class 1a (RcF, 30 to 50 percent slopes and RtF, 30 to 50 percent slopes) 8,351 sq. ft. (100 percent of parcel) to Class 4 (XXX, 16 to 30 percent slopes) 2,394 sq. ft. (29 percent of parcel) and Class 6 (XXX, 0 to 16 percent slopes) 5,957 sq. ft. (71 percent of parcel).

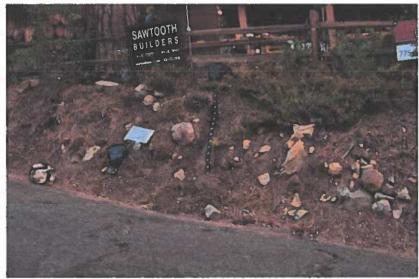
Figure 2 - Road cut on E. Tuscarora Road

A spot observation was taken by Davis² Consulting near the south east corner of the parcel. Ms. Munnecke observed the small road cut in this area, and it indicates that the soil is similar to the soil described in the pit and is also deeper than 40 inches in this area.

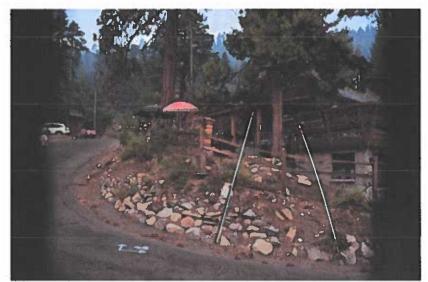
Figure 3 - Landscape looking west from intersection of Wassou and Tuscarora Roads.

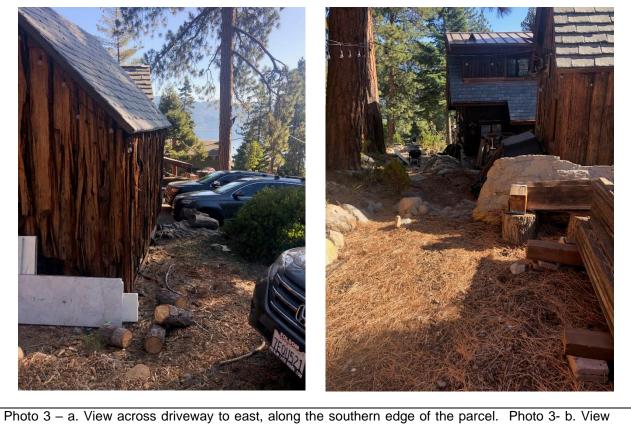
Photo 3 - a. View across driveway to east, along the southern edge of the parcel. Photo 3- b. View looking east along north boundary of parcel.

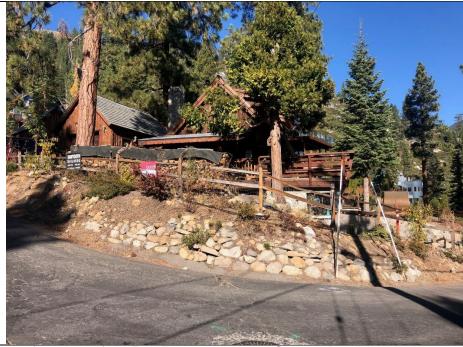
Photo 4- a. View of residence from East Tuscoara Ave and Goshute Road Junction.

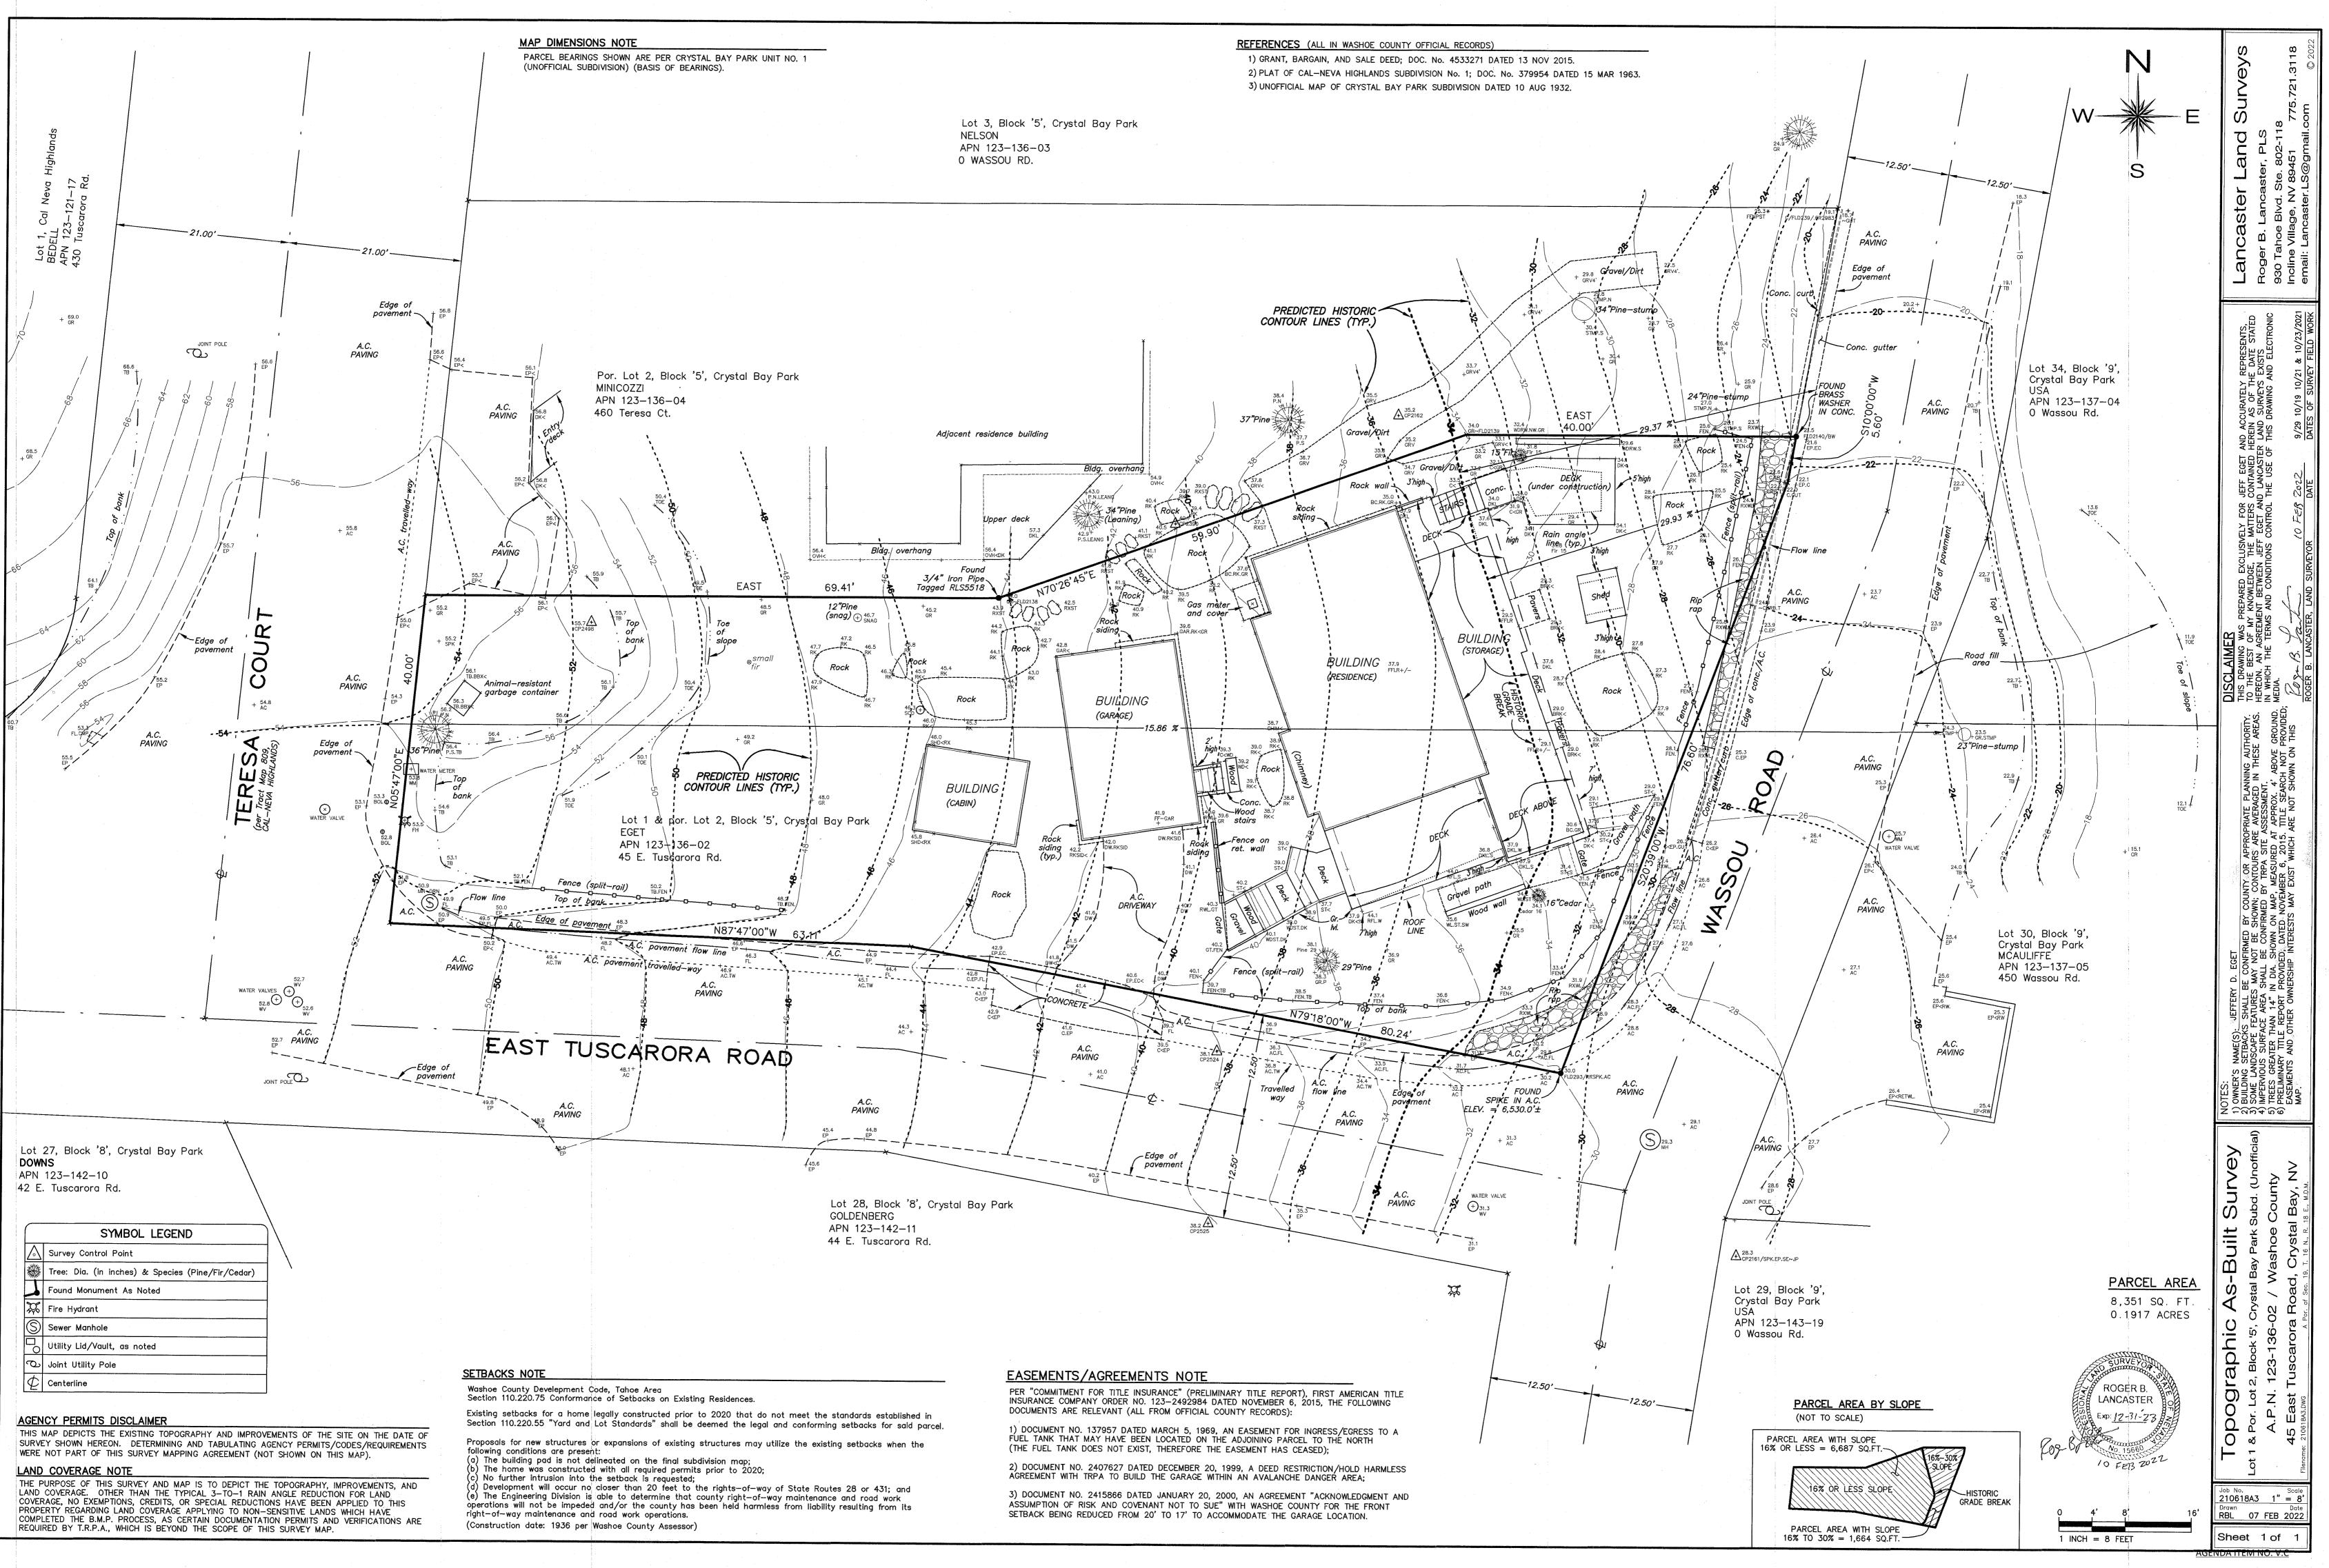
Attachment D

Topo with proposed natural slopes provided by applicant

Since the last hearing, the applicant hired a surveyor to produce a new map of the parcel that has topographic contour lines extending beyond the parcel boundary. The applicant then infers natural slope based on slope contours that presumably represent the natural slopes based on undisturbed slopes (See Attachment D). At the request of Mr. Ford, this information was reviewed. TRPA is in partial agreement with the applicant but concludes that a portion of the area proposed as Class 6 by the applicant, has slopes greater than 16 percent on the natural slope analysis submitted by the applicant and remains Class 4 (Attachment E). Based on the new information provided, TRPA staff has again adjusted the land capability delineations to account for the assumed natural slope and now proposes 5,957 square feet of Class 6 and 2,394 square feet of Class 4. TRPA staff still does not believe there is sufficient evidence that the center of the parcel was historically less than 16 percent slope (the topographic survey submitted by the applicant shows slopes measuring between 15.2 percent and 16.5 percent and existing slopes measuring between 17 and 22 percent- Attachment E).

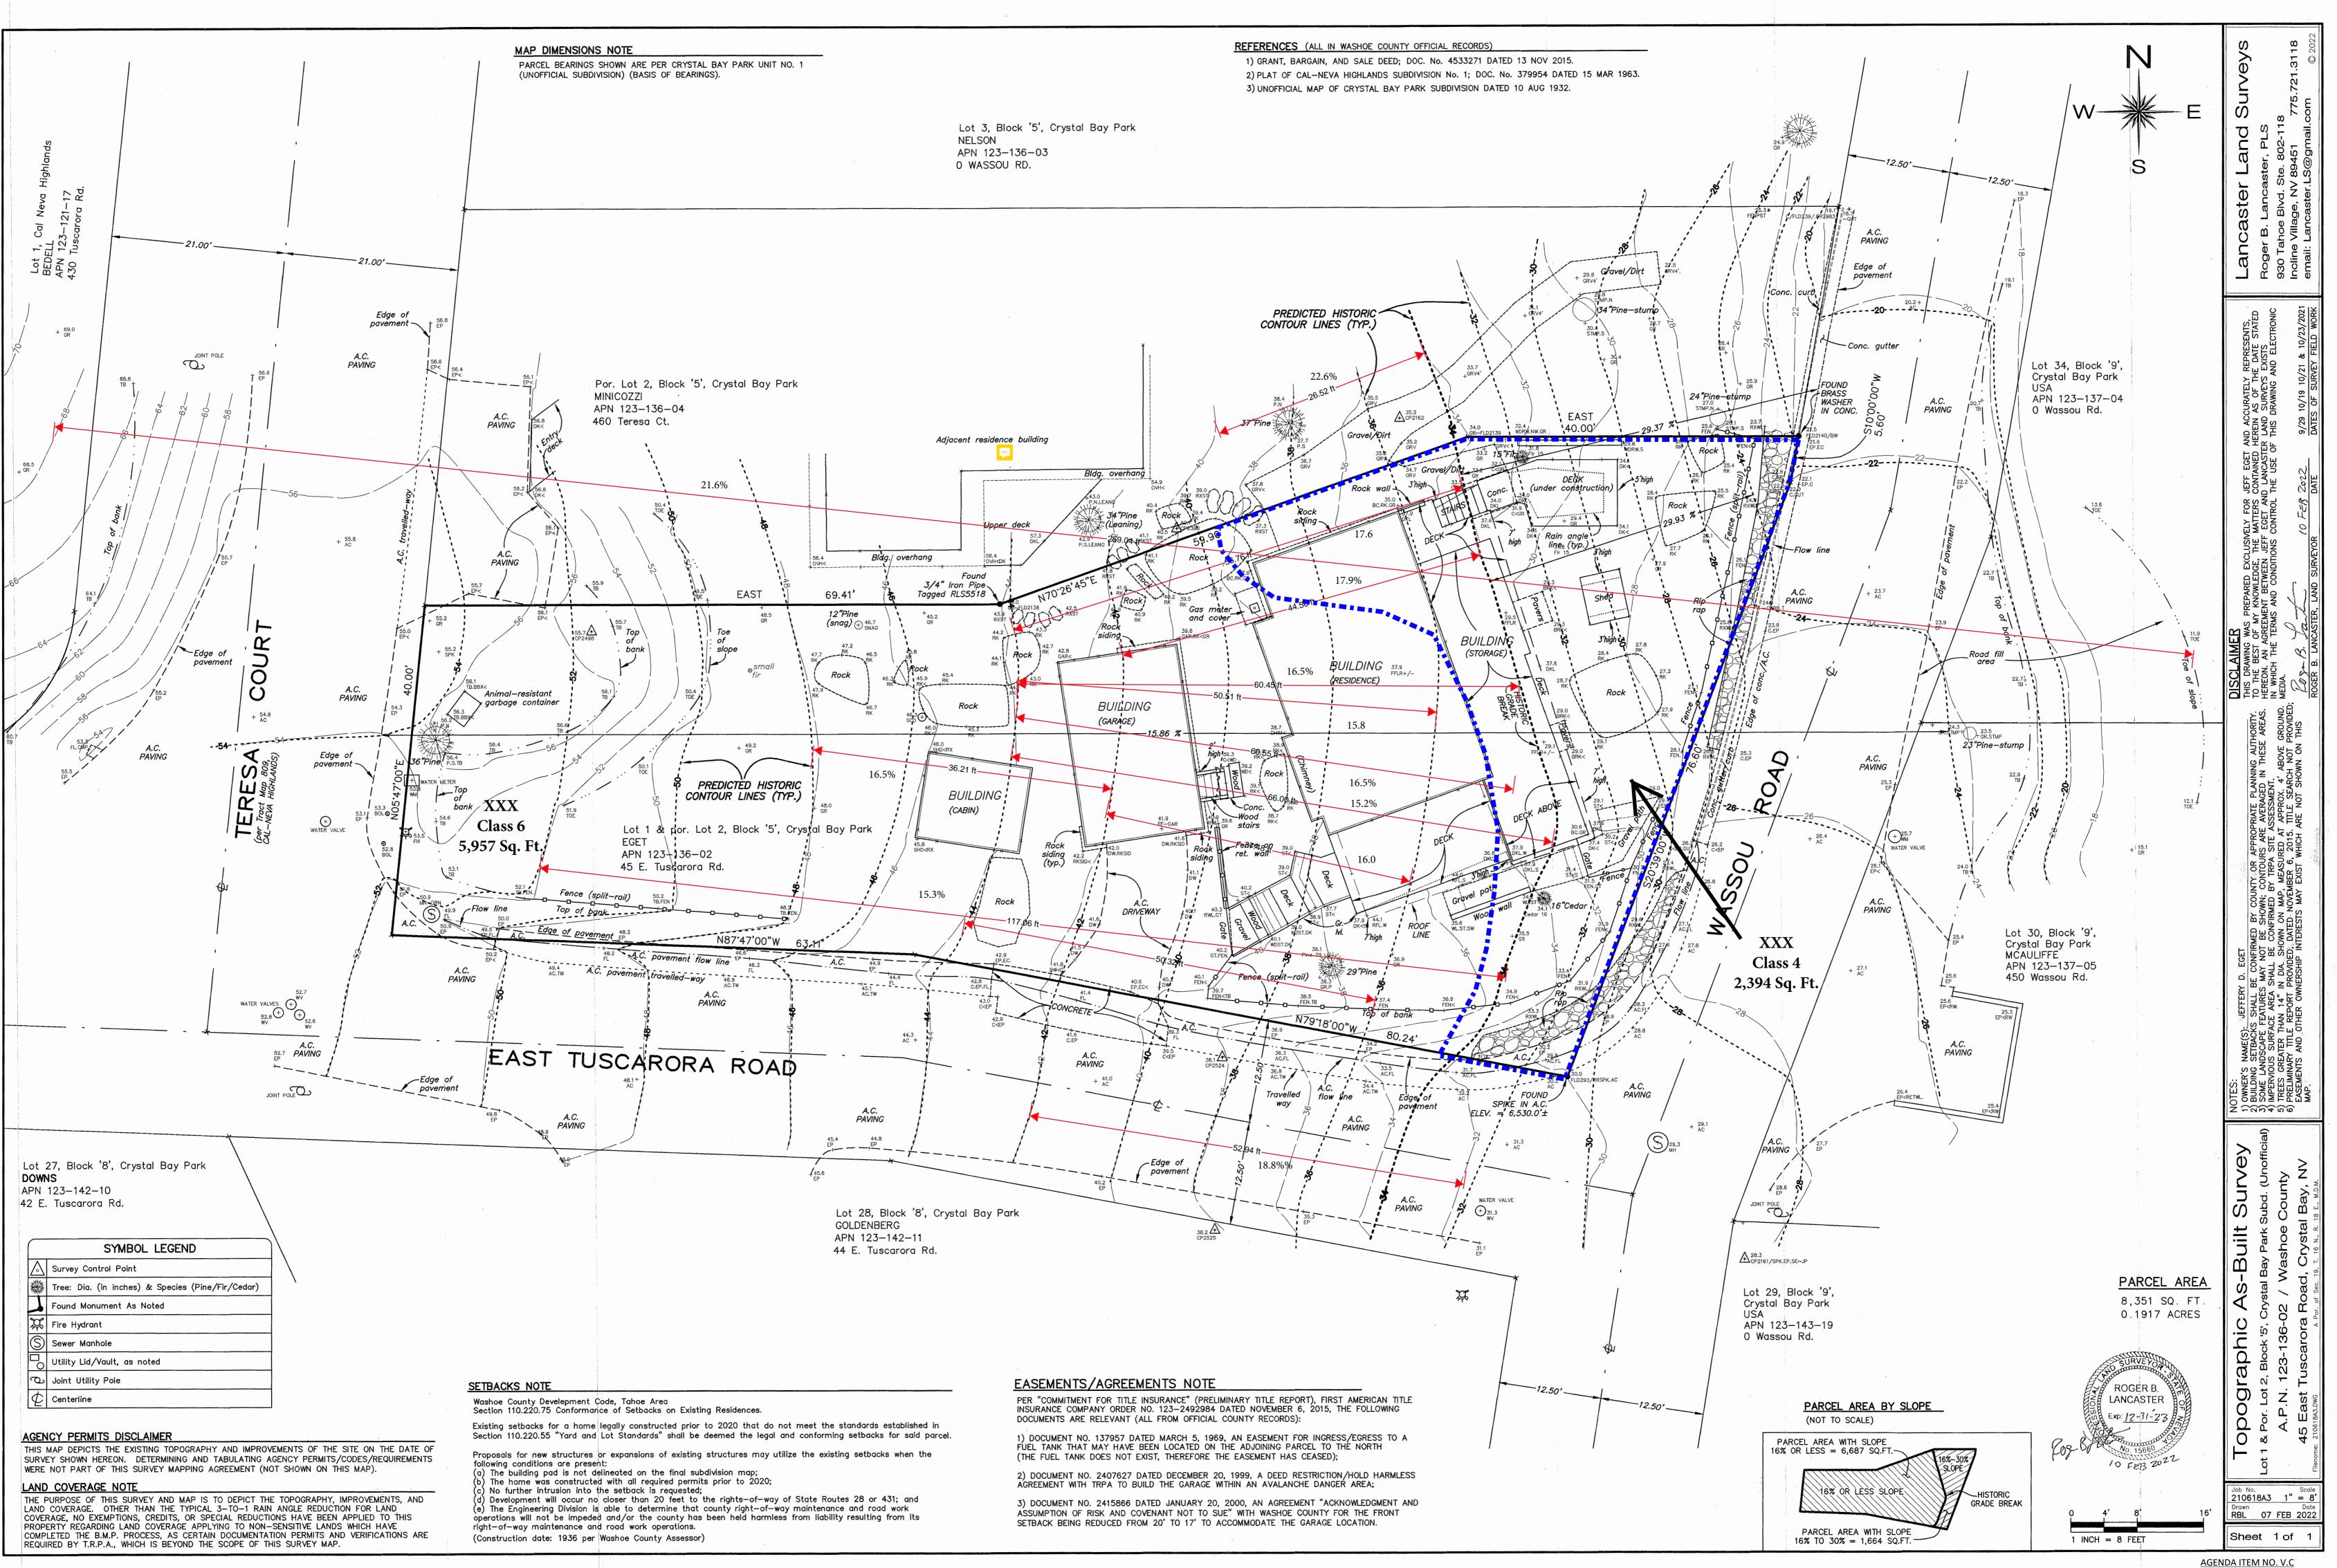
Attachment E

TRPA slope analysis

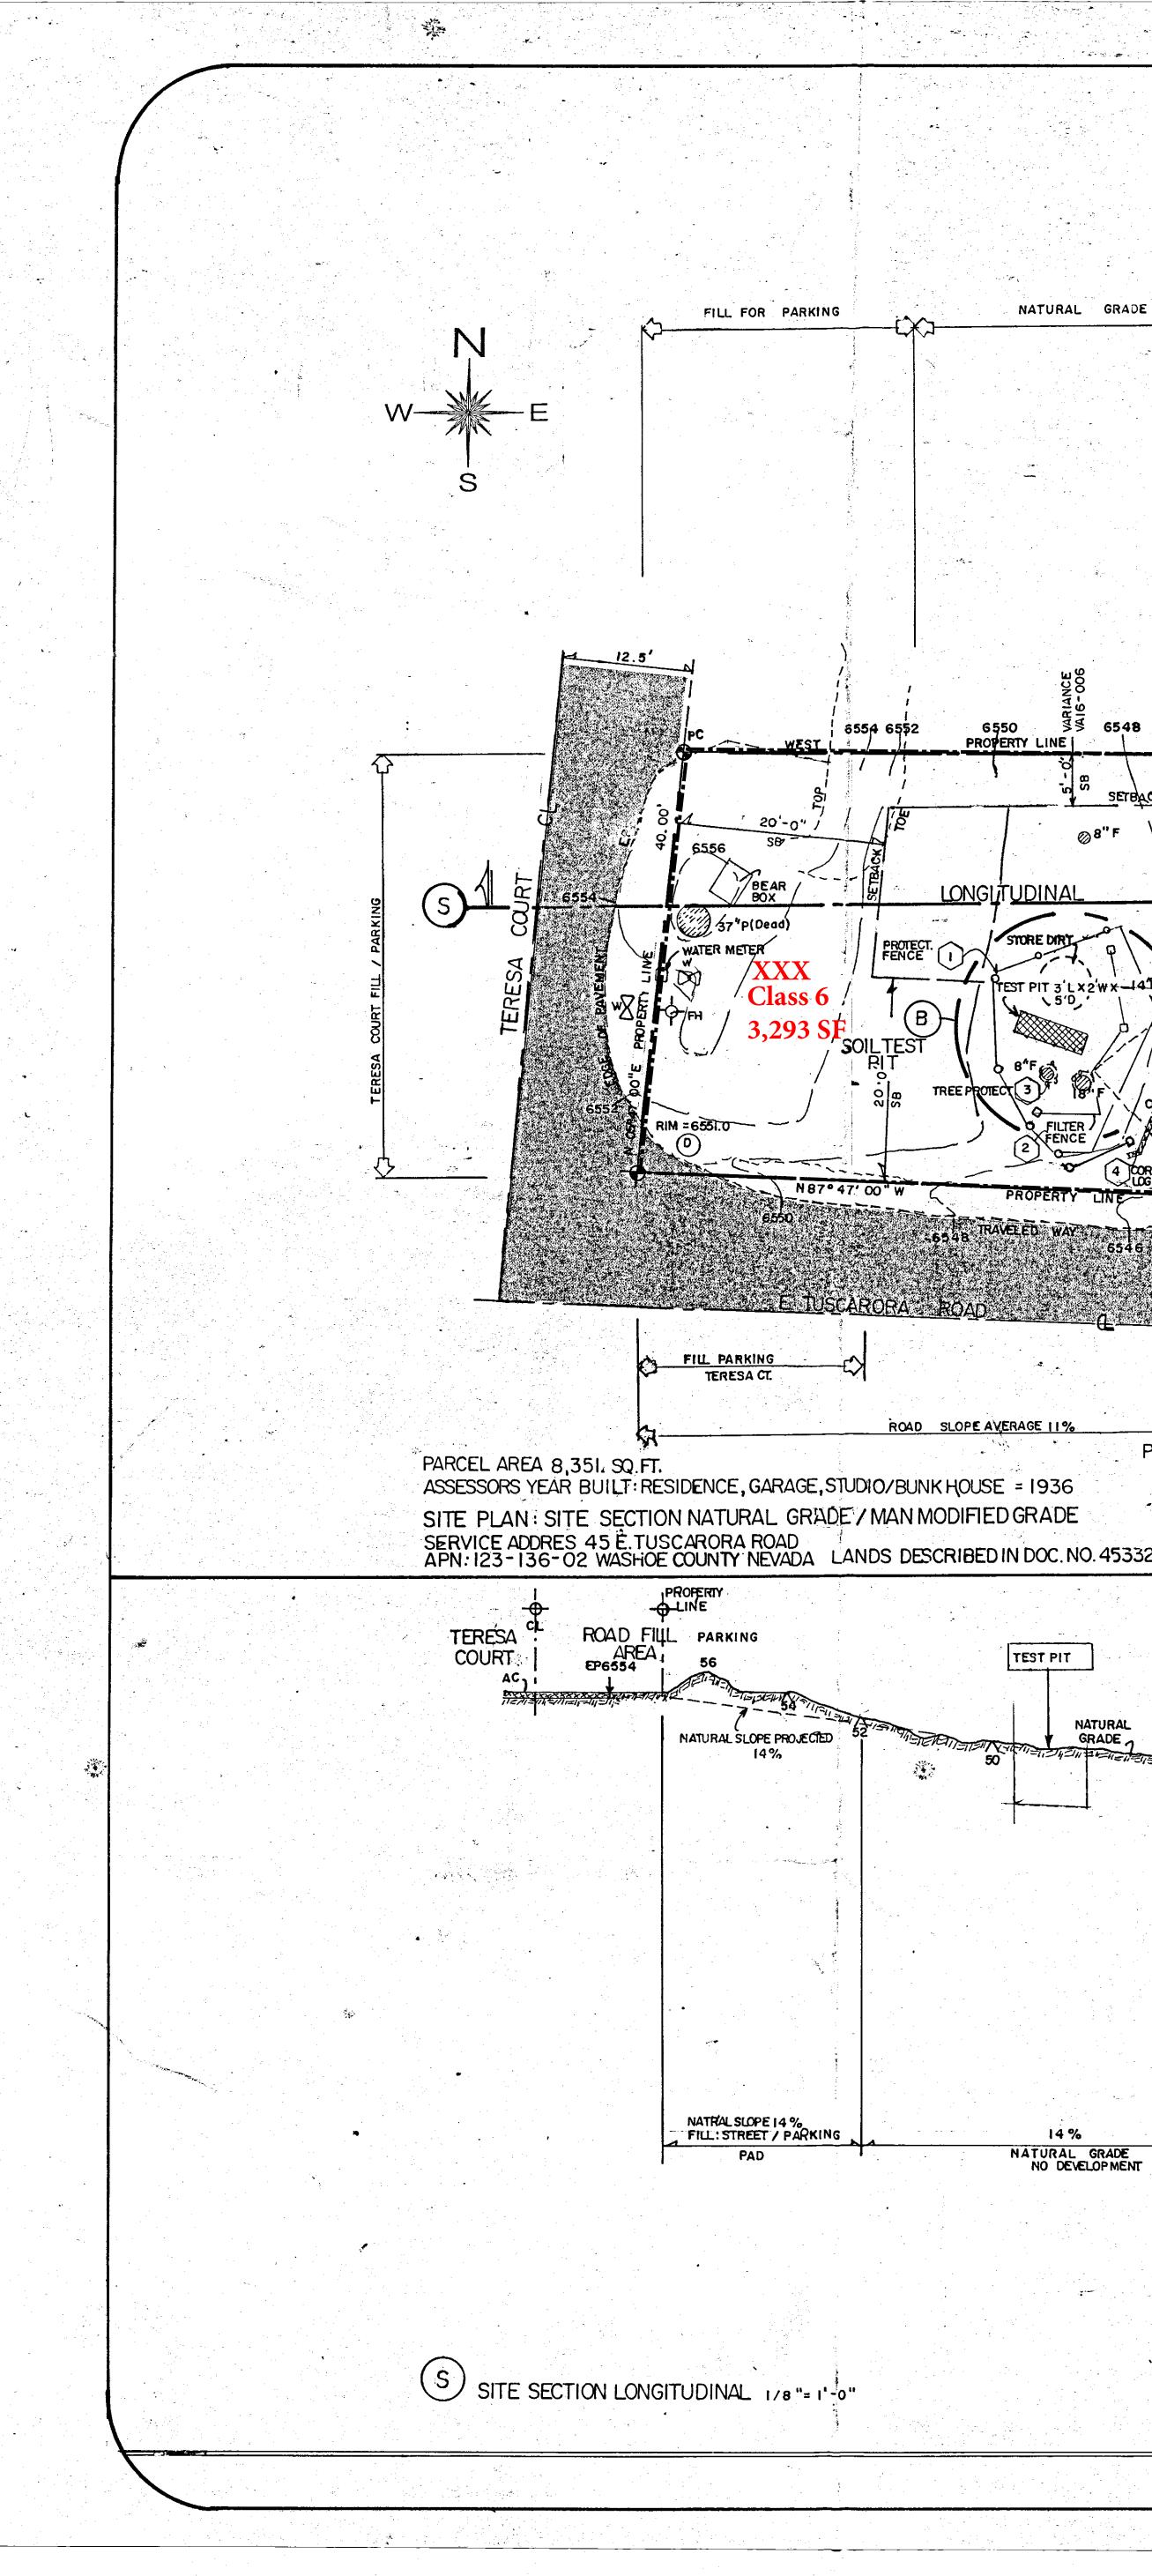
Attachment F

Parcel map from 5/13/21 hearing

Land Capability Classes based primarily on existing slopes, 5-13-2021 hearing

This land capability challenge has been presented at two prior Hearings Officer meetings. The first meeting occurred on May 13, 2021. The staff recommendation at that time was to delineate the Class 4 and Class 6 areas based on the existing slope (Attachment F), resulting in 3,293 square feet of Class 6 and 5,058 square feet of Class 4. The applicant disagreed with the staff findings because they believed that a portion of the parcel mapped as Class 4 historically (prior to development) had slopes less than 16 percent and should be Class 6. The Hearings Officer continued the item so that there could be more discussion between TRPA staff and the applicant.
