STAFF REPORT

Subject: Brodsky Land Capability Challenge; 649 Alpine View, Washoe County, Nevada;
APN 131-212-13, TRPA File Number LCAP2021-0198

BAILEY LAND CAPABILITY CHALLENGE FINDINGS

- A. Parcel map with soil map units delineated
- B. Ms. Munnecke's soil profile description
- C. Site photographs

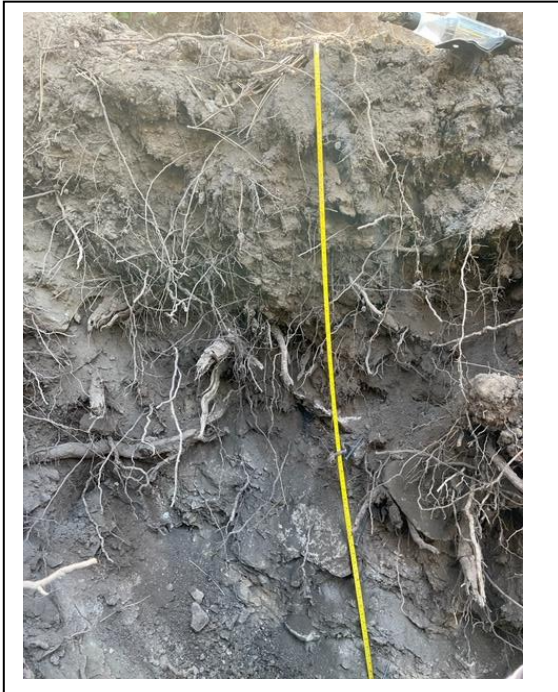
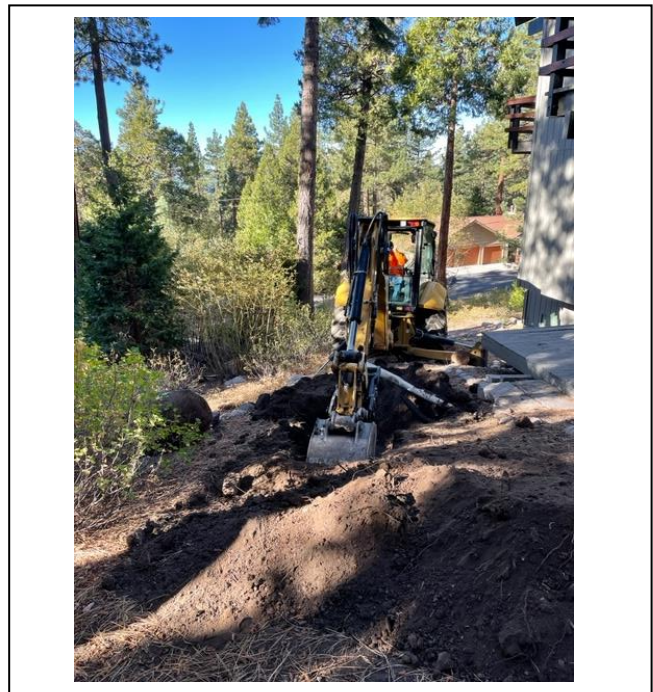
Soil Profile Description

Pit 131-212-13:

Soil Classification: Loamy-skeletal, isotic, frigid Andic Haploxeralfs

Parent Material: Debris flow material over volcanic mud flow material.

- A1 0 to 7 inches; gravelly loam, very dark grayish brown (10YR 3/2), very dark brown (10YR 2/2) moist; moderate medium granular structure; loose, loose, nonsticky and nonplastic; many very fine to medium roots; many very fine and fine irregular pores; 15 percent gravels and 2 percent cobbles; gradual wavy boundary.

- A2 7 to 23 inches; very stony loam, dark grayish brown (10YR 4/2), very dark brown (10YR 2/2) moist; moderate medium subangular blocky structure; loose, loose, nonsticky and nonplastic; many very fine to very coarse roots; many very fine and fine irregular pores, 20 percent gravel, 5 percent cobbles, and 20 percent stones; gradual wavy boundary.

- Bw 23 to 35 inches; very stony sandy loam, brown (10YR 4/3), very dark grayish brown (10YR 3/2) moist; weak fine subangular blocky structure; soft, very friable, slightly sticky and slightly plastic; many very fine to coarse roots; many very fine and fine irregular pores, 25 percent gravel, 2 percent cobbles, and 15 percent stones; gradual wavy boundary.

- Bt1 35 to 43 inches; very cobbly sandy clay loam, variegated brown (10YR 5/3) and yellowish brown (10YR 5/6), dark brown (10YR 3/3) moist; weak medium subangular blocky structure; moderately hard, firm, moderately sticky and moderately plastic; many fine to coarse roots; common clay films bridging sand grains; many very fine and fine irregular pores; 25 percent gravel, 15 percent cobbles and 5 percent stones, gradual wavy boundary.

- Bt2 43 to 58 inches; very gravelly silt loam, variegated grayish brown (10YR 5/2) and yellowish brown (10YR 5/6), brown (10YR 4/3) moist; massive; moderately hard, firm, slightly sticky and slightly plastic; common fine and medium roots; common clay films on ped faces; common fine irregular pores and common fine and medium tubular pores; 25 percent gravel, 15 percent cobbles and 5 percent stones, gradual wavy boundary.

- C 58 to 65+ inches; extremely gravelly silt loam, pale brown (10YR 6/3), dark yellowish brown (10YR 4/4) moist; massive; very hard, extremely firm, slightly sticky and slightly plastic; few fine roots; few fine tubular pores; 60 percent gravel.

This pit was excavated to 144 inches for a soil hydrology application. Beginning at 65 inches are layers of weathered volcanic mud flow material. At 138 inches is a layer with a light gray (7.5YR 7/1) color, with silty clay texture, and 15% yellowish brown (10YR 5/6) redoximorphic concentrations. These features indicate a seasonal high-water table at this depth (11.5 feet).

The upper 35 inches appears to be colluvium over old debris flow material (colluvium and alluvium) over layers of volcanic mud flow deposits. The soil has ash mixed in between 43 to 58 inches but is not quite enough to call the texture a very gravelly “ashy” silt loam.

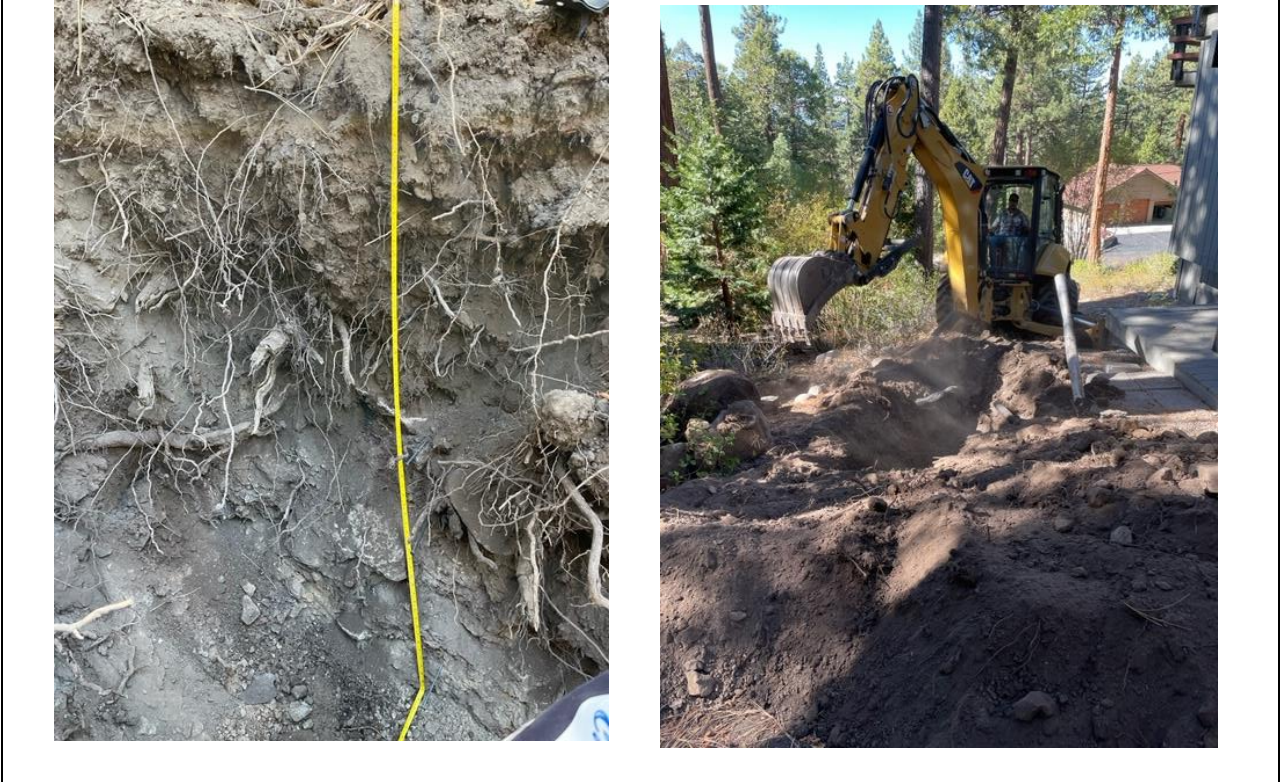
Photo 1 – a. Pit to a depth of 65 inches. Photo 1- b. View looking from above pit towards the west, along the south side of the residence.

One soil pit was excavated by backhoe to 12 feet as part of a soil hydrologic application. The upper 65 inches was described for this land capability challenge. The pit was located approximately 15 feet southeast of the southeast side of the residence. This soil formed in colluvium and debris material from primarily volcanic parent material. This soil is characterized by a gravelly loam surface texture, with very stony loam, very stony sandy loam, very cobbly sandy clay loam, very gravelly silt loam and extremely gravelly silt loam subsurface textures. From 35 to 65 inches the soil is unsorted and has inclusions of various material including silty alluvial material, pieces of volcanic mud flow rocks, and colluvium. There is also ash mixed in the soil from 43 to 55 inches. Beginning at 65 inches are layers of weathered volcanic mud flow material. At 138 inches is a soil layer with a light gray color, a silty clay texture, and 15% yellowish brown redoximorphic concentrations. These features indicate a seasonal high-water table at this depth (11.5 feet). This soil is very deep, well drained, and is a member of Soil Hydrologic Group B. The vegetation is dominated by a white fir, incense cedar and Jeffrey pine forest with creeping snowberry dominant in the understory. There are also patches of Sierra current, a few Scouler's willows, and one aspen tree with suckers near the front of the residence.

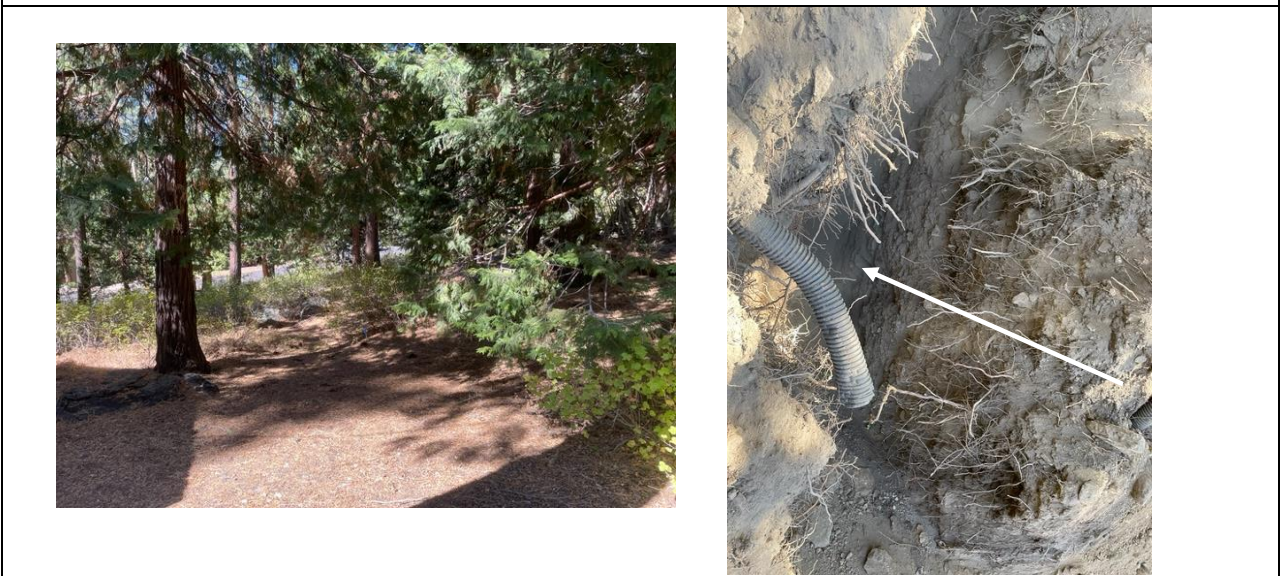
Photo 2 – a. View from behind the house towards northwest corner of the parcel. Photo 2— b. Pit to 12 feet deep. Tube is from old gravel drainage system. The arrow points to the deepest part of the pit.

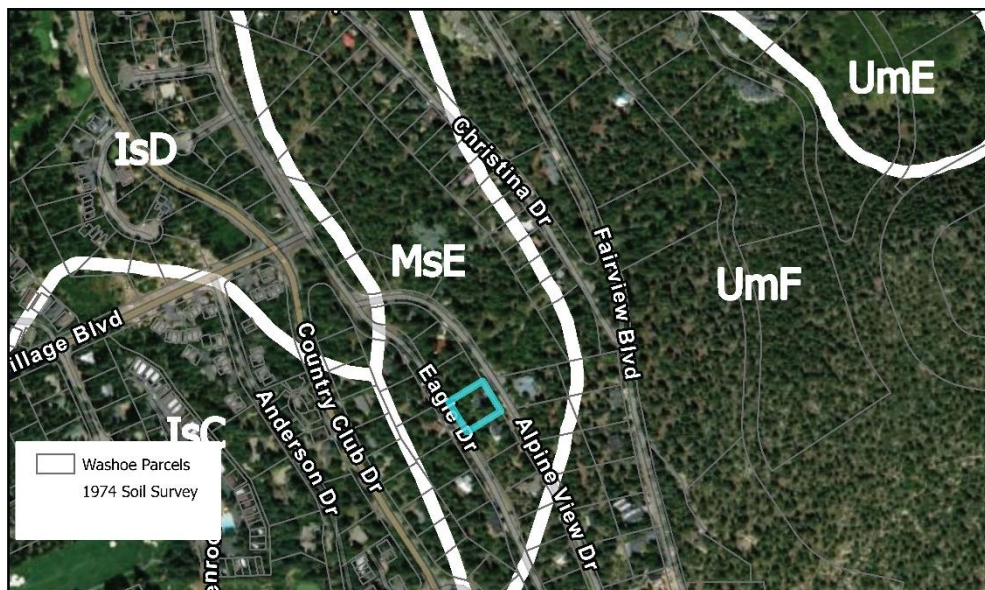
Image 4– ESRI map showing the 1974 Soil Map Units (white boundary).

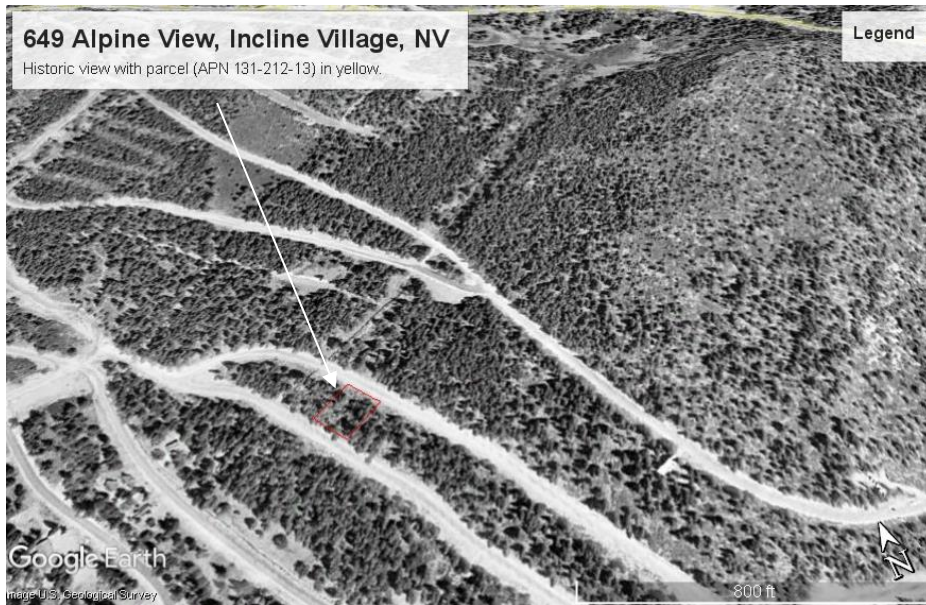
Image 5 – 1969 Google Earth image of general area, with parcel shown in faint red. Note creek drainage to the north (left of the parcel).

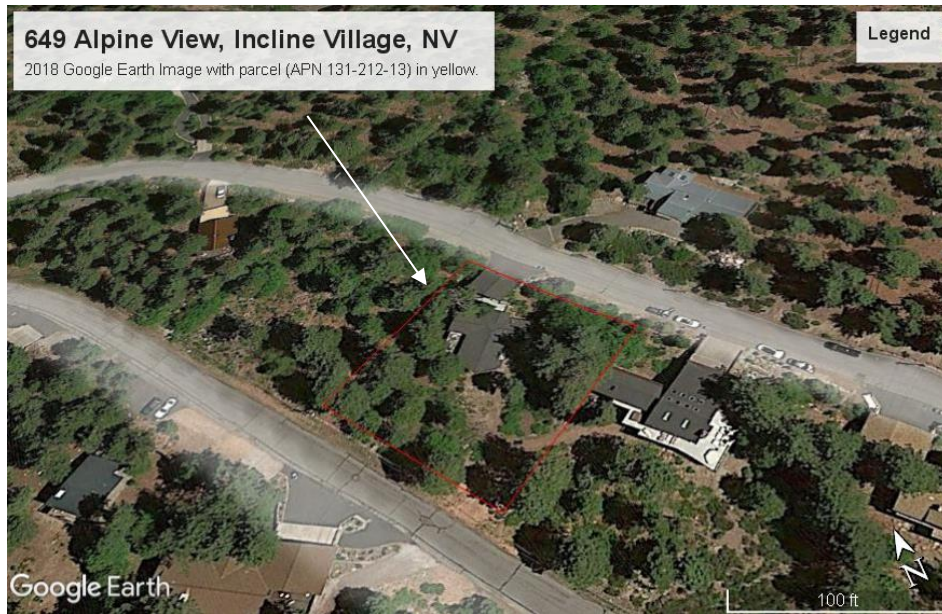
Image 6– Google Earth image with approximate parcel boundary shown in red.
