STAFF REPORT

Subject: Castro Land Capability Challenge; 960 Sky Way, Placer County, CA; APN 083-254-005; TRPA File Number LCAP2021-0275

#### BAILEY LAND CAPABILITY CHALLENGE FINDINGS

**IMPERVIOUS COVERAGE SURVEY**  
LOT 81 TALMONT ESTATES UNIT NO. 1  
APN 083-254-005 PLACER COUNTY CALIFORNIA  
ADDRESS: 960 SKY WAY, TAHOE CITY, CA

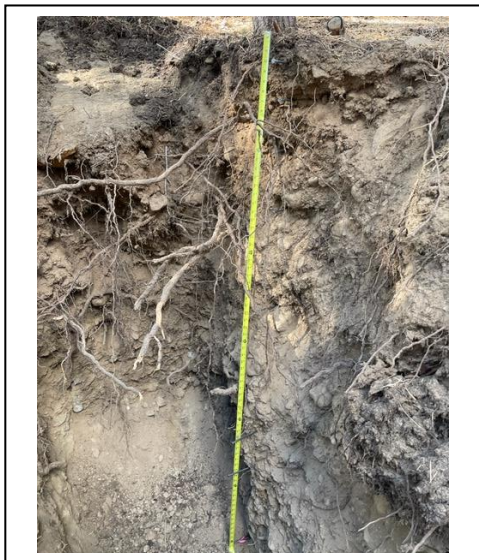
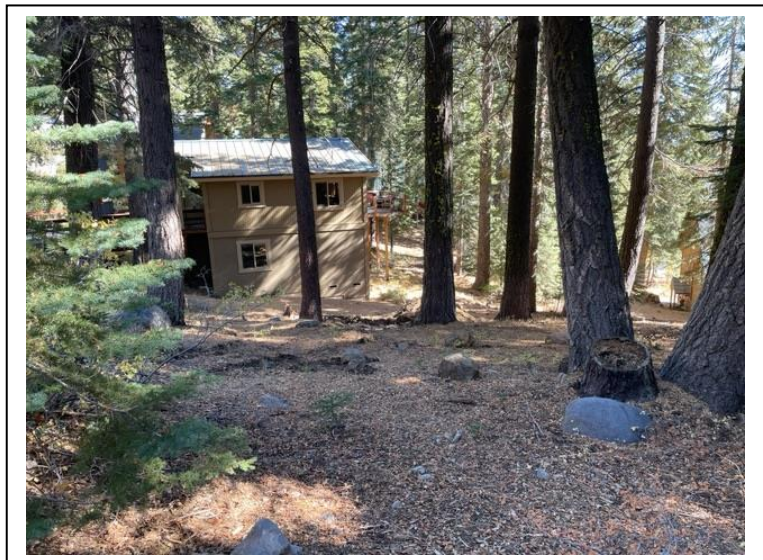
**Pit 083-254-005:**

**Soil Classification:** Medial-skeletal, mixed, Typic Vitrixerands (Some assumptions, made due to lack of lab analysis, based on soils mapped in this area in 2007 Soil Survey of the Tahoe Basin Area, California and Nevada.)

- A1 0 to 3 inches; sandy loam, dark brown (10YR 3/3), very dark brown (10YR 2/2) moist; moderate medium granular structure; soft, very friable, nonsticky and nonplastic; many very fine to fine roots; many very fine to fine irregular pores; 5 percent gravels; gradual wavy boundary.

- A2 3 to 7 inches; gravelly coarse sandy loam, dark yellowish brown (10YR 4/4), dark brown (10YR 3/3) moist; moderate coarse granular structure; soft, very friable, nonsticky and nonplastic; many very fine to fine and common medium roots; many very fine to fine irregular pores and many fine to medium tubular pores; 15 percent gravel and 5 percent cobbles; gradual wavy boundary.

- AB 7 to 12 inches; gravelly coarse sandy loam, yellowish brown (10YR 5/4), dark brown (7.5YR 3/3) moist; moderate medium subangular blocky structure; soft, very friable, nonsticky and nonplastic; many very fine to fine and few medium to coarse roots; many very fine and fine irregular and tubular pores; 15 percent gravel, 15 percent cobbles; gradual wavy boundary.

- Bw1 12 to 17 inches; very gravelly coarse sandy loam, yellowish brown (10YR 5/4), dark yellowish brown (10YR 4/6) moist; moderate medium subangular blocky structure; soft, very friable, nonsticky and nonplastic; many very fine to medium roots; many very fine and fine irregular pores; 20 percent gravel, 15 percent cobbles; gradual wavy boundary.

- Bw2 17 to 50 inches; very gravelly coarse sandy loam, yellowish brown (10YR 5/4), dark yellowish brown (10YR 4/4) moist; weak medium subangular blocky structure; soft, very friable, slightly sticky and slightly plastic; many very fine to fine and common medium roots; many very fine and fine irregular pores; 40 percent gravel, 5 percent cobbles; gradual wavy boundary.

- Bw3 50 to 56 inches; very gravelly coarse sandy loam, yellowish brown (10YR 5/4), dark yellowish brown (10YR 4/4) moist; moderate medium subangular blocky structure; slightly hard, friable, slightly sticky and slightly plastic; common fine and medium roots; many very fine and fine irregular pores; 35 percent gravel, 2 percent cobbles; gradual wavy boundary.

- Bw4 56 to 72 inches; very gravelly coarse sandy loam, yellowish brown (10YR 6/3), brown (10YR 4/3) moist; moderate medium subangular blocky structure; slightly hard, friable, slightly sticky and slightly plastic; common fine and medium roots; many very fine and fine irregular and tubular pores; 35 percent gravel, 1 percent cobbles; gradual wavy boundary.

C 72-77+ inches; coarse sandy loam, variegated very pale brown (10YR 7/3) and yellow (10YR 7/6), dark yellowish brown (10YR 4/4), rubbed, moist; massive; moderately hard, firm, slightly sticky and slightly plastic; few fine and medium roots; common very fine and fine irregular pores; 10 percent gravel; gradual wavy boundary.

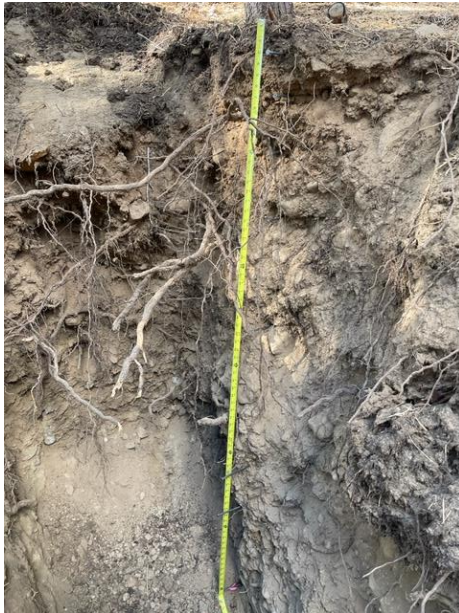
One soil pit was excavated by backhoe to 77 inches. The pit was located approximately 25 feet southwest of the southern corner of the residence. The soil is characterized by a sandy loam surface texture, with gravelly coarse sandy loam and very gravelly coarse sandy loam subsurface textures. This soil formed in colluvium over glacial deposits. This soil has greater than 35 percent rock fragments in the particle control section. Soils in this area were mapped as Andisols (soils that have a significant content of volcanic glass) in the 2007 Soil Survey of the Lake Tahoe Basin Area. If this soil has andic properties (requires laboratory analysis) the taxonomy is Medial-skeletal, mixed, frigid Typic Vitrixerands. If the soil lacks andic properties, then the taxonomy would be Loamy-skeletal, mixed, frigid Typic Dystroxerepts. This soil is very deep, well drained, and is a member of Soil Hydrologic Group B. The vegetation is a white fir forest with a few Jeffrey pine trees. The understory has scattered shrubs such as creeping snowberry, serviceberry, huckleberry oak, mountain whitethorn, Sierra current, woolly mule-ears, needle grass, and a Scouler's willow. There is a small ephemeral stream along the eastern side of the parcel. Vegetation along the stream is composed of thimbleberry, fireweed, and bracken fern. In some areas, there is no change in vegetation, with upland vegetation adjacent to the channel (see Appendix C).

Photo 1 – a. Pit. Photo 1- b. View looking across parcel to the east.

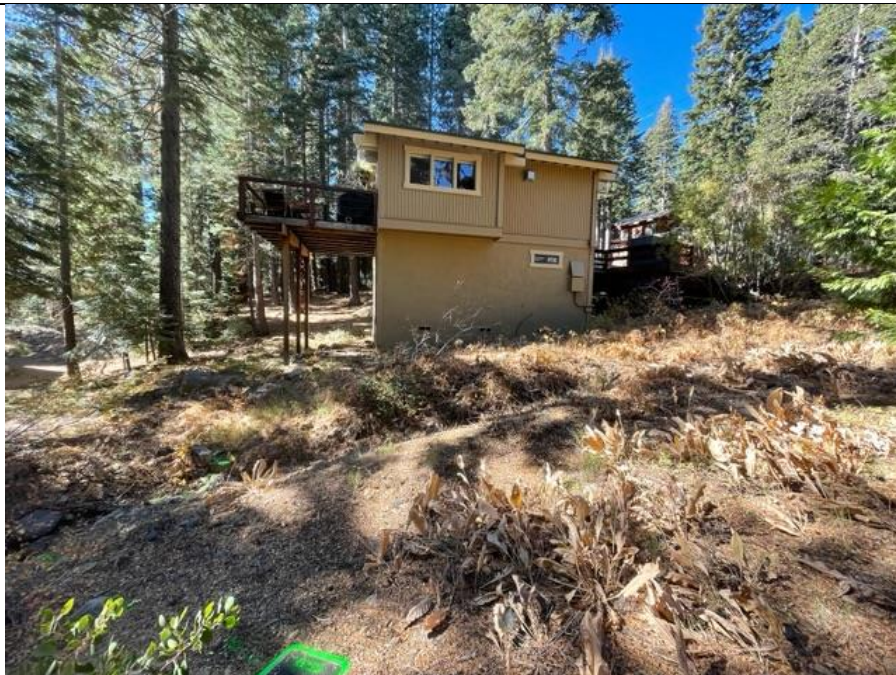
The ephemeral stream on the east side of the parcel occurs in a natural swale but is seasonally dry with limited riparian vegetation. This area is mapped as 1b-SEZ based on evidence of surface flow.

Photo 2 – a. View from east to west across the parcel. The ephemeral channel is visible in foreground, and Class 6 area is around house and downslope (left of photo).

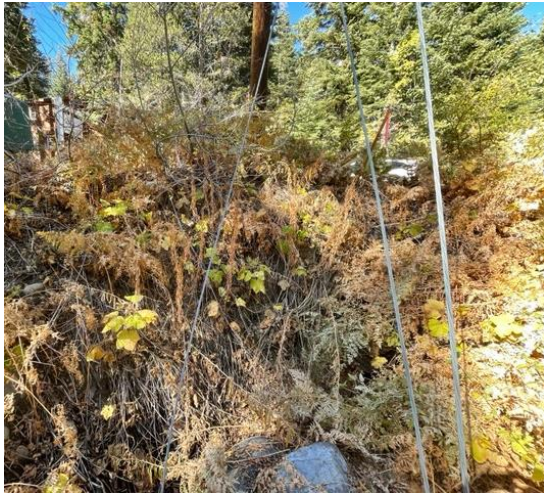
Photo 3 – a. SEZ below road by culver outlet. Photo 3- b. SEZ on lower parcel.

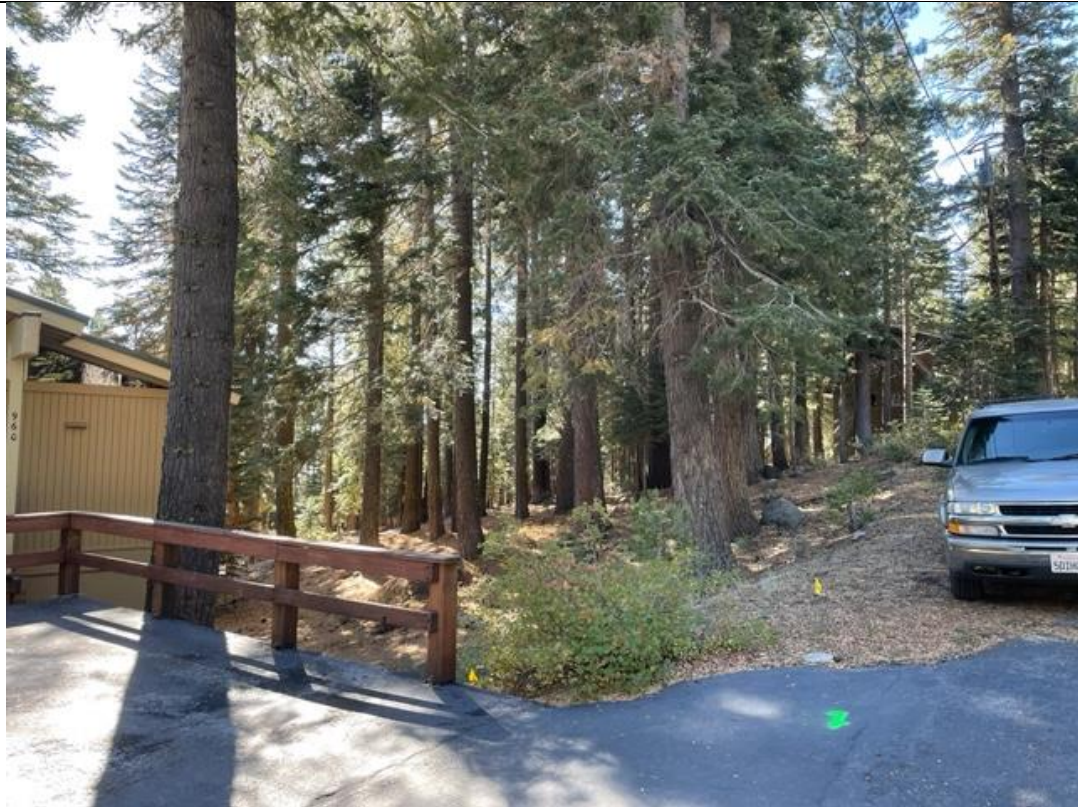
Photo 4 – a. View from driveway and Sky Way to south.
