#### STAFF REPORT

Subject Jedlowski Land Capability Challenge; 553 Lantern Court, Washoe County, NV;

APN 125-492-30; TRPA File Number LCAP2021-0306

# Land Capability Report 553 Lantern Court, Incline Village, Nevada (APN 125-492-30)

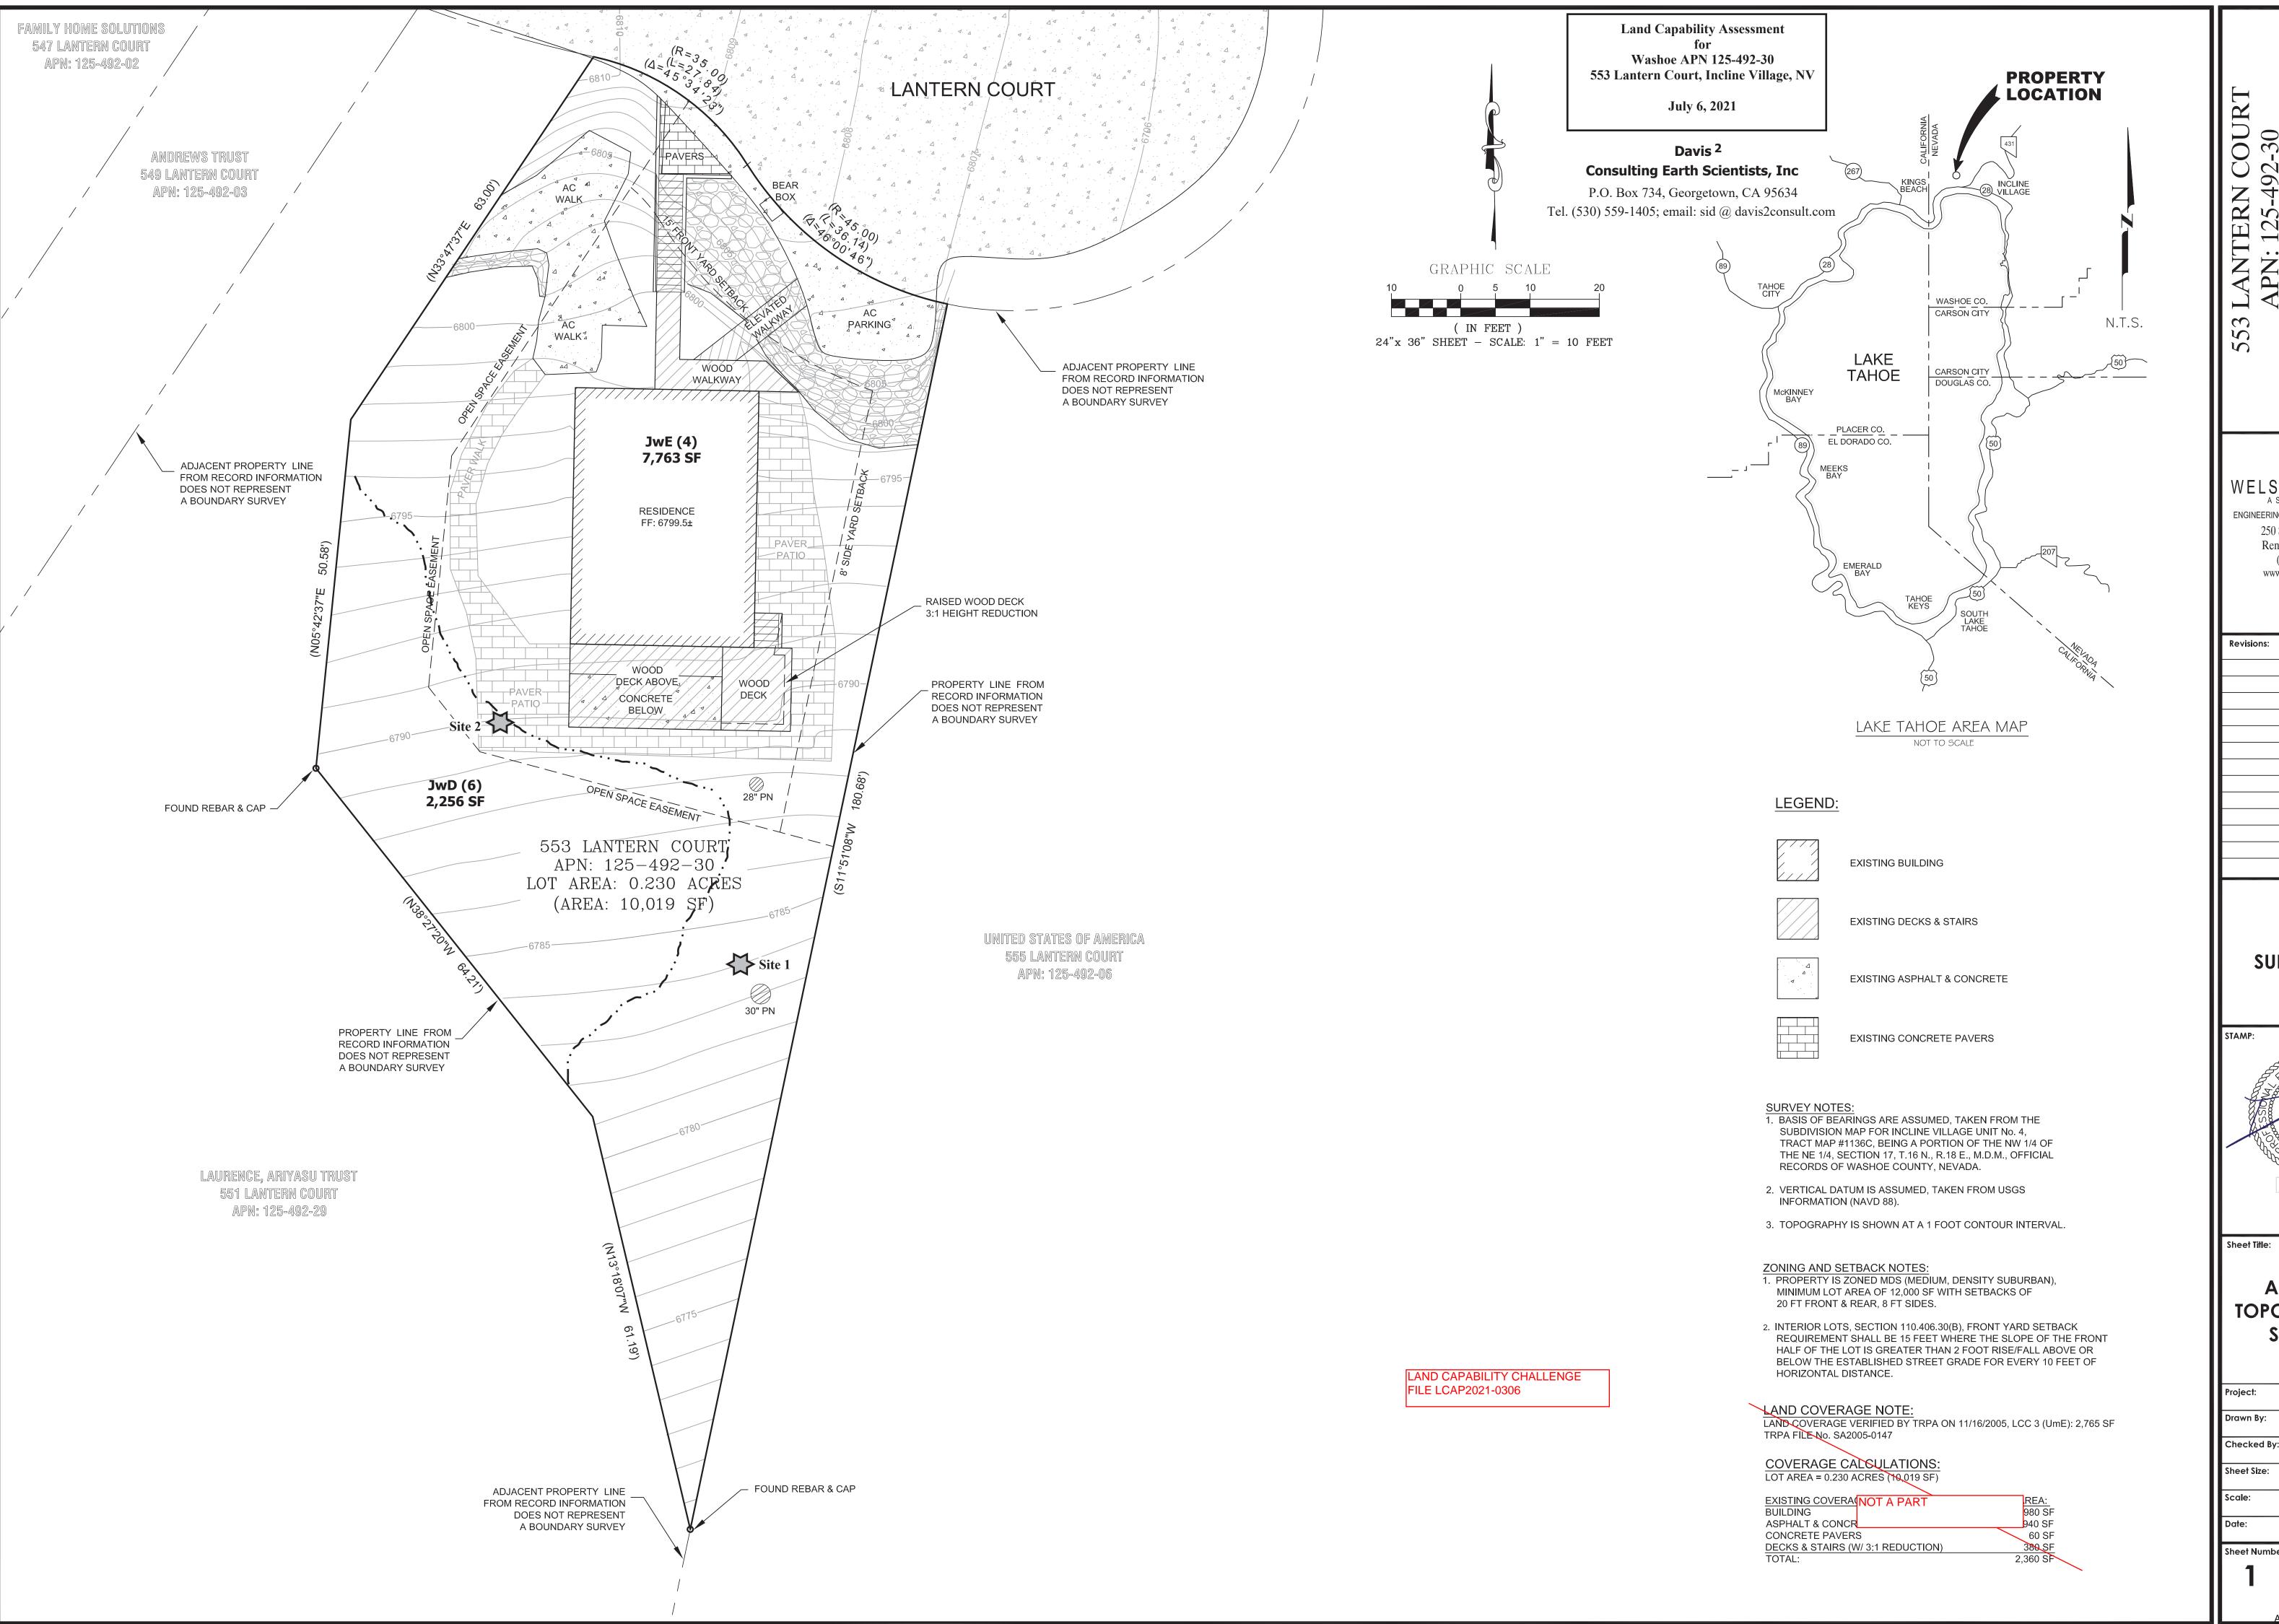
# **AS-BUILT TOPOGRAPHIC SURVEY**

material). The soil at Stop 1 is within the range and characteristic of the Jorge soil and the soil at Stop 2 is
characteristic of the Jorge soil and the soil at Stop 2 is
· · · · · · · · · · · · · · · · · · ·
within the range and characteristics of the Tahoma
soil. The main difference between the Jorge and
Tahoma soils is the amount of rock fragments. The
Jorge soils have greater than 35 percent rock
fragments in the particle control section and the
Tahoma soils have less than 35 percent rock
fragments. Based on soils and slopes, this parcel is
mapped as JwD- Jorge-Tahoma very stony sandy loams, 2 to 15 percent slopes and JwE- Jorge-Tahoma
very stony sandy loams, 15 to 30 percent slopes.
Slope Determination 12 to 25 percent slopes.
TRPA Conclusion(s)  TRPA concurs with consultant's determination and
rationale above.
Applicable Area See site plan for soil delineations.

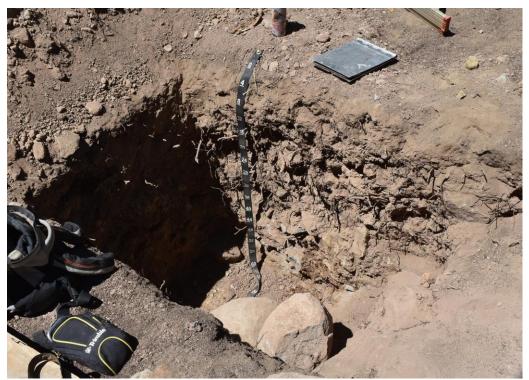
Figure 1- Stop 1 (Jorge series).

Jorge series soils can be characterized having topsoil approximately 14 thick consisting of dark brown gravelly sandy loam dark brown very stony sandy clay loam subsoil to 60 inches depth. The andesite parent material have weathered to saprolite at depth, roots explore all depths in the profile (Stop 1).

A 0-4 inches, brown (10YR 4/3) gravelly sandy loam near sandy clay loam, dark brown (10YR 3/3) moist; moderate fine granular grading to moderate medium platy structure; slightly hard, very friable, slightly sticky and slightly plastic; many very fine and fine and few medium roots; many very fine and fine interstitial pores; slightly acid; fifteen percent gravel; clear smooth boundary

Soil Series: Jorge

Soil Classification: Loamy-skeletal, mixed, frigid, Ultic Haploxeralfs

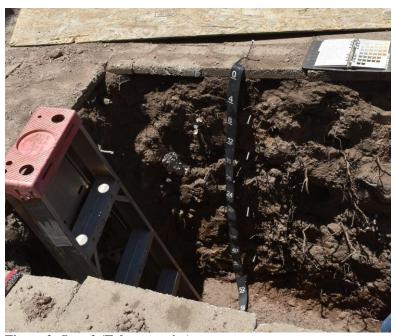
Figure 2- Stop 2 (Tahoma series).

Tahoma soil is described at Stop 2. This profile is beneath pavers adjacent to the residence. It has a thick dark brown gravelly sandy loam topsoil approximately 14 inches thick over a dark brown gravelly sandy clay loam subsoil to 52 inches depth.

Notes: Non-skeletal pit. Covered by paving stones.

Soil Series: Tahoma

Soil Classification: Fine-loamy, mixed, frigid, Ultic Haploxeralfs

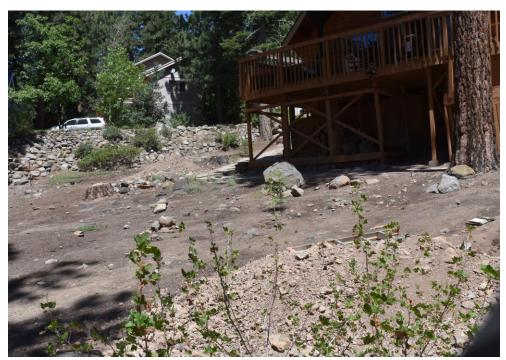
Figure 3- Parcel landscape.

The site is located at 553 Lantern Court, Incline Village, Nevada. Vegetation consists of Jeffrey pine and Ribes, species. Slopes range between 12 and 25 percent on a southern aspect. There are no stream environment zones (SEZ) influencing this parcel.

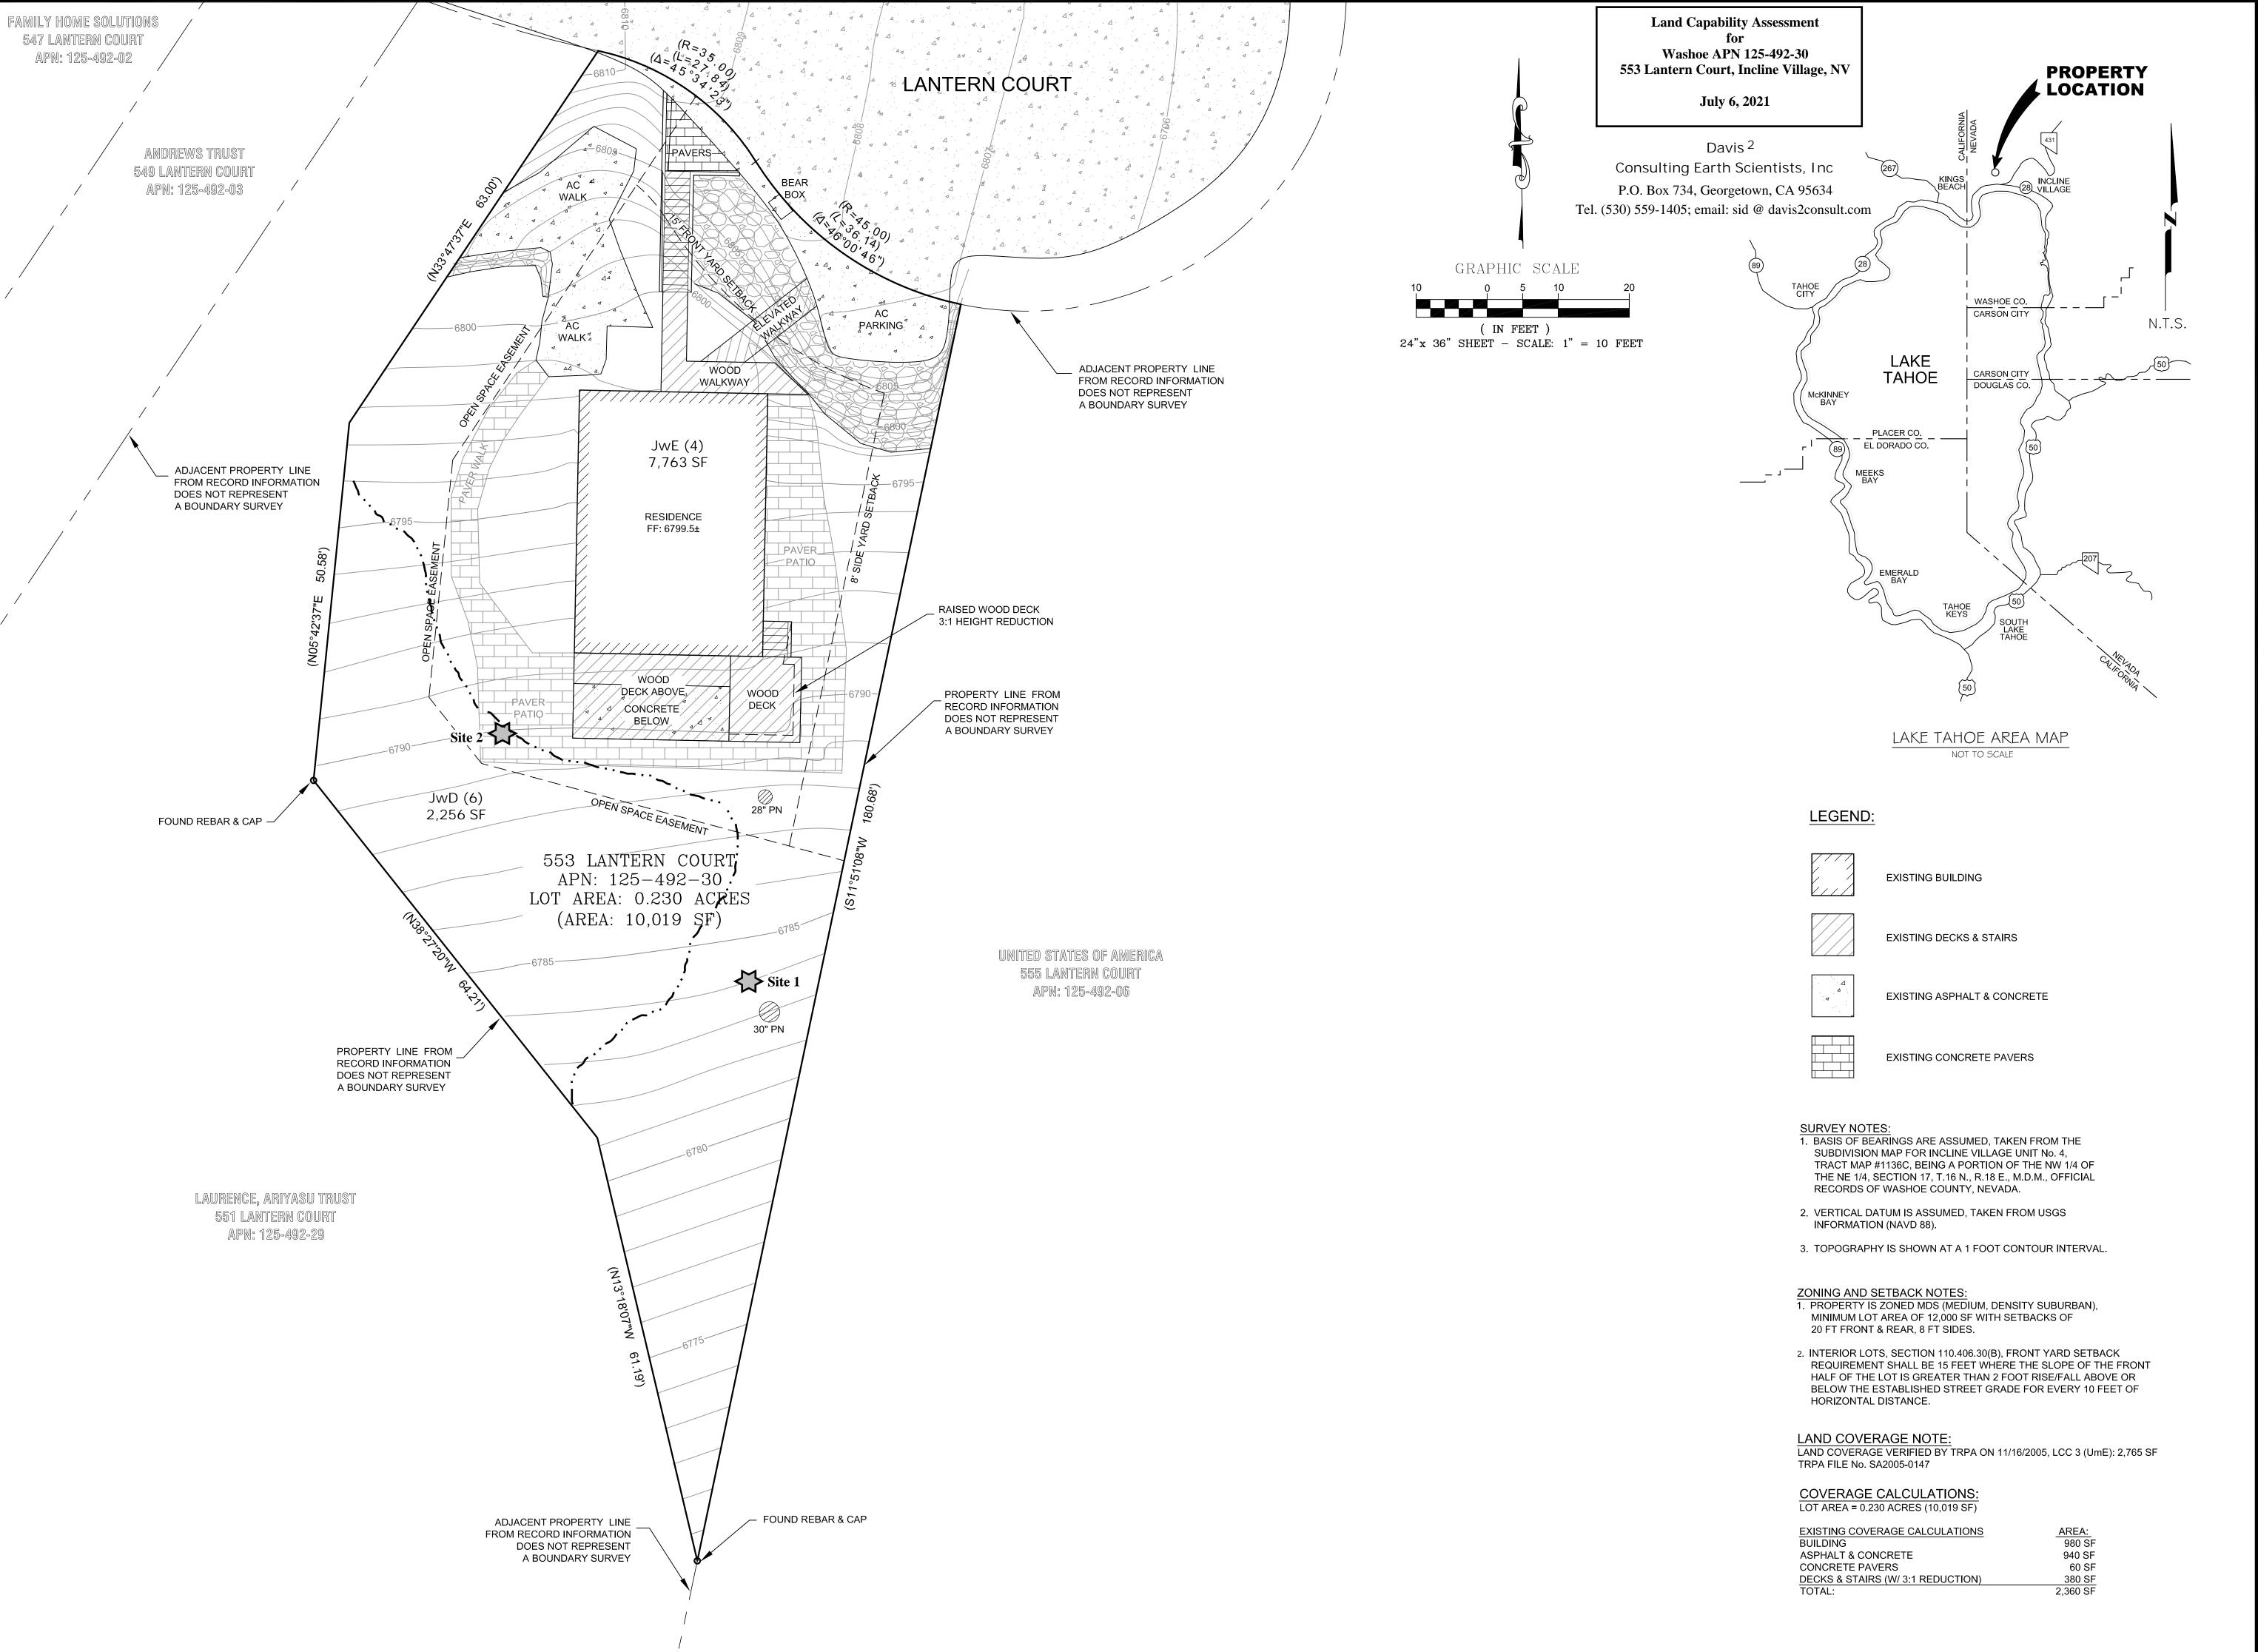
# AS-BUILT TOPOGRAPHIC SURVEY

Please refer to the following soil profile descriptions that support the findings and the attached map showing the spatial distribution of the appropriate land capability classes on the parcel.

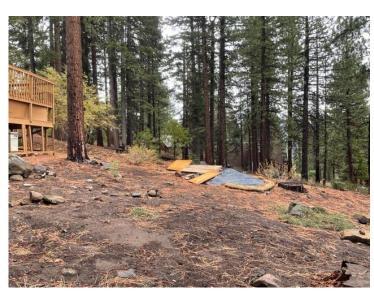
Two soil pits were excavated by backhoe to 60 and 52 inches. Site 1 was located approximately 40 feet south of the residence and Stop 2 was located approximately 10 feet west of the back deck. These soils formed in colluvium and residuum from volcanic parent material. The soil at Stop 1 is characterized by a gravelly sandy loam surface texture, with gravelly sandy clay loam, and very gravelly sandy clay loam subsurface textures. Hard or weathered bedrock was not encountered in the pit. This soil is skeletal with argillic horizons beginning at 14 inches This soil is classified as a Loamy-skeletal, mixed, frigid, Ultic Haploxeralfs. This soil is very deep, well drained, and is a member of Soil Hydrologic Group B. The soil at Stop 2 is characterized by a sandy loam surface texture, with sandy loam, and sandy clay loam subsurface textures. Hard or weathered bedrock was not encountered in the pit. This soil is non-skeletal with argillic horizons beginning at 26 inches. This soil is classified as a Fine-loamy, mixed, frigid, Ultic Haploxeralfs. This soil is very deep, well drained, and is a member of Soil Hydrologic Group B. The vegetation is an open Jeffrey pine forest with scattered patches of prostrate ceanothus, greenleaf manzanita, Sierra current, and a couple Scouler's willow in the understory.

Photo 1 – a. Stop 1 pit. Photo 1-b. View from south of residence looking east toward Stop 1.

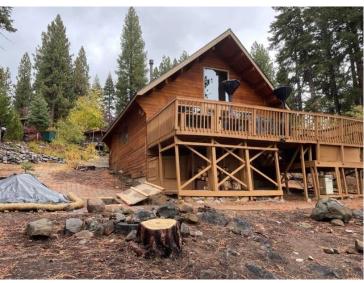
Photo 2 – a. Stop 2 pit. Photo 2 – b View toward Stop 2 from south to north.

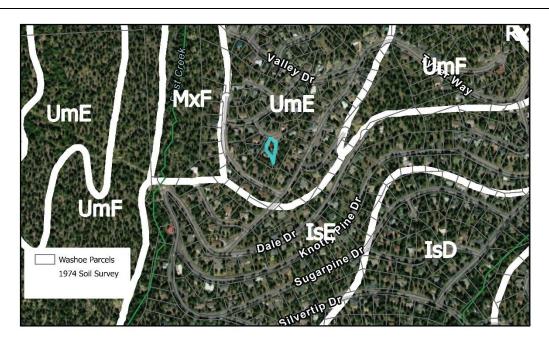
The subject parcel is shown as Class 3 on TRPA Land Capability Overlay Maps (aka Bailey Land Capability maps). The Soil Conservation Service Soil Survey of Tahoe Basin Area, California-Nevada (Rogers, 1974) places the subject parcel in the UmE, Umpa very stony sandy loam, 15 to 30 percent slope mapunit. A land capability verification completed in 2005 verified the entire parcel as 1a-Umpa very stony sandy loam, 15 to 30 percent slope mapunit. The updated Soil Survey of Tahoe Basin Area, California and Nevada (NRCS, 2007) maps this parcel as mapunit 7151- Jorge very cobbly fine sandy loam, 5 to 15 percent slopes and 7152- Jorge very cobbly fine sandy loam, 15 to 30 percent slopes. This parcel has a geomorphic mapping of D2 for Streamcut volcanic flowlands, Headlands (Moderate hazard lands). The Umpa soils formed in colluvium and residuum over andesitic bedrock. Umpa soils have a very stony sandy loam A-horizon, with gravelly sandy loam subsurface textures in the upper 40 inches. Hard, fractured andesite is typically encountered between 20 and 40 inches below ground surface. The Jorge soils formed in colluvium and residuum over andesitic bedrock. Jorge soils have a stony sandy loam Ahorizon, with gravelly sandy loam or very gravelly sandy loam subsurface textures in the upper 50 inches. An argillic horizon is present at 33 inches to a depth of 50 inches, where a C horizon is present. Depth to weathered andesitic bedrock is below 60 inches.

Image 4– 1974 Soil Mapping with parcel 125-492-30 shown in blue.
