STAFF REPORT

Subject: Balas Land Capability Challenge, 457 Eagle Drive, Washoe County, NV,
Assessor's Parcel Number (APN) 131-224-02, TRPA File Number LCAP2020-0495

PETER BALAS PARCEL, 457 EAGLE DR., INCLINE VILLAGE, NEV. PHOTOGRAPHS (APN 131-224-02)

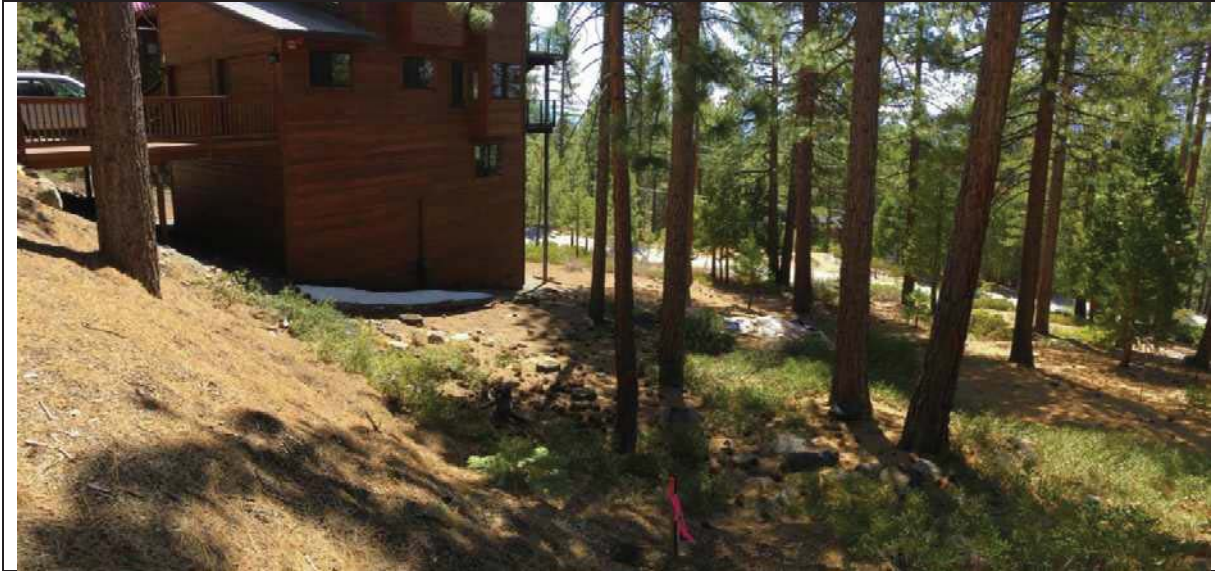
Photo 1 – View south (left) to southwest (right) from northeast property corner. Eagle Drive located just beyond left edge of photo. Natural slopes within the parcel range from 23 to 29%, but the road embankment (left edge) has 35 to 58% slopes. See Photo 7 for related comment.

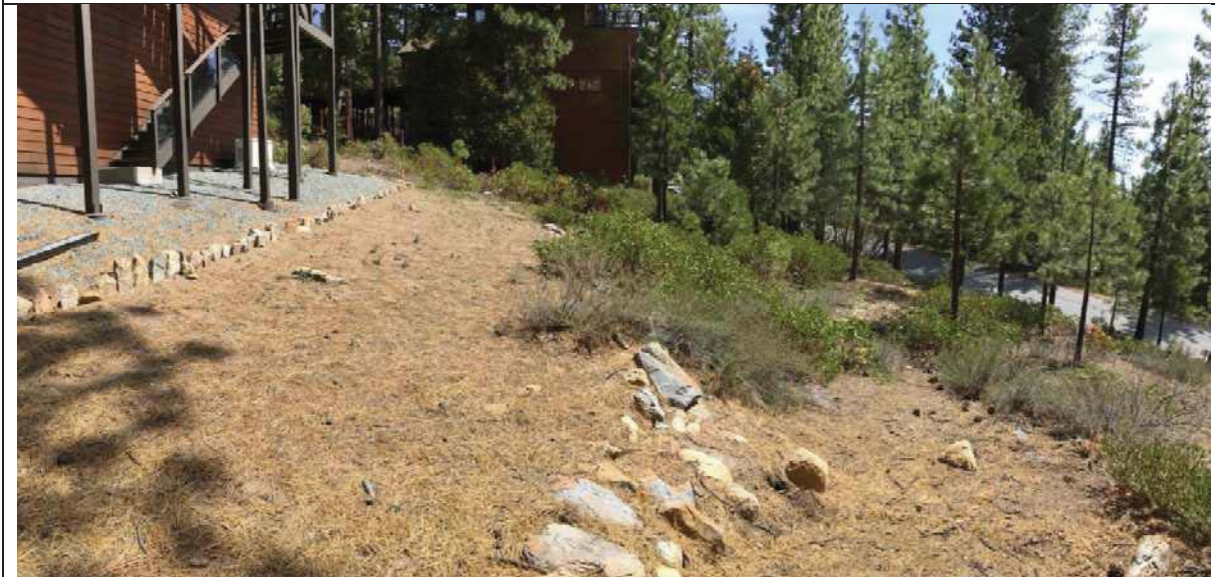
Photo 2 – View south (left) to southwest (right) from north-center part of parcel. Land below (west) of residence has subtle landscaping terraces that are partly vegetated with native shrubs; also has ground cover of pine needles and twigs. The parcel is mapped as Umpa very stony sandy loam (UmF), 30 to 50% slopes (Class 1A). This soil is derived from andesitic debris flow (deeper than 60 in. on this property). The observed deep soils provide greater land capability (including infiltration) and better growing conditions than the mapped UmF soil.

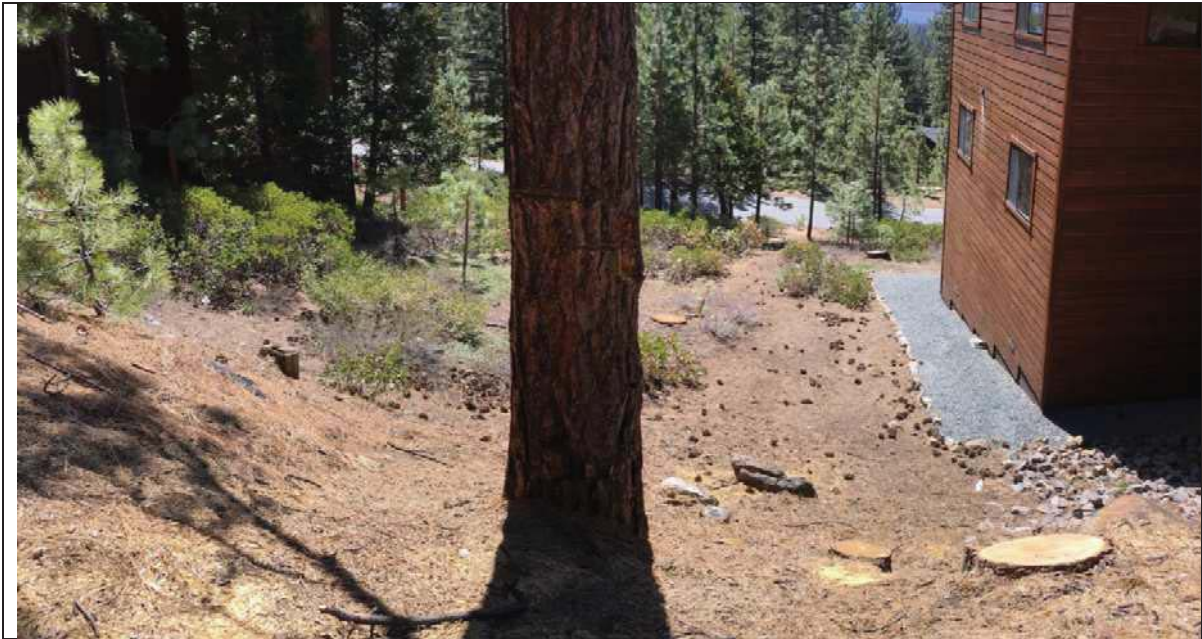
Photo 3 – View southwest (left) to west (right) along south side of residence. The upper elevation of the parcel is 6680 ft., while the lower elevation is 6639 ft. Slope aspect is mostly southwest. Driver Way located along west property line (upper center of photo). Eagle Drive located in opposite direction of photo.

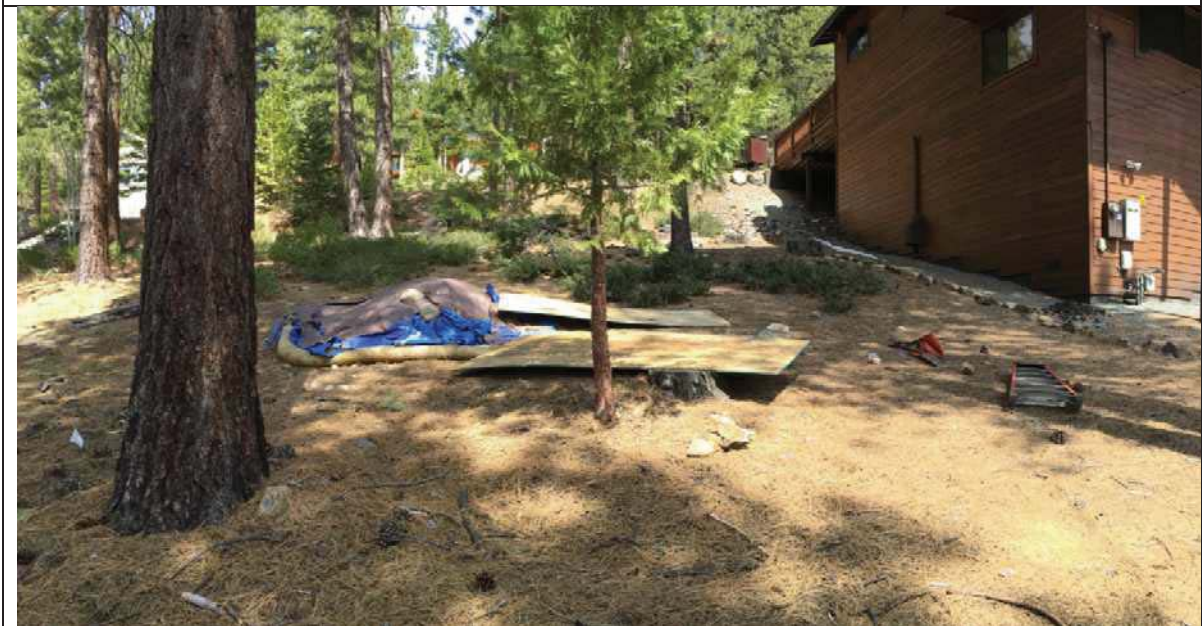
Photo 4 – View northeast (left) to east (right) along north side of residence. The soil pit (between plywood sheets) was dug in this vicinity, since it shows the least degree of past disturbance. The north portion of the parcel is mostly forested and supports Jeffrey pine, incense cedar, greenleaf manzanita, huckleberry oak, whitethorn, and prostrate ceanothus. Soil profile described by Sid Davis (Nov. 2020).

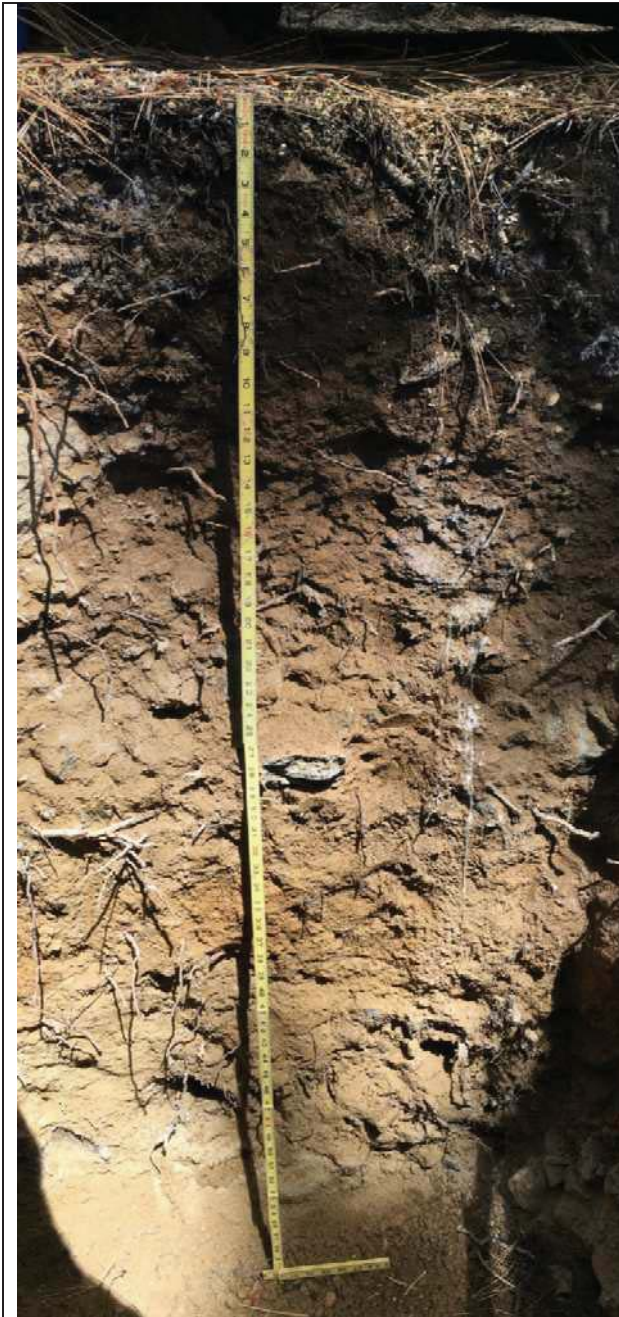
Photo 5 – Soil profile in soil pit located northwest of the residence. The topsoil layer is 24 inches thick and composed of eroded soil from hillside above (colluvium). The subsoil below is 30 inches thick and has thin clay films that qualify those layers as argillic (slightly lower permeability) Profile lacks root-restricting layer (such as a high water table or brittle layer), so this unnamed soil (XXX) qualifies as Class 4, as per Table 4 of the Bailey land capability report.

Soil on the subject parcel does not resemble any of the named series in the 1974 soil survey and therefore it is an unnamed soil (XXX) that is considerably deeper than the Umpa soil type. The Umpa soil also formed only from andesite; however, it is a shallow soil (20 to 40 inches deep). The observed soil has a minor amount of clay accumulation in the subsoil (i.e. cambic horizon), but it is significantly less gravelly/cobbly/stony than the Jorge and Tahoma soils (also found in this vicinity). This deep, unnamed soil lacks a root-restricting layer (claypan, silica-cemented layer, etc.), so it is considered Hydrologic Soil Group B (HSG-B). From Page 20, Table 4 of Land-Capability Classification of the Lake Tahoe Basin, California-Nevada (Bailey, 1974), this unnamed XXX soil with 16 to 30% slopes qualifies as Class 4 (20% allowable land coverage). The subject parcel has only one slope class, so this conclusion applies to the entire parcel (see Attachment C). Slopes associated with the street fill (immediately below Eagle Drive) and minor landscape terraces (west of residence) are not historic conditions, whereas this land capability analysis relies upon pre-disturbance soil conditions. The table below summarizes the changes in land capability as concluded by this land capability challenge.

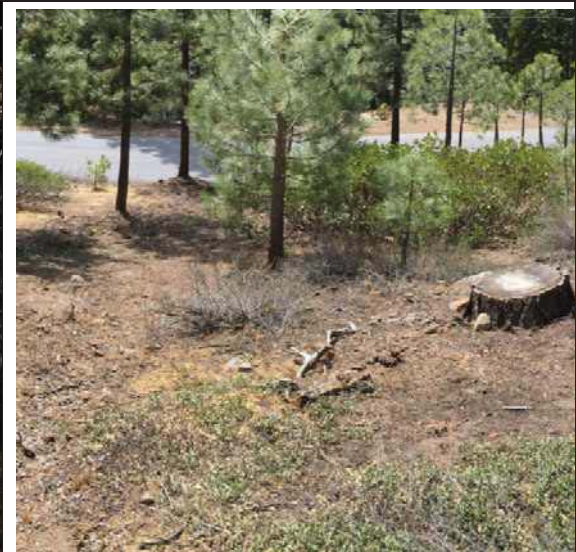
Photo 6 – View of downslope (toward Driver Way to southwest) from southwest part of subject parcel. This vicinity has fewer mature trees and more shrub understory (due to greater solar exposure). Jeffrey pine saplings, along with greenleaf manzanita, and prostrate ceanothus are the dominant plants in the south and center of lot. Slope in this vicinity is 23% (hence, Class 4).

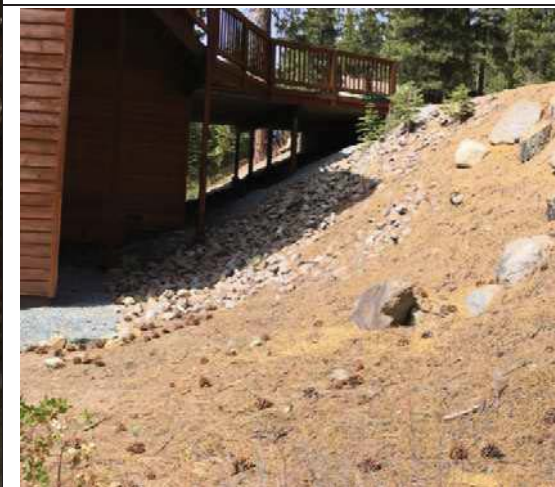
Photo 7 – View north at steep embankment between residence and Eagle Drive. The steep, fill slope was created by original road construction and now has ground cover as scattered shrubs and pine needles/twigs. For land capability purposes, TRPA acknowledges the historic slope, which is estimated as 23 to 29% (steeper toward south prop. line.). Class 4 has a slope range of 16 to 30%.

TRPA Findings	
2006 Soil Survey Map Unit	Jorge very cobbly fine sandy loam, 15 to 30% slopes (map unit 7152), Class 4, HSG-B.
Consultant Soil Mapping Determination and Rationale	The observed soil does not match the mapped UmE soil or other soils described in the 1974 soil survey (hence unnamed, XXX). It is deep, well drained, and has gravelly sandy loam (HSG-B) in the upper 55 inches of the profile. The soil is deeper than the Umpa series, and less rocky and less clayey than the Jorge and Tahoma series, respectively. No evidence of perched water table or other restricting layer. Rooting depth is deeper than 60-inch pit depth.
Slope Determination	23% for majority of parcel, with slopes up to 25 to 29% in the northwest and southeast corners, respectively. Minor landscaping terraces (20%) and street fill slopes (35 to 58%) are exempt.
TRPA Conclusion(s)	XXX Soil, HSG-B, Class 4 for 16 to 30% slopes (20% base allowable cover). Created fill slope below Eagle Drive was historically 16 to 30% slopes, hence also Class 4.
