STAFF REPORT

Subject: ECN Tahoe LLC Land Capability Challenge, 6674 North Lake Boulevard, Placer County, California, APN 117-072-007, TRPA File Number LCAP2022-0299

**Land Capability Assessment  
For  
Placer APN 117-072-007  
6674 N. Lake Blvd., Tahoe Vista, CA**

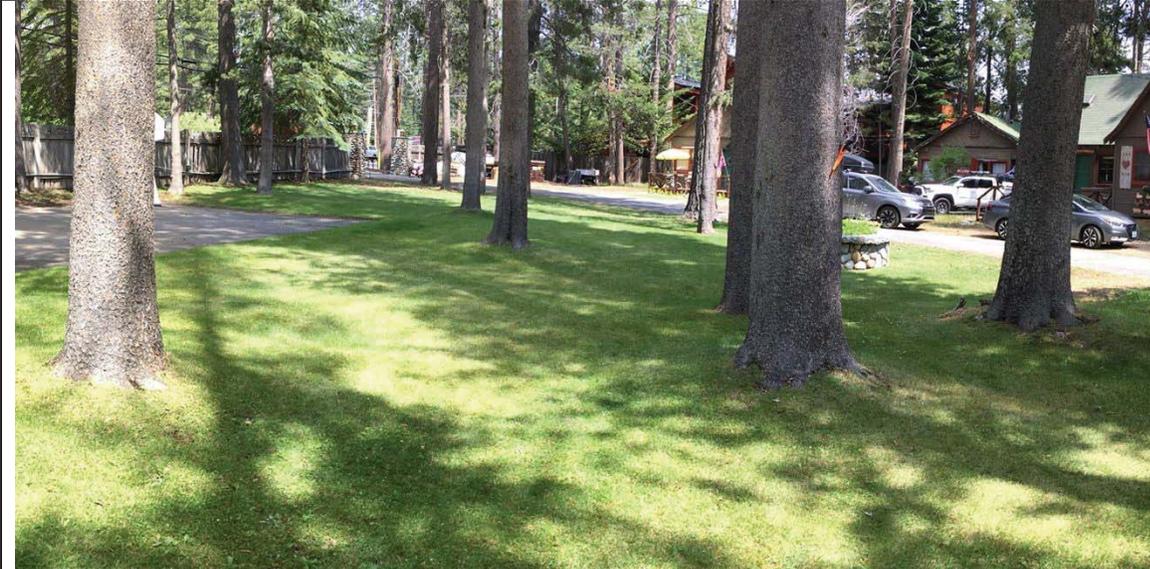
Photo 1 – View east at lawn area between North Lake Blvd. (also Highway 28) and row of rental cabins (far right edge of photo) . The north part of the property is vegetated with lodgepole pine, Jeffrey pine, and white fir. The understory is mostly landscaped lawn, shrub and scattered native currant shrubs.

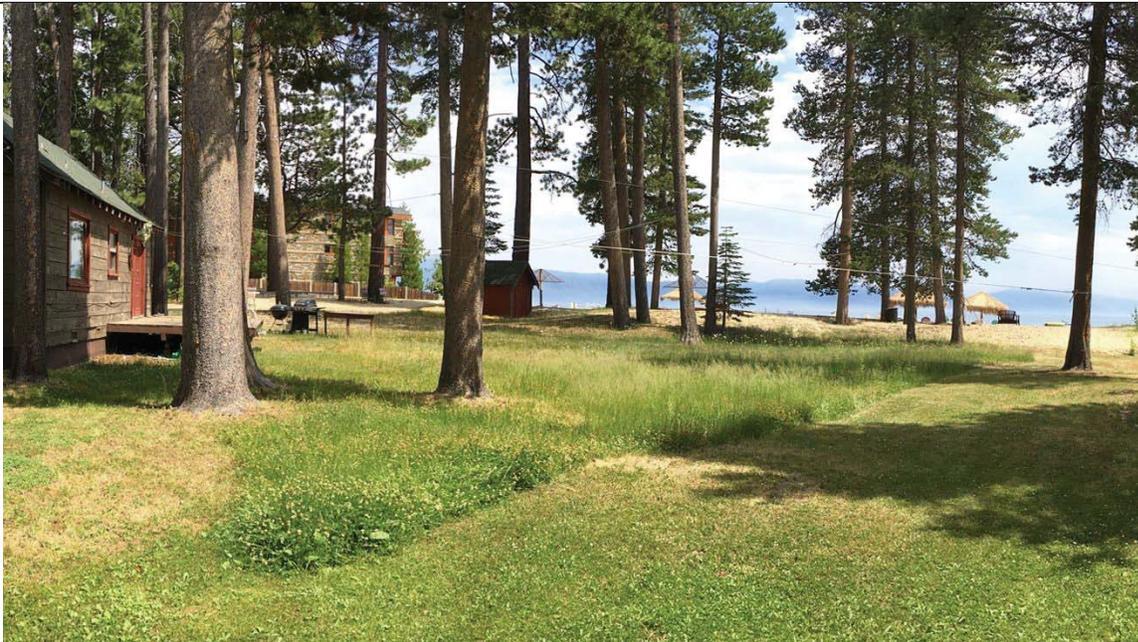
Photo 2 – View southeast at land area south of rental cabins. Such area is regularly mowed but not irrigated. The surface is mostly flat, with slight dip to the south. Soils in this vicinity are windblown sand deposits, 10 to 30 inches thick atop buried soils. Pictured area is unnamed, 0 to 5% slopes (XXX, Class 7).

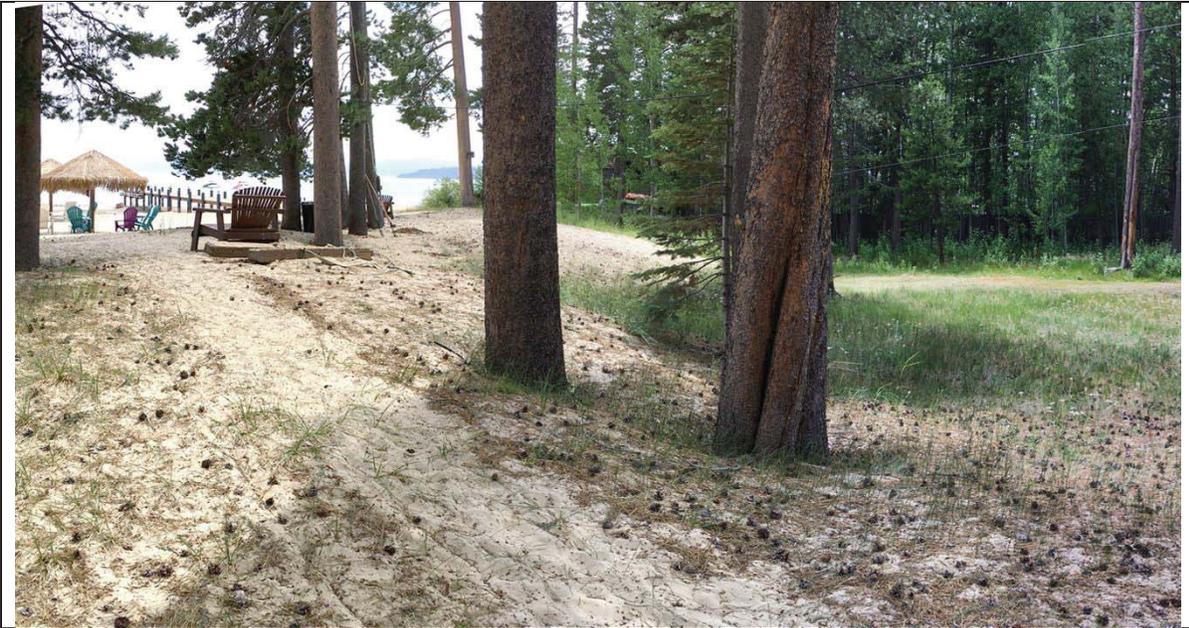
Photo 3 – View southwest at subtle ridge (left side of photo) that has slopes 5 to 16%. Recent sand deposition (via wind action) is 30 to more than 40 inches thick. Baltic rush (often associated with SEZs) grows extensively in sandy deposits by spreading underground via roots (not in response to wetness).

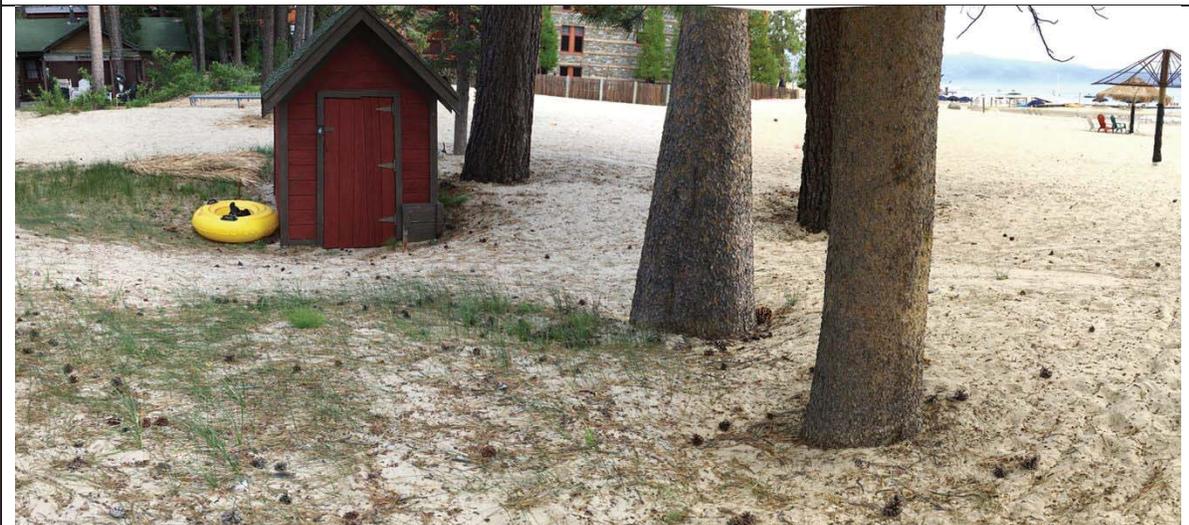
Photo 4 – View east by southeast at south portion of property. Windblown sand noticeably accumulates on windward side of trees and leaves a small hollow on the leeward side. Such accumulation is accelerated by extensive foot traffic that disturbs the soil surface and allows strong southwest to northeast winds to move sands further north into parcel. Pictured area is unnamed soil, 5 to 16% slopes (XXX, Class 6).

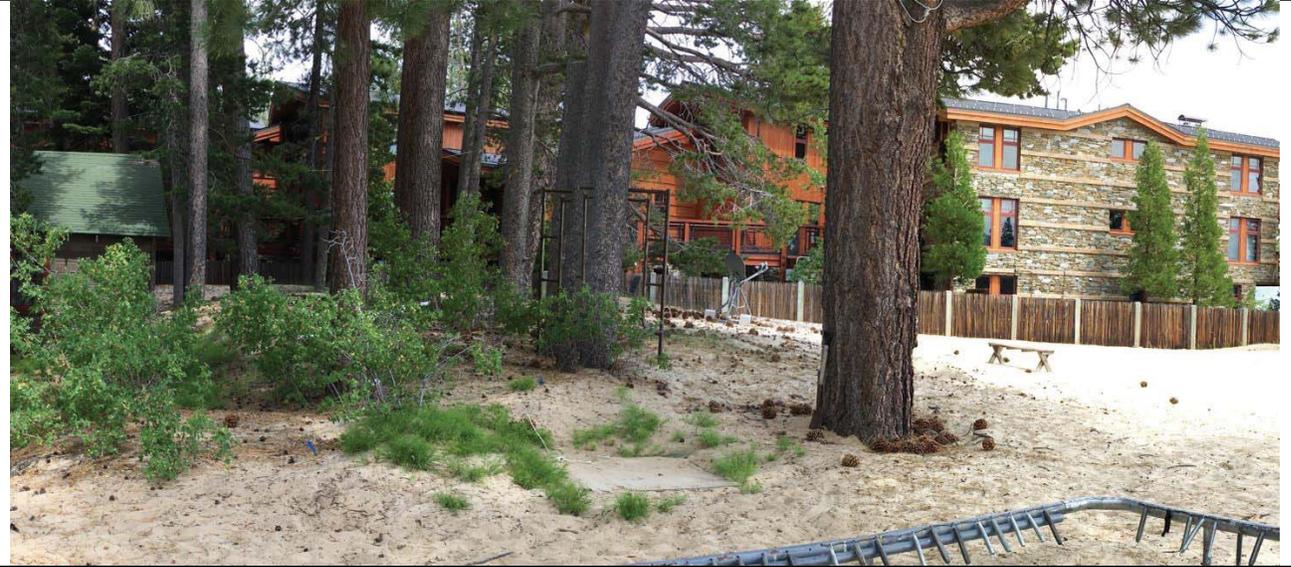
Photo 5 – View east by southeast toward subtle ridge that has formed south of several rental cabins and maintenance sheds. Lodgepole pine and Jeffrey pine pre-date sand deposition, which now has buried the original soil the trees became established upon. Understory vegetation is native current and bluegrass.

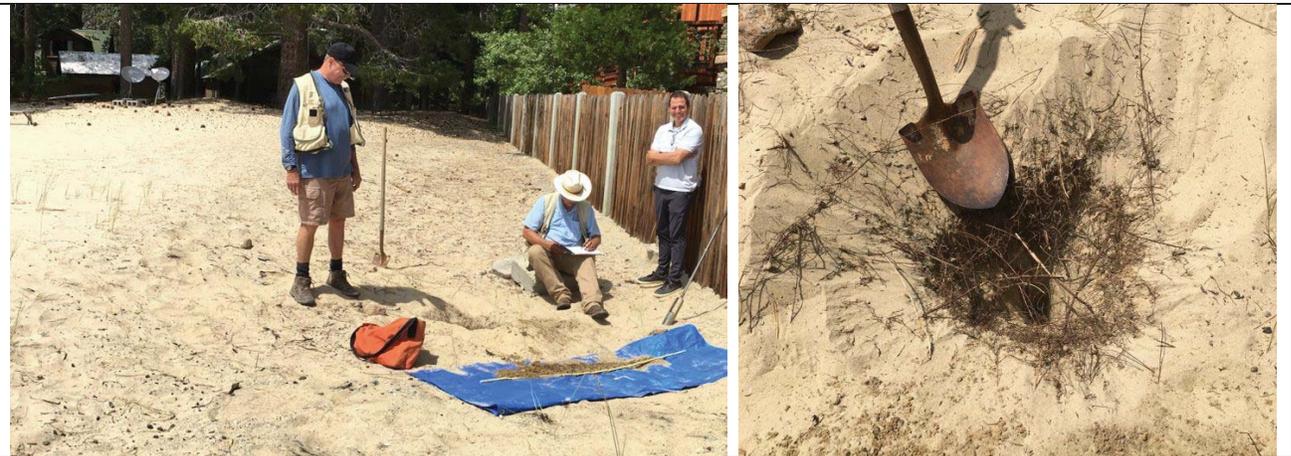
Photo 6 – View north near southeast property corner. TRPA consultant hand-dug and augered hole in this vicinity to better understand how excessive foot traffic gave area a dune-like appearance. The soil in this vicinity has many roots below 6-inch depth, which indicates such area is stable and does not qualify as beaches. If not for the ongoing foot traffic, such area would likely be partially vegetated with saplings, shrubs and scattered grasses / forbs.

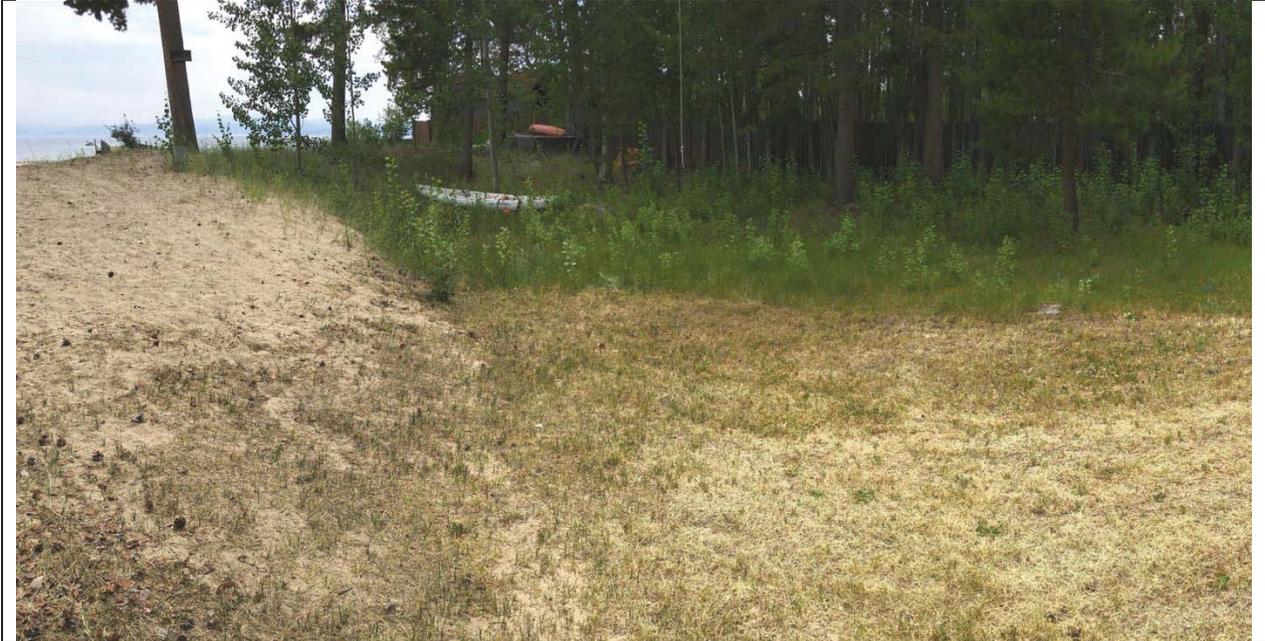
Photo 7 – View southwest at subtle ridge of wind-deposited sand (unnamed soils, 5 to 16% slopes, Class 6). Such ridge is 2 to 3 feet higher than the older sand deposited in the center and right side of photo. The unmowed area in background is slightly lower and qualifies as Stream Environment Zone (SEZ, Class 1B).

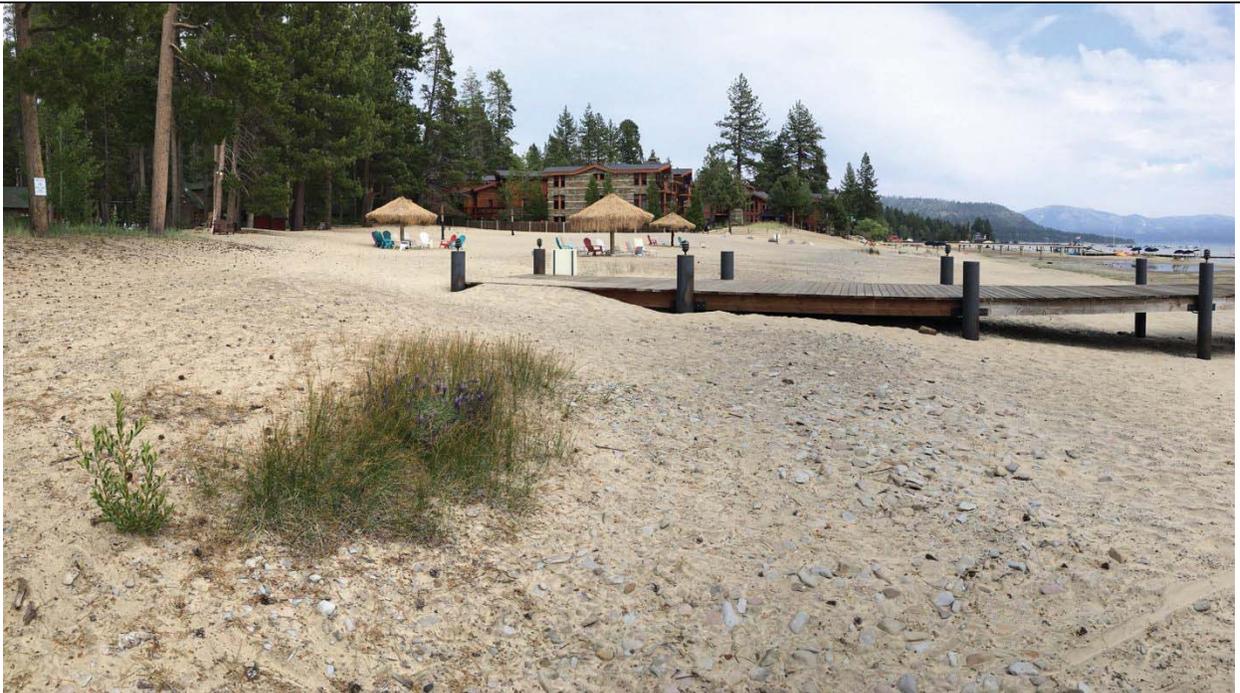
Photo 8 – View east along Lake Tahoe shoreline. The area delineated as Beaches is the grayer, more rocky surface below (right) of the patch of Baltic rush (left foreground). Beaches are unconsolidated sands and gravels that generally lack vegetation and rooted material below the surface. Beaches are considered Class 1B.

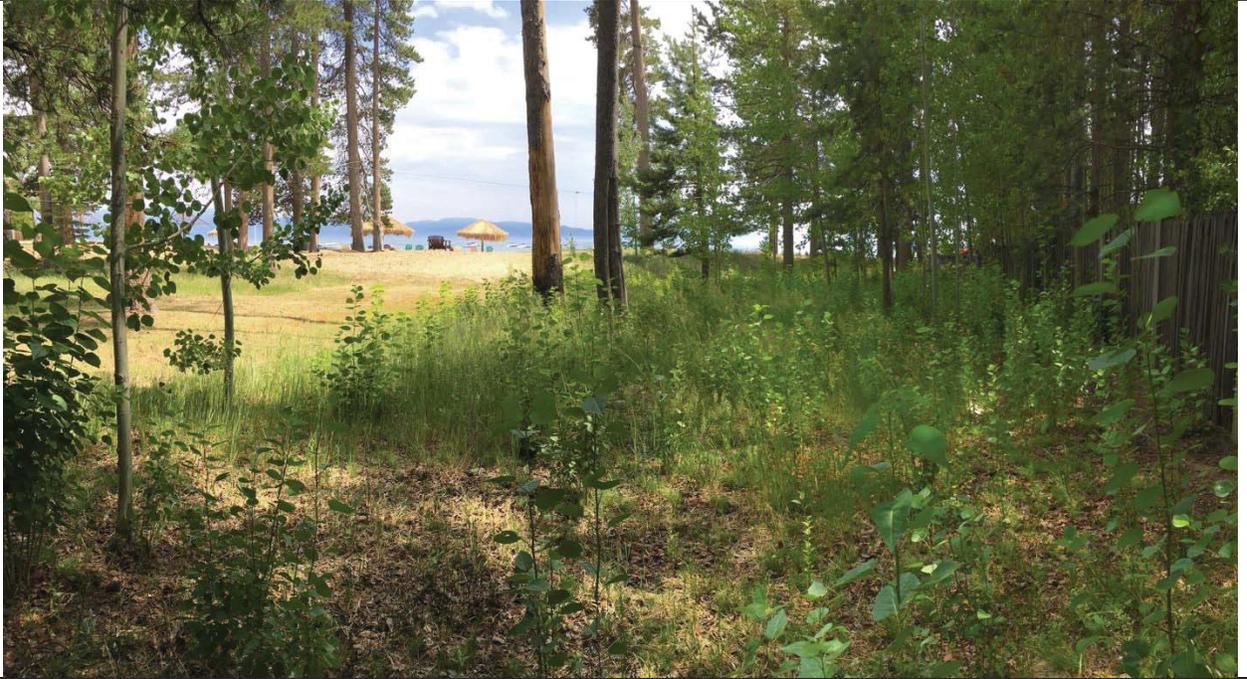
Photo 9 – View south toward center of delineated SEZ area. The SEZ is dominated by quaking aspen, lodgepole pine, saplings, field horsetail, Baltic rush, sedges, bluegrass and other grasses/ forbs. Such area met SEZ key (primary) indicator for vegetation.

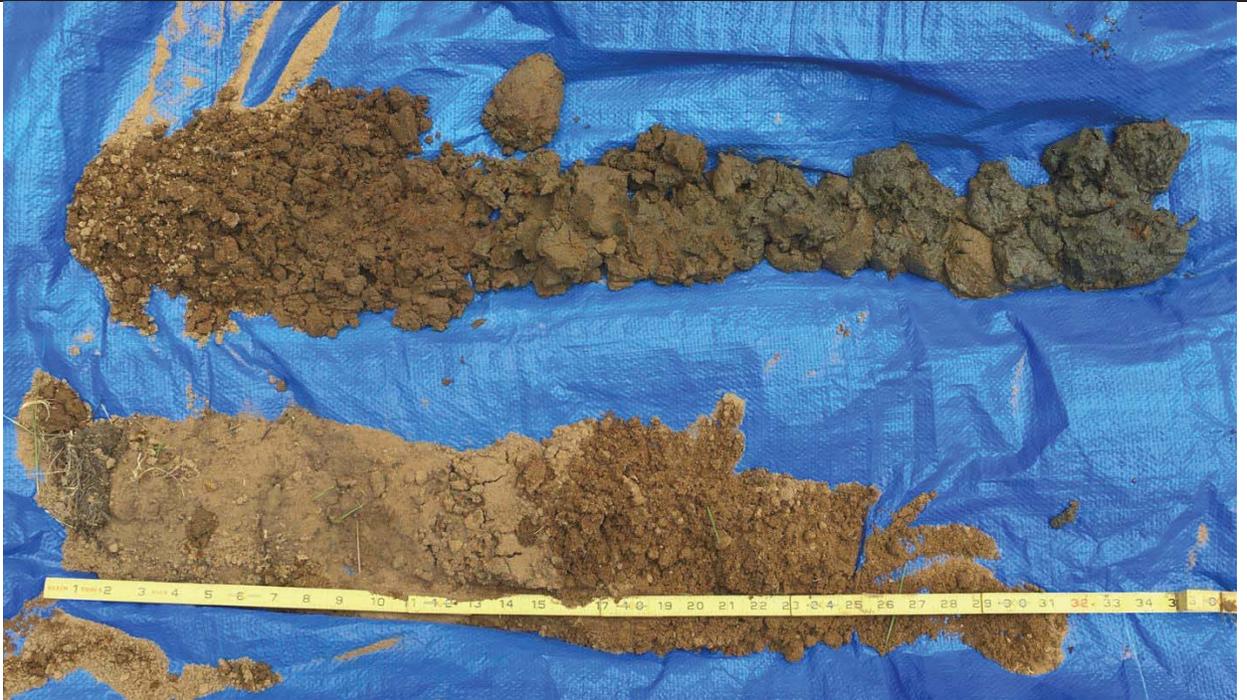
Photo 10 – Close-up view of soil profile for SEZ area near southwest corner of subject parcel. The surface layer (0 to 16 inches) has familiar brown topsoil color, while deeper layers have increasing abundance of iron stains (aka redoximorphic concentrations) and grayer matrix color. Seasonal high water table was present at 46.5 in.

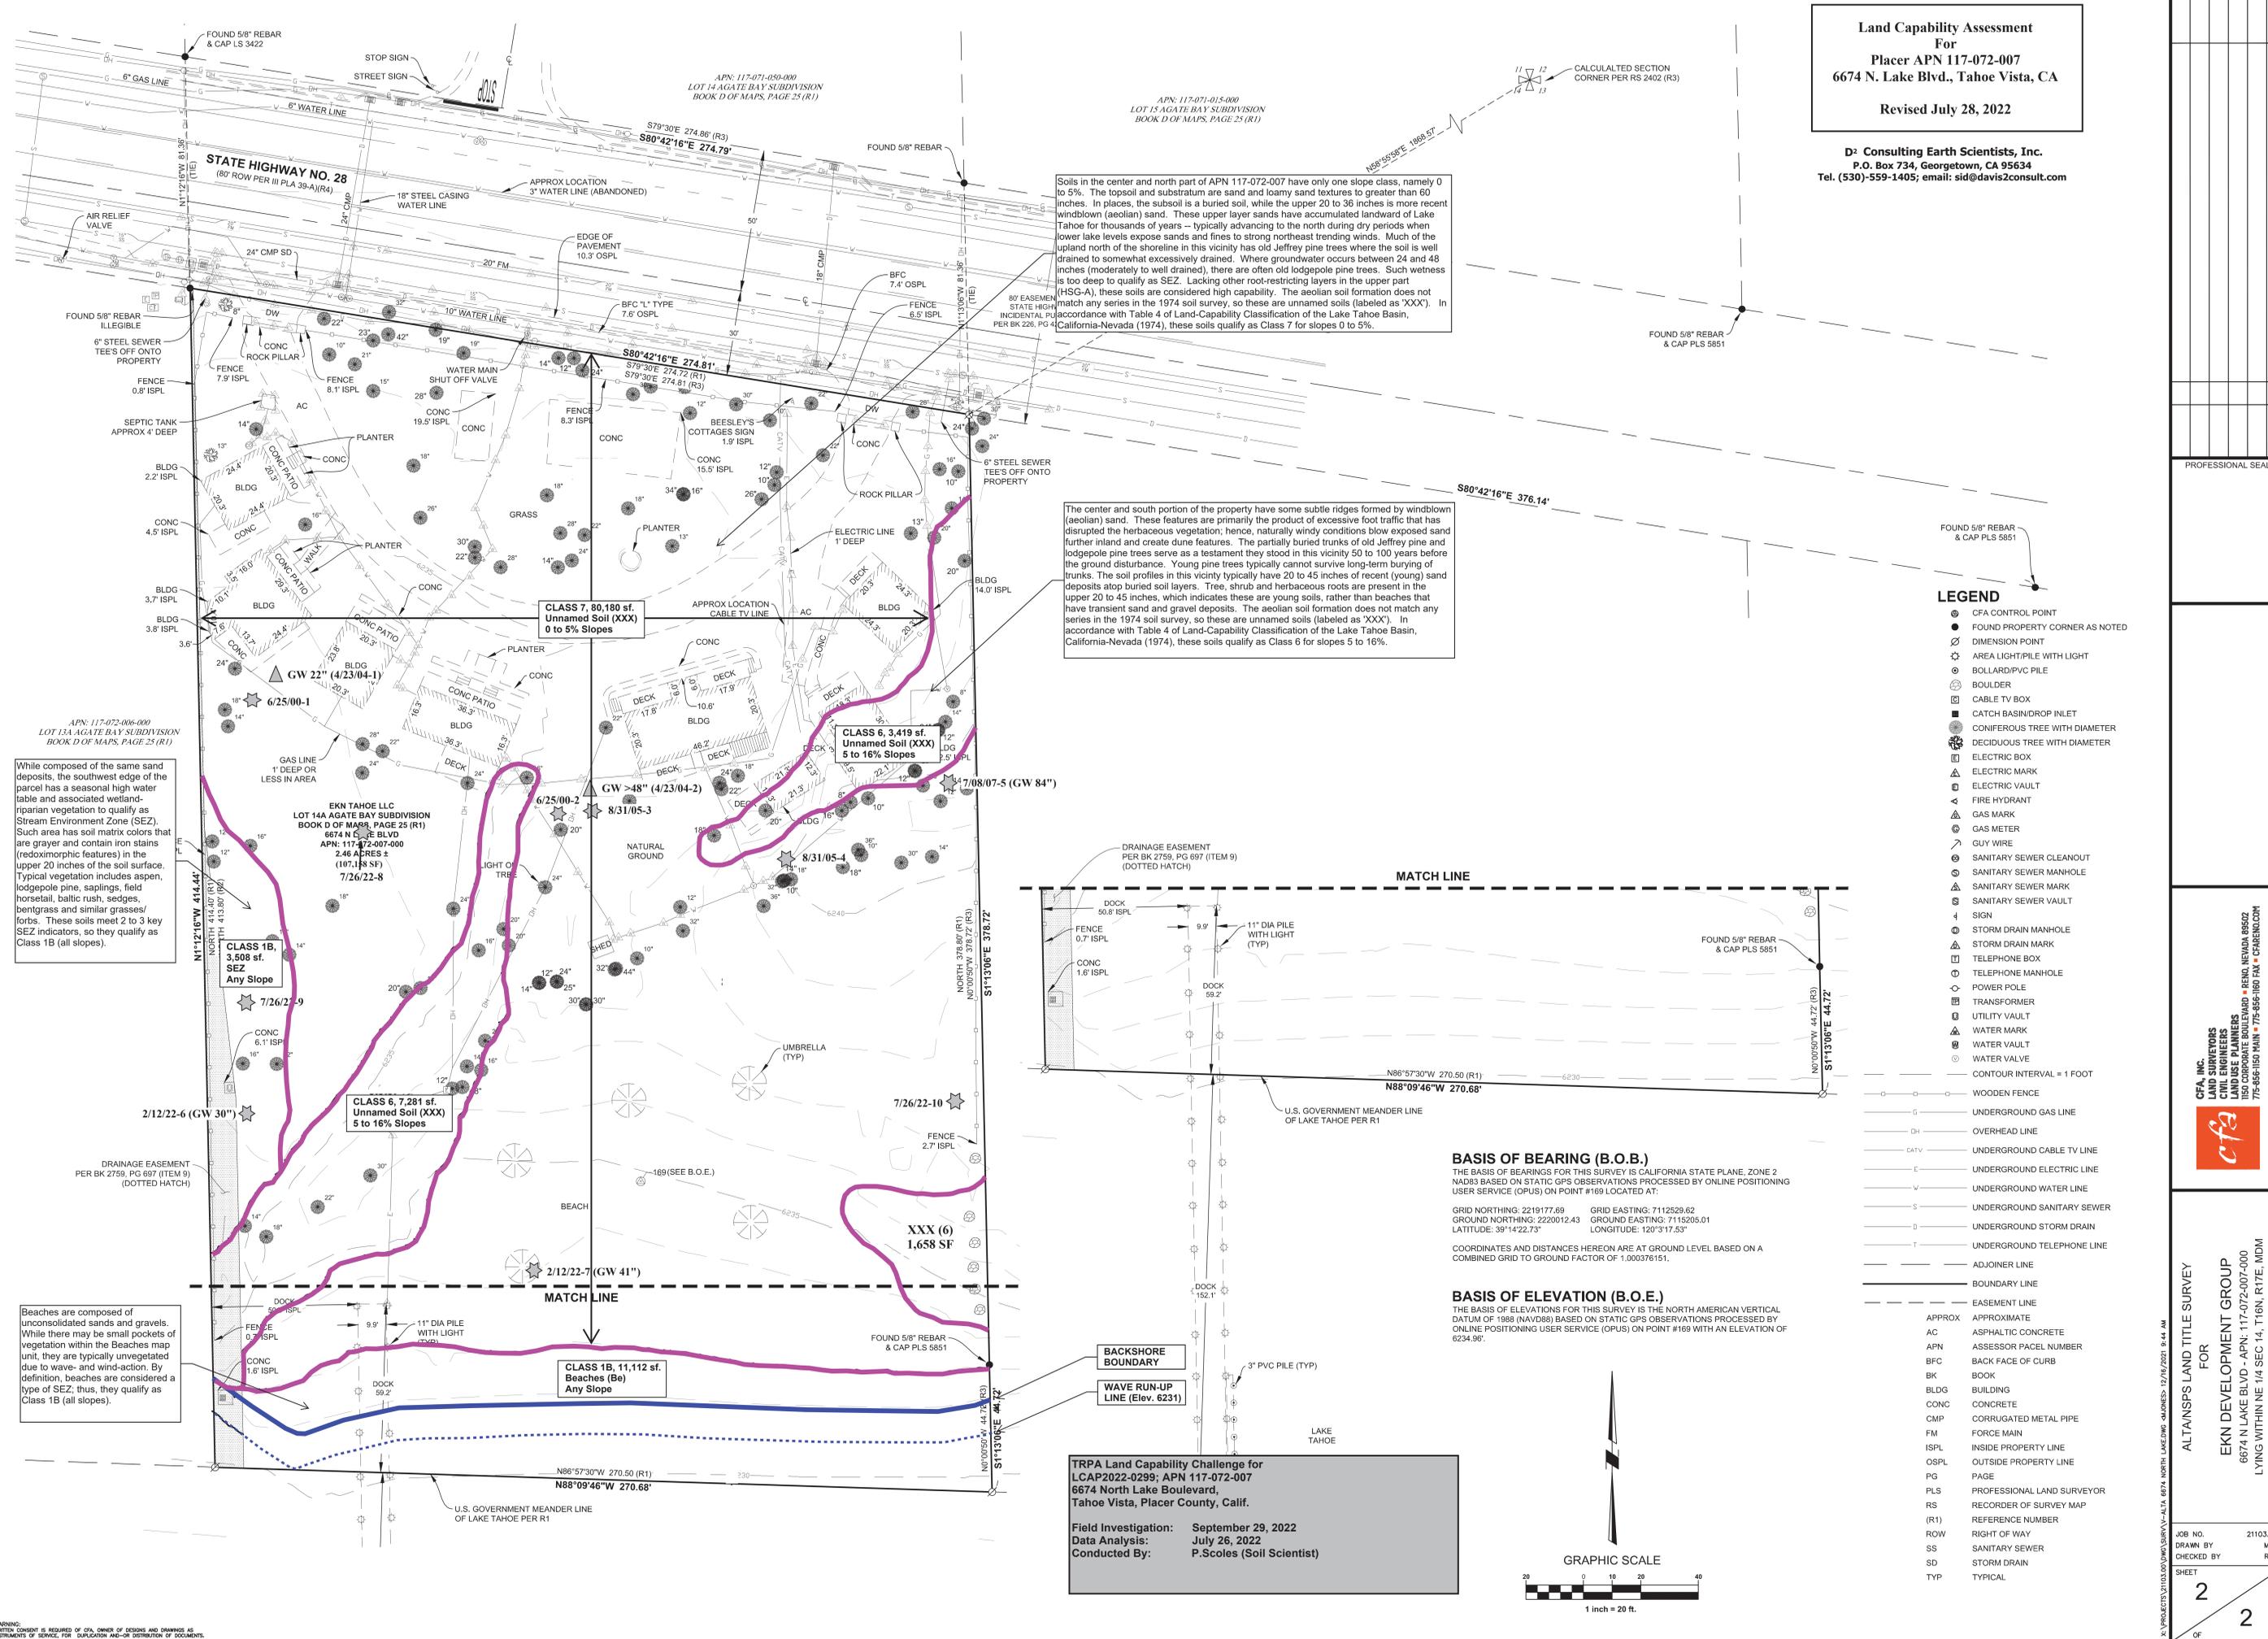
Soils in the center and north part of APN 117-072-007 have only one slope class, namely 0 to 5%. The topsoil and substratum are sand and loamy sand textures to greater than 60 inches. In places, the subsoil is a buried soil, while the upper 20 to 36 inches is more recent windblown (aeolian) sand. These upper layer sands have accumulated landward of Lake Tahoe for thousands of years – typically advancing to the north during dry periods when lower lake levels expose sands and fines to strong northeast trending winds. Much of the upland north of the shoreline in this vicinity has old Jeffrey pine trees where the soil is well drained to somewhat excessively drained. Where groundwater occurs between 24 and 48 inches (moderately to well drained), there are often old lodgepole pine trees. Such wetness is too deep to qualify as SEZ. Lacking other root-restricting layers in the upper part (HSG-A), these soils are considered high capability. The aeolian soil formation does not match any series in the 1974 soil survey, so these are unnamed soils (labeled as 'XXX'). In accordance with Table 4 of Land-Capability Classification of the Lake Tahoe Basin, California-Nevada (1974), these soils qualify as Class 7 for slopes 0 to 5%.

The center and south portion of the property have some subtle ridges formed by windblown (aeolian) sand. These features are primarily the product of excessive foot traffic that has disrupted the herbaceous vegetation; hence, naturally windy conditions blow exposed sand further inland and create dune features. The partially buried trunks of old Jeffrey pine and lodgepole pine trees serve as a testament they stood in this vicinity 50 to 100 years before the ground disturbance. Young pine trees typically cannot survive long-term burying of trunks. The soil profiles in this vicinity typically have 20 to 45 inches of recent (young) sand deposits atop buried soil layers. Tree, shrub and herbaceous roots are present in the upper 20 to 45 inches, which indicates these are young soils, rather than beaches that have transient sand and gravel deposits. The aeolian soil formation does not match any series in the 1974 soil survey, so these are unnamed soils (labeled as 'XXX'). In accordance with Table 4 of Land-Capability Classification of the Lake Tahoe Basin, California-Nevada (1974), these soils qualify as Class 6 for slopes 5 to 16%.

While composed of the same sand deposits, the southwest edge of the parcel has a seasonal high water table and associated wetland-riparian vegetation to qualify as Stream Environment Zone (SEZ). Such area has soil matrix colors that are gray and contain iron stains (redoximorphic features) in the upper 20 inches of the soil surface. Typical vegetation includes aspen, lodgepole pine, saplings, field horsetail, Baltic rush, sedges, bentgrass and similar grasses/forbs. These soils meet 2 to 3 key SEZ indicators, so they qualify as Class 1B (all slopes).

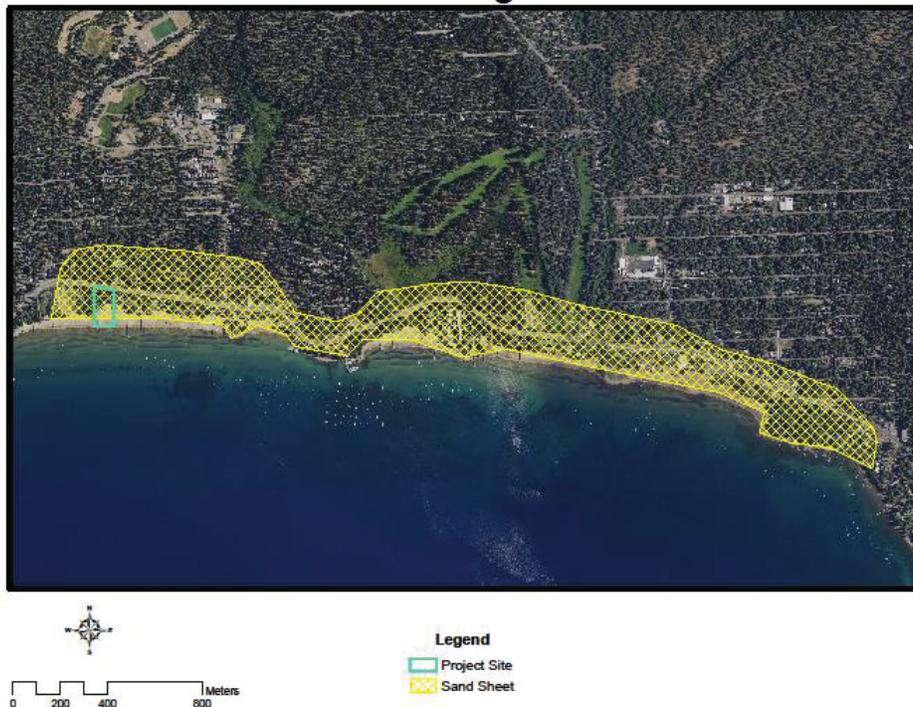
The landform at Tahoe Vista consists of accretionary deposits derived from the exposed shoreline below high and low surface water during periods when the lake level dropped below the spillway at the dam at Tahoe City (Elevation 6,229.1 feet). Deposits at 6674 North Lake Boulevard, and elsewhere in Tahoe Vista and Kings Beach, constitute a sand sheet, composed dominantly of 0.05-1.0 mm sand, and are devoid of coarse sand (1.0-2.0 mm) and gravel size (2.0 mm – 75.0 mm) aggregates. Similar eolian deposits are identified in the area through other soil investigations performed by Davis<sup>2</sup>, well north of State Route 28 at this locale and extending for some distance to the east end of Kings Beach, which measure at a minimum 200 acres (Figure No. 2).

Figure 2- Sand sheet area at Tahoe Vista-Kings Beach.

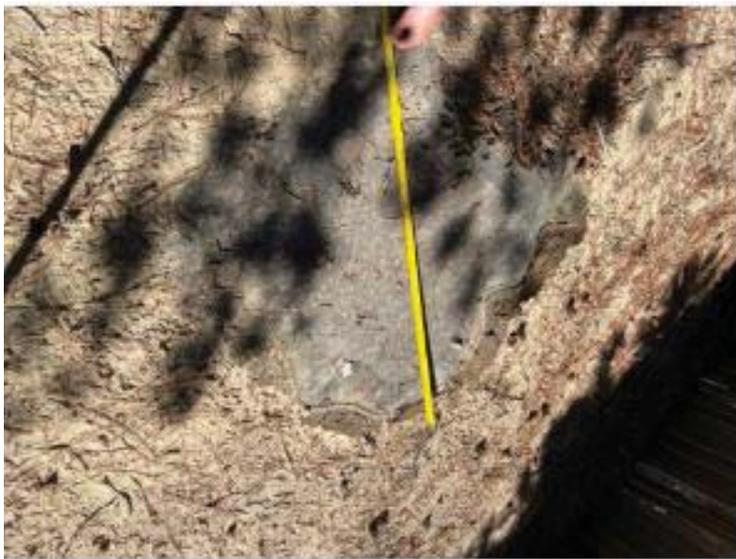
The landform is predominantly vegetated with mature mixed conifer. One older cedar tree on the subject property (above elevation 6,240 feet), showing as 80 inches in diameter on the LCV map (Figure 3), was removed sometime between 2007 and 2022. On its measured stump radius of 36 inches, approximately 16-18 tree rings per inch were counted (Figure 4). Assuming one tree ring forms per year of growth, the estimated age

of the tree is around 576-648 years old. The presence of a tree this size/age is indicative of relatively long-term landscape stability.

Figure 4 - Cedar tree stump, 36" radius.

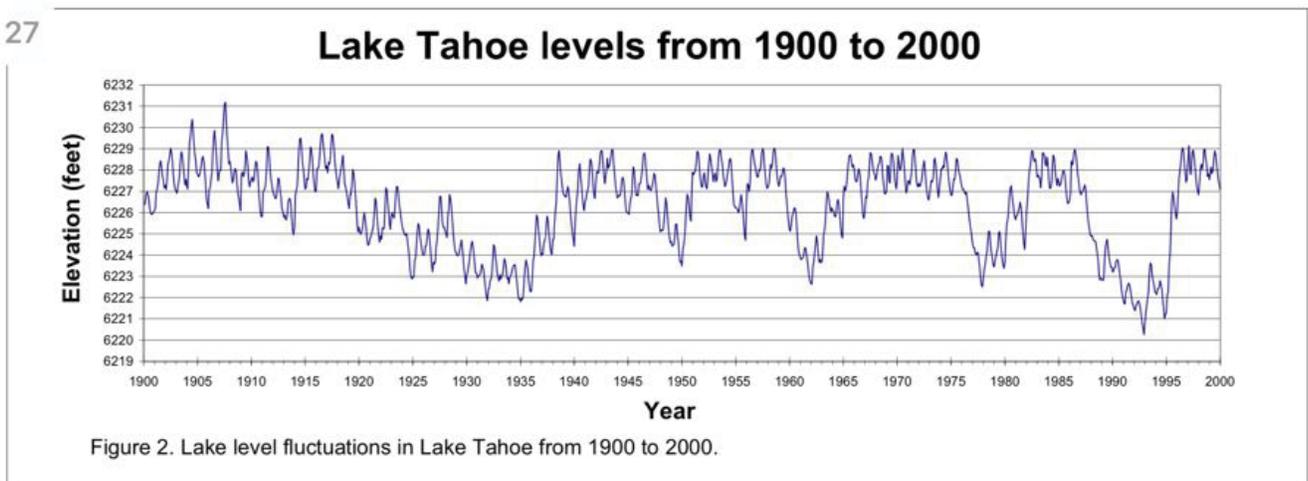
Adams (2001) also shows that lake levels have been below the Tahoe City dam spillway (Elevation 6,229.1 feet) for approximately 70 percent of the last century, indicating that the swash zone between historically high and low water levels has been left exposed along the rim of lake. These areas of exposed sediment provide a source for windblown material. Given that the prevailing winds are from south to north (Western Regional Climate Center, 2022), areas above the shoreline in and around Tahoe Vista-Kings Beach are prone to accumulate eolian materials well above the historic high-water line. Where the eolian material is thickest, HSG A is interpreted. Where the eolian material is greater than 20 inches but less than 40 inches to seasonal groundwater table from the present ground surface, HSG B is interpreted (NRCS 2009). Soils in HSG A and B, according to Bailey's (1974) criteria, place Land Capability in Class 7 where slopes are less than 5 percent gradient.

Figure 5- Lake level elevations (Adams, 2001)

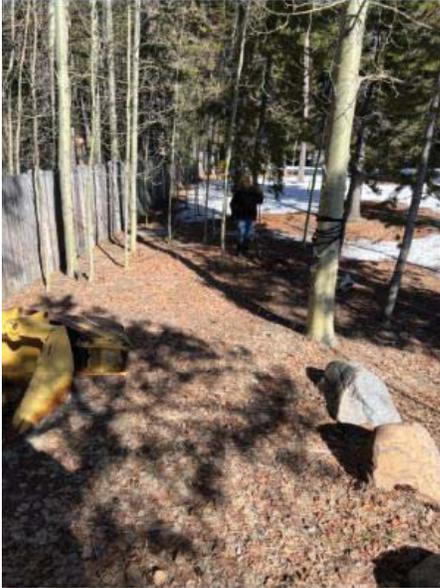
A limited area of Aspen trees (Figure 6) growing along and within the drainage easement along the west property line (Appendix 2) justify SEZ by primary indicators.

Figure 6 - SEZ area.

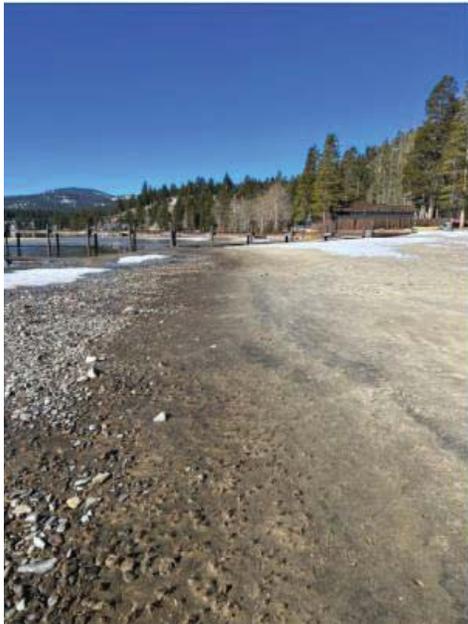
The modern beach expresses coarse gravel deposits, including coarse sand and finer materials in and below the swash zone (Figures 7 and 8). Stop No. 7 (Appendix 2) is near the second inland umbrella stand at an elevation of 6,234 feet. The presence of gravels and coarse sands are absent landward within the eolian deposits. Groundwater was encountered at this site 41 inches below ground surface, putting the water table slightly above 6,230 feet elevation, thus placing the Be delineation lakeward of and below elevation 6,233 feet contour. Adams (2004) design storm wave transect locations numbers 55 and 56 place wave runup elevation at this site at 6,230 feet elevation.

Figure 7 – Gravel associated with the Be unit.

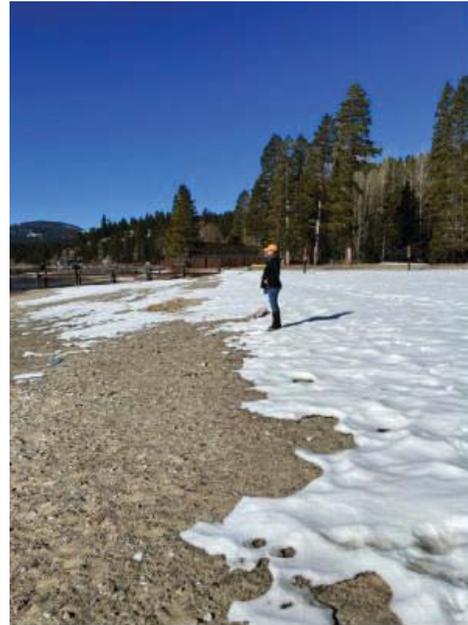
Figure 8- Geologist marking the Be / Upland boundary.

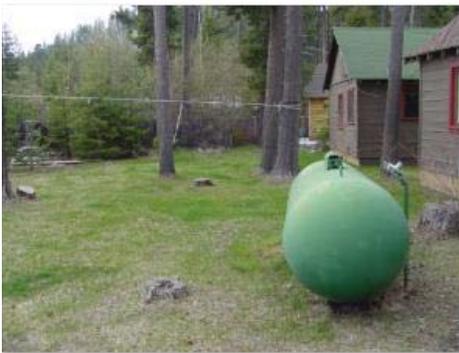
Drainage Class: Moderately well

Soil Hydrologic Group: B

Figure 9 - Looking west, area of Stop 1 and GW 1.

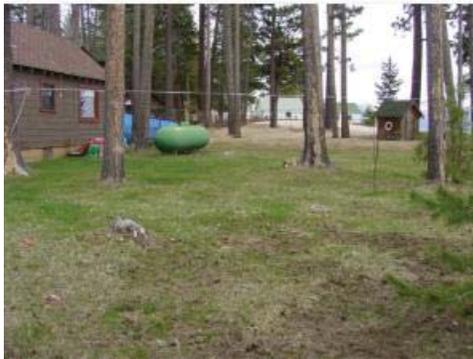
Soil Drainage Class: Excessive

Hydrologic Soil Group: A

Figure 10 - Looking west, area of Stops 2, 3, 4 and GW 2.

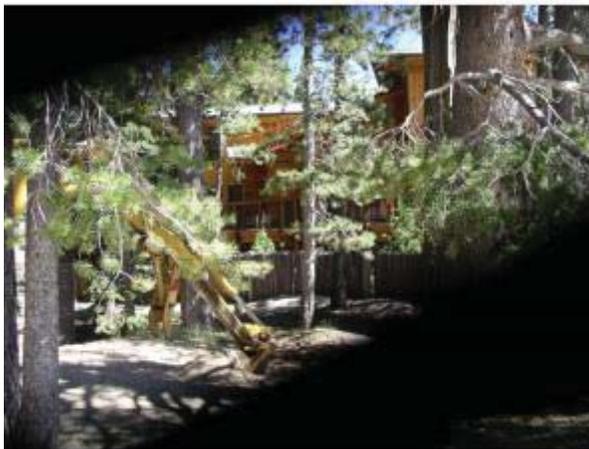
Soil Drainage Class: Excessive

Hydrologic Soil Group: A

Figure 11 - Stop 5 looking west. roots.

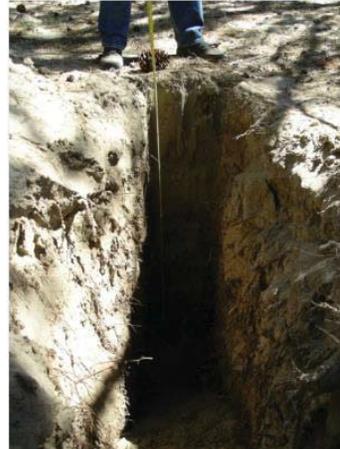
Figure 12 - Stop 5 excavation, note many roots.

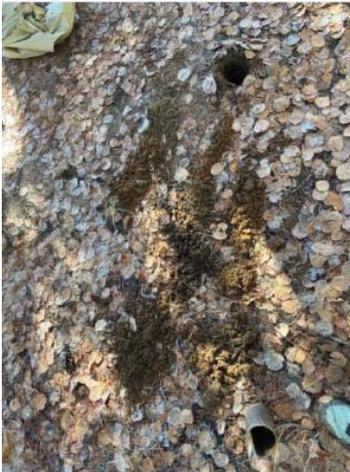
Soil Drainage Class: Moderately well drained

Soil Hydrologic Group: B

Figure 13- Stop 6, auger hole and soil material.

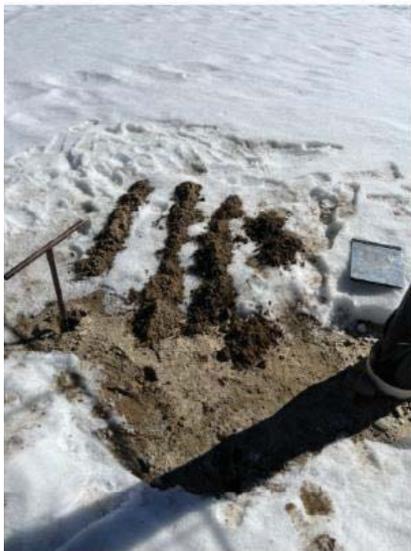
Soil Drainage Class: Excessive

Soil Hydrologic Group: A

**Figure 14 - Stop 7, auger hole and soil material**

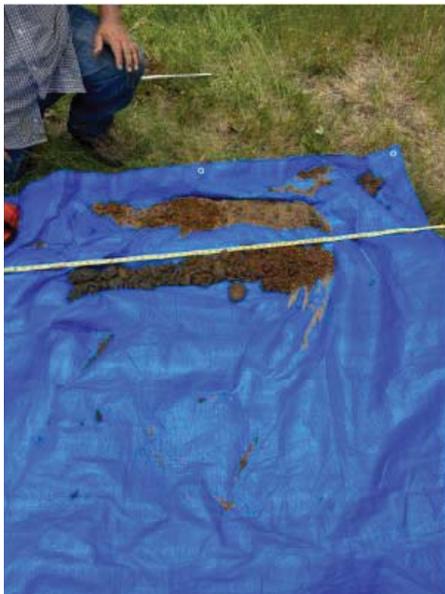
Drainage Class: Moderately well

Soil Hydrologic Group: B

Figure 15, Stop 8 soil description site materials.

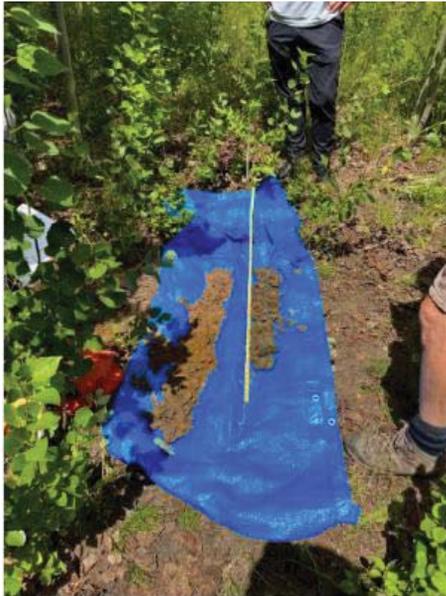
Drainage Class: Moderately well

Soil Hydrologic Group: B

Figure 16 - Stop 9 soil materials.

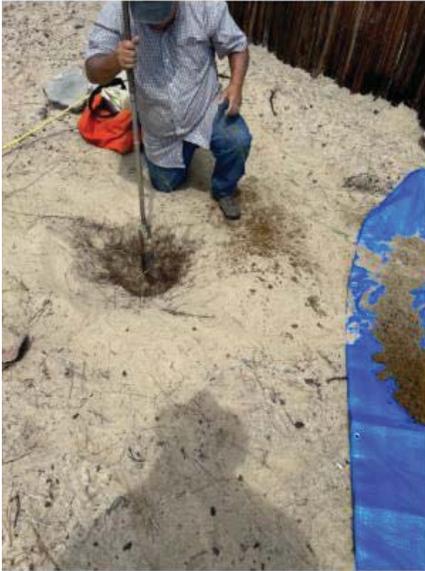
Soil Drainage Class: Excessive

Hydrologic Soil Group: A

Figure 17 - Stop 10 showing rooted surface.

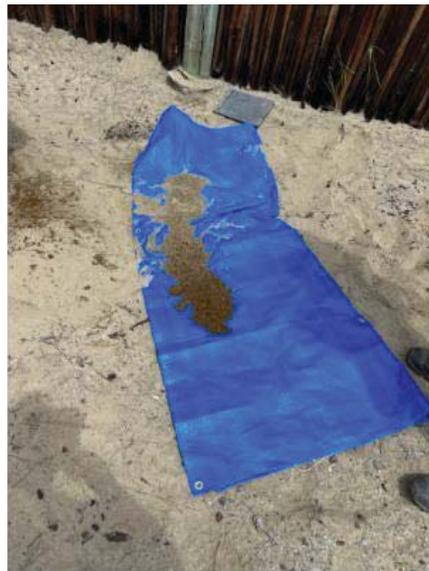
Figure 18 - Stop 10 showing dark buried surface at 36 inches depth.
