CHAPTER 9

Scenic Resources

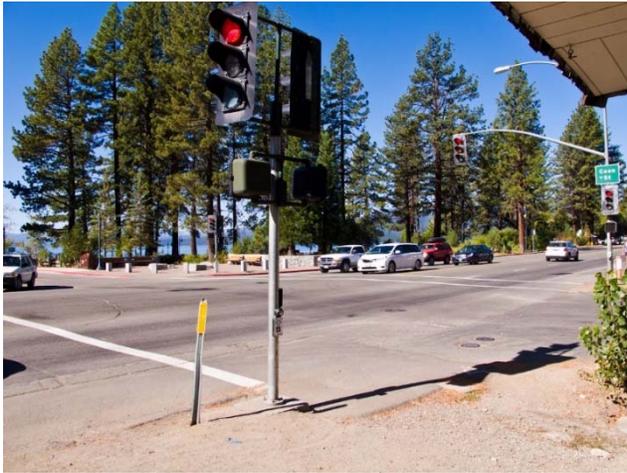
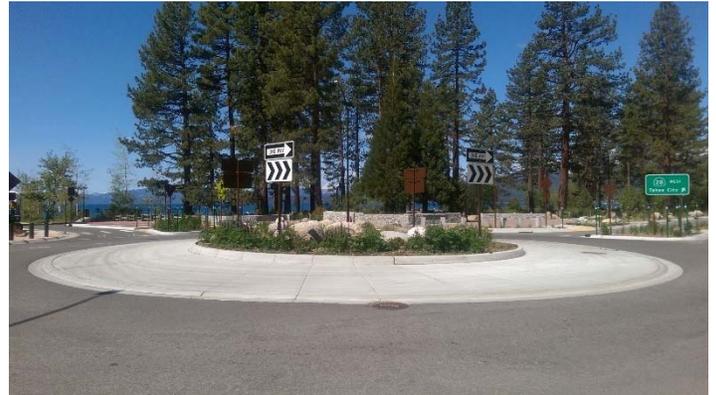
Figure 9-2: Intersection of Coon Street and State Route 28 in Kings Beach before (left) and after (right) installation of a roundabout.

One roadway unit, Unit 20B Kings Beach, moved from nonattainment into attainment. The score increased 2.5 points from the 2011 rating with scores improving in the man-made features and road structures categories. This section of Kings Beach has seen the implementation of a portion of the Kings Beach Commercial Core Improvement Project which has substantially redesigned portions of State Route 28 through Kings Beach with reduction of travel lanes and the installation of sidewalks, roundabouts, and landscaping.

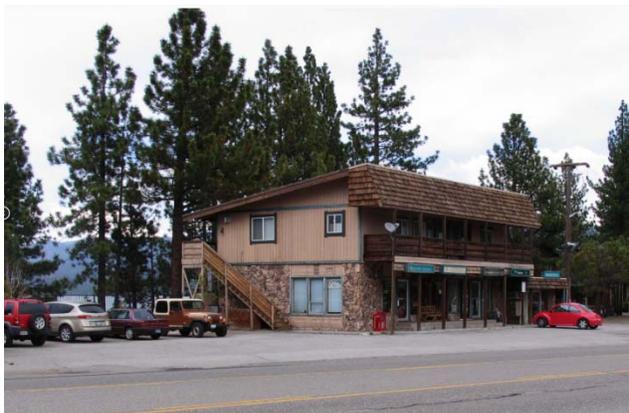
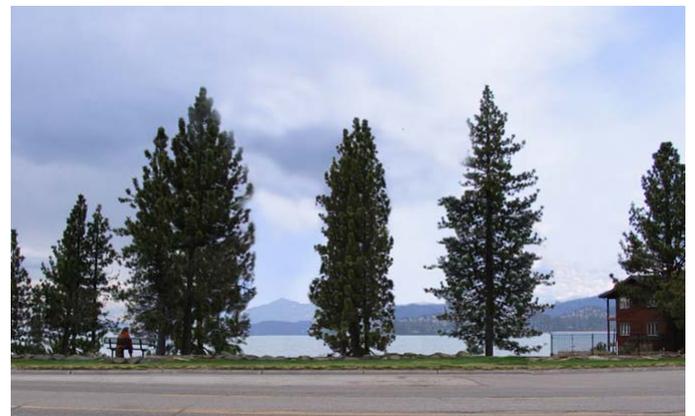
Figure 9-3: Photo of the Alta Mira building before (left) and after removal (right) which increased views to Lake Tahoe from U.S. Highway 50 in the City of South Lake Tahoe.

1. Roadway Unit 34 El Dorado Beach increased was already in attainment but the score increased due to the Alta Mira building being removed which increased views to the lake and the Harrison Avenue project which reconfigured parking, installed sidewalks, and improved landscaping.

1. Roadway Scenic Resource Number 34.2 increased because of the removal of the Alta Mira building which increased views to the lake (see Figure 9-3).
2. Roadway Scenic Resource Number 20.4 score included due to the streetscape improvements for the Kings Beach Commercial Core Improvement project.
3. Roadway Scenic Resource 11.4 increased as a result of curb and gutter installation as part of a Caltrans water quality improvement project which improved the unity score for this resource.

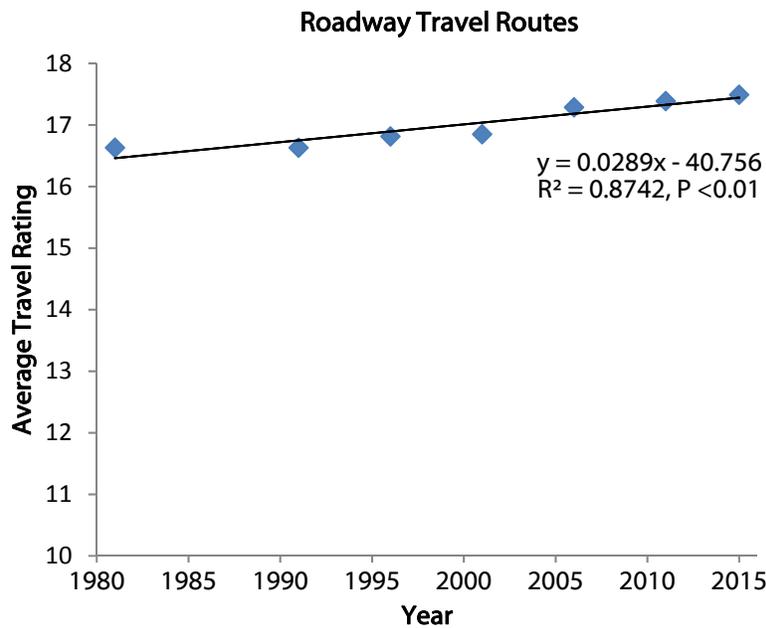
Figure 1: Change in average Roadway Travel Route Rating by year, 1982 to 2015. The average scores show a statistically significant, but slow, improving trend.

Another way to assess the trend is to compare the average ratings of all roadway travel units over time. The average scores have steadily improved from 1982 to 2015, which can be seen in Figure 1. The average scenic score for all roadway travel route units has steadily increased from 16.63 in 1982 to 17.49 in 2015, with the long term trend line showing an increase of 0.17 percent per year. While this is a marked improvement, because change is occurring very slowly it would be considered little to no change using the methodology described in Chapter Two of this report.

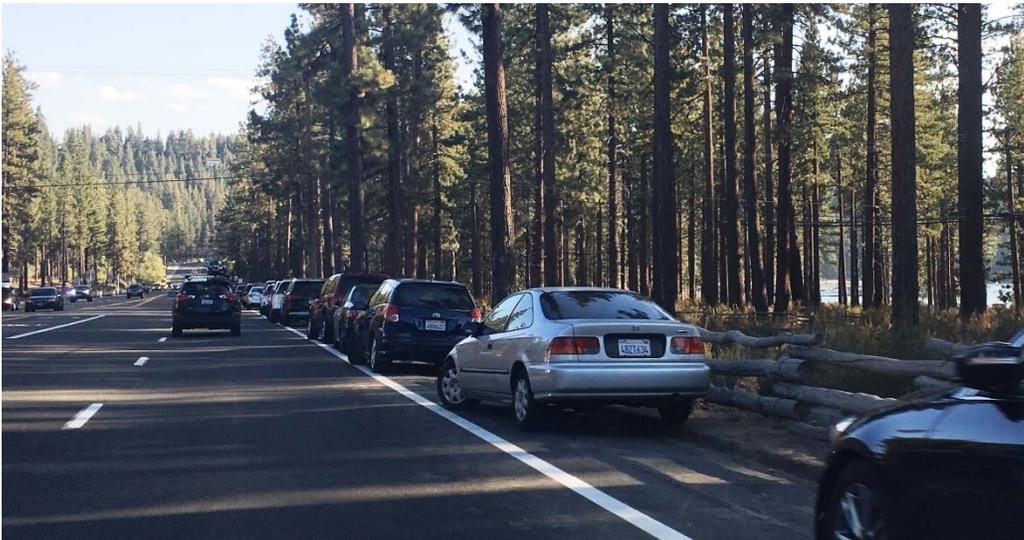
Figure 2: Uncontrolled parking along many sections of scenic roadway units continues to cause roadway distractions and blocks views to the lake putting these scenic units at risk of falling out of attainment. Highway 50 near Zephyr Cove Beach September 2016.

- Significant roadwork in some units is still in the planning stage. Once constructed these improvements should raise the road structure scores as they have in other roadway units.
- Although redevelopment of existing buildings has occurred and are noted as improvements, not enough redevelopment has occurred to increase the score into attainment.
- Unauthorized roadway parking is occurring along a number of roadway units and in some cases is extensive. This is causing visual distraction and blocking views to Lake Tahoe and has put a number of roadway units at risk of scores dropping (see Figure 2).

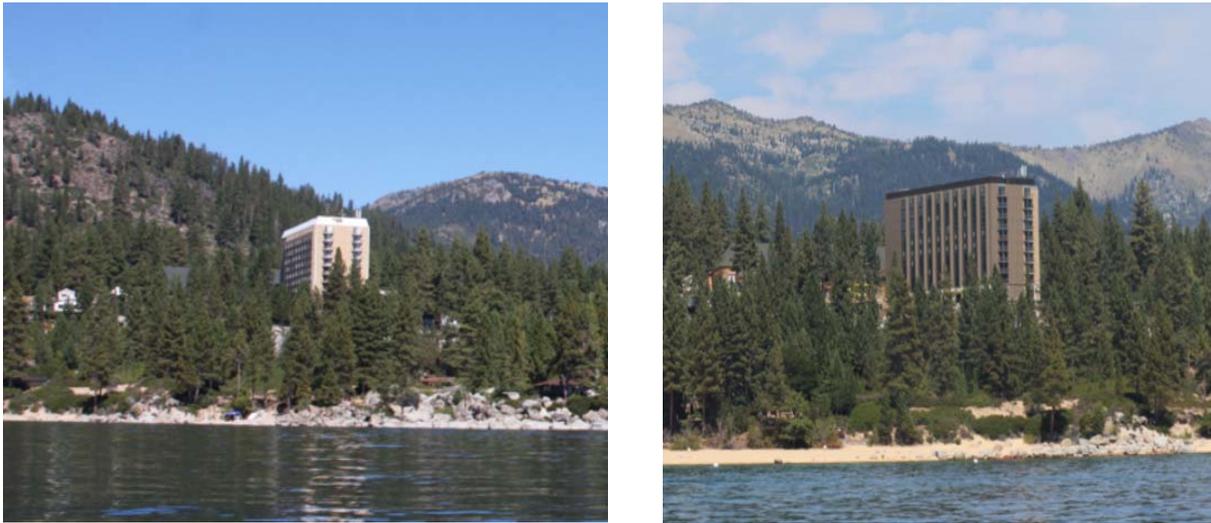
Figure 9-4: Cal Neva hotel as seen from the lake in 2011 (left) and in 2015 (right) after exterior was painted.

Scores for two other shoreline units increased as well. Shoreline Unit 12 McKinney Bay was already in attainment but the score increased. Screening of a boat storage area and a marina is effective and numerous residential rebuilds that comply with the scenic shoreland ordinances increased the man-made features score. Shoreline Unit 22 Brockway, a unit that is in nonattainment, remained in nonattainment but its score increased due to the repainting of the Cal Neva building to a shade that blends into the background (see Figure 9-4).

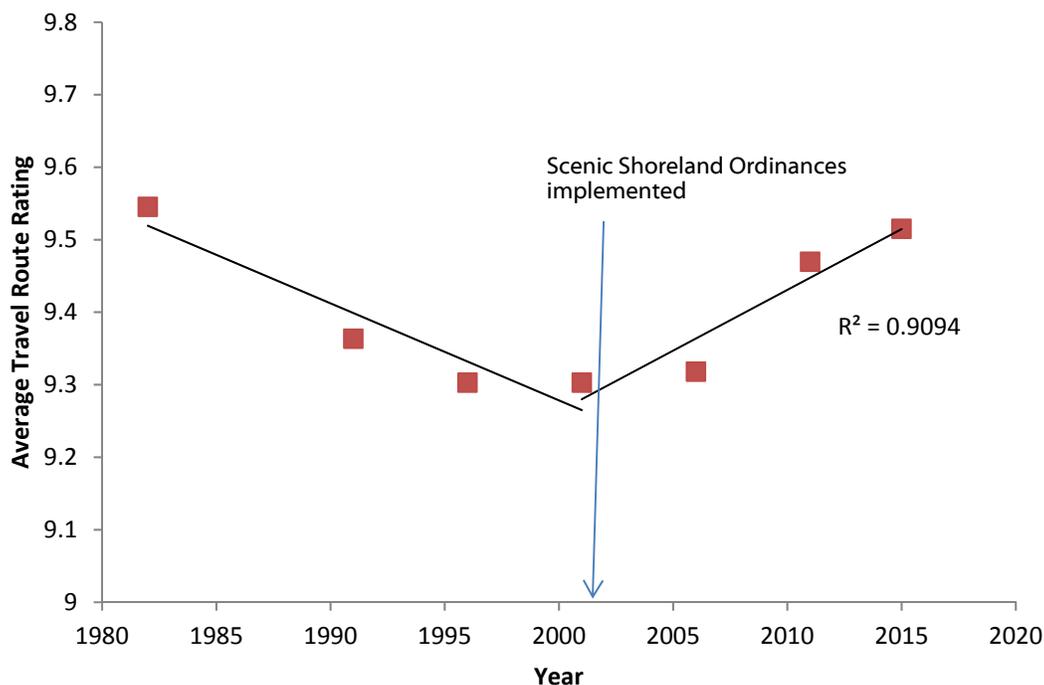
Figure 1: Change in average shoreline travel route rating by year, 1982 to 2015. Overall scores have rebounded to what they were in 1982 after significant decreases from 1982 to 2001.

Another way to look at trend is to compare the average ratings of all shoreline units through the years. Average shoreline travel route ratings show a similar trend where from 1982 to 2001 there was a significant worsening trend, and since 2001 there has been a significant improving trend. This trend is demonstrated in Figure 1. Average scores have almost fully rebounded to 1982 levels.

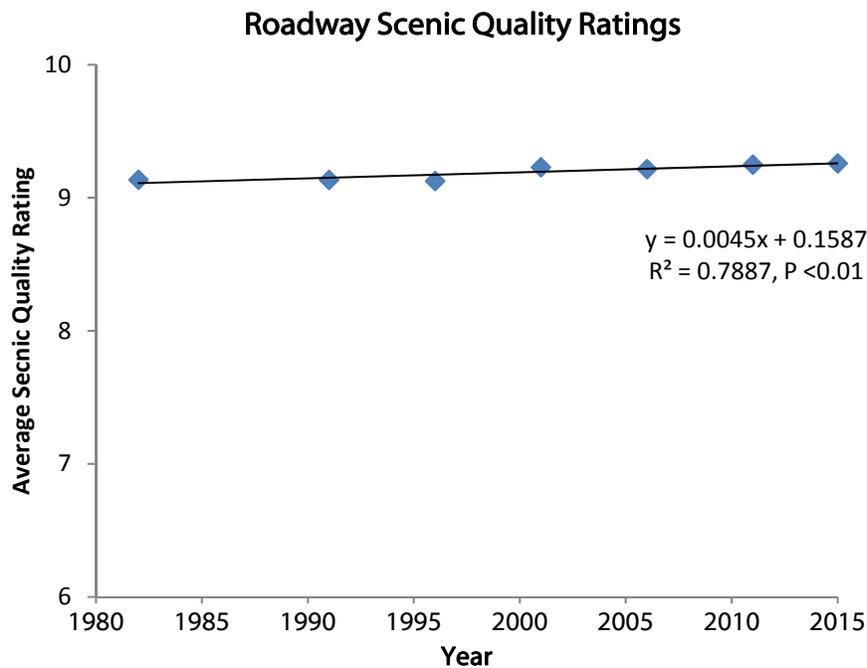
Figure 1: Change in average roadway scenic resource rating by year, 1982 to 2015. Overall scores show a very slight improvement, which overall would be considered “little to no change”.

Another way to look at trend is to compare the average ratings of all roadway scenic resources over time. Average roadway scenic resource ratings show a slight improving trend from 1982 to 2015. However, it is so slight that it would be considered little to no change (see Figure 1).

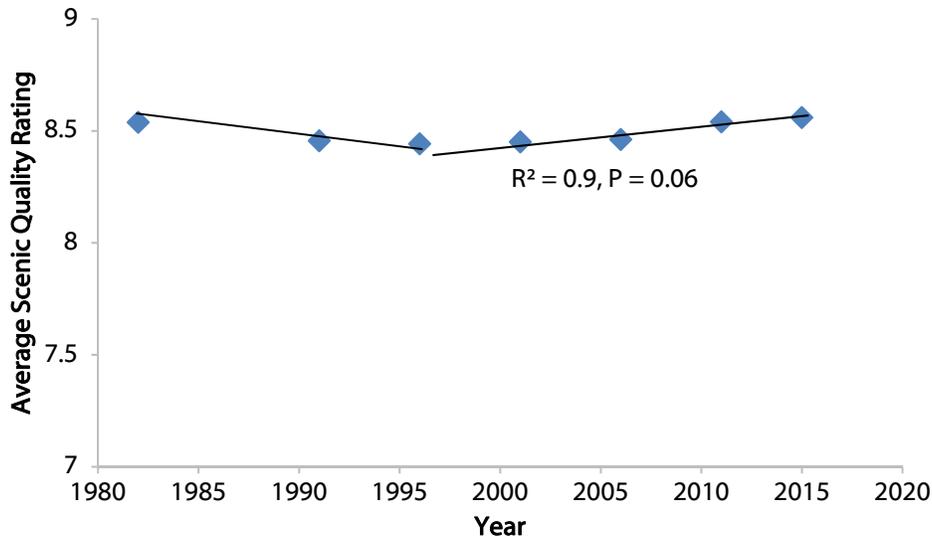
Figure 1: Change in average shoreline scenic resource rating by year, 1982 to 2015. Scores dropped from 1982 to 2001, but since 2001 there has been a separate improving trend. Overall scores show a very slight improvement since 1982, but overall would be considered little to no change.

Another way to look at trend is to compare the average shoreline scenic quality ratings over time. Average shoreline scenic resource ratings show a very similar trend where overall scores decreased from 1982 to 2001, and have steadily increased since 2001. However, the increase since 2001 is so slight that it would be considered little to no change (see Figure 1).

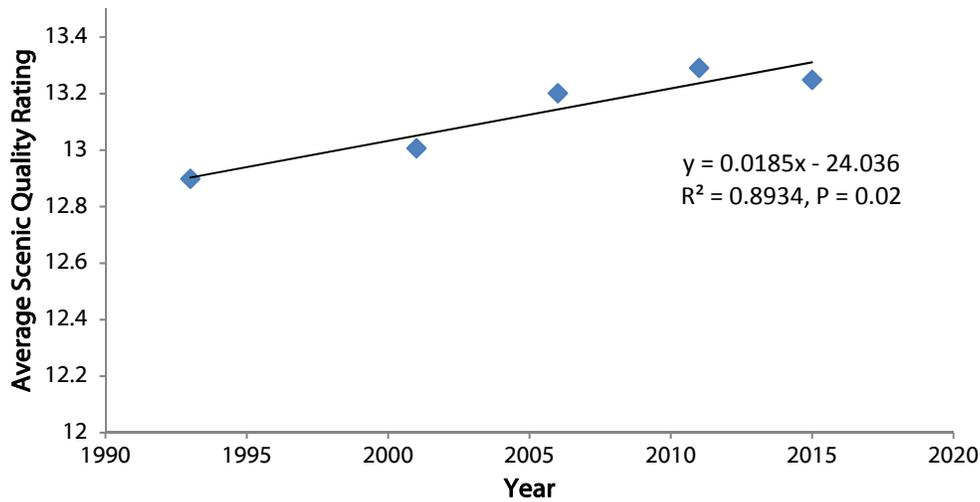
Figure 1: Change in average scenic quality rating by year, 1993 to 2015. Overall scores show a slight improvement of 0.14 percent per year, but according to the methodology described in this report; this is considered little to no change.

Another way to look at trend is to compare the average ratings of all recreation area and bike trail scenic resources through the years. Average scenic quality ratings for all units have gone up 0.14 percent per year since 1993, which would be considered little to no change (see Figure 1).

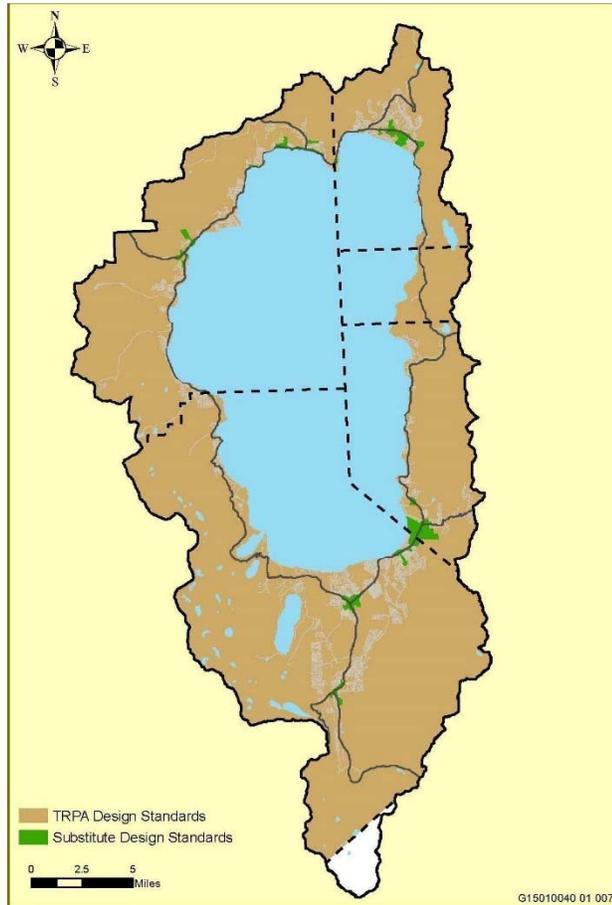
The map shows the location of adopted Community Plans and Area Plans where community-specific substitute design standards apply to new development and redevelopment projects. TRPA design standards apply throughout the region unless they are replaced by substitute standards. Note that topic-specific substitute standards for signage, parking, and other topics apply in other areas outside of Community Plans and Area Plans.

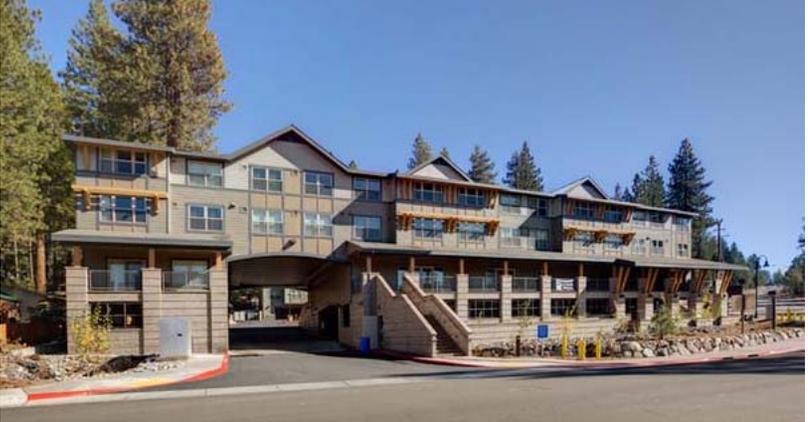
Project Description and General Location	Positive Design Elements	Opportunities for Improvement	Photograph of Building/Site
<p>Domus affordable housing project, Kings Beach, California</p>	<ul style="list-style-type: none"> • Materials and colors blend with natural environment • Textured concrete adds visual interest • Underground parking with vegetative screening minimizes views of vehicles 	<ul style="list-style-type: none"> • Greater setback and/or upper story setbacks from the road would create a less imposing structure • Screening of utility box in front of building would improve character • Greater articulation of front façade would improve visual interest and consistency of scale with surrounding structures • Planting more mature trees would reduce the time needed for landscaping to provide visual screening

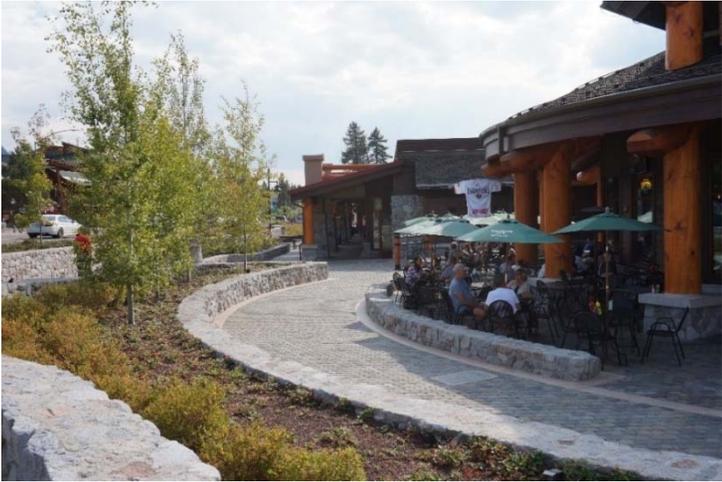
<p>Chateau at Heavenly Village, South Lake Tahoe, California</p>	<ul style="list-style-type: none"> • Excellent landscaping and public pedestrian amenities are integrated into the development • Pedestrian areas provide vibrant, usable space that is physically separated from the road • Public spaces provide room for both outdoor seating/dining and wide walkways 	<ul style="list-style-type: none"> • A more natural color for the metal roof material would better blend with the natural environment

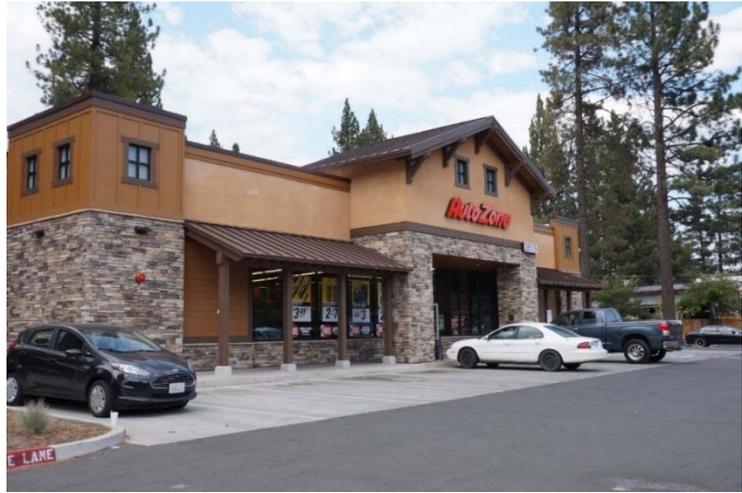
Project Description and General Location	Positive Design Elements	Opportunities for Improvement	Photograph of Building/Site
AutoZone, South Lake Tahoe, California	<ul style="list-style-type: none"> Architectural details (e.g., faux windows) provide visual interest Majority of parking is on the side of the building, which reduces its visibility Mostly natural materials and colors, which blend with the natural environment 	<ul style="list-style-type: none"> Additional landscaping, especially between the road and parking lot, would screen development and reduce the appearance of barren ground Screening of dumpster and utilities in front of the building would improve appearance and community character Stucco material is not compatible with the desired community character

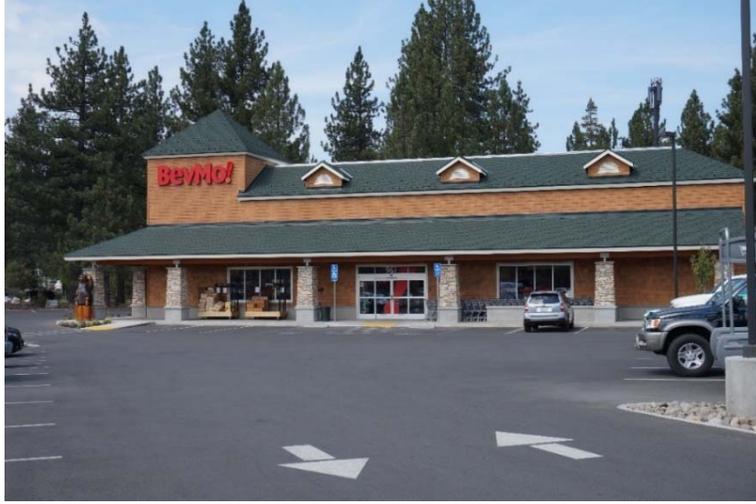
BevMo!, South Lake Tahoe, California	<ul style="list-style-type: none"> Screening of the dumpster blocks it from view Parking islands incorporate infiltration cobbles and vegetation, which are visually compatible and provide stormwater infiltration benefits 	<ul style="list-style-type: none"> A different orientation of the building would reduce the visual prominence of the structure Greater consistency between the sign material and the sign base would improve compatibility

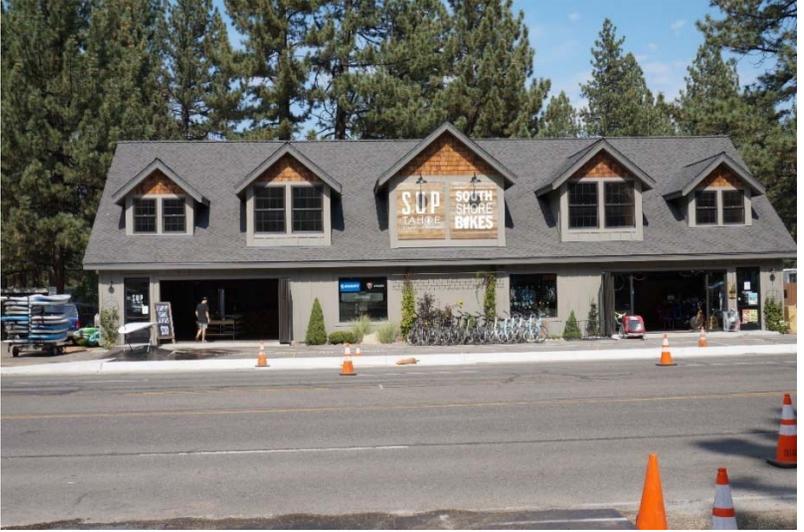
Project Description and General Location	Positive Design Elements	Opportunities for Improvement	Photograph of Building/Site
<p>SUP Tahoe – South Shore Bikes, South Lake Tahoe, California</p>	<ul style="list-style-type: none"> • Architectural details, signs, and materials provide a visually interesting and contemporary design that reflects the natural environment • Minimal and targeted use of exterior lighting provides interest without light pollution • Parking on the side of the building improves character 	<ul style="list-style-type: none"> • No comments

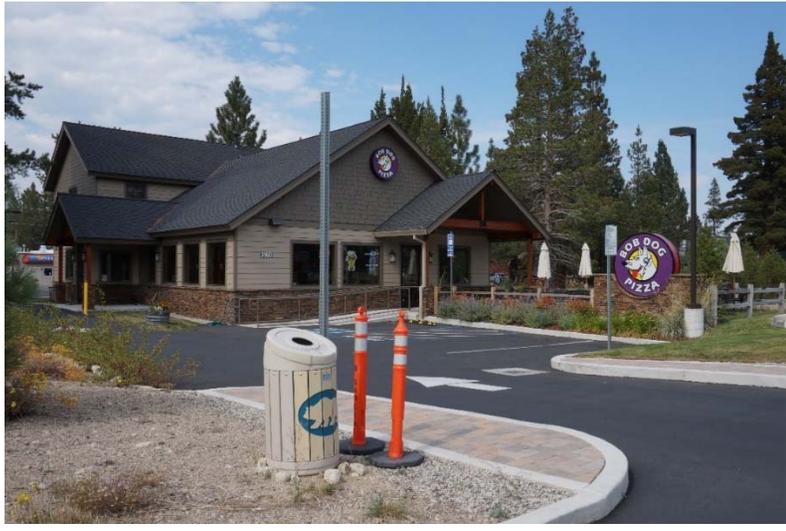
Project Description and General Location	Positive Design Elements	Opportunities for Improvement	Photograph of Building/Site
<p>Bob Dog's Pizza, Meyers, California</p>	<ul style="list-style-type: none"> Materials provide visual interest and character and reflect the natural mountain setting Parking in the rear of the building blocks views of vehicles and improves character Separated pedestrian access from the road improves the character and accessibility of the site 	<ul style="list-style-type: none"> Screening of the dumpster would improve the aesthetic

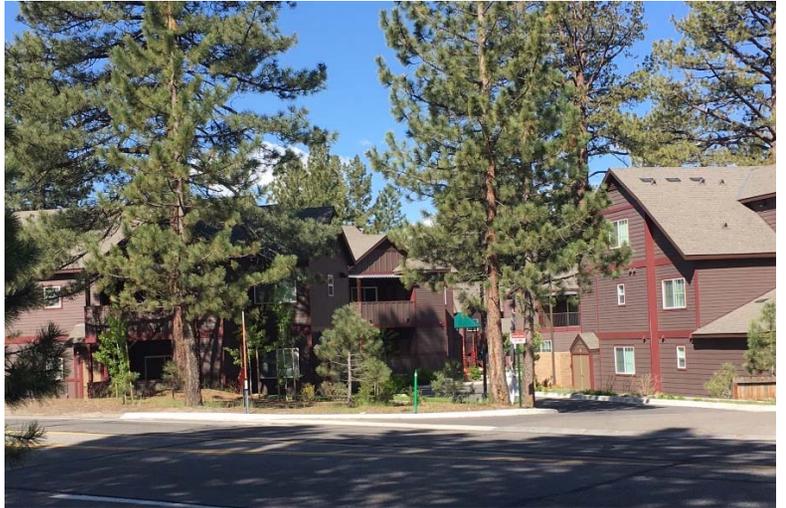
<p>The Aspens at South Lake, South Lake Tahoe, California</p>	<ul style="list-style-type: none"> The third story is integrated into the roofline reducing the overall building height and mass Landscaping and dumpster screening along the road screens visual distractions 	<ul style="list-style-type: none"> A more earth-toned color would be more compatible with the character of surrounding buildings and the natural environment Silver utility box adjacent to Pioneer Trail should be painted an earth-tone color and screened

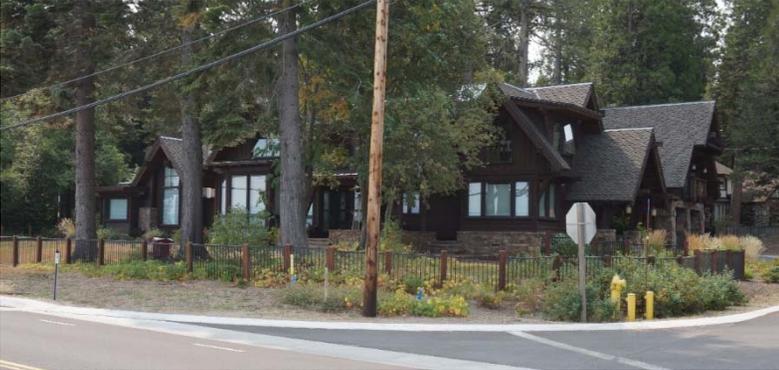
Project Description and General Location	Positive Design Elements	Opportunities for Improvement	Photograph of Building/Site
Private Residence, Homewood, California	<ul style="list-style-type: none"> • Building articulation provides visual interest and breaks up façade • Dark color and natural materials blend into the natural environment 	<ul style="list-style-type: none"> • No comments

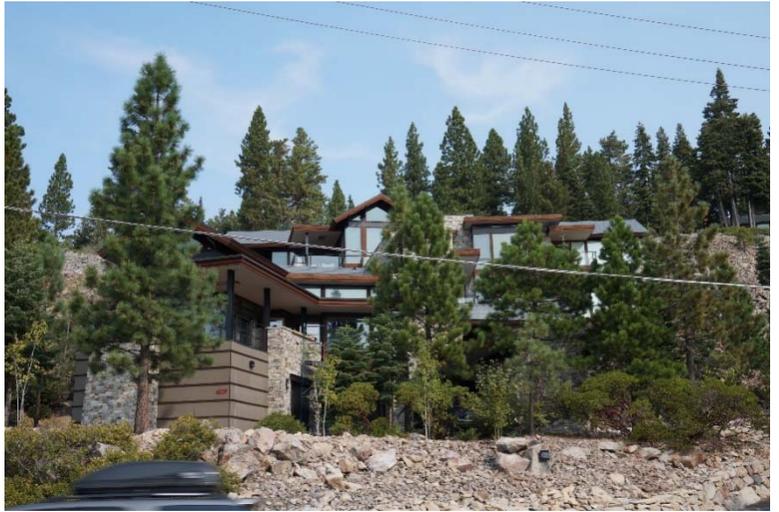
Private Residence, Carnelian Bay, California	<ul style="list-style-type: none"> • Rock material matches the backdrop and blends into the natural environment • Articulation breaks up façade and makes the building appear smaller • Vegetation screening reduces the visibility of the building 	<ul style="list-style-type: none"> • No comments

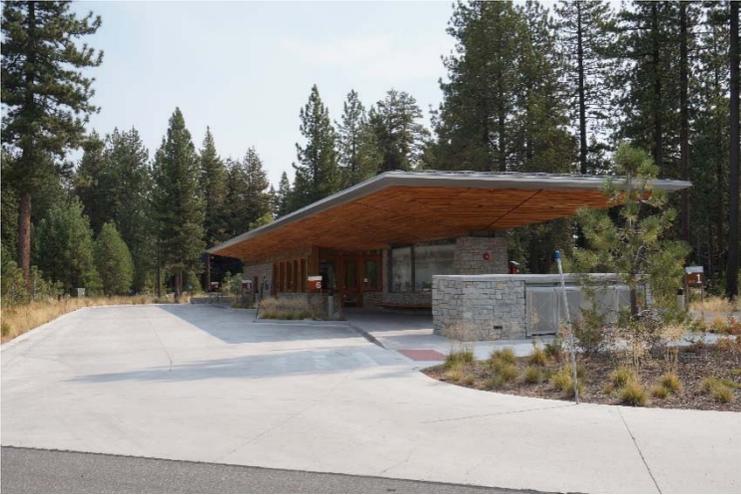
Project Description and General Location	Positive Design Elements	Opportunities for Improvement	Photograph of Building/Site
<p>Tahoe City Transit Center, Tahoe City, California</p>	<ul style="list-style-type: none"> • Architecture is interesting and unique but still includes colors, materials, and textures that reflect the natural mountain setting • Excellent use of natural materials • Integration of interpretive features provides interest for pedestrians 	<ul style="list-style-type: none"> • No comments

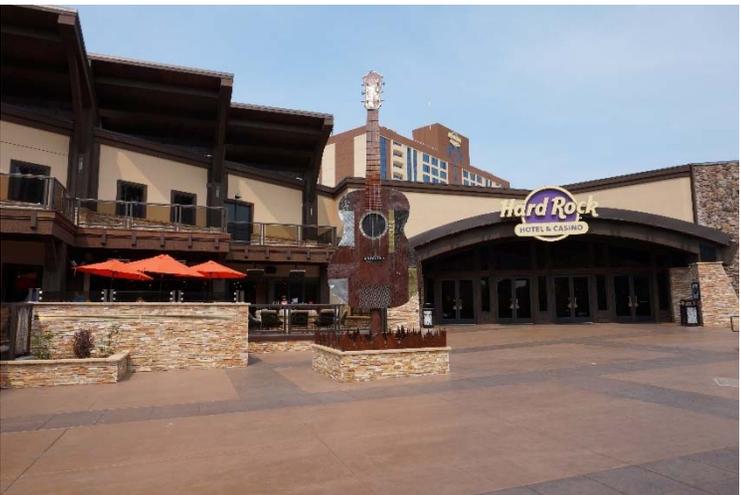
<p>Hard Rock Hotel and Casino, Stateline, Nevada</p>	<ul style="list-style-type: none"> • Outdoor seating and gathering areas provide visual interest and enhance the character of the area • Public artwork and architectural details provide interest and provide pedestrian-scaled elements 	<ul style="list-style-type: none"> • Darker colors on the hotel tower would help the tall buildings to blend into the backdrop when viewed from a distance
