Tahoe City, Placer County, California

Pedestrian & Bicycle Road Safety Audit

Conducted April 27-29, 2015

FINAL REPORT October 2015

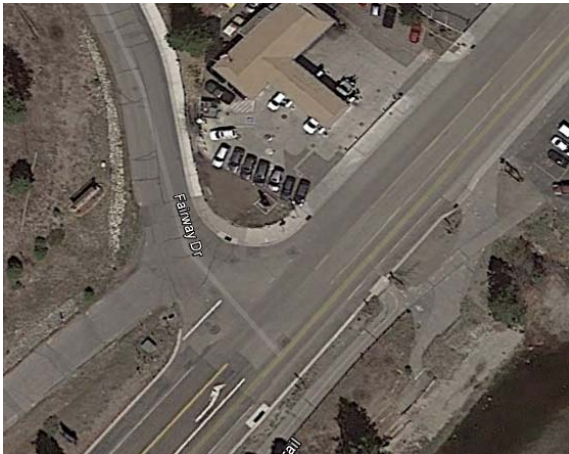
Fairway Drive "T" Intersection

Figure 2: Study area intersections (Aerial Image Source: Google Earth)

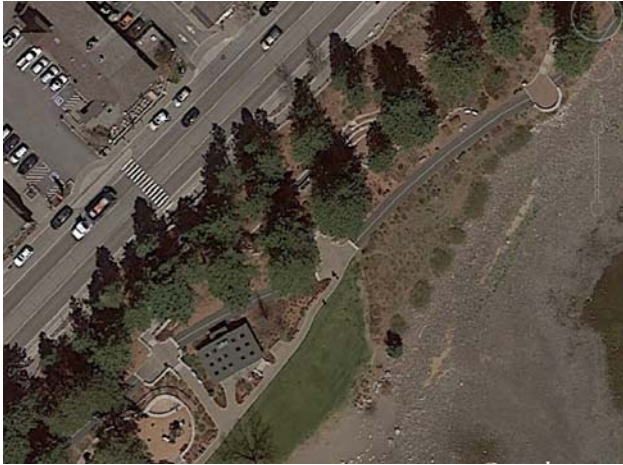
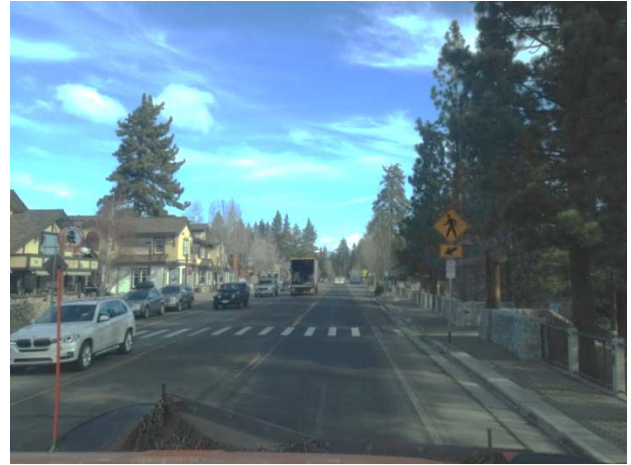
Cobblestone Pedestrian Crossing

Figure 3: Midblock Pedestrian Crossings (Aerial Image Source: Google Earth; Photo Source: Isebrands)

With parking along much of the Highway 28 corridor - a positive multi-modal and traffic calming feature - the line of sight between pedestrians and drivers at the crosswalks was observed to be consistently blocked along the corridor. Parked vehicles encroached into the pedestrian crosswalk locations which contributed to the visibility issues. Pedestrians are hidden behind vehicles parked too closely to the crosswalks. Additionally, the proximity of driveways to crosswalks also was observed to contribute to sight line issues at the pedestrian crossings.

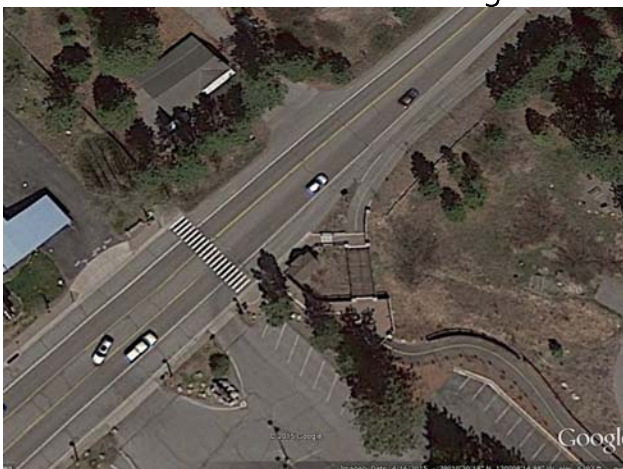
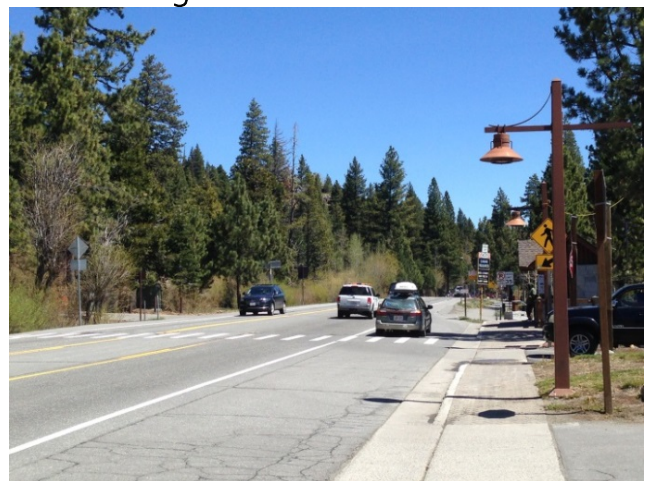
Lighthouse Pedestrian Crossing

The east end of the study area appeared to have the highest speeds as drivers were entering and leaving Tahoe City. There is weak connectivity between the Class I bike pathway and the sidewalk network and roadway bike lanes as shown in Figure 15. Numerous pathway riders rode against traffic to transition either to the sidewalk on the south/west side of the road or to cross over to the east side and ride on the shoulder. Substantial sign clutter exists and potential wayfinding issues were observed where the Class I bike trail, road shoulder, pedestrian crosswalk and transit stop/bus shelter converged. Four driveways leading to the same parking lot also seem to allow unnecessary conflict points for all users.

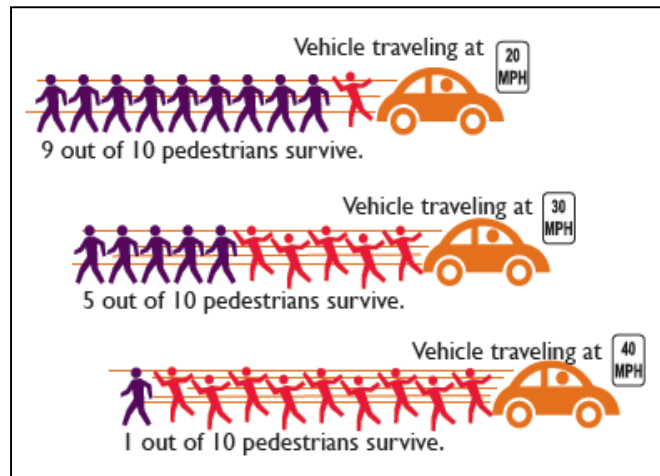
Figure 4: Survivability of Pedestrians (Source: Seattle DOT)

While the RSA is pedestrian and bicycle-focused, to gain a more complete understanding of how the corridor functions, it is important to look at crashes involving both motorized and non-motorized vehicles. It is a known fact that pedestrian and bicyclist are vulnerable road users if they are involved in a crash. If a vehicle is traveling at 20mph, a pedestrian has a 90% chance of surviving; at 30 mph a 50% chance of surviving; and at 40mph a 10% chance of surviving. Figure 4 is from the Seattle DOT Pedestrian Safety Action Plan illustrating the exponential risk associated with vehicular speeds.

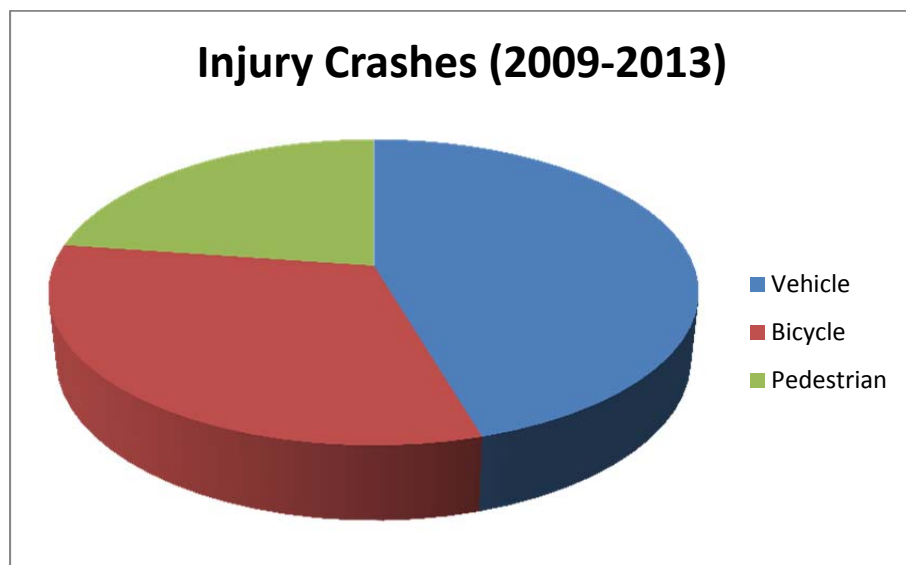
Figure 5: Crash Data for Tahoe City from 2009 – 2013

Over a five year period along the study area, from 2009-2013, there were 75 total crashes³, of which 29% were injury crashes. The crashes were concentrated near the Highway 89, Commons Beach Road and Grove Street intersections. Over the same period, five pedestrian crashes and seven bicyclist crashes were reported, all resulting in an injury. (Only one bike crash was outside of the study area.) Fifty-percent of the injury crashes in Tahoe City from 2009-2013 were pedestrian or bicycle crashes within the study area, shown in Figure 5. Over the 5 year period, an average of 1.0

pedestrian injury crash occurred per year and 1.4 bicyclist injury crash per year occurred within this corridor. Although the numbers are not large, it illustrates that if there is an injury crash, there is a 50/50 chance it will be pedestrians and bicyclist.

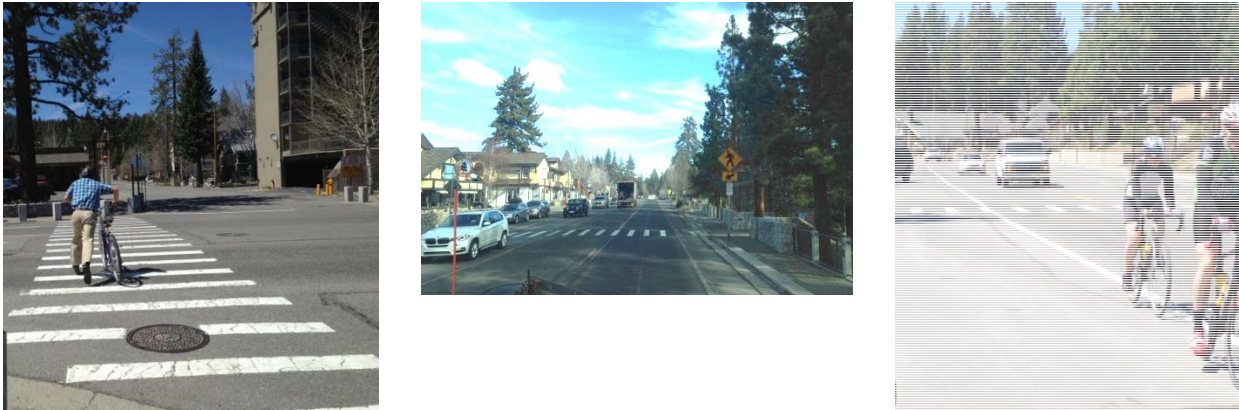
Figure 6: Photos of Existing Safety Features in Tahoe City (Photo Source: Isebrands)

- **High visibility crosswalk pavement markings:** Most of the marked pedestrian crossings on Highway 28 (between Commons Beach Road and the Lighthouse Shopping Center) had high visibility style crosswalk pavement markings.

- **Crosswalk spacing and locations:** The marked pedestrian crossings along Highway 28 are appropriately spaced (between 350 ft and 660 ft) based on destinations on both sides of the highway.

- **Sidewalk lighting:** Pedestrian level lighting along the sidewalks provided good visibility along the sidewalk.
- **Crosswalk signing:** All marked crossings included supplemental pedestrian crossing signs and temporary in-street crossing signs during late spring, summer and early fall.

- **Multimodal atmosphere:** Most sidewalk widths were desirable based on the number of pedestrians and Class I shared use paths provide options users. Many cyclists were riding with traffic on Highway 28 and complete Street design amenities such as parking, is present.

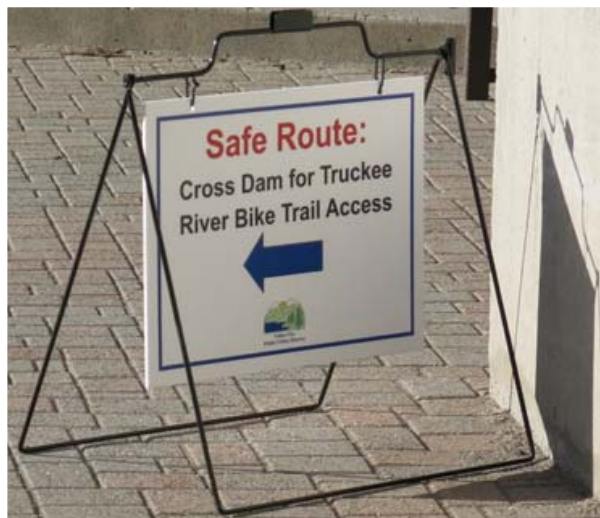
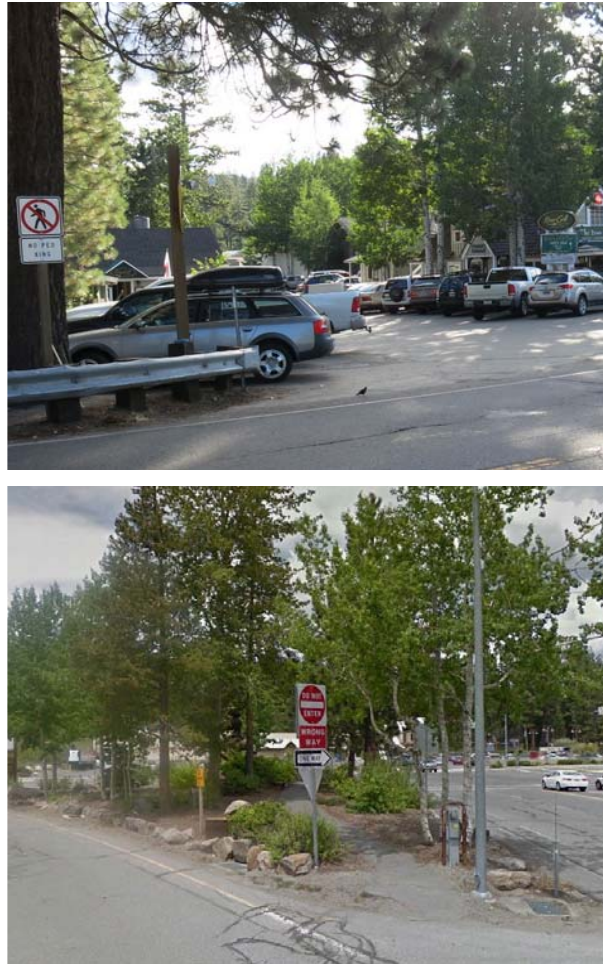
Figure 7: Examples of Pedestrian Restrictions, Access and Lack of Infrastructure (Photo Source: Isebrands)

The sidewalks/multi-use trails have several gaps in connectivity within the study area, particularly on the western terminus of the study area. Currently there is not easily identifiable pedestrian access or infrastructure to cross the “wye” intersection. Additionally, there are several pedestrian crossing restrictions (i.e. “No Pedestrian Crossing” signs) near the “wye” intersection and the Fanny Bridge area. These

restrictions are not consistent with the pedestrian and bicycle desire lines, beautiful views, common area and businesses. Examples of these issues are shown in the photos in Figure 7. The following descriptions and corresponding areas in Figure 8 show gaps in sidewalk, multi-use path connectivity and/or crossing restrictions.

1. Between Fairway Drive and the Highway 89/28 “wyé” intersection (south side),
2. Within the Highway 28/89 “wyé” intersection,
3. North end of Fanny Bridge,
4. Between Highway 28/89 “wyé” intersection and Mackinaw Road bus stop,
5. Between the TART Transit Center, along Highway 28, to Fanny Bridge, and
6. Between Commons Beach area and Fanny Bridge.

- *Provide sidewalk infrastructure where it does not exist.*
- *Provide accessible crossings at logical origins and destinations (i.e. where people already naturally walk).*
- *Eliminate pedestrian crossing restrictions.*
- *Provide defined access (driveways) from Highways 28 and 89 to businesses (Area 1 and Area 4 in Figure 8).*
- *Re-purpose the Highway 89/28 within CalTrans right of way from Fairway Drive to Mackinaw Road to include sidewalk, bike lanes, parking, bulb outs, defined access.*

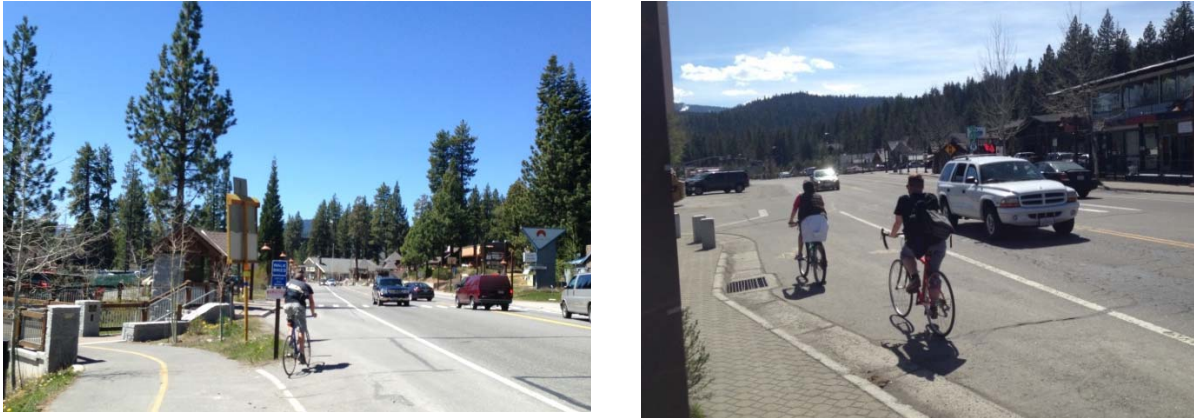
Figure 9: Wrong-way Bicyclist on Highway 28 (Photo Source: Isebrands)

The PBRSA Team observed inconsistency in bike lane markings within the study area as well as inconsistencies between the bike signing and pavement markings. Additionally, bicyclists were observed riding against traffic in several locations - near Mackinaw Road and at the Class I multi-use

trail near the Lighthouse development - where the pathway connections and/or change in type of bicycle facility was not clear. Bicyclists riding against traffic in the roadway put them at higher risk for a crash.

- *Close the gap between West Shore Bike Trail to the Lakeside Bike Trail*
- *Provide wayfinding for bicyclists where the bicycle facility type changes or ends (Near Fairway Drive and Lighthouse development)*
- *Widen sidewalk where it narrows between Commons Beach Road and Mackinaw Road, and use wayfinding signs to guide bicyclists to bike routes.*
- *Ensure consistent bike lane signing and pavement markings*
- *Re-stripe pavement markings for the travel lanes, bike lanes and parking spots in the Spring rather than the Fall*
- *Install “sharrow markings” where the roadway width does not allow for a full bike lane width*
- *Explore modifications to Mackinaw Road to provide the bicycle connection between Commons Beach and Fanny Bridge (i.e. bike boulevard, one way roadway)*

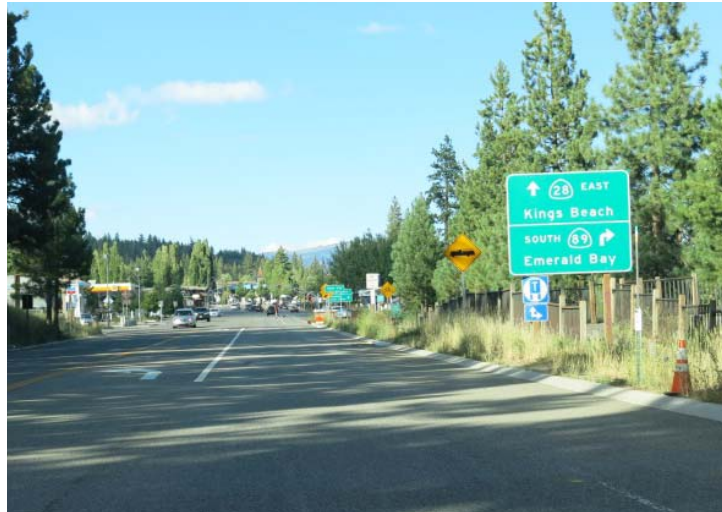
Figure 10: Entrance to Tahoe City, CA (Photo Source: Isebrands)

The PBRSA Team identified the Fairway Drive intersection as the existing Gateway into Tahoe City from Squaw Valley and Truckee; however the wider roadway width of Highway 28 appeared to encourage drivers to increase their speeds heading into the Tahoe City and the signalized intersection. The location is shown in Figure 10. Highway 28 widens from a 2 lane road to a wide three lane cross section, with approximately 55ft of pavement.

The existing Class I bike trail/multi-use path on the east side of the road ends abruptly at this intersection leaving the pathway user “stranded.”

- *Provide bump outs to shorten pedestrian crossing distance from multi use trail to Fairway Drive intersection.*
- *Consider bicycle wayfinding signs to direct Class I bike trail users over the existing bridge to the Tahoe Rim Trail. Potential bicycle road riders would be directed to Highway 89 via the pedestrian crossing.*
- *Provide sidewalk infrastructure on the south side of the roadway to connect pedestrians to the “wye” intersection.*
- *Provide defined access (driveways) to the properties on the south side of Highway 89.*

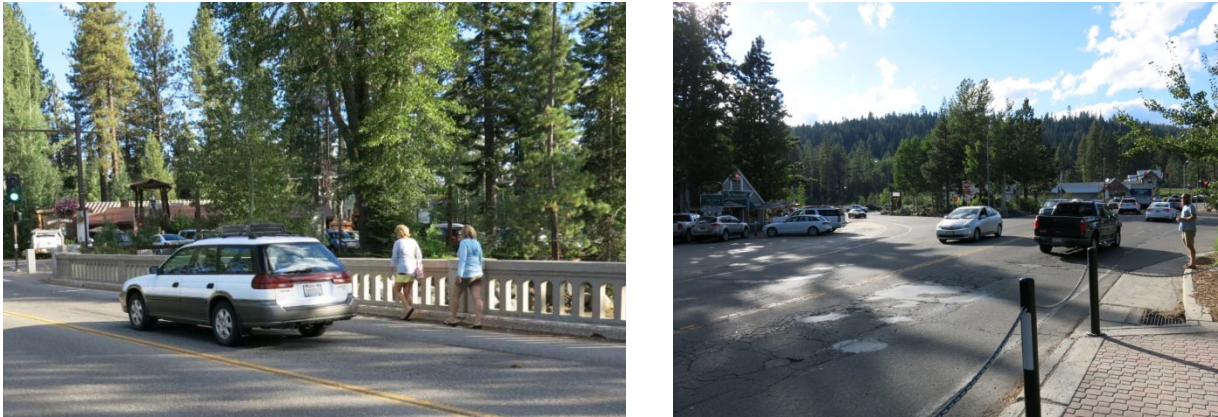
Figure 11: Photos of Pedestrian and Bicycle Activities at Fanny Bridge (Photo Source: Isebrands)

The “Wye” intersection of Highway 28/89 and Fanny Bridge provides significant access to attractions for both locals and visitors to Tahoe City and Lake Tahoe year round; yet, the pedestrian infrastructure and connectivity is significantly lacking as mentioned above. The pedestrian movement restrictions in this intersection are not consistent with a community that promotes and thrives on visitors. Desire lines exist between both sides of this intersection; however, countless observations were made of pedestrians running across the road to avoid speeding traffic in the free right turns and walking in the roadway across Fanny Bridge. The existing Pedestrian Signal on the

south end of Fanny Bridge provides for controlled, safe crossing but lacks efficiency. Figure 11 shows examples of pedestrian activity in this area. Improved safety and mobility can be achieved in this area with investments in sidewalks, traffic calming, high visibly crosswalks and efficient traffic and pedestrian traffic control.

- *Provide pedestrian infrastructure at the “wye” intersection for all movements.*
- *Provide a controlled pedestrian crossing - Pedestrian Hybrid Beacon (PHB)- on the north end of the Fanny Bridge that is coordinated with the south end treatment.*
- *Replace the Pedestrian Signal at the south end of Fanny Bridge with a PHB at Fanny Bridge and coordinate with a second PHB on the north end of Fanny Bridge.*
- *Consider using the extra width on the existing Fanny Bridge for marked bike lane or add a raised sidewalk on the west side⁵*

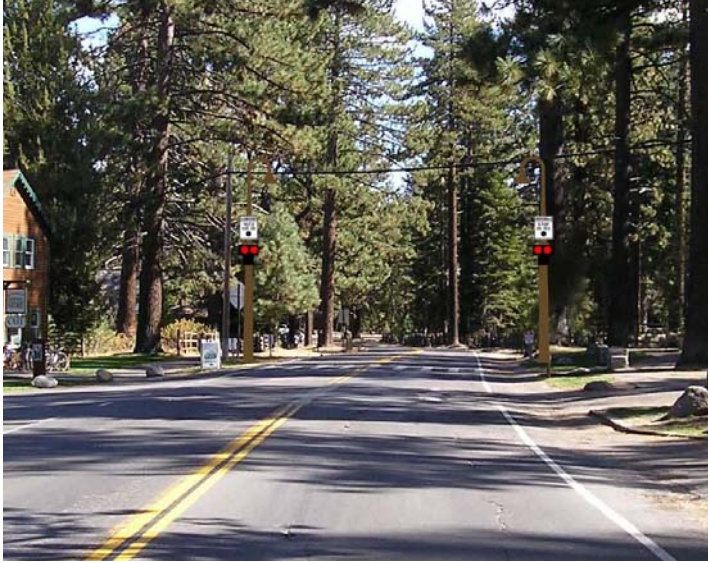
Figure 13: Mock up of Pedestrian Hybrid Beacon at Camp Richardson (Source: USFS)

The USFS is installing a Pedestrian Hybrid Beacon at Camp Richardson during the Fall of 2015. Figure 13 shows a mock-up of the Pedestrian Hybrid Beacon.

- *Install a pedestrian activated Pedestrian Hybrid Beacon. Figures 12 and 13 provide locations of PHB installations that are similar in context to Tahoe City. (More information about the PHB can be found in Appendix E.)*
- *Improve the bulb outs by making them larger in order to improve sight distance.*
- *Use high visibility crosswalk markings for the two crosswalks across Grove Street.*

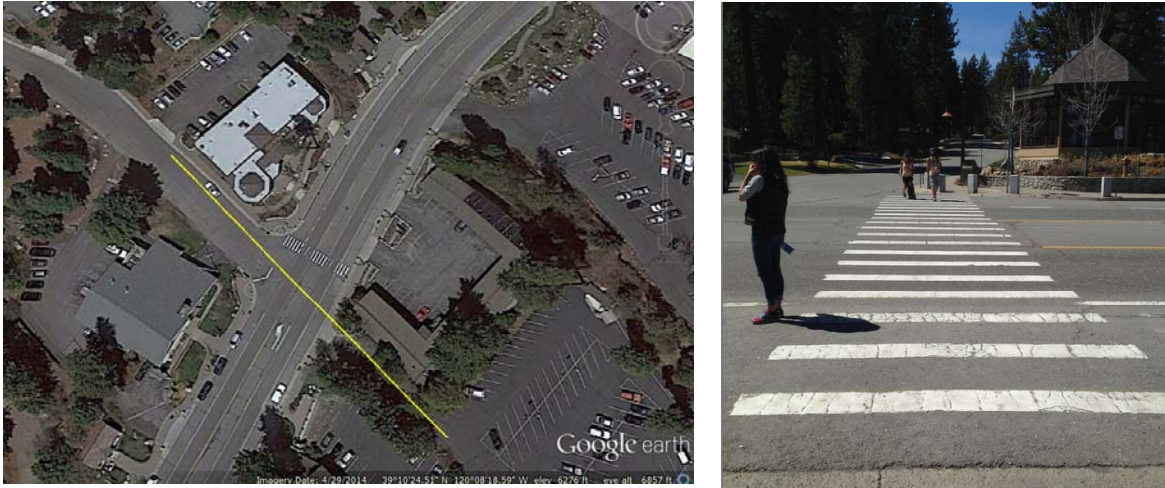
Figure 14: Re-alignment of Jackpine St and Long Pedestrian Crossing Distance (Aerial Image Source: Google Earth; Photo Source: Isebrands)

The Jackpine Street intersection had more pedestrian activity than was expected and the crossings appeared unpredictable in terms of where pedestrians were crossing at this intersection. Highway 28 traffic speeds were observed to be higher in this area, perhaps due to the wider roadway cross section. The intersection has a slight skew and aligns with one of the driveways to the Tahoe City Marina and shopping area. Because of the skew, the left turn movements for one direction can block the movement from the other direction. An exclusive right turn lane is marked in the southbound direction where it appears parking is still allowed. The pedestrian crosswalk is over 65ft in length. For an average pedestrian, it would take 20 seconds to cross the roadway with higher observed speeds and numerous driveway conflicts. Figure 14 illustrates the skewed nature of the intersection as well as the lengthy crossing distance.

- *Re-align Jackpine Street by adding curbing to the south radius. This will square up Jackpine Street to Highway 28.*
- *Provide curb bump outs on both sides of Highway 28 to improve sight distance for pedestrians and vehicles exiting the Marina and to reduce the crossing distance*
- *Eliminate right turn lane from westbound direction.*
- *Optional: Add a second crosswalk at Jackpine Street but consider additional conflict points and impacts to sight distance.*
- *Optional: If ingress and egress of the Marina can be modified, consider the west driveway as an exit only (better sight distance) and the east driveway as right-in-right-out only movements.*
