Complete Street Focused Road Safety Assessment Report

U.S. Highway 50 Stateline (MP DO 0.00) to S.R. 28 (MP DO 12.3)

**Pre-Construction Phase Assessment
December 2016**

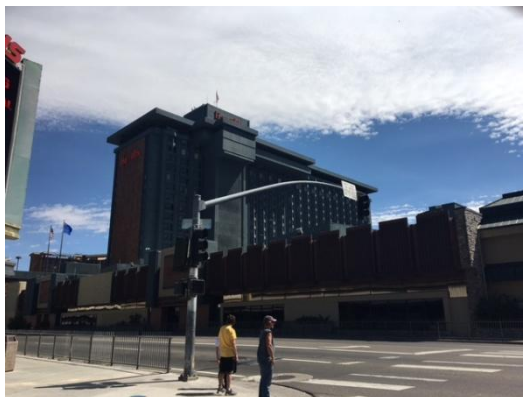
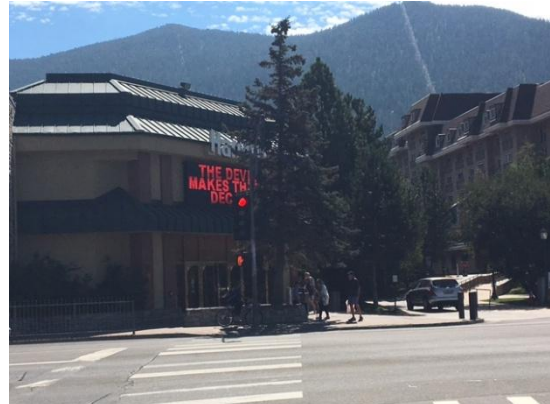
Photo 2- Intersection at Stateline Avenue without overhead lighting

- At Stateline Avenue there are no detectable warnings in the pedestrian ramps on the Nevada side of the street. There is no overhead lighting on the traffic signal on the Nevada side. The southwest corner (California side) is the only corner with overhead lighting. See photos 2 and 3 (page 18). There are no pedestrian push buttons at this intersection and the pedestrian phase operates with every traffic signal cycle.
- ❖ **Priority 2a- Consider installing overhead lighting at Stateline Avenue on both sides of US 50.**
- ❖ **Priority 2a- Construct new ADA compliant pedestrian facilities at Stateline Avenue on the Nevada sides of US 50, including push button activated pedestrian crossing signs.**

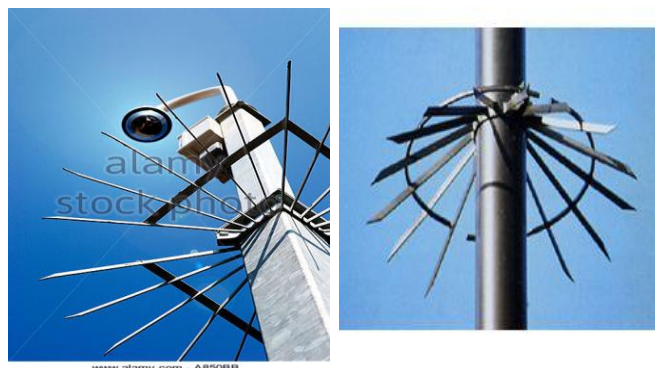
Photo 4- Example of light fixtures used in Las Vegas to discourage pedestrians from climbing.

- Per NHP representative of the RSA team, pedestrians attempt to climb traffic signal/light poles in the casino corridor.
- ❖ ***Priority 2a-Consider constructing improvements to discourage pedestrians from climbing the traffic signal and light poles throughout the casino core area. See photo 4.***

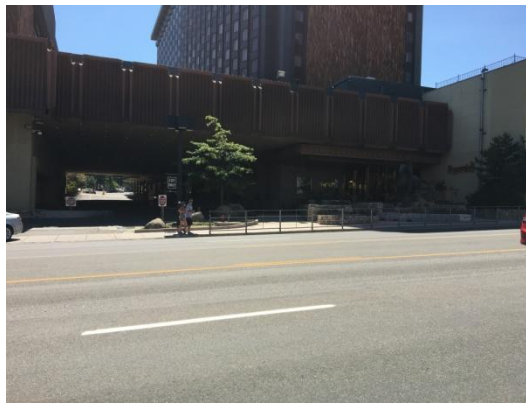
Photo 5- Gap in fence where pedestrians jaywalk in casino area.

- Pedestrian traffic in the casino area (Stateline Avenue to Lake Parkway) is high. The RSA team observed jaywalking in the casino area and damaged pedestrian fencing. See photos 5 and 6.
- ❖ ***Priority 2a- Repair damaged pedestrian fencing from Stateline to Lake Parkway.***
- ❖ ***Priority 2a- Install pavement markings and signs at gaps in the pedestrian fencing (at driveway entrances) to discourage jaywalking from Stateline to Lake Parkway.***
- ❖ ***Priority 3b- Conduct access management study to compare existing driveway locations to Access Management standards and consider consolidating driveways throughout the casino core area.***

- 38. Repair damaged pedestrian fencing from Stateline to Lake Parkway.**
- 39. Install pavement markings and signs at gaps in the pedestrian fencing (at driveway entrances) to discourage jaywalking from Stateline to Lake Parkway.**

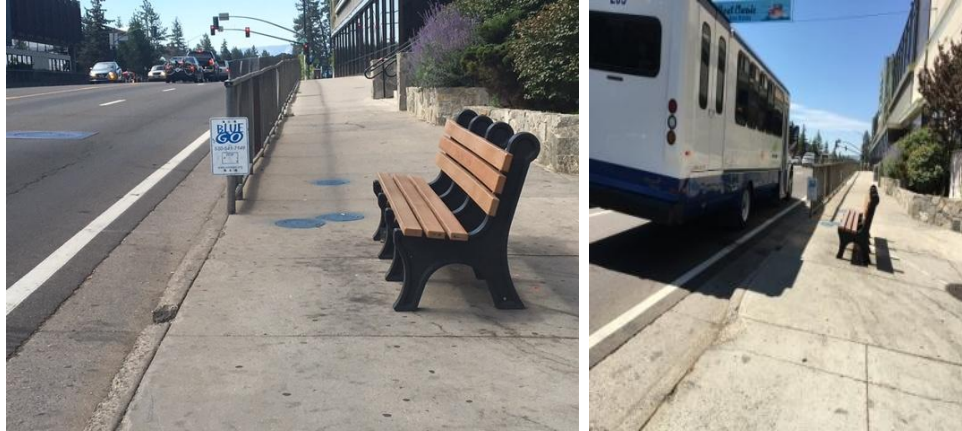
Photo 7- Transit stops lacking proper signage.

- The sign installations for transit stops do not meet MUTCD standards (at the entrance to Harvey's, for example). The transit stops do not exhibit route and schedule information. Some signs are shielded from view by nearby signs (near the Hard Rock, for example). See photos 7 and 8.
- ❖ **Priority 1b- Install BlueGo transit signs in accordance with MUTCD standards at locations with good visibility.**
- ❖ **Priority 1b- Consider adding route and schedule information to the existing transit signs.**

- Bus stop locations in the casino corridor have no shelters or pullouts and currently buses block through lanes when stopped. See photo 7.
- ❖ **Priority 3b- Consider installing new transit shelter facilities.**
- ❖ **Priority 3b- Consider the installation of bus turnouts with the US 50 South Shore Revitalization Project.**

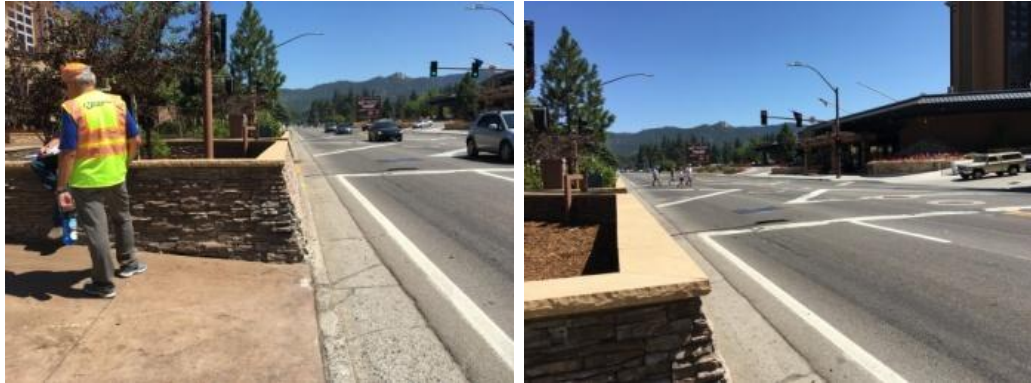
Photo 9- Large planters on US 50 in front of the Hard Rock Hotel and Casino.

- There are large planters in the sidewalk immediately adjacent to the back of curb in front of the Hard Rock Hotel and Casino. There are no visual or detectable warnings to guide pedestrians, especially disabled pedestrians, around the planters. See photos 9 and 10.
- ❖ ***Priority 2b- Tahoe Transportation District to coordinate with casinos to create a pathway with detectable warnings to guide pedestrians, especially the visually impaired, around the planters outside the Hard Rock Hotel and Casino.***
- ❖ ***Priority 3b- Create a pathway with detectable warnings to guide pedestrians, especially the visually impaired, around the planters outside the Hard Rock Hotel and Casino.***

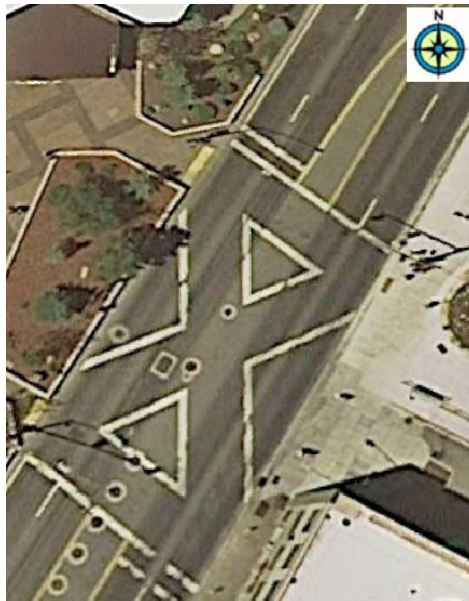
Photo 11- Aerial view of crosswalk between Hard Rock, Montbleu, and CVS.

- The “X” shaped crosswalk at the Hard Rock Hotel and Casino facilitates an “all walk” movement across the highway with diagonal and perpendicular crossings of US 50. The diagonal crossings are long and there are no diagonally facing heads on the traffic signal poles on the CVS and Montbleu corners. (There are two pedestrian signal heads at these locations, one facing perpendicular to the highway and the other facing across the alley). Pedestrians approaching the crosswalk from Harvey’s must take a circuitous route around a planter to access the crosswalk, and some pedestrians choose to enter the street rather than take that route. The planters restrict the width of sidewalk access to the crosswalks in front of the Hard Rock Hotel and Casino. See photos 11 and 12. There were 5 crashes at or near this crosswalk during the five year study period.

- ❖ ***Priority 2a- Consider redesigning the crosswalk between Harvey’s, Montbleu, and CVS after reevaluating the overall crosswalk design with respect to crossing distances and the need for diagonal crosswalks.***

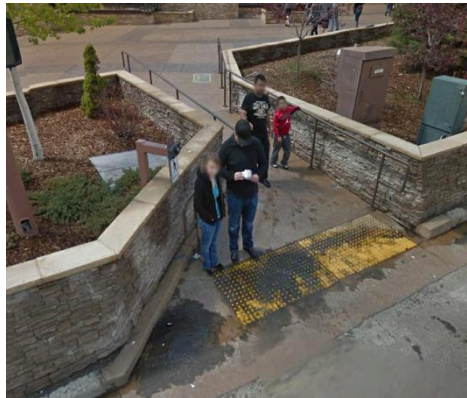
Photo 13- Non-ADA compliant ramp outside of Hard Rock Hotel and Casino. This ramp is too steep and narrow.

- Many of the pedestrian facilities in the casino core areas are not ADA compliant. Many pedestrian ramps do not meet current construction standards because they have a raised lip and/or lack the required detectable warnings. Also, many of the pedestrian push buttons are not ADA compliant. For example, the push button in front of the Hard Rock Hotel and Casino is mounted higher than ADA standards. See photos 13, 14, and 15 (page 24).
- ❖ ***Priority 2a- Reconstruct the existing pedestrian facilities at the north and south corners of the intersection by the Montbleu/CVS entrances to be ADA compliant.***
- ❖ ***Priority 2a- Lower the height of the pedestrian push button at the crosswalk in front of the Hard Rock Hotel and Casino to be ADA compliant.***

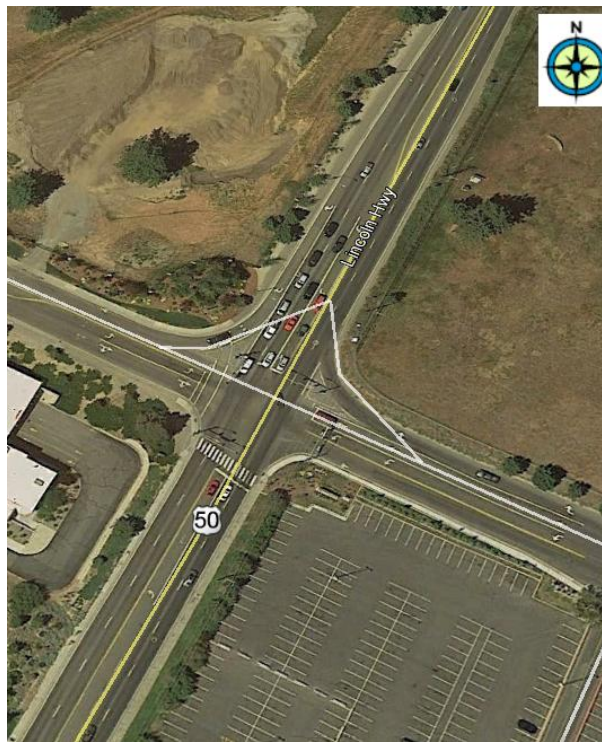
Photo 16- Aerial view of US 50 and Lake Parkway.

- At the Lake Parkway intersection there is no crosswalk across US 50 on the north side of the intersection and no sidewalk on the east side of US 50, north of the intersection. See photo 16.
- ❖ ***Priority 1a- Install signage directing eastbound pedestrians on the southeast corner of US 50/Lake Parkway East to cross US 50 because the sidewalk on the east side of US 50 ends at the intersection.***

- 1. *Replace all NDOT-maintained signs that exhibit reduced reflectivity with new signs that meet current standards.***
- 2. *Install signage directing eastbound pedestrians on the southeast corner of US 50/Lake Parkway East to cross US 50 because the sidewalk on the east side of US 50 ends at the intersection.***

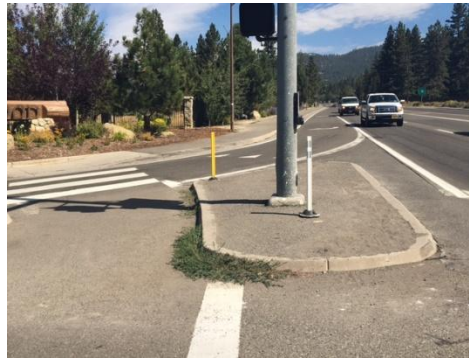
Photo 17-Pedestrian push button at Lake Parkway facing wrong direction and no pedestrian ramp.

- Also at Lake Parkway, the pedestrian push button in the island on the northwest corner of the intersection is located on the wrong side of the signal pole (back side of the pole relative to the crosswalk location), and is not ADA accessible since there is no ramp onto the island. See photo 17.
- ❖ **Priority 2a- Move the push button on the northwest corner of the Lake Parkway/US 50 intersection to the crosswalk side of the pole and add a pedestrian ramp to the island for push button access.**
- ❖ **Priority 2a- Move the signal pole on the southwest corner of the Lake Parkway intersection out of the sidewalk or widen the sidewalk behind the pole.**
- ❖ **Priority 2a- Construct ADA compliant pedestrian facilities on all four corners of the Lake Parkway intersection.**

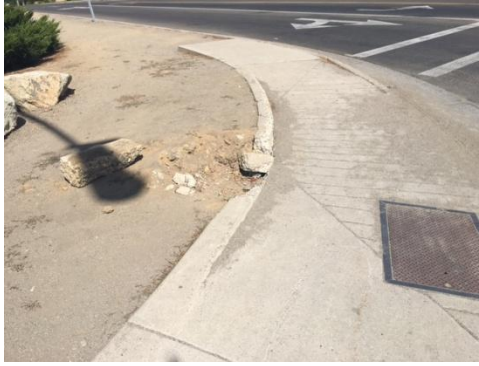
Photo 18-Broken concrete sidewalk.

- The space available for pedestrians waiting at the southwest corner of the Lake Parkway intersection is insufficient for large groups. The traffic signal pole on the southwest corner is in the sidewalk and the sidewalk is broken. See photos 18 and 19 (page 26).
- ❖ **Priority 2a- Widen the existing sidewalk on the corners of the Lake Parkway intersection to accommodate more pedestrians.**
- ❖ **Priority 2a- Reconstruct the broken concrete sidewalk at the intersection of Lake Parkway.**

48. *Widen the existing sidewalk on the corners of the Lake Parkway intersection to accommodate more pedestrians.*
49. *Reconstruct the broken concrete sidewalk at the intersection of Lake Parkway.*

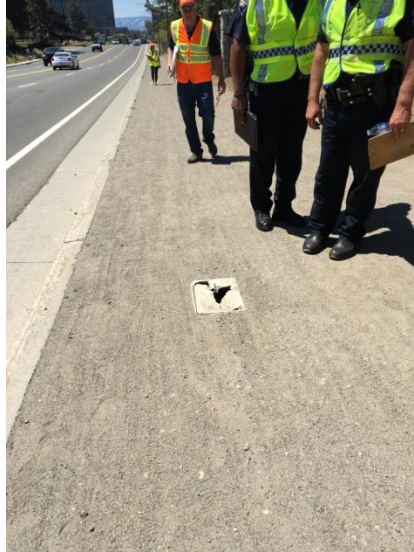
Photo 20- Broken lighting utility box cover.

- The Lake Parkway intersection is planned for reconstruction as a roundabout with the future US 50 South Shore Revitalization Project, by Tahoe Transportation District (TTD). See photo 16 on page 24.
- ❖ ***Priority 3a- Support reconstruction of the Lake Parkway intersection as a roundabout as part of the US 50 South Shore Revitalization Project by TTD.***
- ❖ ***Priority 3b- Reconstruct the Lake Parkway intersection as a roundabout as part of the US 50 South Shore Revitalization Project by TTD.***
- The lighting utility box cover in the shared use path between Lake Parkway and SR 207 (also known as Kingsbury Grade) intersections is broken. See photo 20, page 27.

- ❖ ***Priority 1c- Replace the broken lighting utility box cover between Lake Parkway and SR 207.***
- ❖ ***Priority 2c- Consider replacing all non-traffic rated utility boxes in the right of way between Lake Parkway and SR 207 with traffic rated boxes and covers.***

19. *Replace all County-maintained signs that exhibit reduced reflectivity with new signs that meet current standards. (Douglas County maintains the signs associated with the traffic signals on the highway.)*
20. *Replace the broken lighting utility box cover between Lake Parkway and SR 207.*

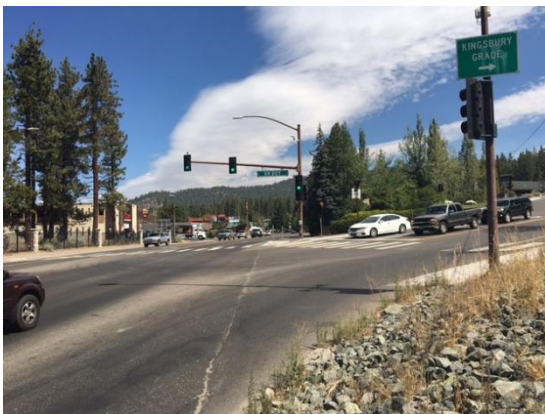
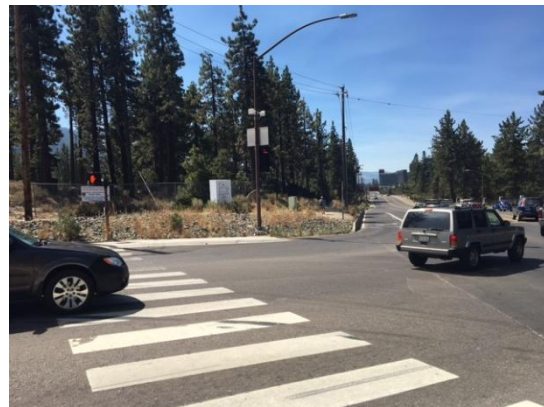
Photo 21- The crosswalk on the intersection of SR 207 (also known as Kingsbury Grade) and US 50 is not in the same line of sight as the driver.

- The pedestrian signal to cross SR 207 shows “WALK” at the same time that the eastbound drivers have a green through light and are able to make a free right turn onto SR 207. The pedestrian crossing appears to be out of the direct line of sight of approaching drivers. See photo 21.
- ***Priority 2a- Evaluate the sight distance at SR 207 pedestrian crosswalk with respect to eastbound vehicles on US 50 turning onto SR 207, and consider installing a separate right turn signal for vehicles turning from US 50 onto SR 207, prohibiting drivers from turning right during the pedestrian phase.***

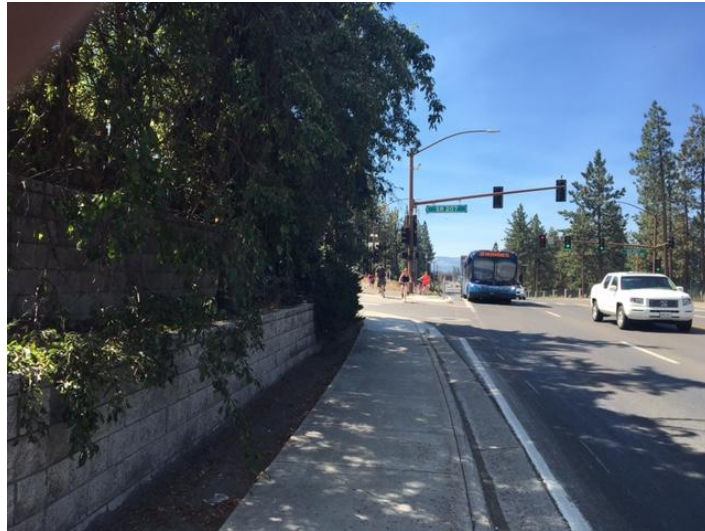
Photo 22- Sidewalk at the intersection of SR 207

- At the SR 207 intersection with US 50, not all facilities are ADA compliant. Some pedestrian ramps lack detectable warnings and some pedestrian areas in the island undulate and are not clearly defined. See photos 22 and 23.
- ❖ ***Priority 2a- At the SR 207 intersection, reconfigure all pedestrian facilities to meet ADA requirements.***

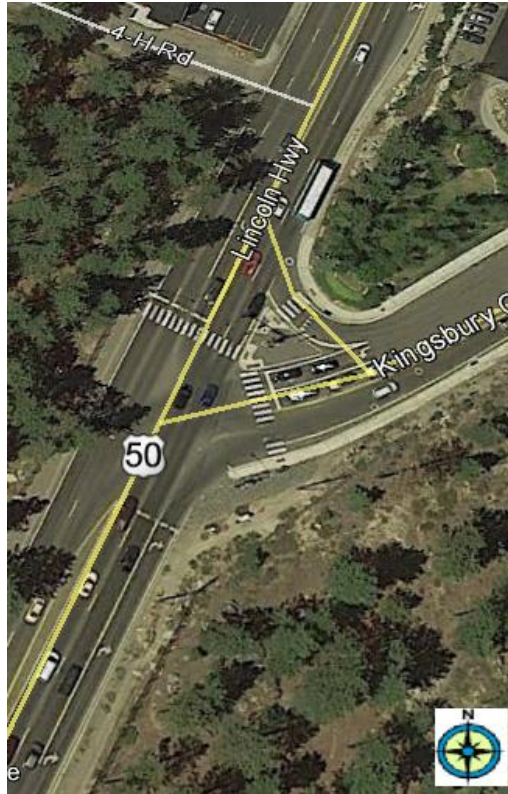
Photo 24-Aerial view of the SR 207 And US 50 intersection.

- The RSA team noticed westbound trucks on US 50 having difficulty making left turns onto Kingsbury Grade.
- ❖ **Priority 2a- Evaluate the SR 207 intersection for potential conversion to a roundabout.**
- ❖ **Priority 2a- Evaluate turning movement geometry and consider adjusting the current SR 207 intersection geometry to improve turning movement for trucks.**

53. *Evaluate turning movement geometry and consider adjusting the current SR 207 intersection geometry to improve turning movement for trucks.*
54. *From SR 207 to Kahle Drive, replace the sidewalk and pedestrian ramps, as needed, to make this area ADA compliant.*

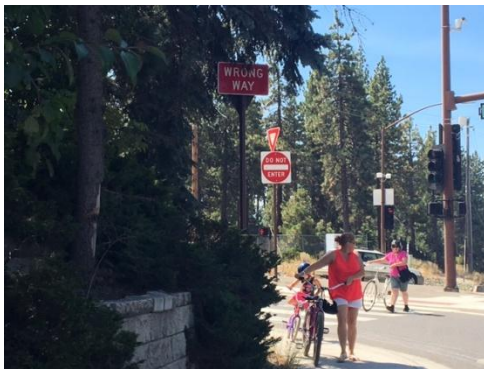
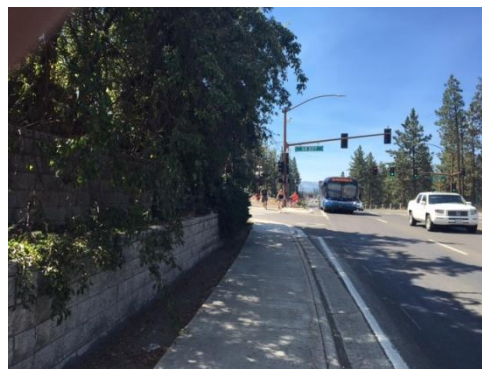
Photo 25- “Wrong Way” sign at SR 207 blocked by trees.

- The “Wrong Way” sign on westbound US 50 at SR 207 is partially blocked by tree branches. See photo 25.
- ❖ **Priority 1a- Trim tree to improve the visibility of the “Wrong Way” sign on westbound US 50 at SR 207.**

- 3. *Trim tree to improve the visibility of the “Wrong Way” sign on westbound US 50 at SR 207.***
- 4. *Install Wayfinding guide signs from Kahle Drive to Round Hill Pines to direct users to the new multi-use paths. See 2016 ATP, Complete Street Resource Guide, and SR 28 Signage Master Plan for TRPA recommended way finding signage.***

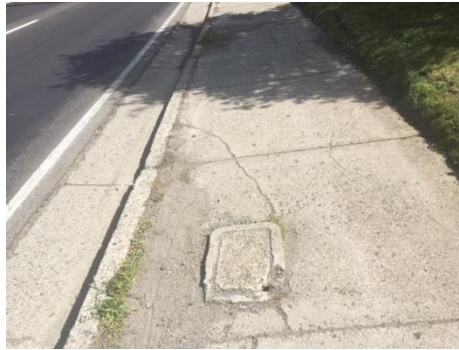
Photo 26- Sidewalk in poor condition.

- From SR 207 to Kahle Drive the sidewalks are deteriorated and the pedestrian ramps are not ADA compliant. See photo 26.
- ❖ ***Priority 2a- From SR 207 to Kahle Drive, replace the sidewalk and pedestrian ramps, as needed, to make this area ADA compliant.***

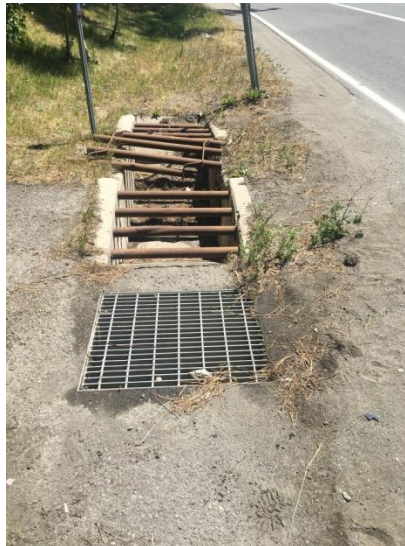
Photo 27- Broken drop inlet.

- Per the NHP representative of the RSA team, standing water and ice sometimes occur at the Lake Village Drive intersection with US 50. There are two drop inlets on the highway, one on each side of Lake Village Drive. The drop inlet on the south side is damaged. Both drop inlets have debris in them. The PCC curb and gutter on the south side of the intersection ends well short of the drop inlet on the south side. See photo 27.
- ***Priority 1a- Clean drop inlets and culverts on US 50 at Lake Village Drive.***
- ***Priority 1a- Repair broken grate on drop inlet on the south side of the Lake Village Drive intersection.***
- ***Priority 2a- Construct a valley gutter across Lake Village Drive with curb, gutter, and spandrels to the drop inlets to eliminate standing water.***

- 5. *Clean drop inlets and culverts on US 50 at Lake Village Drive.***
- 6. *Repair broken grate on drop inlet on the south side of the Lake Village Drive intersection.***

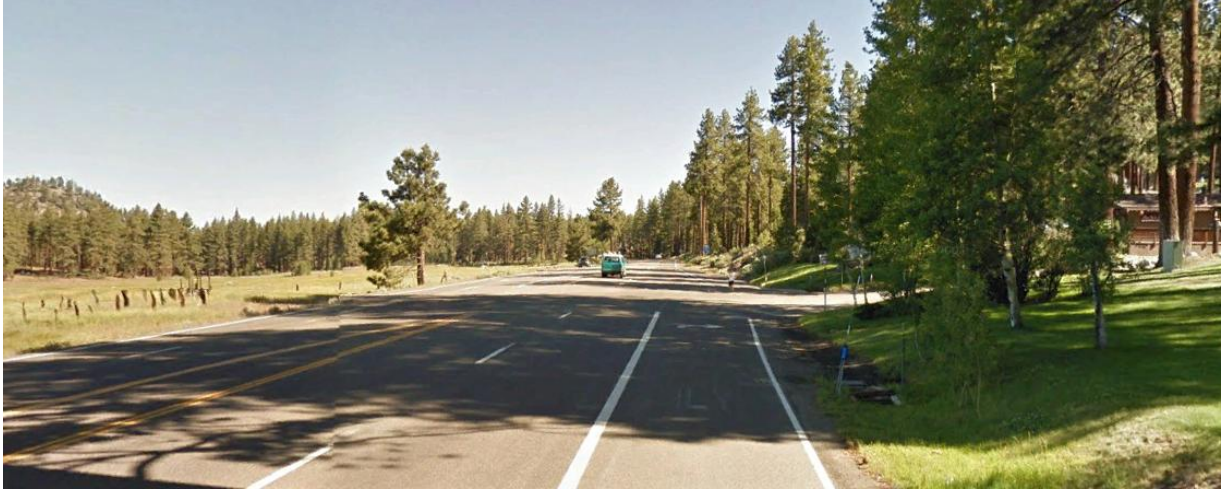
Photo 28-Trees blocking line of sight for drivers on Lake Village Dr.

- There is limited visibility for drivers turning onto US 50 from Lake Village Drive. See photo 28 (page 32).
- ❖ ***Priority 1a- Move the stop bar closer to the highway to improve sight distance looking south from Lake Village Drive.***
- ❖ ***Priority 1a- Evaluate right of way limits and remove or trim the trees near US 50, within right of way, to improve sight distance looking south from Lake Village Drive.***

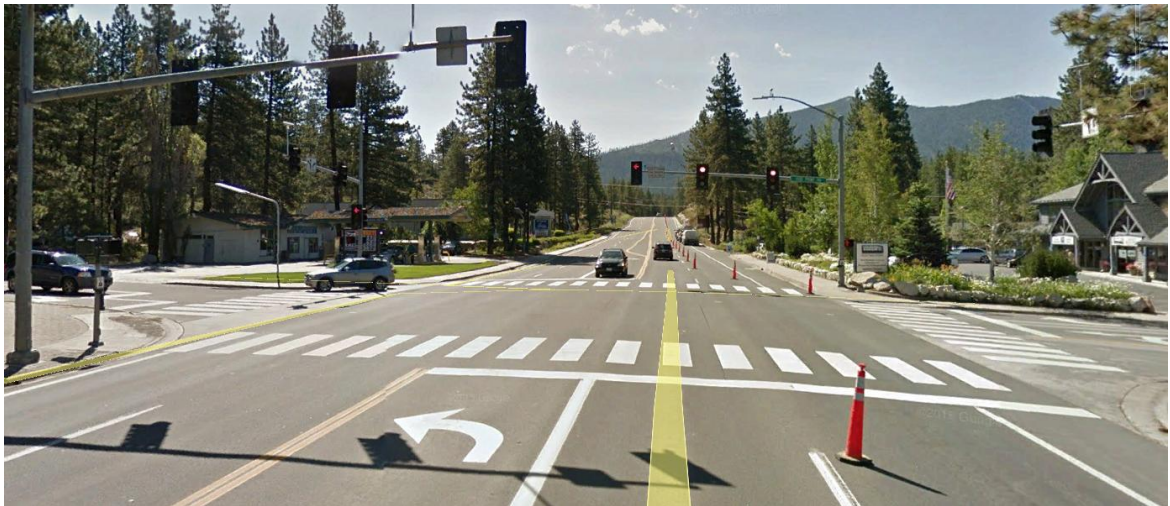
Photo 29- Current pedestrian ramps and traffic signal poles at US 50/Elks Point Road.

- At Elks Point Road, none of the pedestrian ramps and pedestrian push buttons are ADA compliant. The traffic signal poles on the southeast and southwest corners obstruct portions of the sidewalk. See photo 29.
- ❖ ***Priority 2a- Construct new ADA compliant pedestrian facilities at the Elks Point Road/US 50 intersection on all four corners.***
- ❖ ***Priority 2a- Relocate the traffic signal poles or widen the sidewalk as needed to meet ADA requirements at the Elks Point Road/US 50 intersection.***

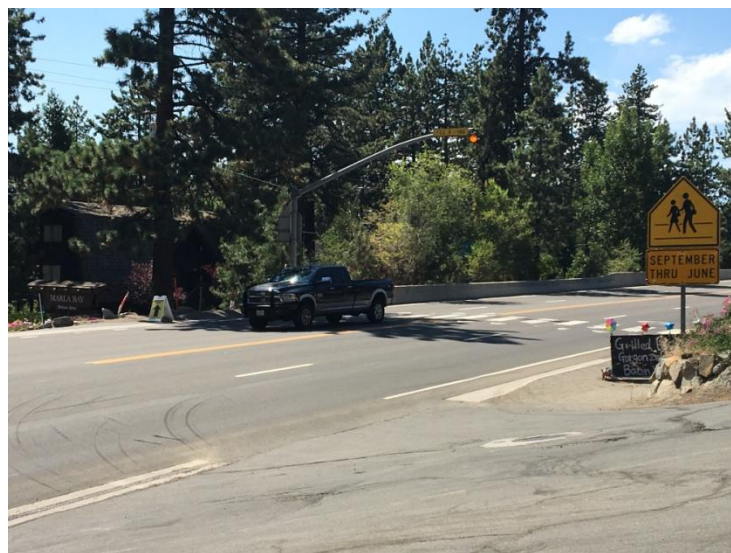
Photo 31- School zone signage.

- The school zone signage “September thru June” is inconsistent with the continuously operated flasher, the summertime use of the crosswalk by the general public, and the time of the school year. See photo 31.
- ***Priority 1a- Remove the “September through June” sign on US 50 and replace it with a down arrow.***

- 11. *Remove the “September through June” sign on US 50 and replace it with a down arrow.***
- 12. *Install new “No Parking Any Time” signs on US 50 west of Zephyr Cove that can be seen by approaching westbound traffic.***

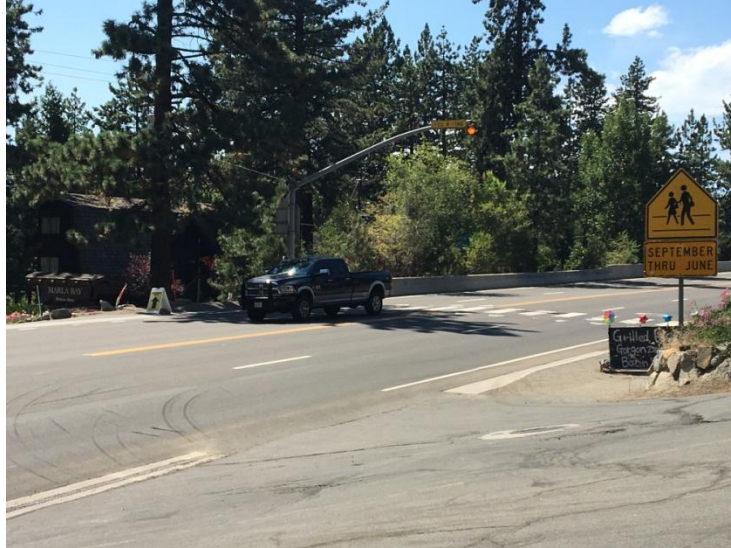
Photo 32- Overhead continuously flashing light.

- There is a current NDOT project to redesign the crosswalk at Lake Shore Boulevard. Currently, there is an overhead flashing light that flashes continuously over the crosswalk. Drivers become accustomed to seeing the flasher in operation and as a result the flasher loses some effectiveness. See photo 32.
- ❖ ***Priority 2a- Coordinate with NDOT on the current on-going project to change the operation of the flashing lights at US 50/Lake Shore Boulevard from continuously flashing to pedestrian activated flashers.***

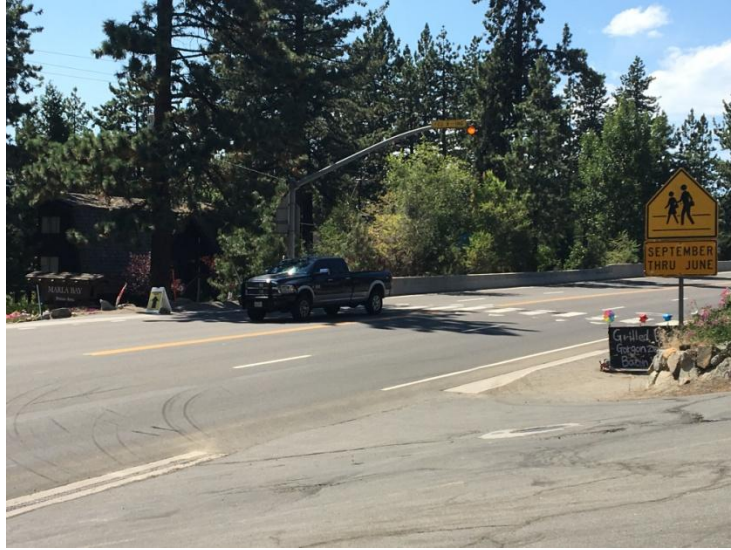
Photo 33- No left turn lane.

- There is no pedestrian ramp on the west side of the highway and no wheelchair access. The ramp on the east side is not ADA compliant.
- ❖ ***Priority 2a- Provide ADA compliant access on the west side of US 50 at Lake Shore Boulevard.***
- Vehicles appear to be driving fast (speed limit of 45mph) and there is no left turn lane at this location. Drivers turning left off the highway stop in the fast lane to cross. See photo 33 (page 36).
- ❖ ***Priority 2a- Consider installing speed feedback signs.***
- ❖ ***Priority 2a- Consider construction of a westbound deceleration lane and acceleration lane on US 50 at Lake Shore Boulevard.***
- ❖ ***Priority 2a- Consider, in the complete street project, a roadway reconfiguration to install a two way left turn lane on US 50 at Lake Shore Boulevard, if feasible based on capacity analysis.***

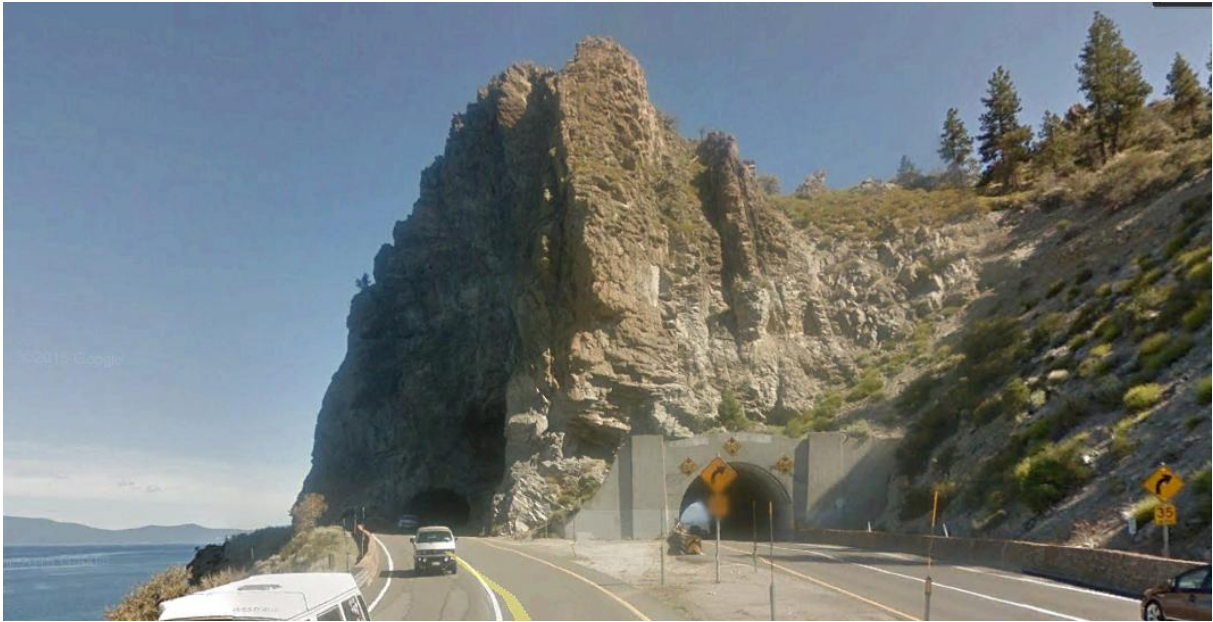
Photo 37- South end at Cave Rock Tunnel

- NDOT recently extended the north end of the westbound tunnel because of falling rock. However, team members indicated seeing a substantial amount of falling rock at the south end of the eastbound Cave Rock tunnel. As shown in photo 37.
- ❖ ***Priority 2a- Install rock netting on the slope at the south end of the eastbound Cave Rock tunnel.***

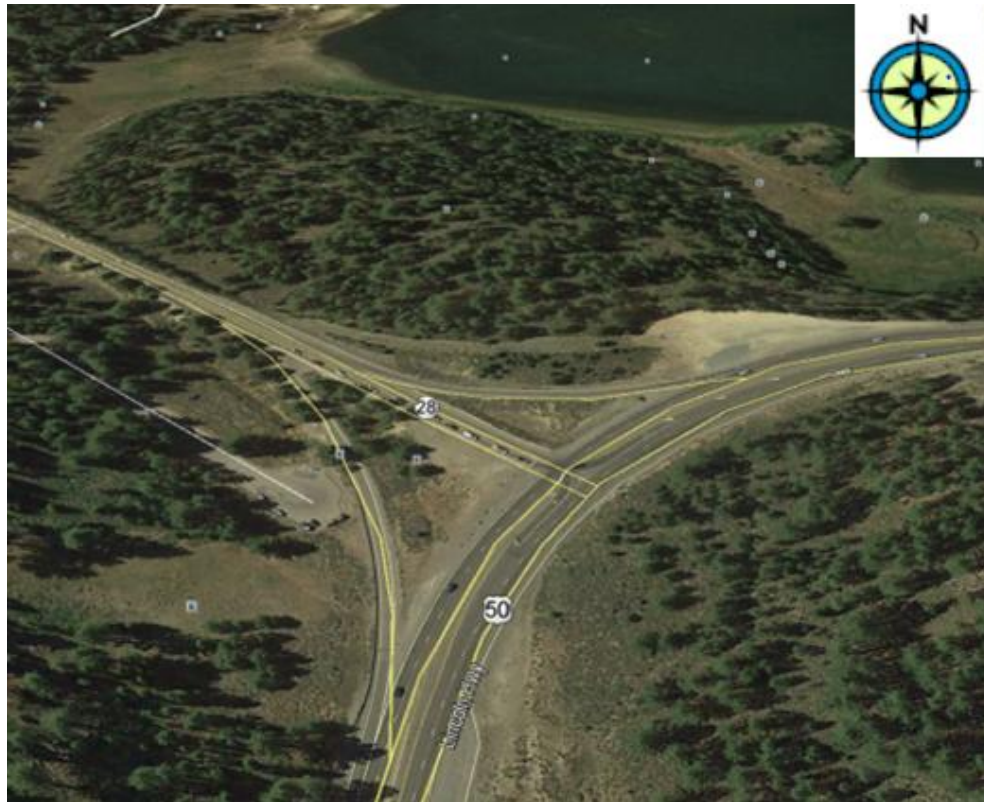
Photo 38- Aerial view of the intersection of US 50 and SR 28.

- The team observed a queue of vehicles on State Route 28 (SR 28) waiting to turn left onto US 50. Potential reasons for the traffic back up could include drivers not knowing/understanding the geometry of the acceleration lane, drivers believing the acceleration lane is too short to accelerate to the speed of traffic, sight distance to the north being restricted by the curve, and being unable to tell whether the eastbound US 50 driver is turning until their turn is in progress. The aerial view of this intersection is shown in Photo 38.

- ❖ **Priority 2a- If the US 50/SR 28 intersection cannot be converted to a roundabout, consider lengthening the eastbound acceleration/merge lane on US 50.**

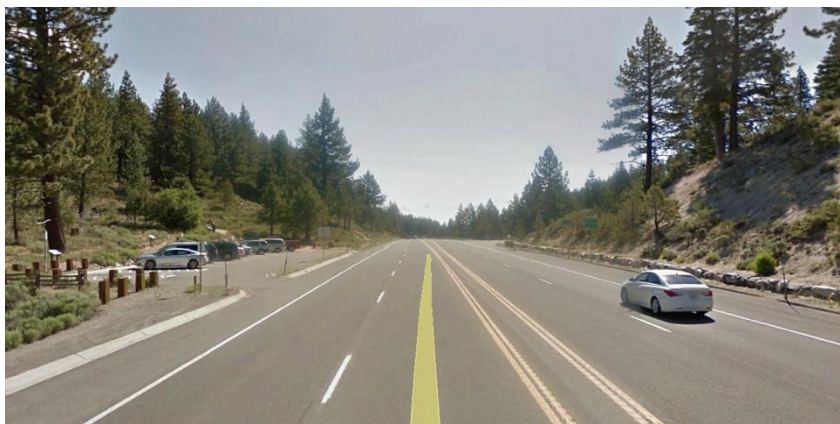
Photo 41- Parking at Spooner Summit.

- The Team observed that there is no gap in the two sets of double yellow stripes on US 50 at Spooner Summit that would provide for legal left turns onto and off of the highway at the trailhead parking lots on both sides of the highway. Also, the Tahoe Rim Trail crosses the highway at this location, and there is no warning for motorists of potential hikers crossing the highway here. See photo 41.
- ❖ ***Priority 2a- Evaluate the access to the Spooner Summit trailhead parking lot. Evaluate the possibility to restripe the centerline striping at Spooner Summit to provide a gap in the two double yellow lines at the trailhead parking lot.***
- ❖ ***Priority 2a- Evaluate ways to improve this Tahoe Rim Trail crossing of US 50 at Spooner Summit for bicyclists and pedestrians.***
