THE UPPER TRUCKEE RIVER:

AQUATIC HABITAT MONITORING FOR RESTORATION AND ADAPTIVE MANAGEMENT

The Upper Truckee River: Aquatic Habitat Monitoring for Restoration and Adaptive Management

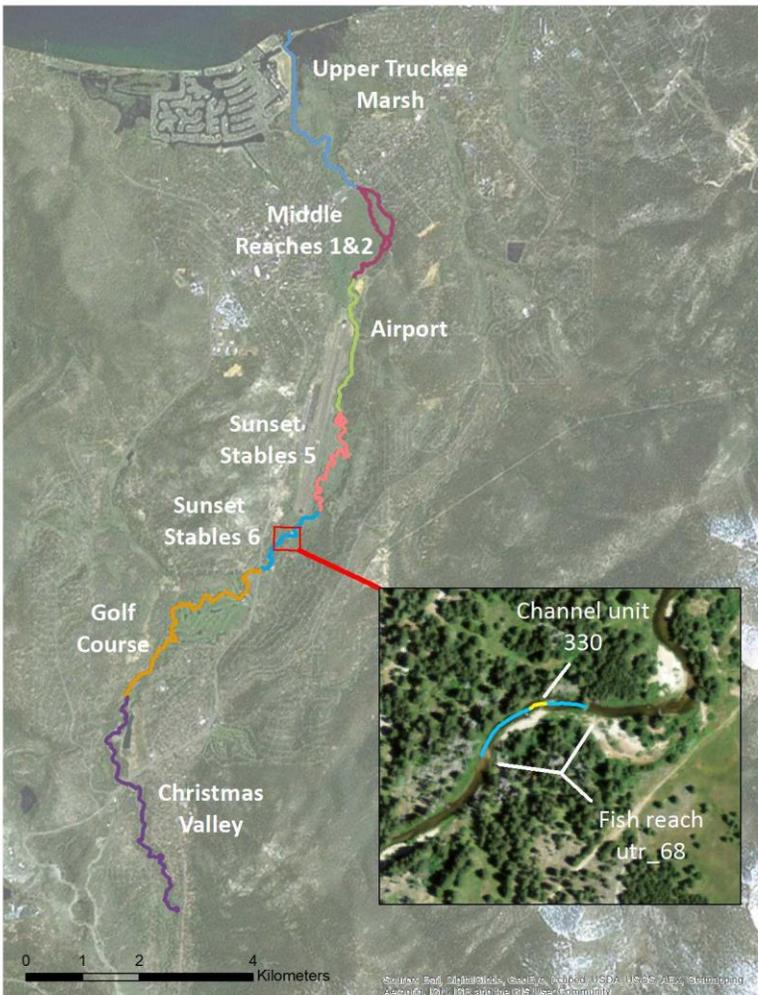
Figure 1. Locator map for the project area showing the seven restoration reaches, as well as an example of the smaller scale fish reach and channel unit (Inset).

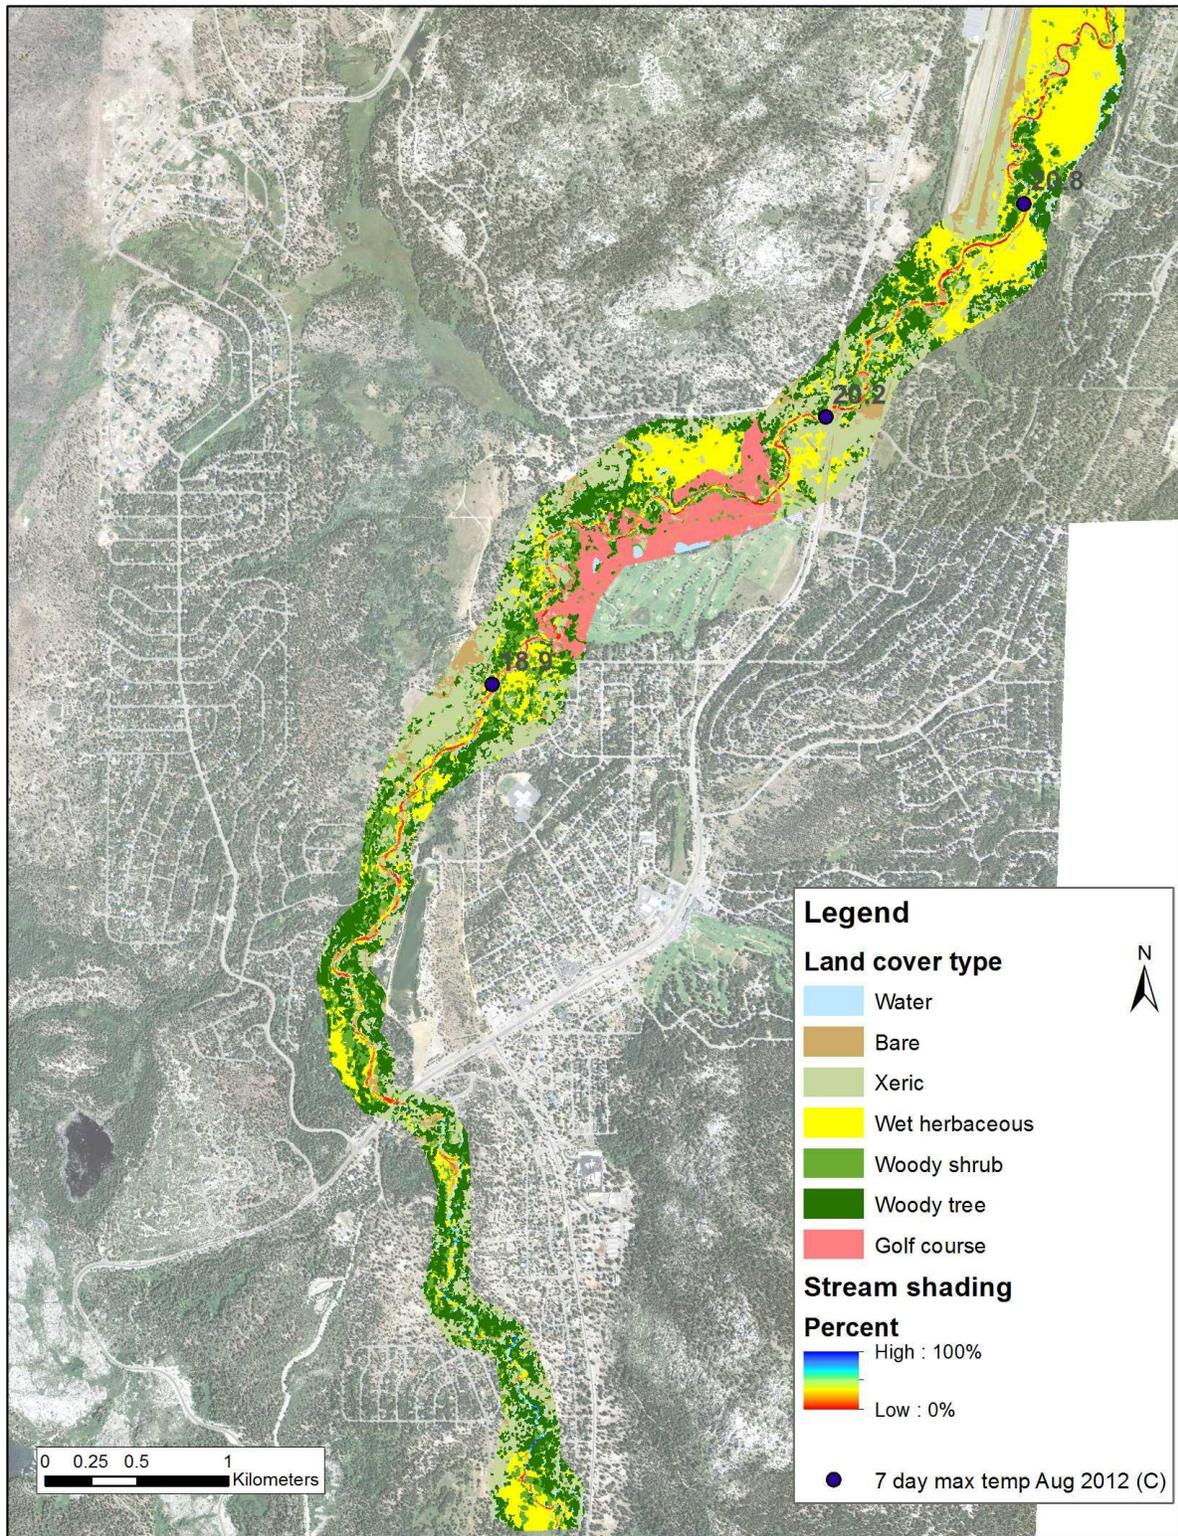
Figure 2. Vegetation distribution, along with shading and stream temperature, for the southern half of the study area (See Appendix).

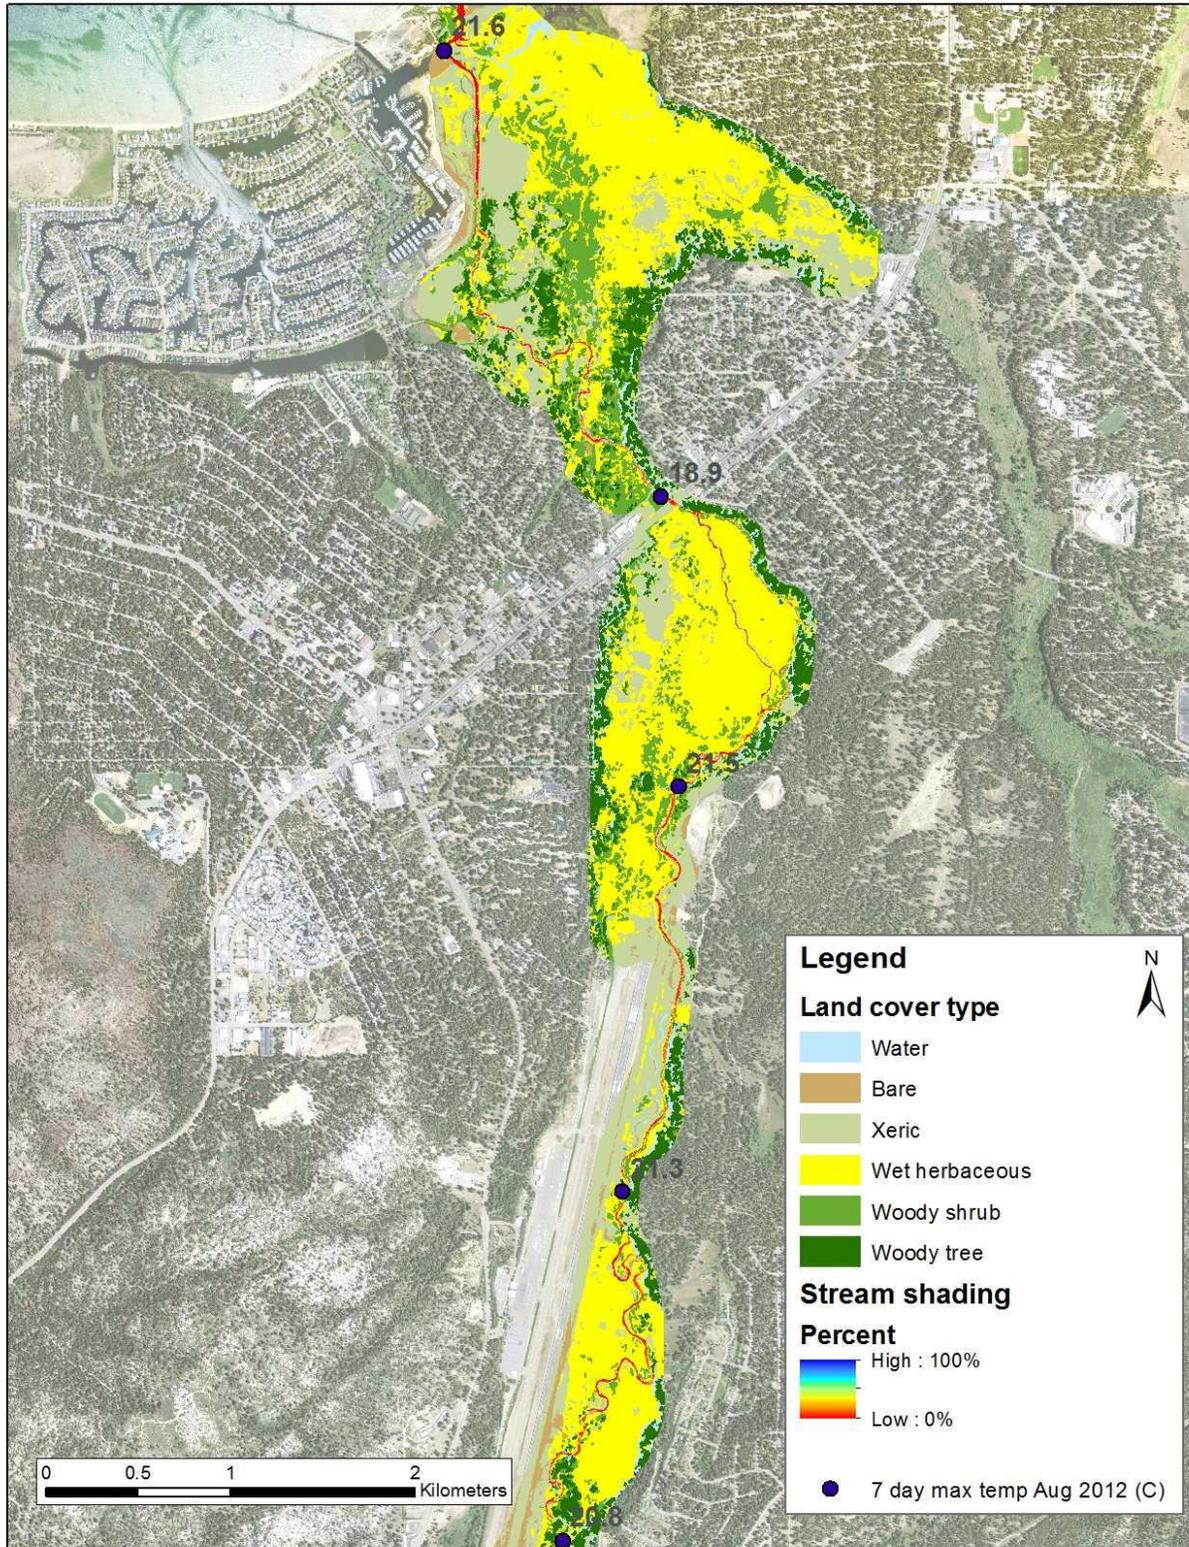
Figure 3. Vegetation distribution, along with shading and stream temperature, for the northern half of the study area (See Appendix). **Inundated habitat area**

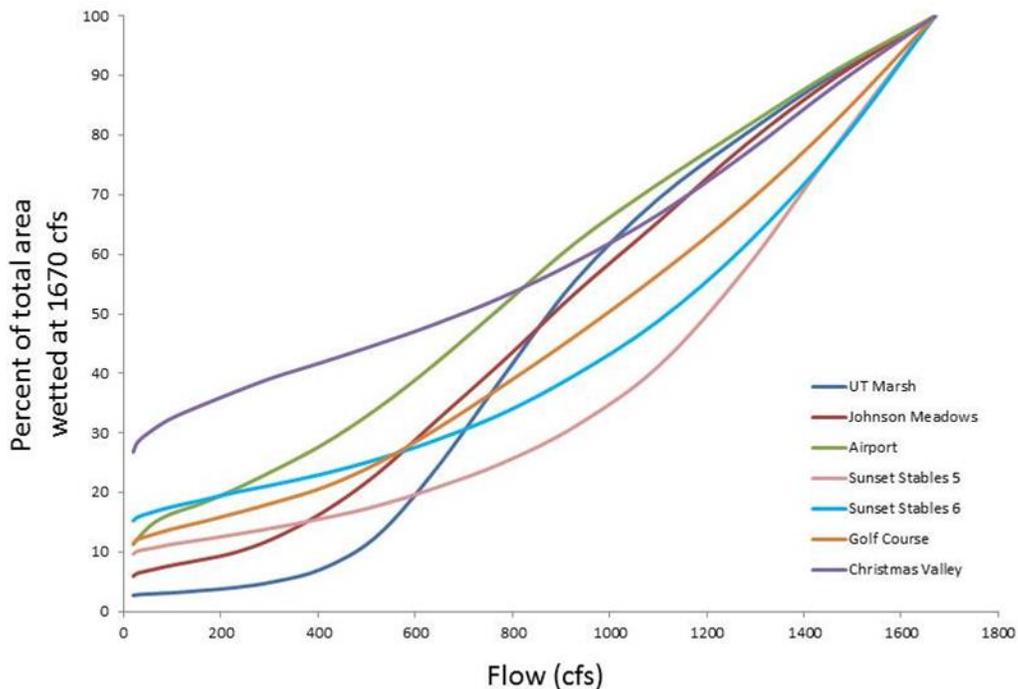
Inundated floodplain area at high flow (1670cfs) per kilometer of the longest valley axis was highest in the Marsh (1.08 km²/km) and generally exhibited a decreasing pattern upstream: Middle Reaches 1&2 (0.77 km²/km); the Airport (0.25 km²/km); Sunset Stables (5) (0.38 km²/km); Sunset Stables (6) (0.28 km²/km); the Golf Course (0.27km²/km); and Christmas Valley (0.11 km²/km). The Airport reach is more similar to the furthest upstream reaches where total inundated floodplain area at high flow is more limited.

Figure 4. Percent of floodplain area inundated relative to flow (CFS) for the seven restoration reaches.

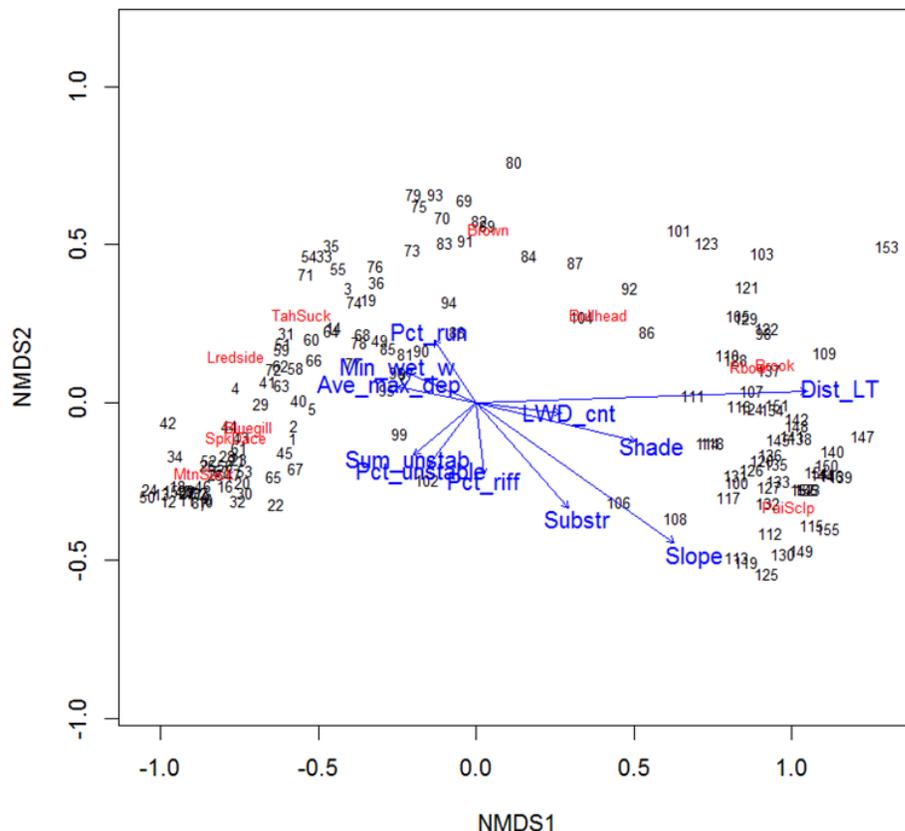
Figure 7. NMDS scaling of fish relative abundance with habitat variables overlaid. Species are arrayed within the two axes of the NMDS to reflect their difference in relative abundance at the fish reach scale. Fish reaches are labeled sequentially from Lake Tahoe.

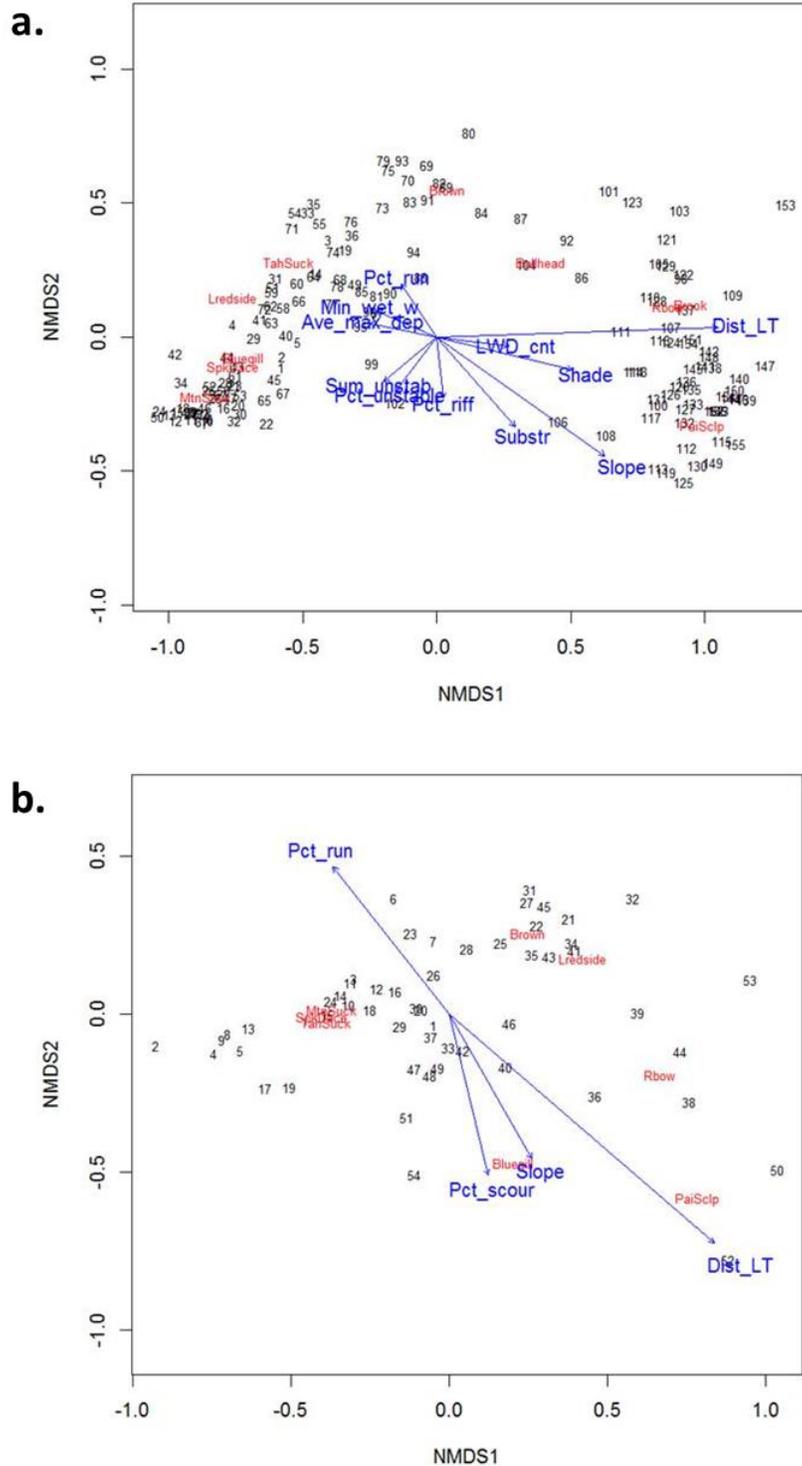
Figure 8. NMDS scaling of fish relative abundance with habitat variables overlaid ($P = 0.05$) a) excluding three most downstream fish reaches and b) for middle 50 fish reaches only. Species are arrayed within the two axes of the NMDS to reflect their difference in relative abundance at the fish reach scale. Fish reaches are labeled sequentially from Lake Tahoe.

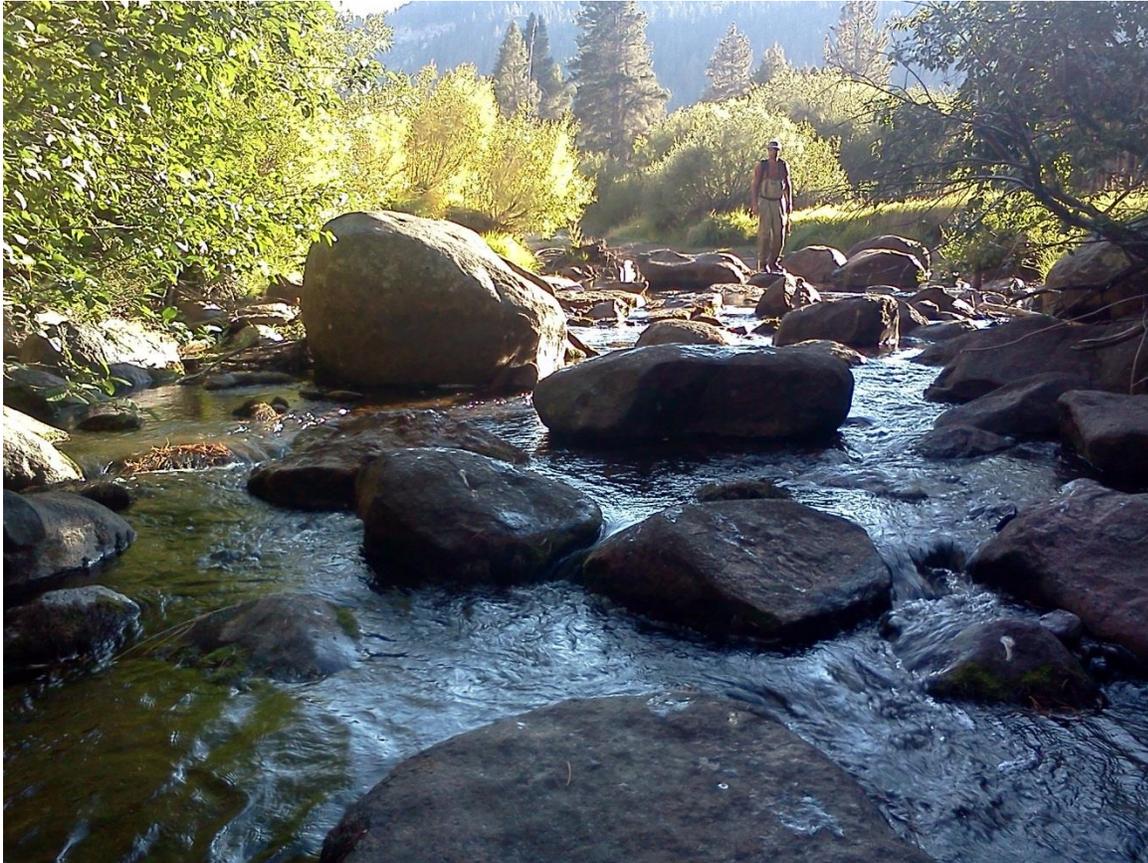
(105.8 mm) with some sections consisting predominantly of large boulders and cobble. Christmas Valley is the reach with the steepest gradient, averaging 0.52%. The reach had the coldest water of any of the reaches with a 7-day max downstream temperature (August-October) of 18.9°C.

Figure 9. Boulder and cobble substrate, higher gradients, and denser forests characterize Christmas Valley reach. Photo: Sabra Purdy

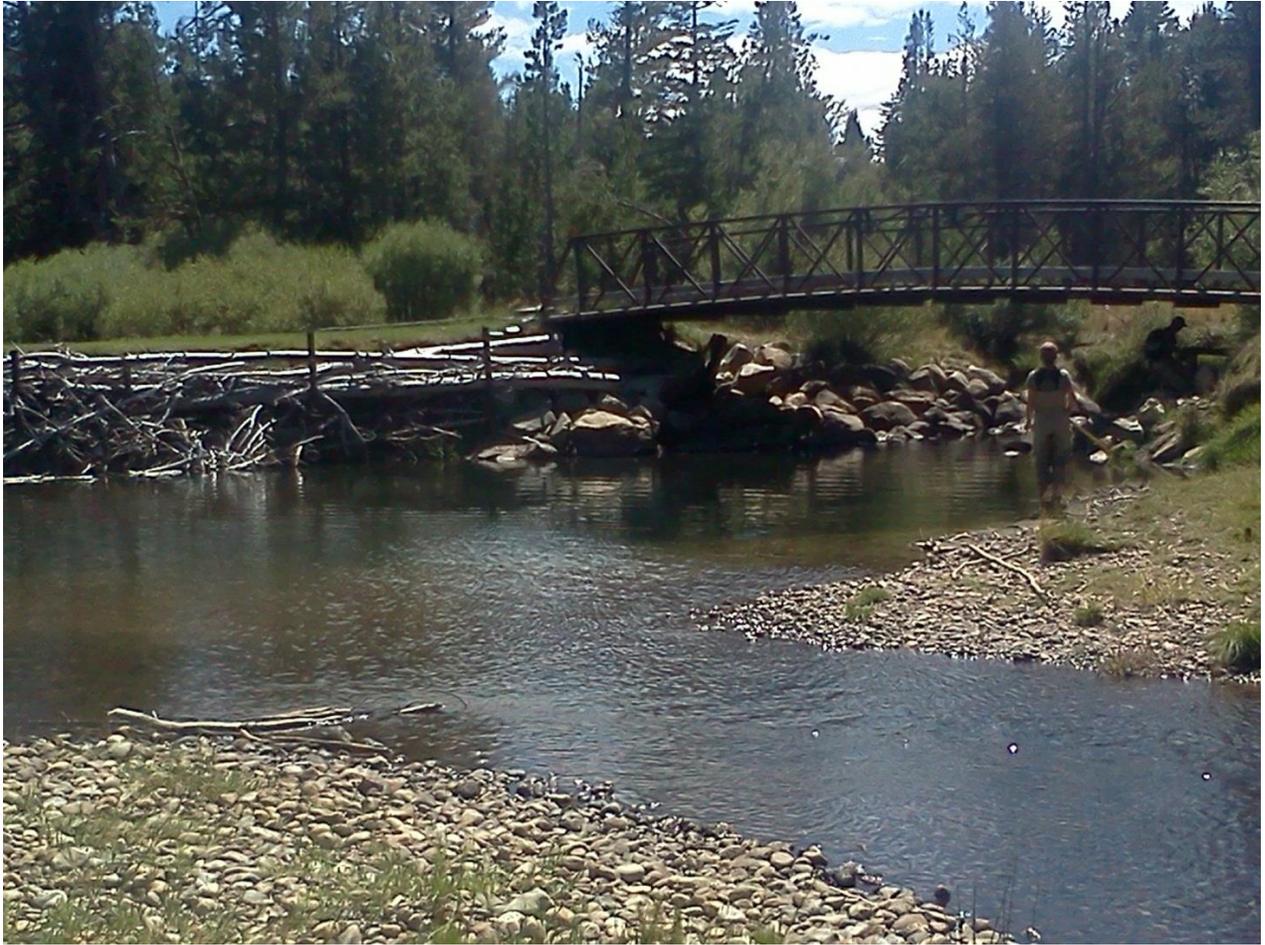
1962 on the former meadow area. Five undersized bridges were installed by the golf course over the UTR and they constrict the channel exacerbating erosion downstream. Average substrate size in this reach is 74.9 mm and consists largely of cobble. In many sections, the fairway comes right to the edge of the river creating an unbuffered source of nutrients and fertilizer and restricting the growth of riparian vegetation. We measured bank instability in this reach at 16.8% unstable banks with 29.8% of the channel units in this reach containing bank stabilization efforts such as riprap, root wads, and log barriers. These efforts have had limited success and there are several sections in this reach that have significant erosion zones that are eating into the fairway. At the upstream and downstream end of this reach STPU sewer lines cross the river and the lines are in the floodplain. The woody debris count in this section is 92, predominantly coming from upstream inputs above the golf course. The gradient changes in this section as it is a transition from the steeper glacial outwash reach in Christmas Valley and the lower gradient meadow and lake-influenced reaches downstream. The average gradient is .20 % and there is a grade control structure near the downstream end of the golf course for water intake. The percent of shaded habitats on this section is presumably lower than it was historically, due to lack of streamside vegetation in the golf course where the fairways extend to water's edge, and is around 18%. This reach gains 1.3°C in temperature from top to bottom, which is probably a direct function of loss of riparian vegetation. California State Parks have put forward a major stream and meadow restoration proposal for this reach which has gone through significant environmental review but has not yet been implemented.

Figure 10. The uppermost of the golf course bridges has created significant downstream erosion problems. Note the heavy bank reinforcement and the fairway up to the edge of the stream. Photo: Sabra Purdy

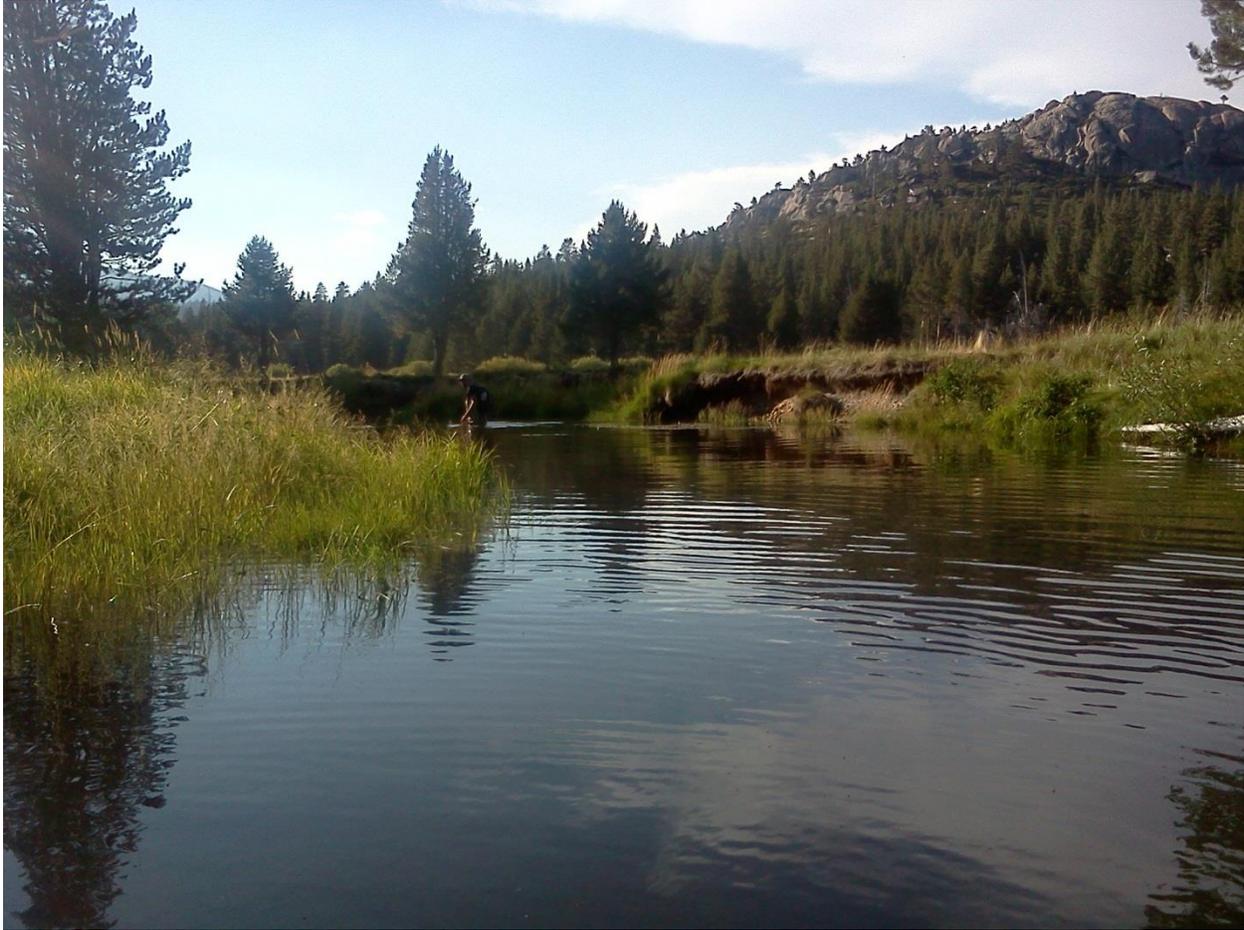
Figure 11. The Golf Course Reach is characterized by frequent cases of bank instability or attempted bank stabilization projects and fairways that come all the way to the water's edge. Photo: Sabra Purdy

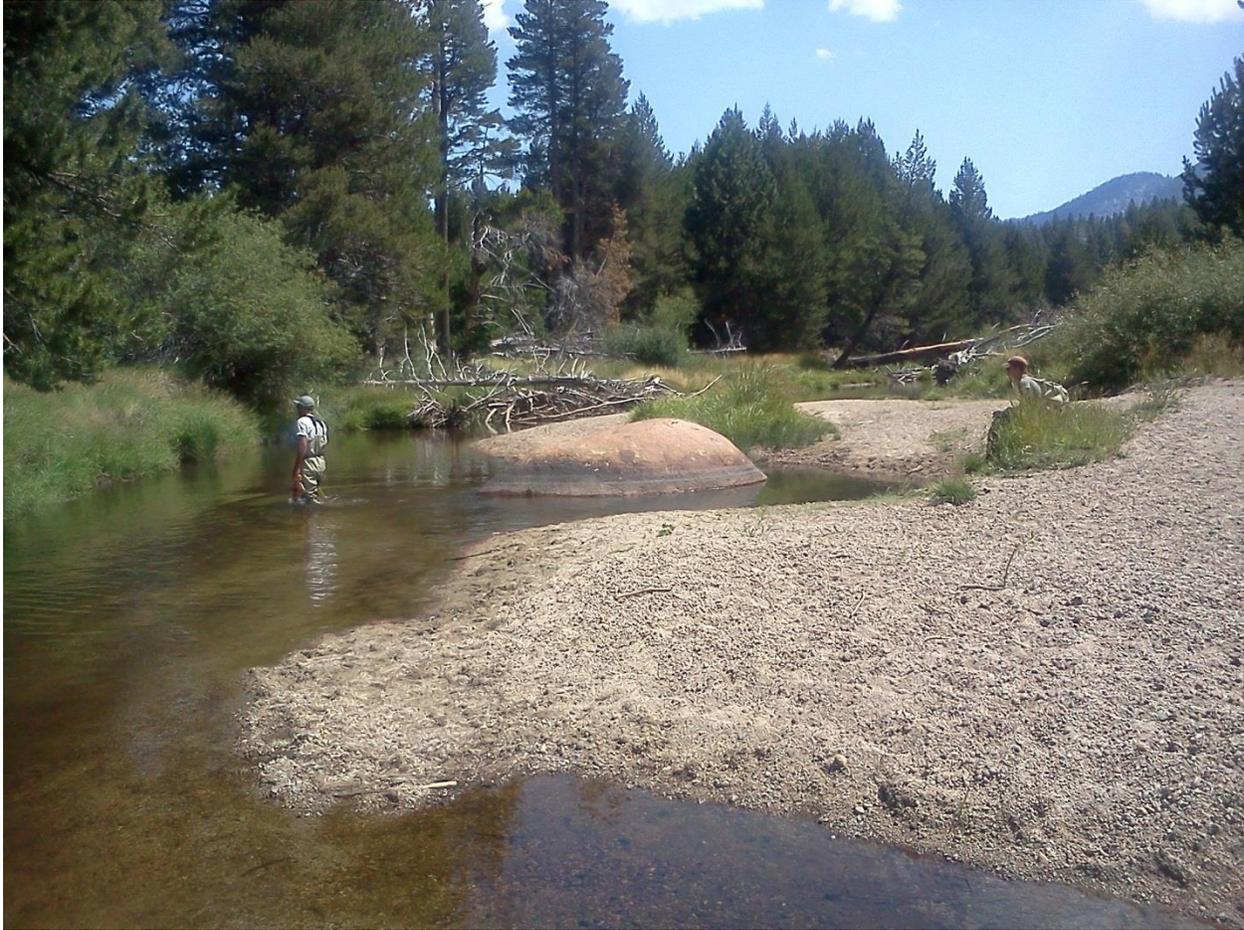
Figure 12. Sunset Stables 6. Photo: Sabra Purdy

This small reach (only 1.5 km, UTR_62-UTR_76) represents the short section between the middle Highway 50 Bridge below the town of Meyers and the end of the Lake Tahoe airport runway. It has meadow habitat mixed with encroaching conifers and has been altered by the burial of the sewer line along the river right bank. The percentage of shaded areas in this reach is 17.1%. The bank stability in this small reach is the best of all of the restoration reaches at 12.0% unstable banks and 16.0% of the channel units contain riprap, gabions or other bank stabilization or substrate augmentation efforts. This reach gains 0.6°C in temperature from top to bottom, which could potentially be improved with riparian revegetation efforts. The average substrate size in this reach is 25.4 mm and is predominantly gravel and small cobble with areas of fine sand. The average gradient is 0.1%, and the floodplain area per kilometer of valley length is 0.28 km²/km. This area contained a large amount of non-native fishes mostly in the form of salmonid species (48.9%). This is the highest relative abundance of non-native species of the sampled reaches on the Upper Truckee.

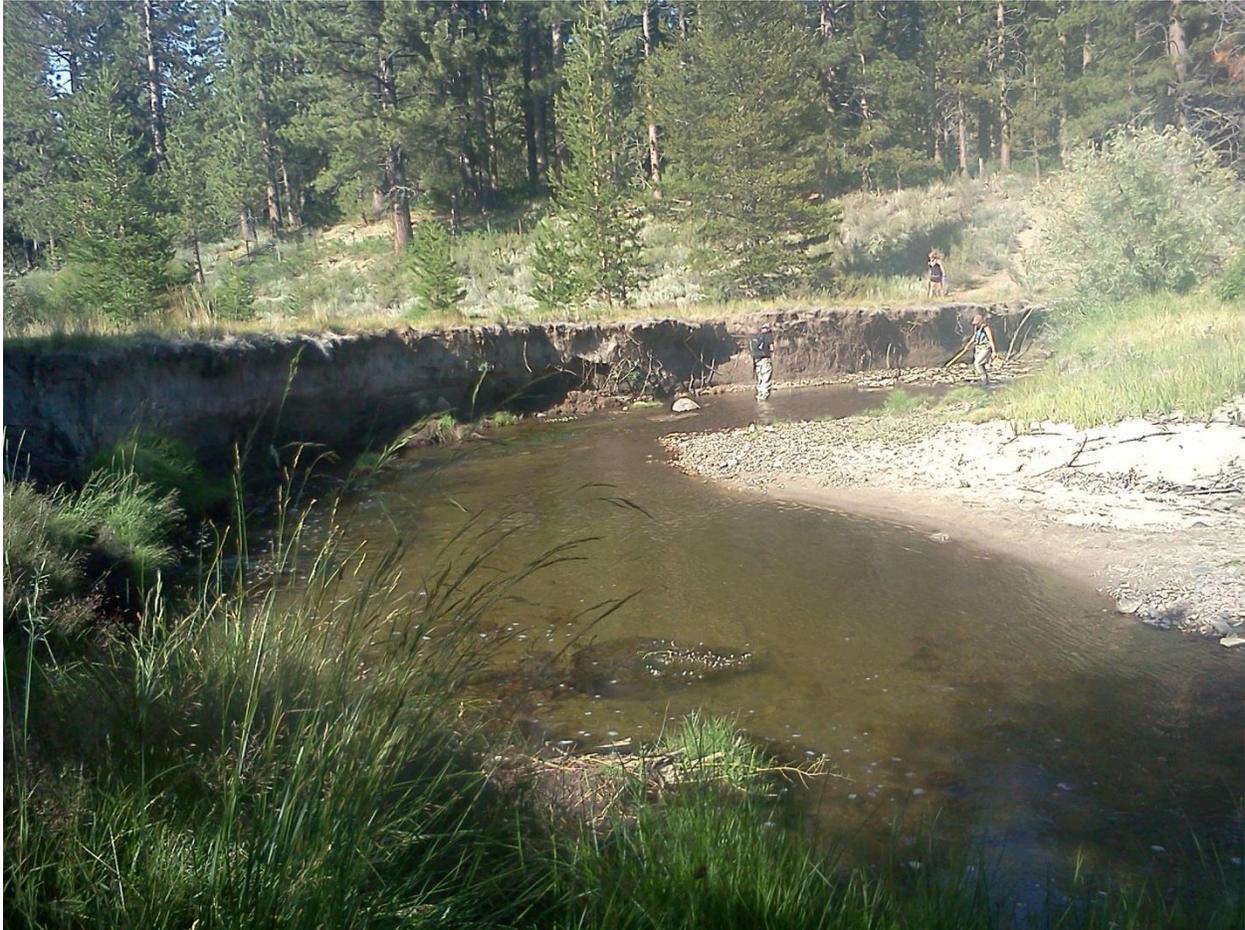
The Sunset Stables 5 reach (2.7 km long, UTR_38-UTR_62) parallels the upper end of the Lake Tahoe airport runway. This section is characterized by generally low gradients (0.10% average gradient), with gravel and sand substrates. The channel is confined here by the airport runway on river left and forested uplands on river right that contain housing developments. Despite the confining presence of the airport runway, there remains some floodplain habitat in this reach (0.38 km²/km of valley length). This section is relatively exposed to solar radiation with only 11.8% shaded habitats and gains 0.50°C over the course of the reach. The woody debris count is high in this reach at 102. This reach contains 20.8% unstable banks with some areas (near the bottom of the reach) that are highly incised, actively eroding, and will likely continue to unravel without intervention. There are bank stabilizing or substrate augmentation efforts in 15% of the channel units in this reach. This reach supports several active mussel beds. While it is not the most impacted reach on the Upper Truckee, the fact that some of the worst channel instability and deepest incision is immediately upstream of the recently completed Airport Reach

restoration project means that those efforts are vulnerable if this section continues to degrade without intervention.

Figure 13. Example of badly incised and actively eroding meander bend at the base of Sunset Stables 5 reach. Note sod sloughing into the stream and the turbidity of the water. These meander bends are very tight and will likely be eroded though in the immediate future without intervention. Photo: Sabra Purdy

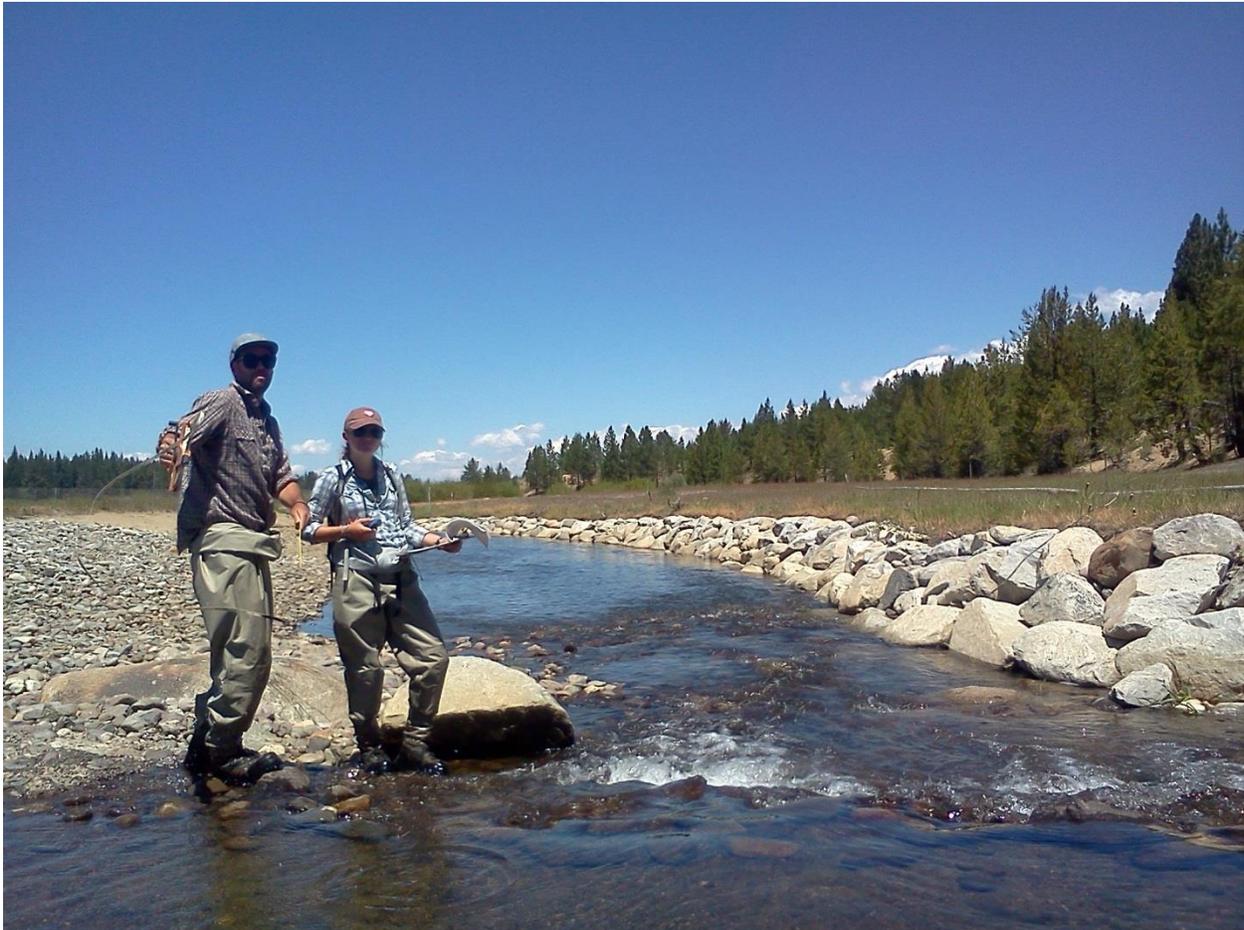
The Airport Reach (2.3 km long, UTR_17-UTR_38) has a history of alteration. It was straightened in the 1960s to make way for the Lake Tahoe Airport runway which created scouring flows and contributed to downstream erosion and incision problems. A channel reconstruction project was completed here in 2011 and our survey was the first to conduct post-project monitoring. The new channel is heavily armored with extensive riprap and gabion structures as well as gravel and cobble augmentation in at least 75% of the channel units. The airport reach gains 0.2°C from top to bottom and has an average gradient of 0.1%. There are several gradient control structures in this reach and the vegetation around the new channel is new and very tender. The areas where netting was implemented had the least observable erosion and highest recruitment of new vegetation. There are several

places where newly constructed banks are unstable and rapidly eroding resulting in an overall percentage of unstable banks of 14%. These areas pose an immediate and acute risk and warrant further assessment and near-term action, particularly while vegetation has yet to take firm root and newly constructed banks are highly vulnerable. The average substrate size in this reach is 32 mm representing a lot of introduced cobble and gravel. The floodplain area in this section is 0.25 km²/km of valley length, nearly identical to Sunset Stables 6 and is highly constrained by the airport runway on river left, and the forested upland on river right.

Figure 14. Restored channel in the Airport reach. Note heavily reinforced banks, gradient control structures, introduced cobble, and pipes for irrigation to encourage new vegetation growth. Photo: Sabra Purdy

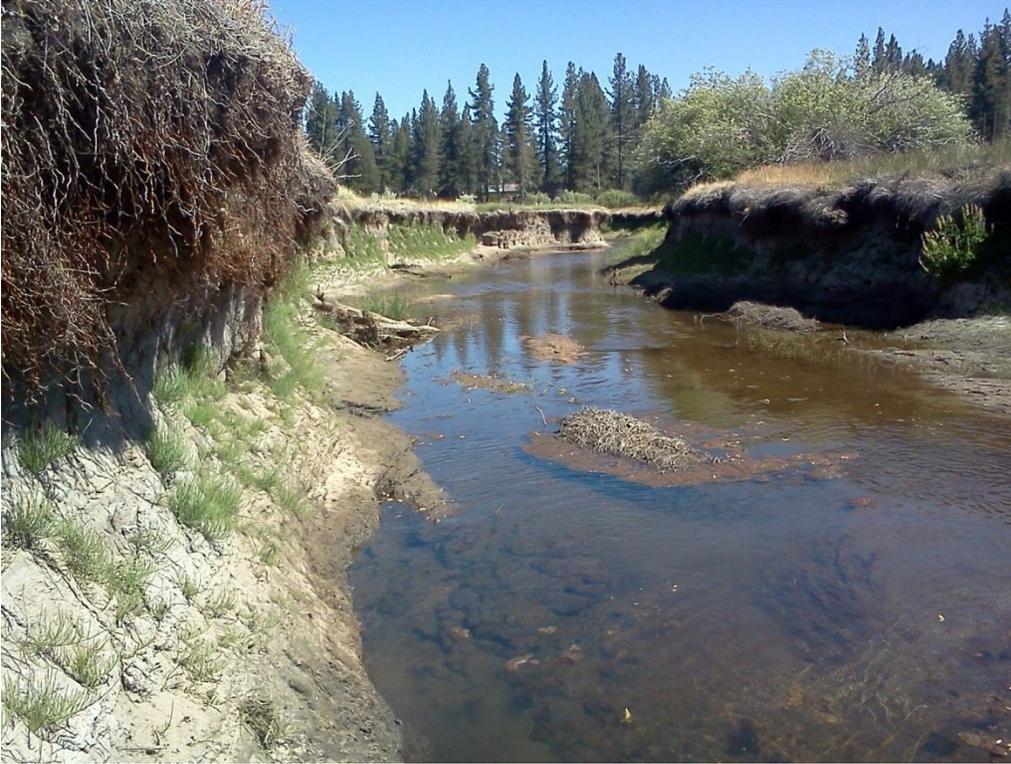
This reach, also known as Johnson Meadow (2.9 km long, UTR_1-UTR_17) is one of the more complex reaches on the UTR. The channel splits into two channels at UTR_12. The right channel hugs the right edge of the meadow along a dense housing development. While there are some bank stability problems in the right channel, the habitat is as a whole in significantly better condition on that side than in the left channel. There are numerous

Figure 15. The highly impacted left channel through Johnson Meadow. Note the deeply incised banks, scoured substrates, sod falling into the channel and the general lack of riparian vegetation and floodplain connectivity. Photo: Sabra Purdy

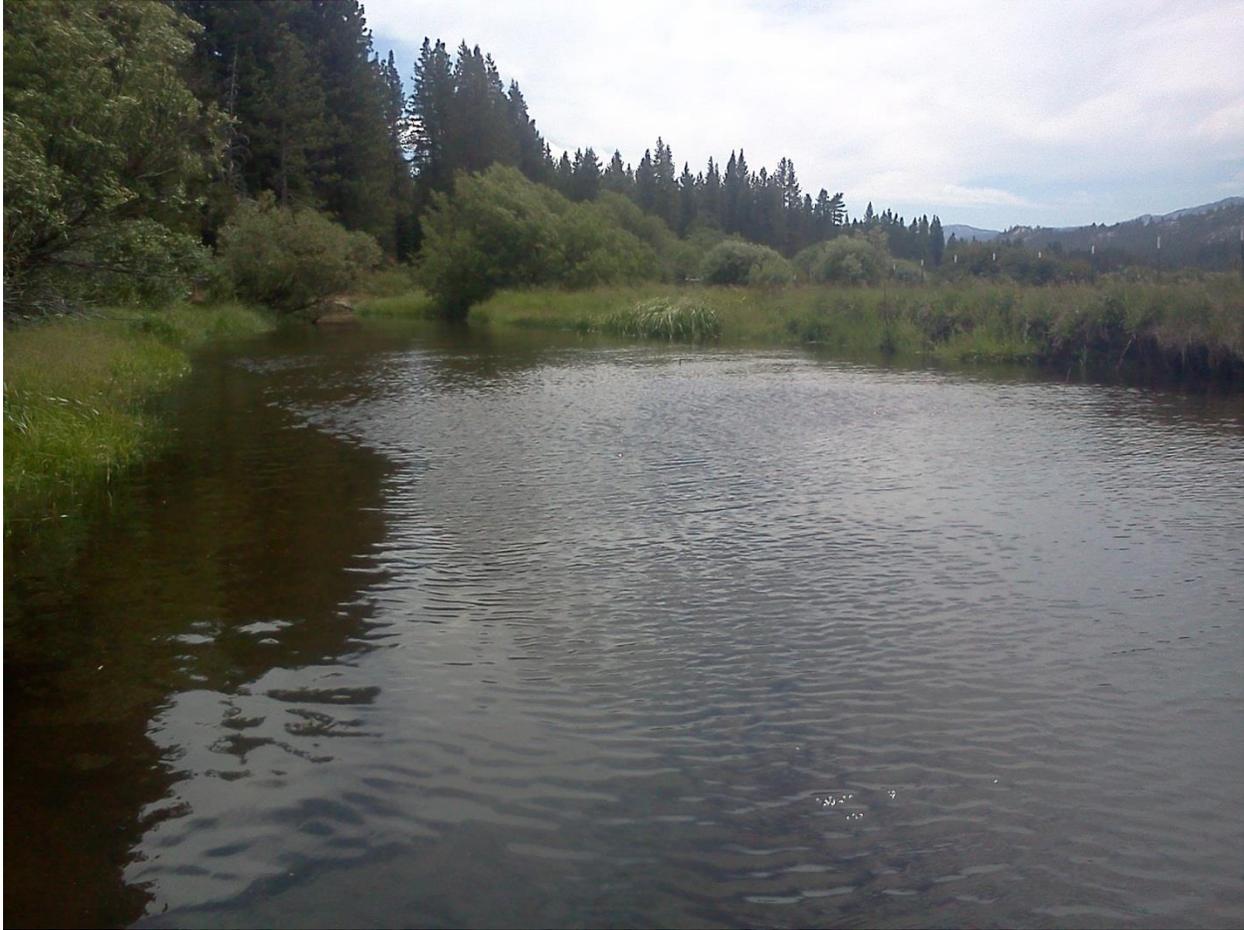
active beaver dams in the right channel, with several new dams added this summer bringing the water table up and backing pools up to cover previously denoted habitat units. The left channel goes from a beaver dam through a riprapped channel to a large eroding pool. This pool is very deep (2-3 meters) and has very cold water (6-10°C) indicating that it is likely draining groundwater through the meadow and negatively impacting hydrology. From the erosion pool downstream, the stream channel is uniformly incised and scoured with slick mud substrate and heavy algal growth. The water is shallow and the banks are highly unstable and support little in the way of riparian vegetation. Based on these characteristics, we would expect this to be a net warming reach, however, the extremely cold water inputs into this section result in a loss of 2.6°C for the reach overall, which is a startling result for such a shallow and exposed reach. This reach is predominantly sand and fine gravel with an average substrate diameter of 4.1 mm and gradients typical of meadow streams at 0.1%. The overall bank instability in this reach is the highest of all of the restoration reaches at 46.3%. The number would be higher if the right channel were excluded, though it has areas of instability and downcutting as well, particularly in the area where the two channels reconvene at UTR_2. There have been bank stabilization and substrate augmentation efforts in 17.7% of the channel units in this reach. The much more forested right channel increases the overall shade values to 18.5%, though again, the two channels are very different and values for variables such as bank instability and shade should be examined separately.

Figure 16. In contrast to Figure 15, the right channel contains sections of very stable banks, good connectivity to the floodplain, healthy riparian vegetation and coarser substrates. This section has an elevated water table due to recent beaver activity. Photo: Sabra Purdy

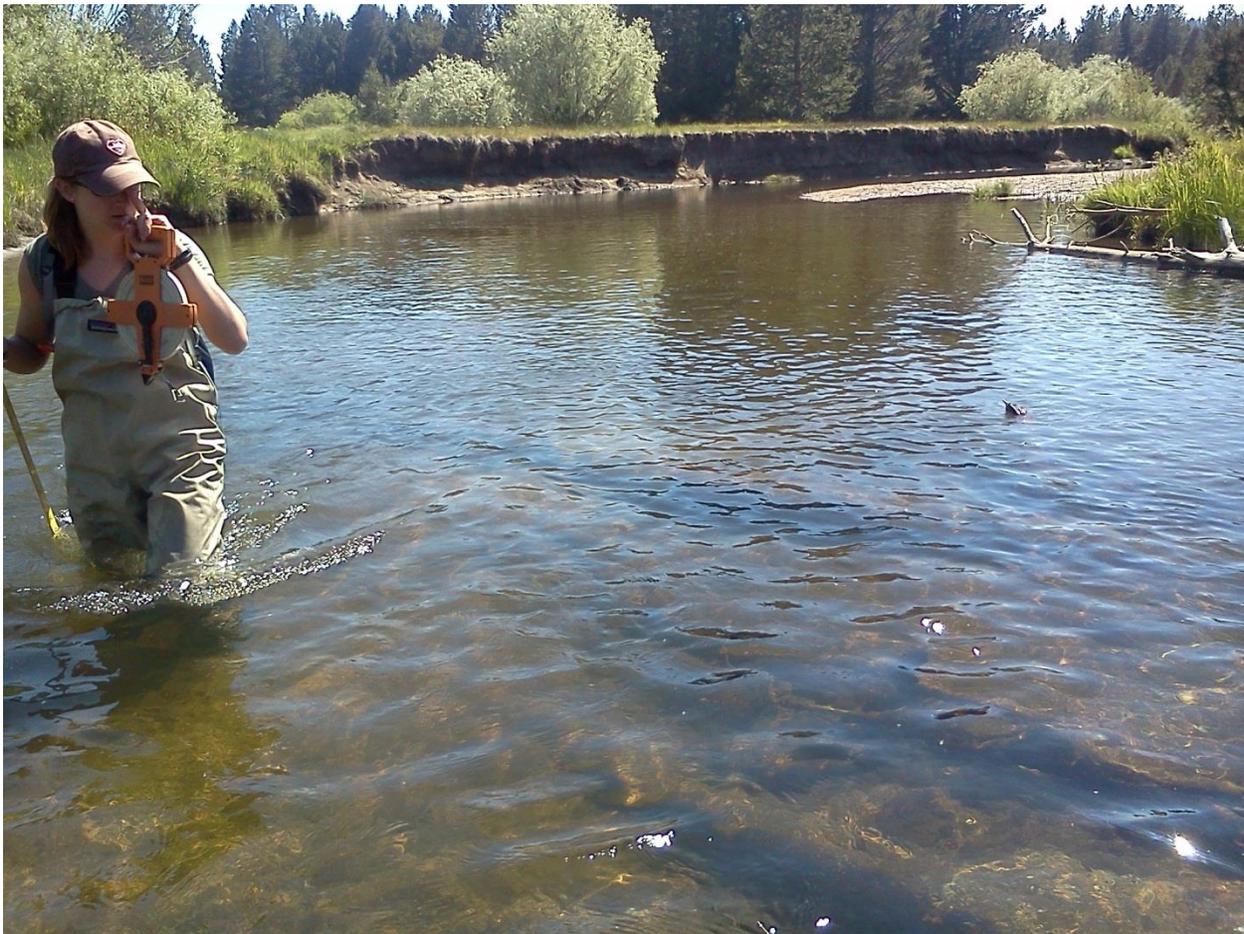
Highway 50 Bridge suffers from erosion caused by the bridge design which increases water velocity below the bridge during high flow events. These impacts continue downstream throughout the reach.

Figure 17. The Marsh Reach is characterized by low gradients, fine sediments and significant bank instability and loss of floodplain access. The lower reaches of the marsh have received considerable restoration efforts that have resulted in increased hydrologic connectivity and more stable banks. Photo: Sabra Purdy

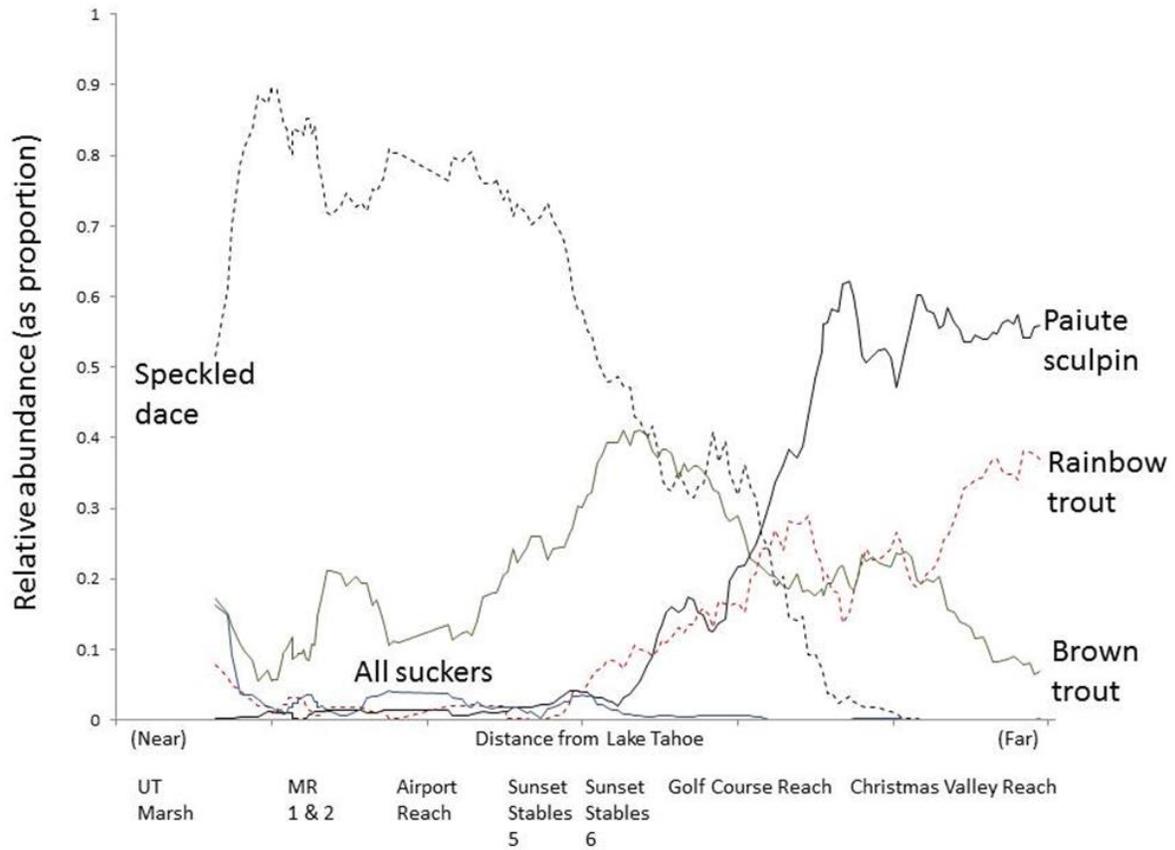
Results from the habitat analysis and correlation of the fish and habitat data reveal trends at multiple scales with important implications for understanding system dynamics and planning future management and restoration actions. At a coarse scale, lower gradient habitat with finer sediments and less vegetation closer to the lake transitions to steeper gradient habitat with larger substrate and increased vegetation further from the lake. Similarly, native fish community dynamics, in terms of two dominant taxa, mirror this transition with speckled dace near the lake, declining and giving way to large numbers of Paiute Sculpin further upstream (Figure 18).

Figure 18. Fish relative abundance by species or species group (y-axis) and distance from Lake Tahoe (x-axis). Trend line is a 10 fish reach moving average. Mountain sucker and Tahoe sucker relative abundance are combined in the 'All Suckers' trend line.

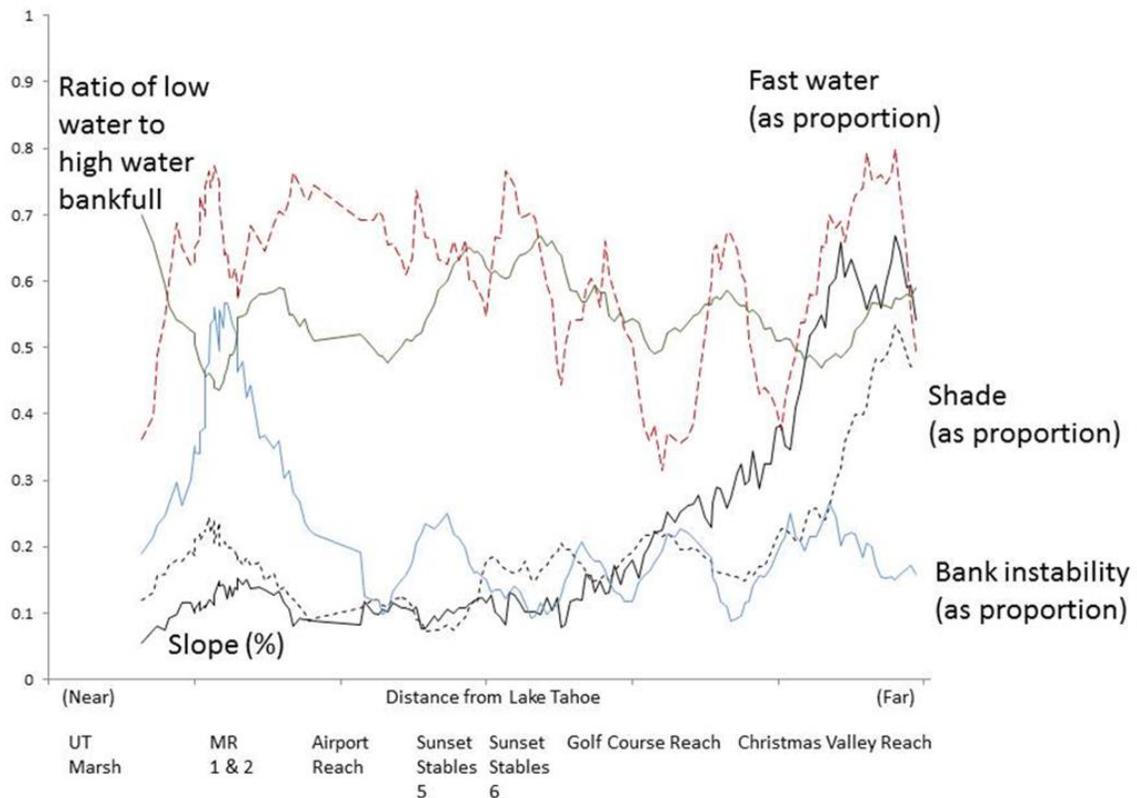
At a finer scale, several distinct habitat types emerge including habitats with deeper scour pools and slow velocities, habitats with unstable banks, wide extended runs, and shaded habitats with stable banks far from the lake (Figure 19).

Figure 19. Patterns in select habitat variables as proportions (Y-axis) with distance from Lake Tahoe by restoration reach (X-axis).
