THE UPPER TRUCKEE RIVER:

AQUATIC HABITAT MONITORING FOR RESTORATION AND ADAPTIVE MANAGEMENT

The Upper Truckee River: Aquatic Habitat Monitoring for Restoration and Adaptive Management

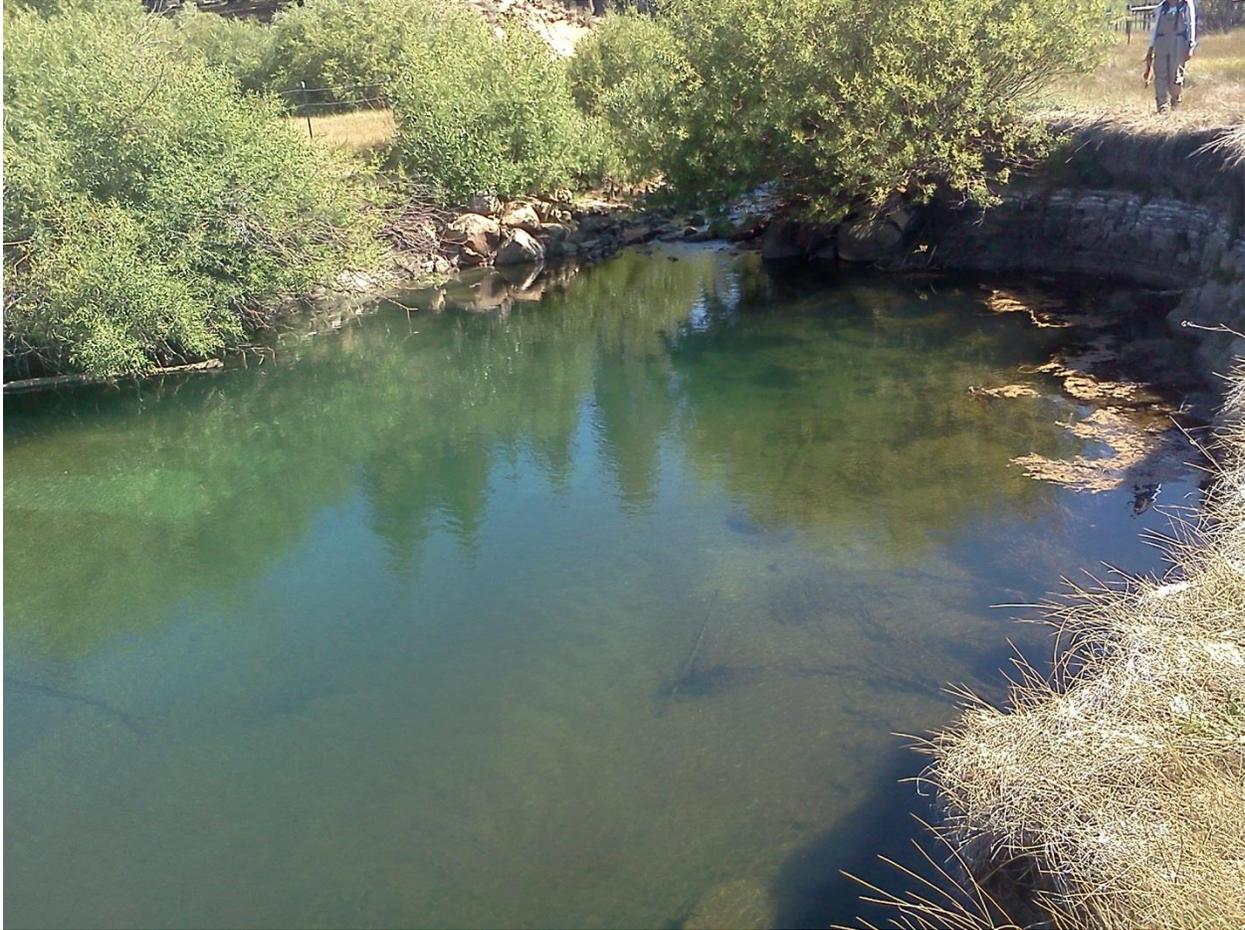
- The left channel at Johnson Meadow is badly eroded and incised. There is an erosion pool ~100 m downstream of the split that is actively eroding and has significantly increased in size over the past 20 years (visible via Google Earth). This section is so eroded and scoured that it supports very little riparian vegetation and the stream substrate is largely slick mud with the meadow serving as an isolated terrace. The erosion pool here is so deep that it appears to be leaching groundwater from the surrounding meadow. Our temperature loggers here indicate a temperature range of ~6-10°C, about 10-15° colder than any other reach in the river. This has significant hydrological implications for the function of the remainder of the meadow and local groundwater dynamics. In addition to this actively eroding pool, the meander bend just downstream of this area (UTR_10) is eroding towards the right channel. There is just 30 m separating the two channels and without some sort of intervention, it seems inevitable that the left channel will capture the right channel, diverting the creek away from the right side and putting all of the water into the highly unstable left channel. This could lead to even more sediment being eroded into Lake Tahoe and the continued loss of meadow function, biodiversity, and ecosystem services in this section.

Figure 20.The problem starts here - deeply eroded and draining cold water from surrounding meadow, this pool represents the location where the left channel at Johnson Meadow becomes extremely degraded. Complete armoring of stream banks and bed for the ~100 m upstream to where the channel splits protects that section from erosion and incision until this point. Photo: Sabra Purdy

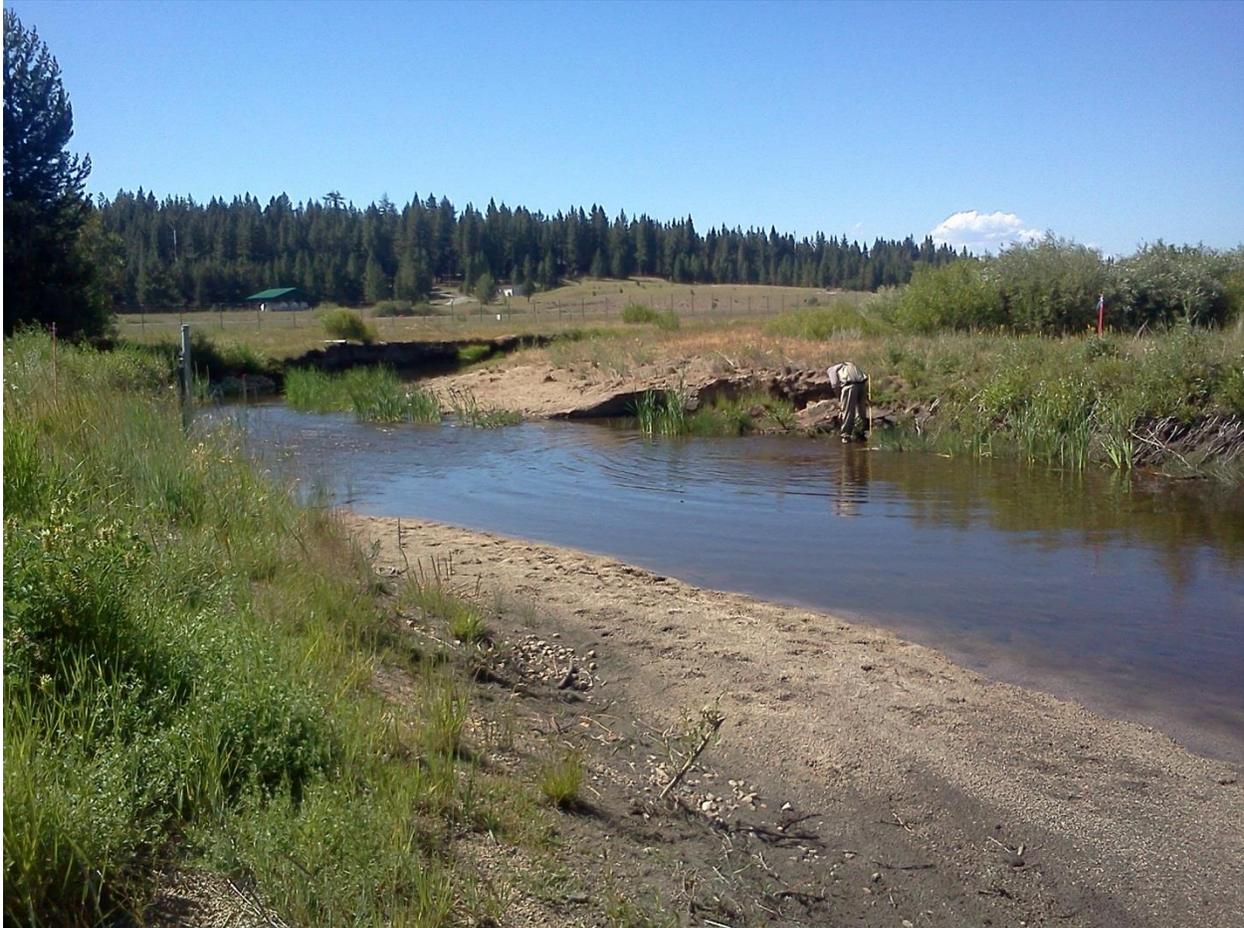
- While all new restorations are vulnerable, there are a few key channel units in the Airport Reach that show signs of dangerous instability and erosion since the completion of the project. Much of the Airport Reach restoration involves highly armored banks, large gabions, and introduction of cobble and gravel. The areas that we observed to be the most unstable and in need of intervention were the channel units FTRF96, SSLS76, and FTRF97. The implications of not addressing these areas quickly could be continued erosion expanding into other areas, the loss of more sediment to Lake Tahoe, and negative impacts to downstream restoration efforts.
- There appeared to be a mix of bank stabilizing techniques used in the Airport Reach. From our observations, the sections that had jute netting overlaying

the banks appeared to have the highest recruitment of new vegetation and the least amount of observable erosion. Areas where willow matting was used (laying willow wands along the bank perpendicular to flow) showed signs of scouring underneath the willow wands and would probably be more successful when used in conjunction with netting over the top. The mix of highly armored sections of the project and those with soft, steep banks creates opportunities for erosion and may present increasing stability problems if not addressed.

Figure 23. Problem area in the Airport Reach restoration where right bank is unstable and actively eroding while downstream lateral scour pool is eating at the left bank as seen near the top of the photo. Early intervention could prevent this from worsening. Photo: Sabra Purdy

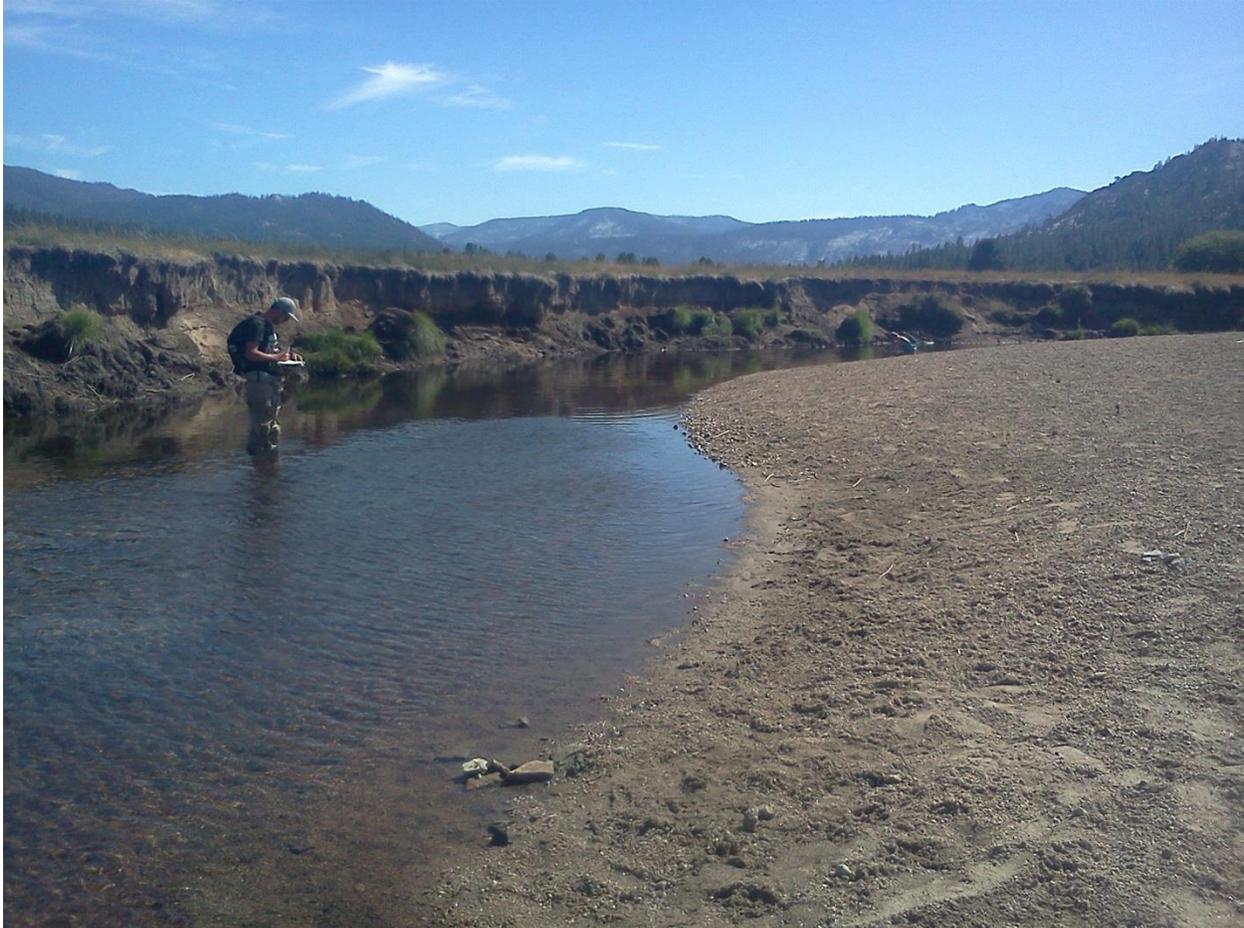
reduce the river's access to the floodplain. This will result in increased stream velocities, which will negatively impact downstream areas and increase downstream erosion and the mobilization of sediments to Lake Tahoe.

Figure 24. The tightness of these meander bends coupled with deep incision leaves the river little option but to cut through, mobilizing tons of sediment, further reducing floodplain access, and negatively affecting aquatic habitat and hydrologic function. Photo: Sabra Purdy

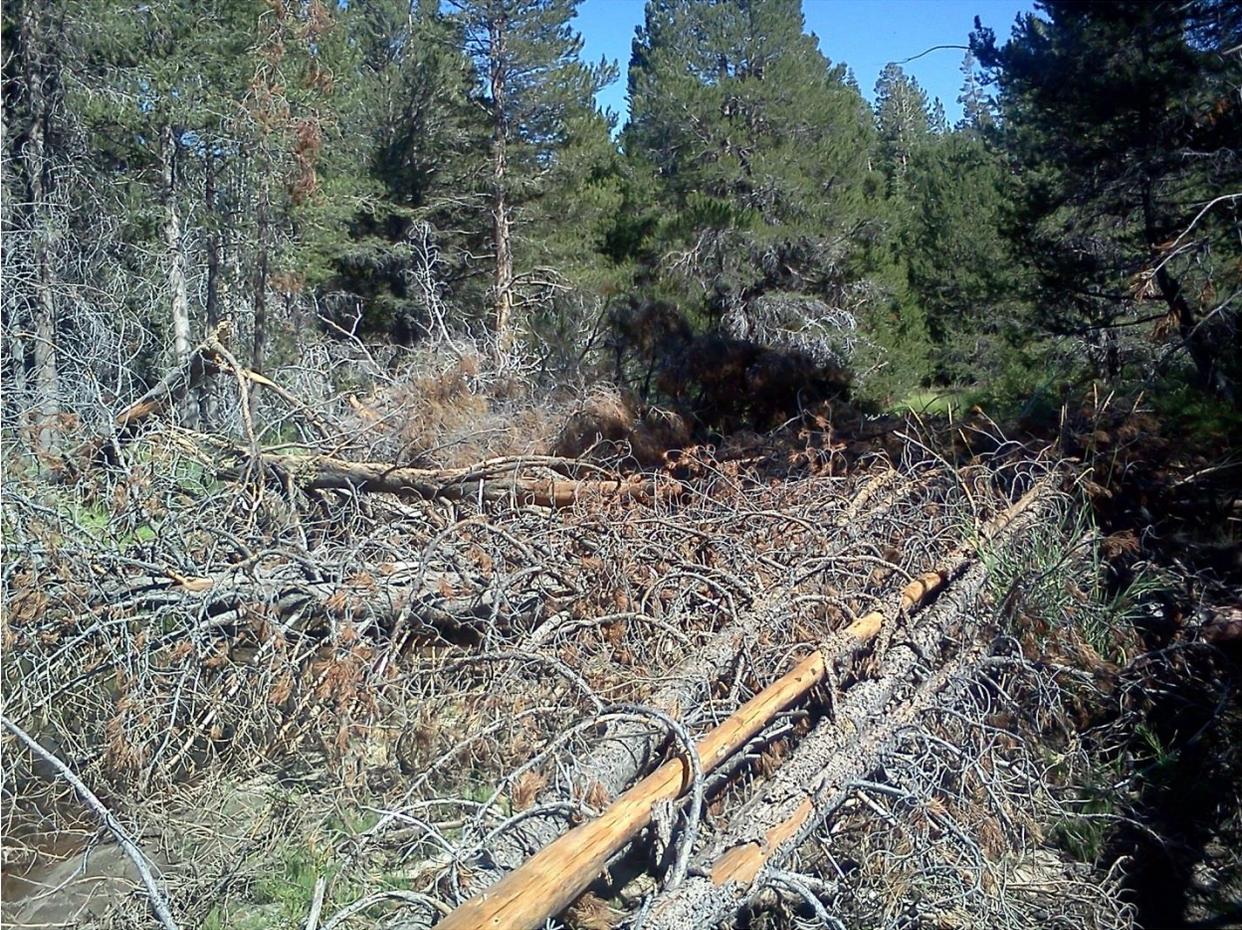
- There are several large debris dams in the Sunset Stables reaches where the river goes through areas of dense Lodgepole forest. The huge tangles of dead trees impede flows, may negatively affect fish passage and divert the river around them, digging new channels that may have negative effects on erosion and bank stability. Conversely, these log jams may provide important shelter for aquatic species.

Figure 25. This large debris pile within the river channel alters flow dynamics and forces the river to cut a new channel. This may impact fish passage or conversely, it may provide good habitat.
