STAFF REPORT

Subject: Eget Land Capability Challenge; 45 East Tuscarora Road, Washoe County, Nevada; APN 123-136-02; TRPA No. LCAP2020-0422

Land Capability Challenge

Eget Project

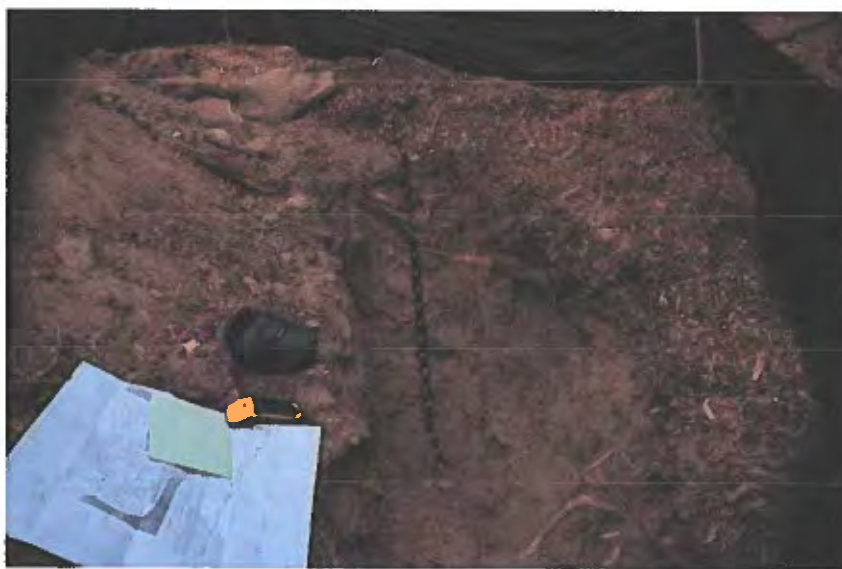
Figure 1 - Soil profile.

Soils are found to be very deep and well drained, members of Soil Hydrologic Group B. They can be characterized having dark brown loamy coarse sand top soil approximately 15 inches thick, over brown very gravelly sandy loam or sandy clay loam subsoils to 72 inches depth. These soils have developed in colluvium over older lake terrace.

- Oi 0 to 1 inches, chipped vegetative material.
- A 1 to 6 inches, brown (10YR 5/3) gravelly loamy coarse sand, dark brown (10YR 3/3) moist; moderate fine granular structure; soft, loose, nonsticky and nonplastic; many very fine, fine roots; many very fine and fine interstitial pores; 15 percent gravel; clear wavy boundary.
- AB 6 to 15 inches, yellowish brown (10YR 5/4) gravelly sandy loam, near loamy sand, dark brown (10YR 3/4) moist; weak fine subangular blocky structure; hard,

- Bt1 15 to 36 inches, pale brown (10YR 6/3) very gravelly sandy loam, dark brown (10YR 4/3), moist; strong medium subangular blocky structure; hard, friable, nonsticky and slightly plastic; common fine, medium and coarse roots; many fine and medium tubular and interstitial pores; many moderately thick clay films on ped faces and lining pores; 30 percent gravel and 15 percent stone; clear wavy boundary.

- Bt2 36 to 48 inches, pale brown (10YR 6/3) very gravelly sandy loam, dark brown (10YR 4/3), moist; strong medium subangular blocky structure; hard, friable, nonsticky and slightly plastic; common fine and medium, few coarse roots; many medium thick clay films on ped faces, lining pores and bridging sand grains; 30 percent gravel, 5 percent stone; clear smooth boundary.

- 2Bt3 48 to 72 inches, light yellowish brown (10YR 6/4) gravelly sandy clay loam, dark yellowish brown (10YR 4/4), moist; strong coarse subangular blocky structure; hard, firm, sticky and plastic; few fine, medium and coarse roots; many thick clay films on ped faces and lining pores; 15 percent gravel, 5 percent stone.

Notes: Colluvium over old lake terrace (?). Skeletal control section. Roots penetrate to beyond 72 inches depth.

One soil pit was excavated by backhoe to 72 inches. The pit was located west of the residence on natural hillslope. The soil is characterized by a gravelly loamy coarse sand surface texture, gravelly sandy loam, very gravelly sandy loam, and gravelly sandy clay loam subsurface textures. This soil formed in colluvium from volcanic parent material with older lake deposits below 48 inches. This soil is very deep, well drained, and is

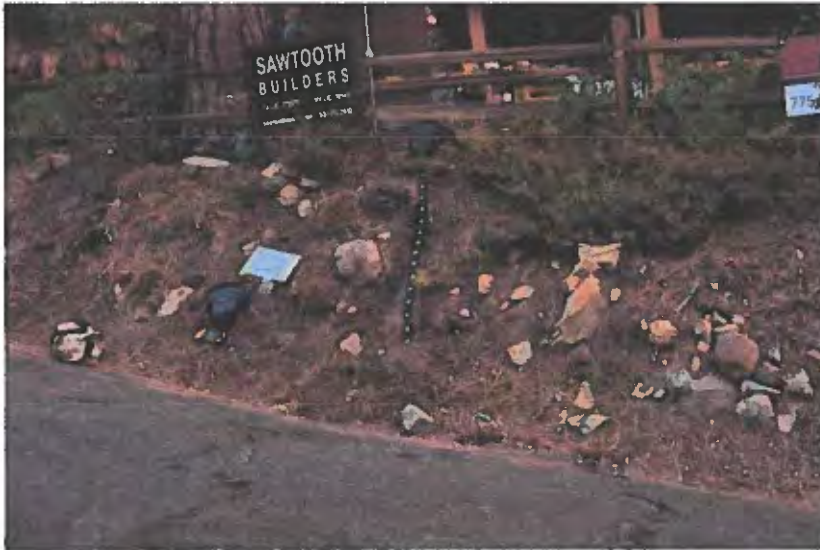
Figure 2 - Road cut on E. Tuscarora Road

A spot observation was taken by Davis Consulting near the south east corner of the parcel. Ms. Munnecke observed the small road cut in this area, and it indicates that the soil is similar to the soil described in the pit and is also deeper than 40 inches in this area.

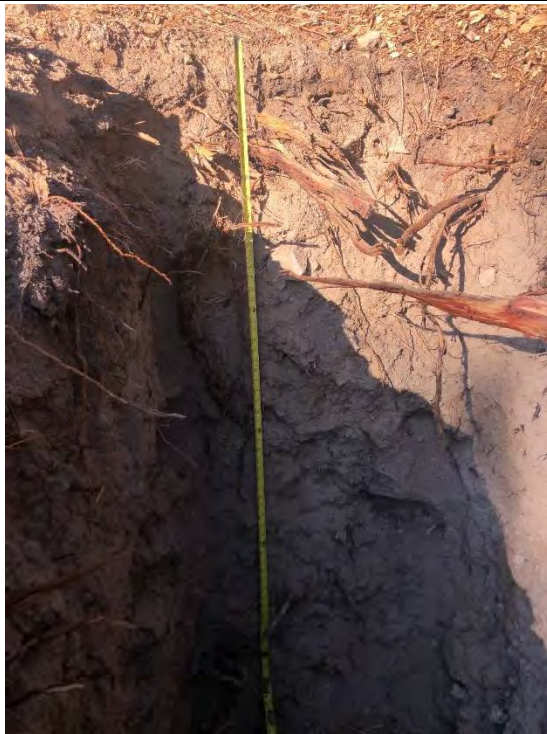
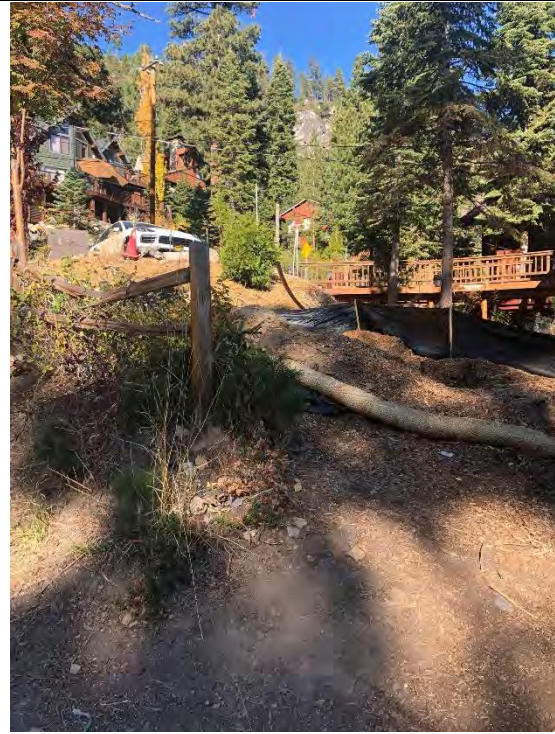
Photo 1 – a. Pit. Photo 1- b. View looking toward pit to northeast.

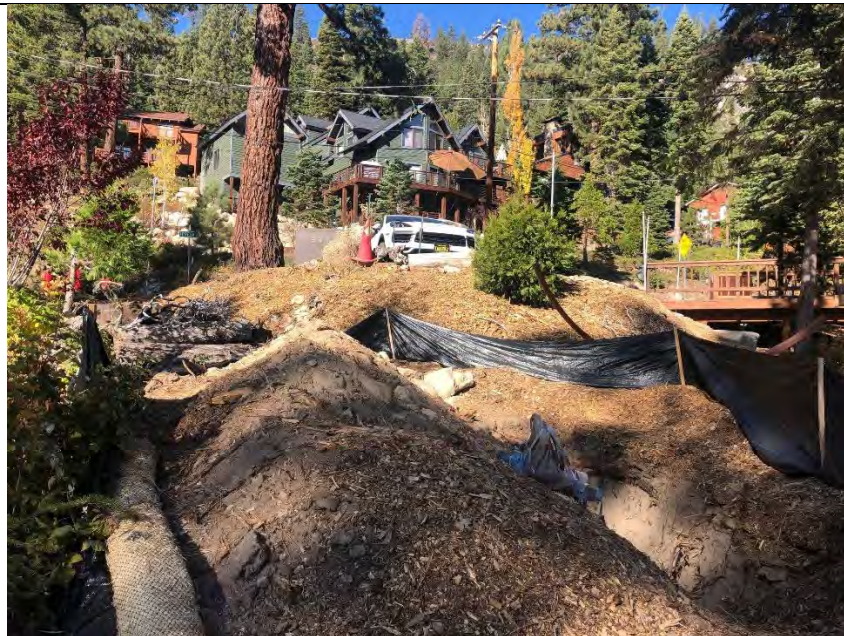
Photo 2 – a. View of pit towards Theresa Court.
