MEMORANDUM

Subject: Homewood Mountain Resort Ski Area Master Plan EIR/EIS  
Methodology for Tracking Land Coverage Banking

5154 West Lake Boulevard, Placer, County, California, Assessor's Parcel Numbers (APNs)  
097-130-16, TRPA File Number STD20061130

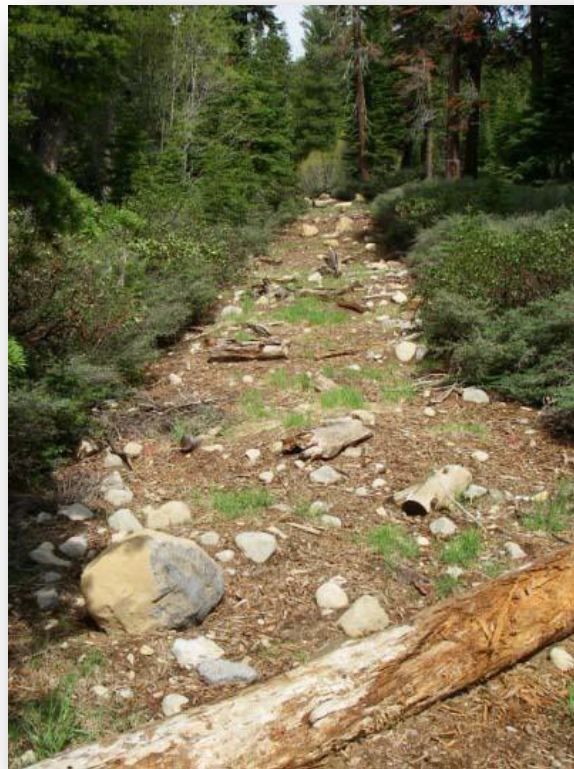
# Homewood Mountain Resort Road Coverage Removal Summary

Prepared by Kevin Drake and Heather Beckman Integrated  
Environmental Restoration Services, Inc. August 13, 2011

Additional Information: The following is further detail on the process used for verifying restored land coverage on the Homewood Mountain Resort project area. Area calculations for the Land Coverage Verification consist of unpaved roads, identified as 'dirt roads' in the TRPA verification letters and ski facilities consisting of; (ski lift tower footings, lift shacks, cable wheel platforms, lift terminals and other structures). A U.S. Forest Service Aerial photograph taken in 1969 was used to verify the legal existence and extent of the roads on the Homewood Mountain Resort site. In addition road maps developed from field surveys were overlaid onto the aerial photo by Tri State Surveying in 2005 and 2006 to confirm the accuracy of both the survey maps and aerial photograph. Road widths for coverage verifications were then measured in the field with the road width dimensions overlaid on the aerial photograph by Tri State Surveying. For restoration purposes, the mapped road segments were broken into 'project areas' of varying lengths based on widths of restored areas that were field measured after undergoing Tier 1, 2, or 3 restoration techniques, (described in the Homewood Mountain Resort Road Coverage Removal Summary), Attachment B. By comparing the restored area road widths and lengths with the recorded

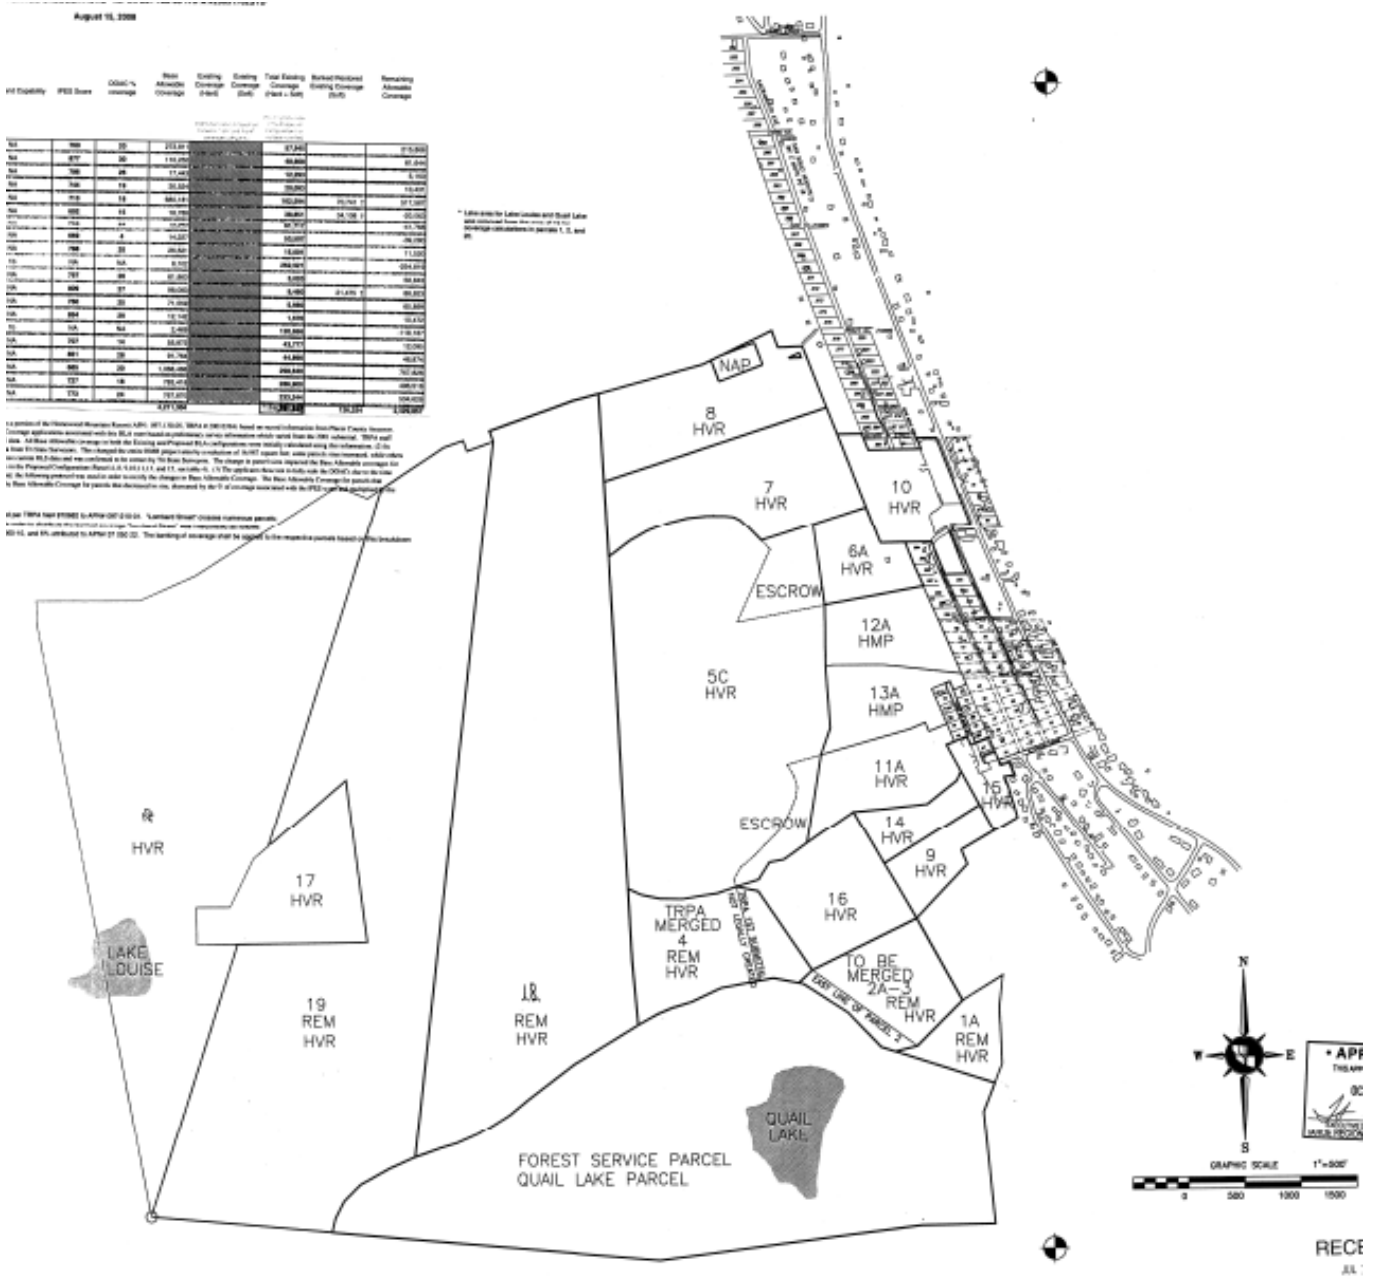
# Attachment D

## Homewood Mountain Parcel Configuration Post-BLA

In moving forward with the completion of the banking application it was necessary to reconcile differences in the previous parcel configuration used for the land coverage verification process and the new, reconfigured parcels used for the banking application. The following is a description of the boundary line adjustment, land coverage verification and land capability processes needed to complete the land coverage banking process.
