STAFF REPORT

Subject: Postmistress Properties LLC Land Capability Challenge,
1949 Glenbrook Inn Road, Glenbrook, Douglas County, NV;
Portion of APN 1418-10-802-010; TRPA File No.: LCAP2022-0779

BAILEY LAND CAPABILITY CHALLENGE FINDINGS

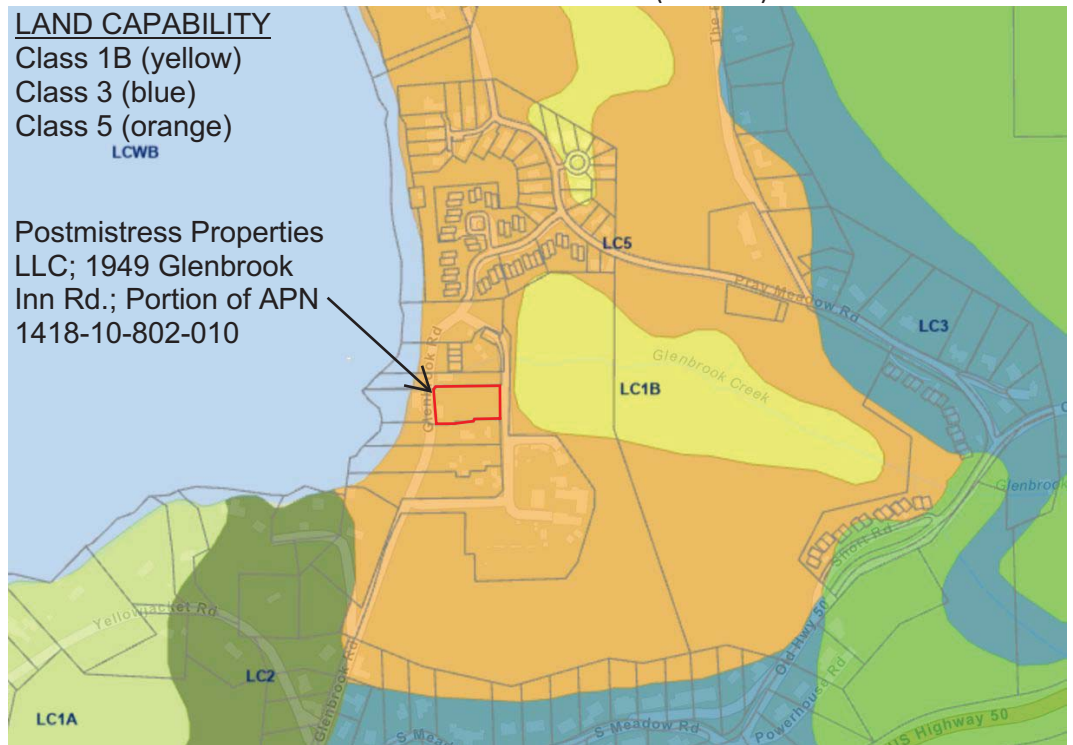
TRPA LAND CAPABILITY MAP (no scale)

The subject study area is shown as Class 5, on TRPA Land Capability Overlay Maps (aka Bailey Land Capability maps, Attachment A). These maps do not identify any Stream Environment Zone (SEZ); however, the Glenbrook Creek corridor and associated wet meadow are mapped immediately to the north and east. The Soil Conservation Service Soil Survey of Tahoe Basin Area, California-Nevada (Rogers, 1974) places the entire study area within the Jabu coarse sandy loam mapping unit (JaC, 0 to 9% slopes). Jabu soils formed in glacial outwash that may have been reworked as a lake terrace and have a less permeable lacustrine layer deeper in the profile. The soil textures are generally coarse sandy loam and the subsoil has small accumulation of clay (argillic horizon) and a weak fragipan below 40 inches of the surface. The fragipan may perch infiltrated water for several weeks in spring or soon after snowmelt. While containing gravel, this soil does not have outcrops or surface stones. The vicinity of this 1.08-acre study area has a geomorphic mapping of E-2 for Depositional lands: Outwash, till, and lake deposits (low hazard lands).

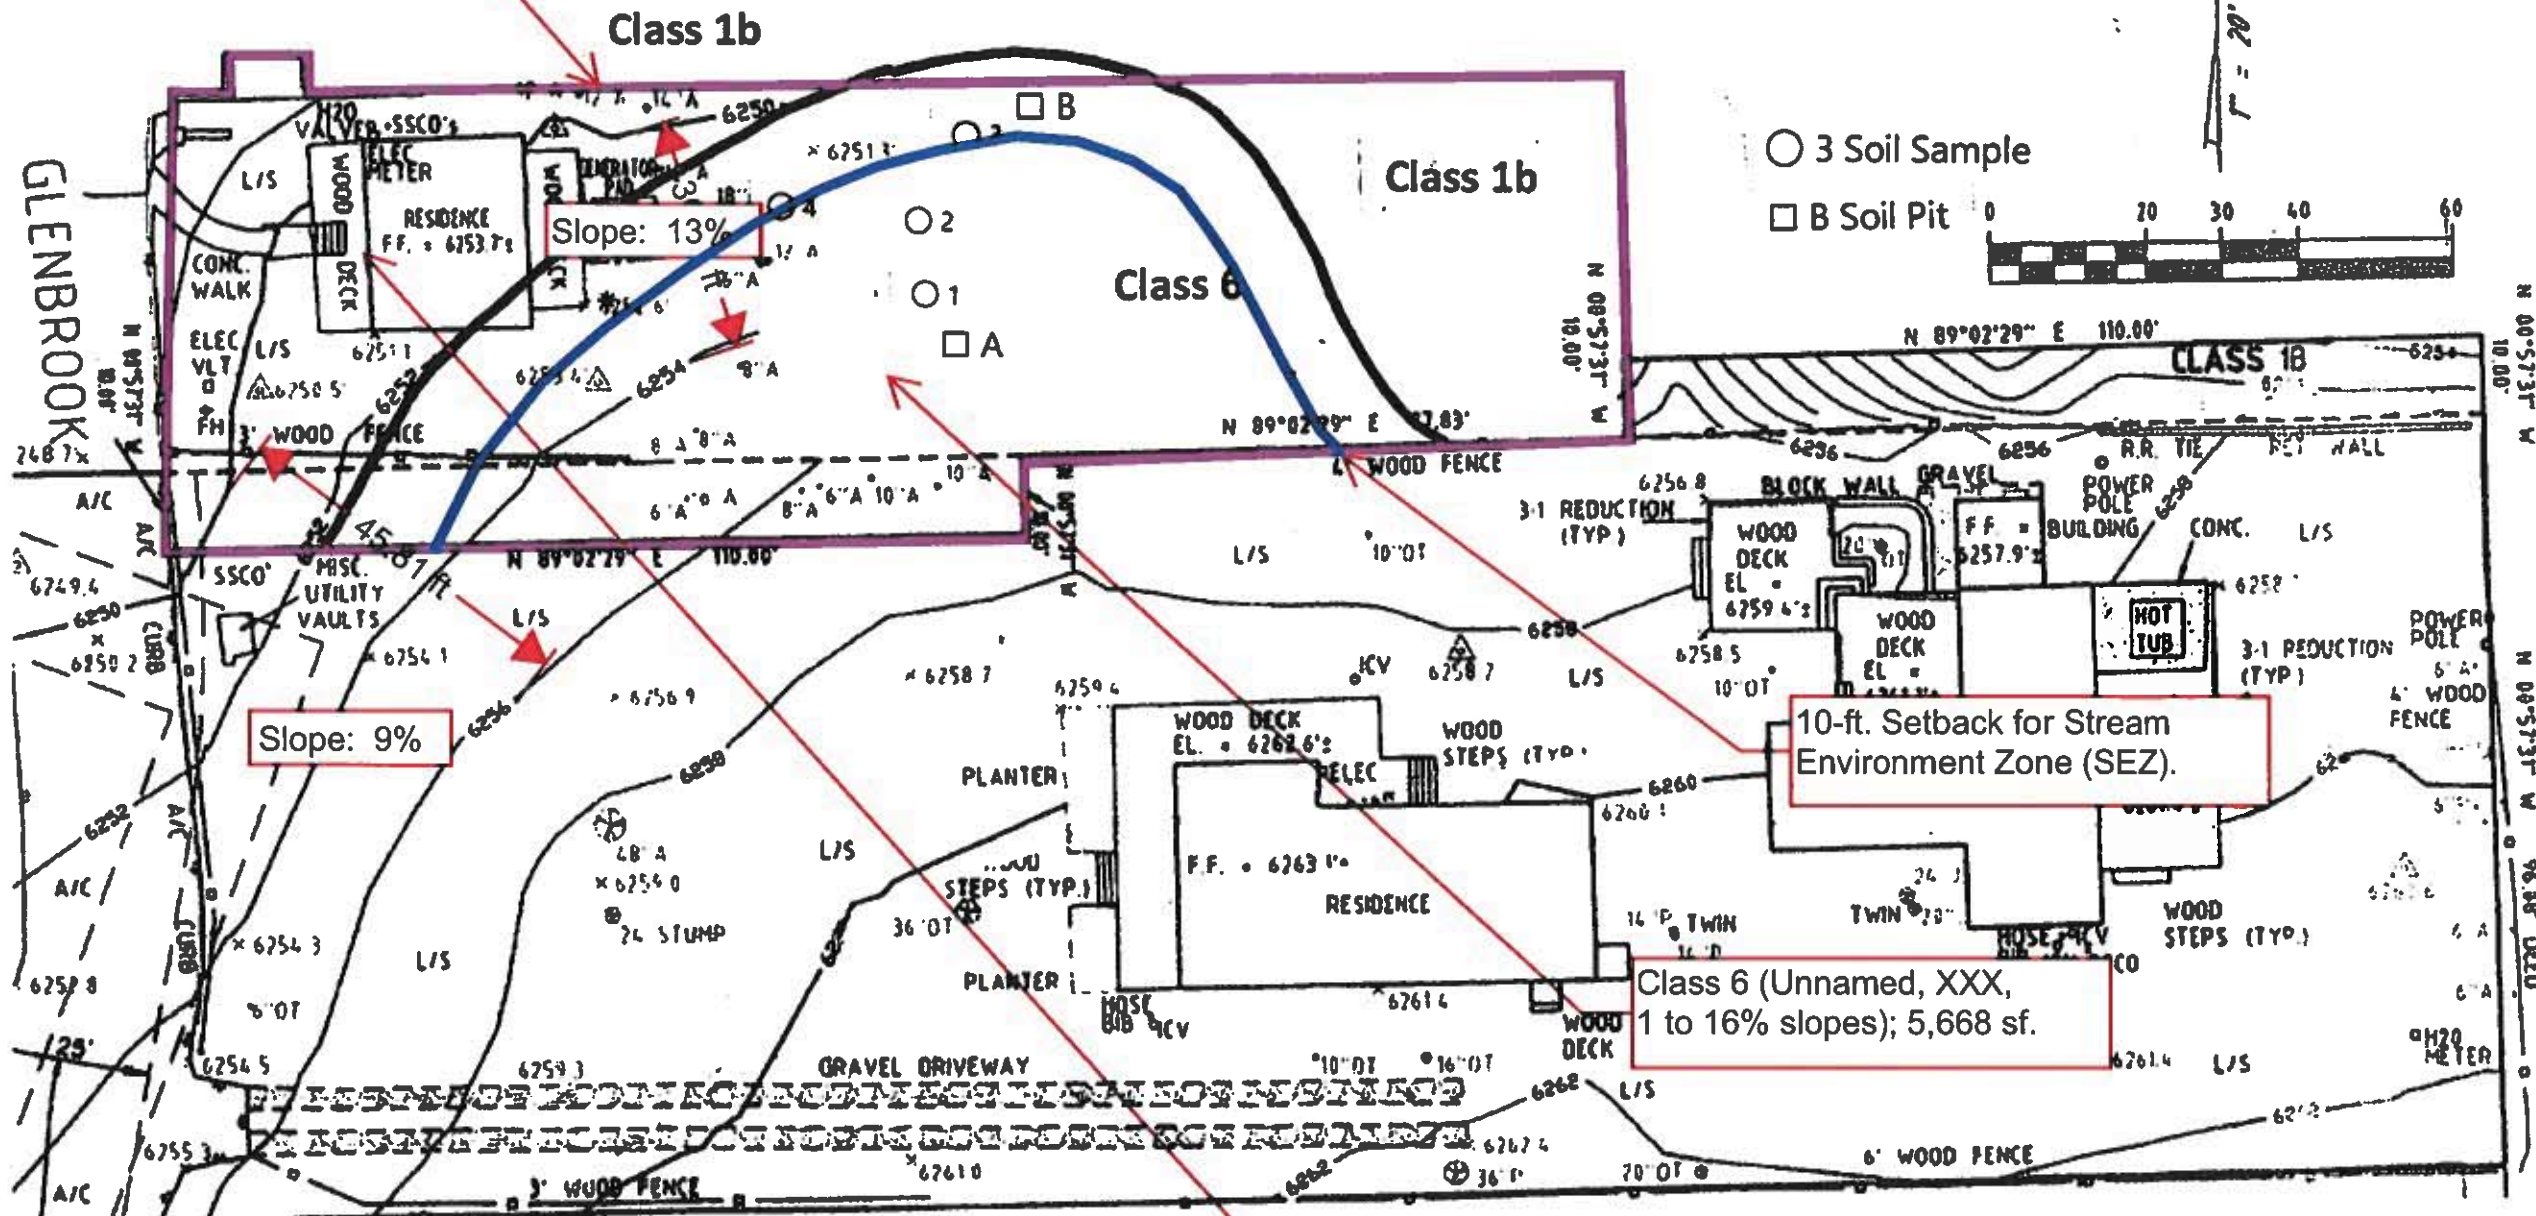
STUDY AREA

Slope: 9%

Slope: 13%

Class 1B (Stream Envir. Zone, SEZ, any slope); West part = 2,762 sf.; East part = 1,861 sf. (extends further east of study area).
