STAFF REPORT

Date: January 11, 2024

Subject: Moore Land Capability Challenge
 362 and 370 Beaver Street, Kings Beach, Placer County, CA
 APN: 090-212-010; TRPA File no: LCAP2023-0268 and
 APN: 090-212-024; TRPA File no. LCAP2023-0269

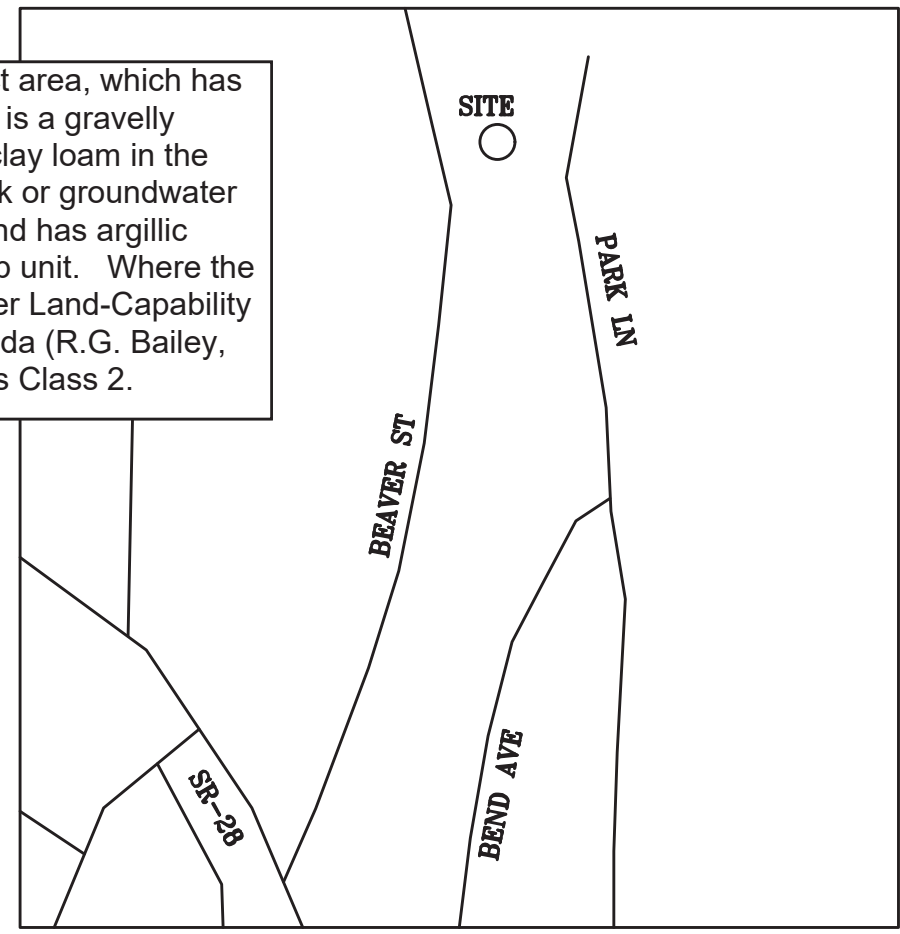
Test Pit no. 1 -- This location is representative of project area, which has two slope classes (15 to 30% and 30 to 50%). The soil is a gravelly sandy loam in the upper part and very gravelly-cobbly clay loam in the lower part. Soil is well drained and HSG-B. No bedrock or groundwater encountered within 60 inches of surface. Soil is deep and has argillic horizon consistent with the Jorge-Tahoma complex map unit. Where the slopes are 15 to 30%, the soil qualifies as Class 4 as per Land-Capability Classification of the Lake Tahoe Basin, California-Nevada (R.G. Bailey, 1974). Where slopes are 30 to 50%, the soils qualify as Class 2.
