Staff Report

Date: October 21, 2021

Subject Hampton Land Capability Challenge, 670 Sierra Vista Avenue, Placer County, CA, APN 085-141-010, TRPA File Number LCAP2021-0250

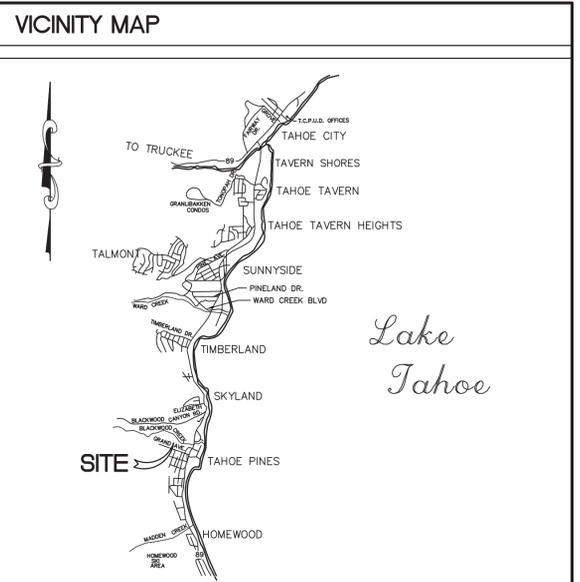
TRPA Land Capability Challenge for  
 LCAP2021-0250; APN 085-141-010  
 670 Sierra Vista Avenue  
 Homewood, Placer County, Cal.  
 Field Investigation: September 27, 2020  
 Data Analysis: October 14, 2021  
 Conducted By: P.Scoles (Soil Scientist)

Gray shaded area has created slopes (hillside cut and fill). In particular, the slopes immediately upslope and downslope of driveway are artificially steep. In contrast, the slope within the driveway is artificially flatter. For land capability challenges, TRPA utilizes historic contours to determine appropriate land classification. The majority of the gray shaded area appears to historically had slopes 16 to 28%.
