Re: Heavenly Mountain Resort 2017 through 2021 Environmental Monitoring Program Five Year Comprehensive Report

Date: January 18, 2022

Facility Name: Heavenly Mountain Resort

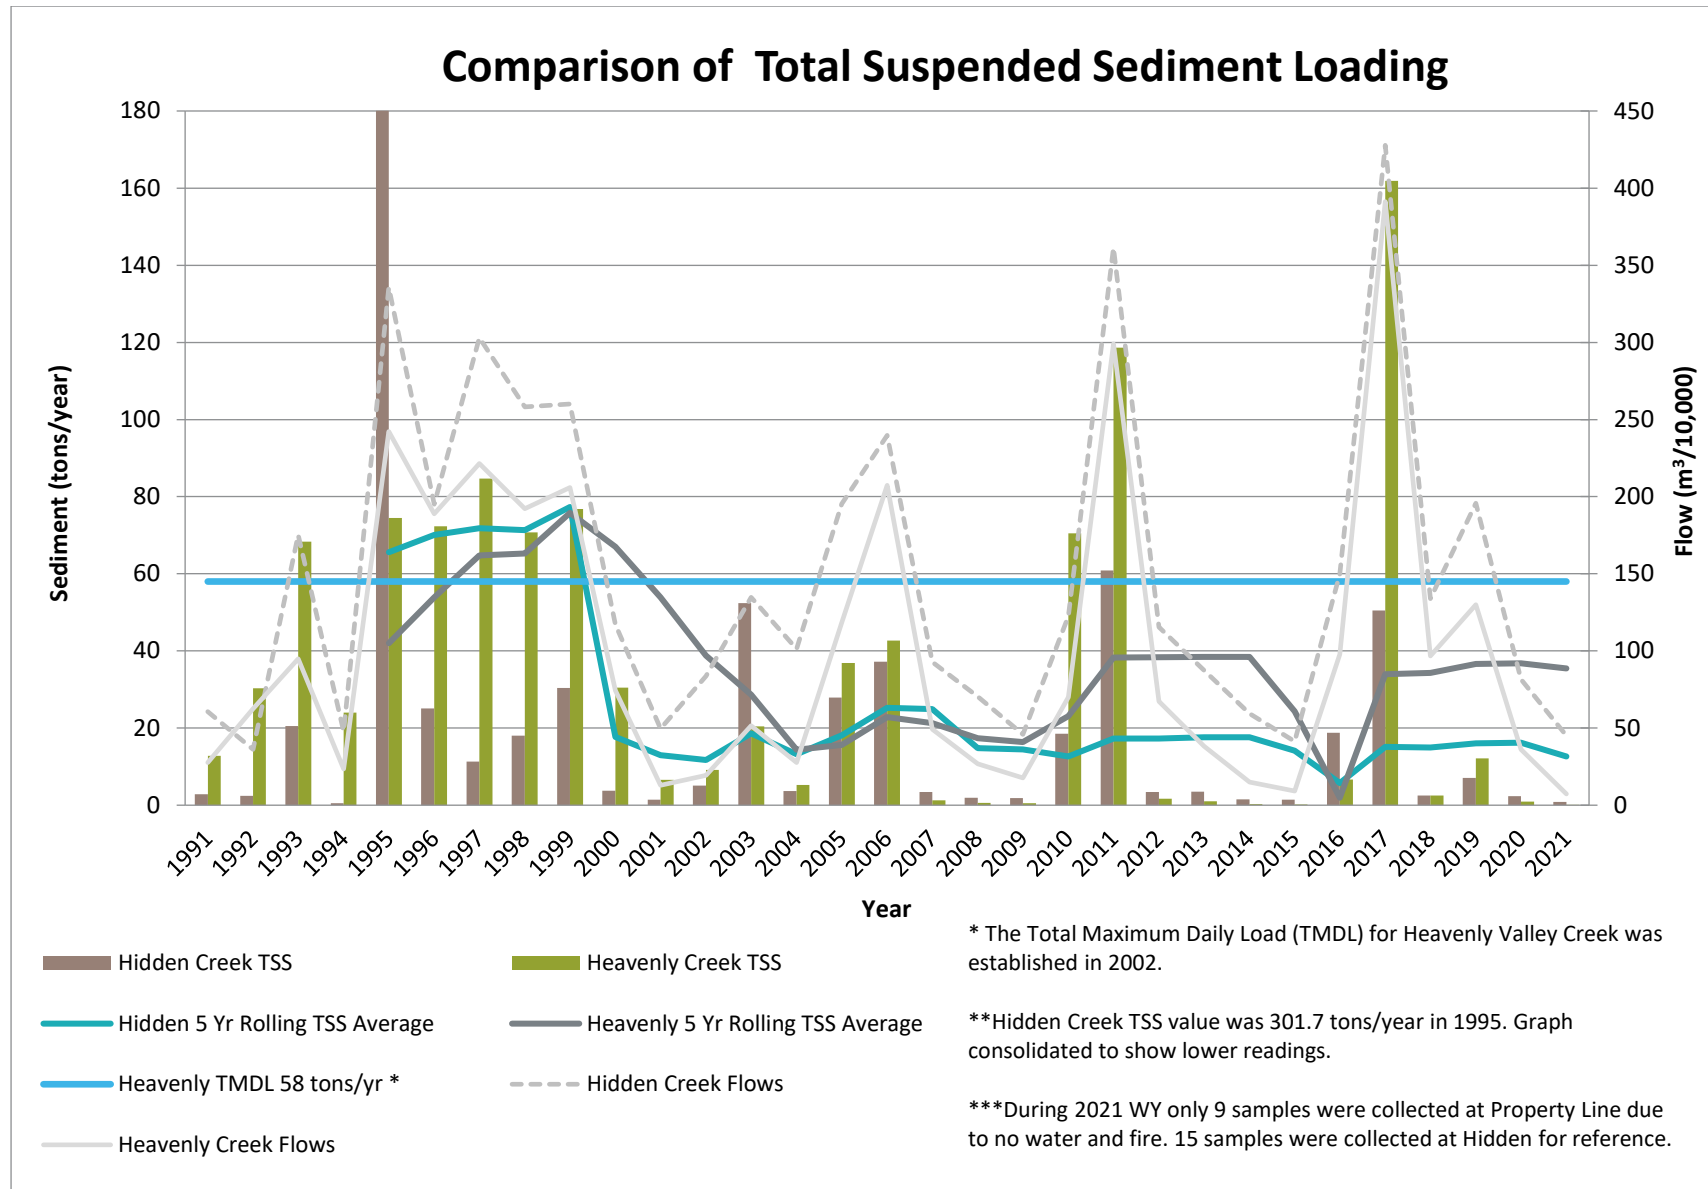
Figure 3-2 Comparison of Sediment Loading (1991 to 2021)

Figure 3-2 compares annual weighted sediment loading at the Property Line monitoring site (43HVC-3) and the reference reach site (43HDVC-5) between 1991 and 2021. Superimposed on the sediment loading data are the total calculated flows per year in cubic meters (divided by 10,000) at each site. Five-year rolling TSS averages for each site and the Lahontan TMDL 5-year rolling standard value of 58 tons/year are also shown on the figure.

Figure 3-2 shows a large TSS increase in 2011 and 2017, consistent with the trends seen in other above-average WYs; as streamflow increases, total sediment loading increases. WYs 2012 to 2015 saw lower TSS values in correlation to lower water flows (drought conditions), while the 2016 average-precipitation year had increased TSS at both the Property Line monitoring site (43HVC-3) and the reference reach site (43HDVC-5). As the graph clearly shows, TSS is linked to WY and streamflow totals and TSS values at the Property Line monitoring site (43HVC-3) and reference reach (43HDVC-5) are trending positive with regards to water quality improvement.

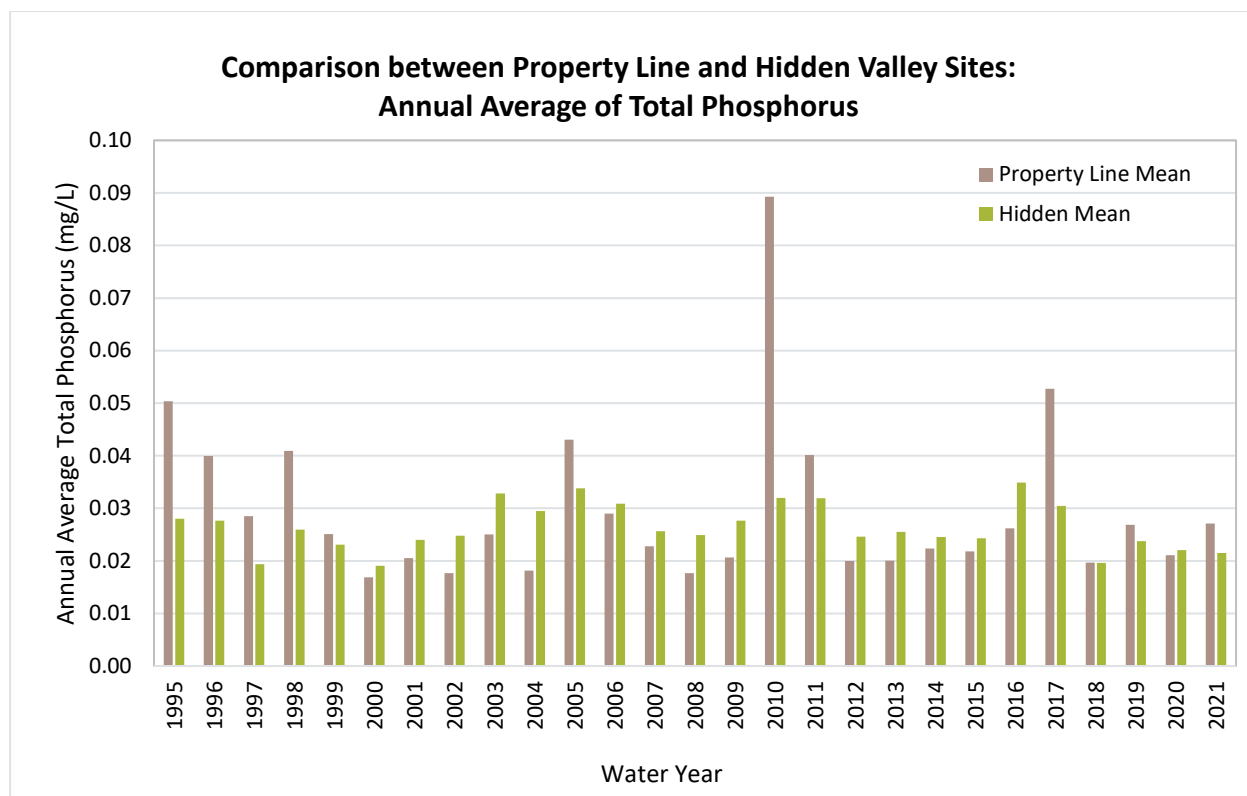
Figure 3-5 Comparison of Annual Averages of Total Phosphorus between the Property Line Monitoring Site and the Reference Reach Site

Comparisons of total phosphorus between the Property Line monitoring site (43HVC-3) and the reference reach site (43HDVC-5) showed relationships that correlated highly with WY (Figure 3-5). In drought years (2000–2004, 2007–2009, 2012–2015, 2020), annual averages of samples from the reference reach site (43HDVC-5) exceeded those of the Property Line monitoring site (43HVC-3), sometimes significantly so. However, during average precipitation WYs, especially those with precipitation well above average (2011 and 2017), the Property Line monitoring site (43HVC-3) had annual averages of total phosphorus higher than those at the reference reach site (43HDVC-5). Some anomalies are present, such as the 2010 annual average mean at the Property Line monitoring site (43HVC-3), which was nearly double the mean observed over the entire reporting period, despite it being an average-precipitation year. This data comparison shows annual averages of total phosphorus at the Property Line monitoring site (43HVC-3) have approximately returned to baseline conditions.

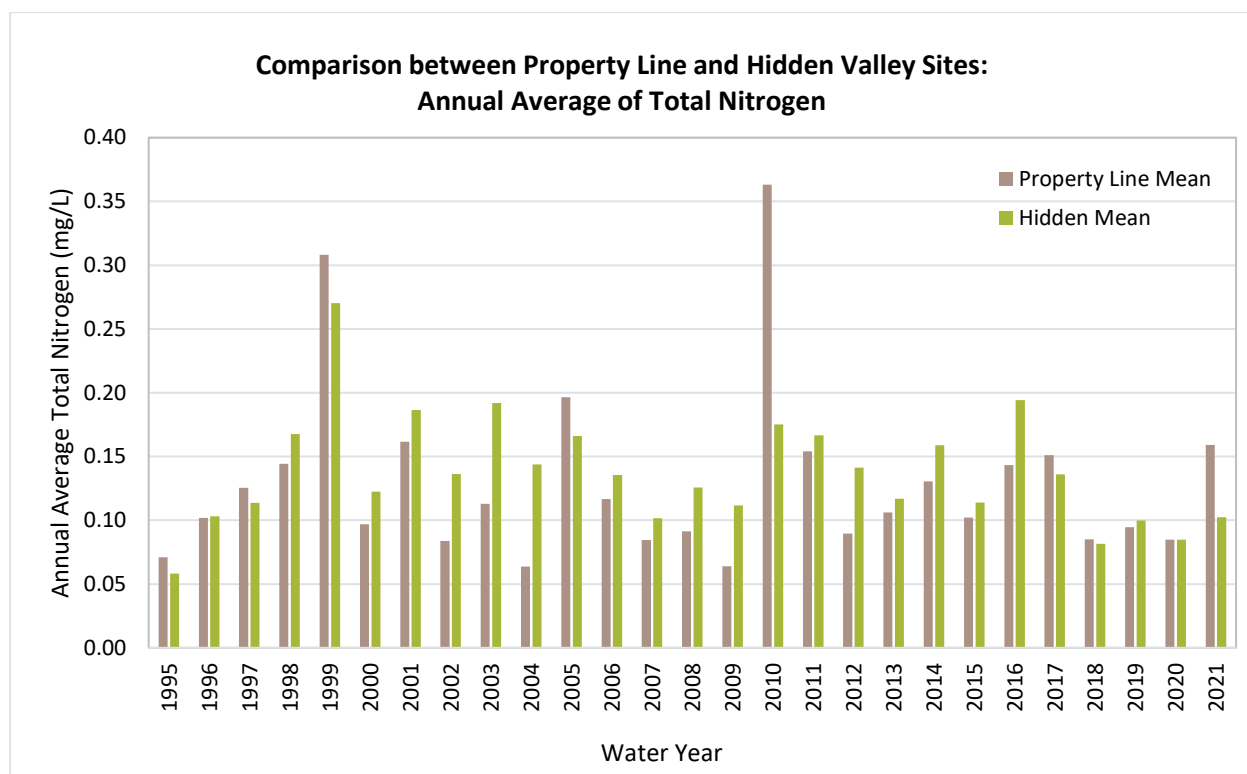
Figure 3-6 Comparison of Annual Averages of Total Nitrogen between the Property Line Monitoring Site and the Reference Reach Site

Similar trends were observed for total nitrogen. In drought years, the reference reach site (43HDVC-5) had more instances of higher annual averages than the Property Line monitoring site (43HVC-3), but in wetter years, the latter's averages for total nitrogen were typically higher (Figure 3-6). Over the 26 years of analyzed data, the annual average of total nitrogen was higher at the reference reach site (43HDVC-5) in 18 years and higher at the Property Line monitoring site (43HVC-3) in 7 years (and equal in one year: 2020). Again, this comparison shows annual averages of total nitrogen at the Property Line monitoring site (43HVC-3) have approximately returned to baseline conditions.

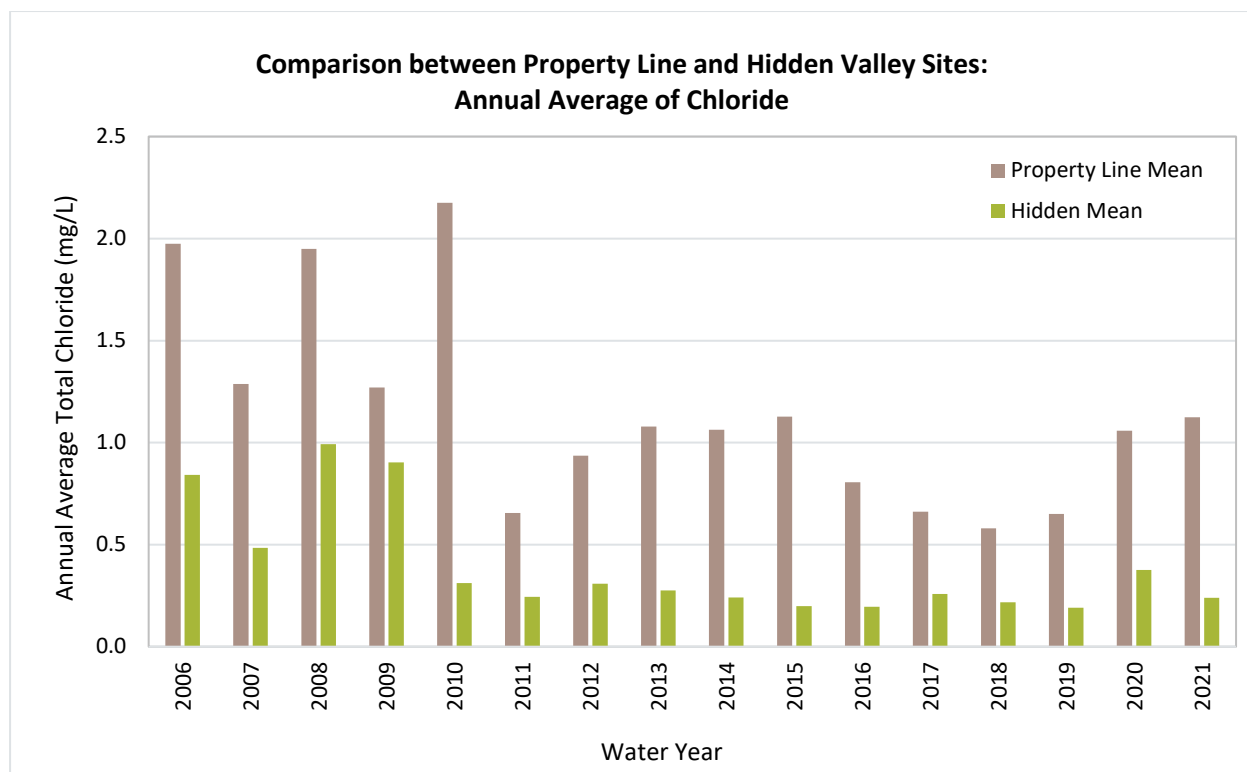
Figure 3-7 Comparison of Annual Averages of Chloride between the Property Line Monitoring Site and the Reference Reach Site

As mentioned above, chloride was first sampled at the sites in 2006, and it was sampled on a quarterly basis between 2006 and 2011. In 2012, sampling began on a monthly basis (and more frequently during the runoff period, on the same sampling schedule as all other constituents). In all years, annual average for chloride at the Property Line monitoring site (43HVC-3) was higher than at the reference reach site (43HDVC-5), although not significantly so until after sampling became more frequent in 2012 (Figure 3-7).

Either small sample sizes or lack of data at valuable times of the year (such as during runoff season) likely contributed to values that were considered not significantly different, more so than actual differences over the course of the year, despite annual averages of chloride being typically smaller at both sites once more regular sampling was initiated. This highlights the importance of sampling on a monthly (or greater) frequency in order to collect representative data. Annual averages of chloride at the Property Line monitoring site (43HVC-3) remain problematic compared to the reference reach site (43HDVC-5), although the reference reach site consistently exceeded state standards as well, as discussed in Chapter 3.6.1.1.

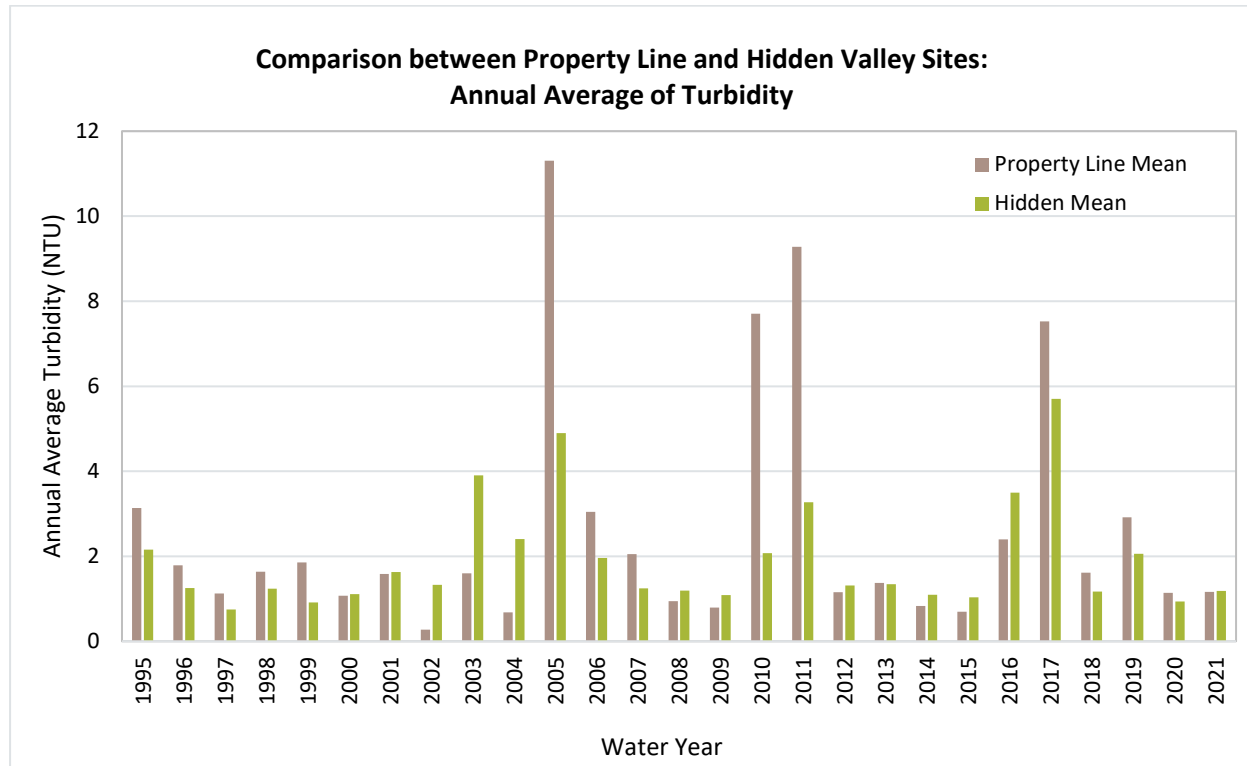
Figure 3-8 Comparisons of Annual Averages of Turbidity between the Property Line Monitoring Site and the Reference Reach Site

In most years, the Property Line monitoring site (43HVC-3) had higher annual average turbidity compared to the reference reach site, although in several drought years the latter had higher annual averages (2002–2004, 2012–2016; Figure 3-8), similar to the trends observed for total phosphorus and total nitrogen (Figures 3-5 and 3-6). Similarly, in above-average WYs, while both sites experienced higher annual turbidity averages, the Property Line monitoring site (43HVC-3) did so exceedingly. This data comparison shows annual averages of turbidity at the Property Line monitoring site (43HVC-3) have approximately returned to baseline conditions.

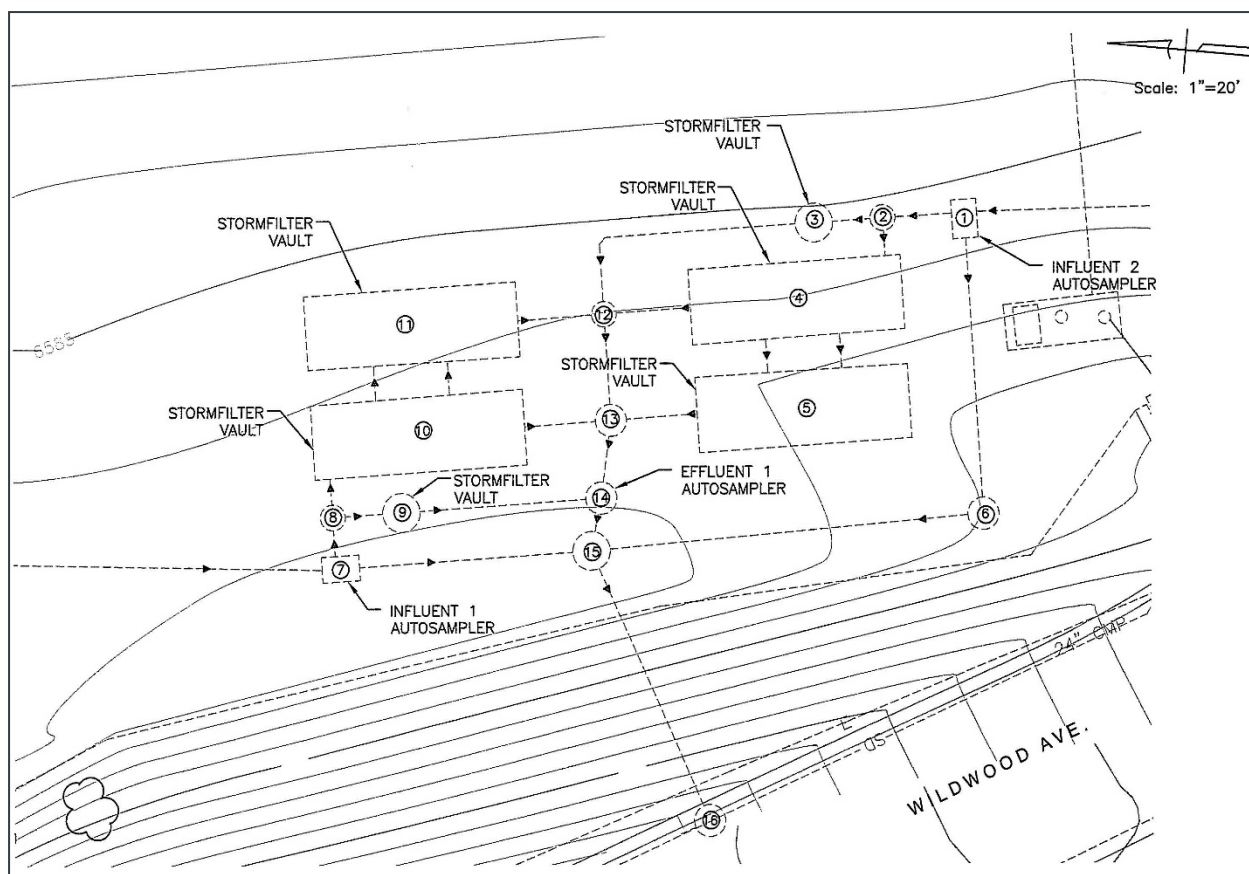
Figure 3-9 California Base Parking Lot Storm Filter Water Quality Treatment System (Source: RCI 1/21/08)

Maintenance of the system was sporadic during the early years of vault installation and operation. The PhosphoSorb™ filters were replaced in the fall of 2009; however, these filters were not replaced again for 2 years, until the fall of 2011. In 2011, Heavenly committed to an annual filter replacement cycle in which all filters (both PhosphoSorb™ and ZPG™) were to be replaced over a 4-year cycle. The replacement of 221 ZPG™ cartridges in June 2014 marked the first time that ZPG filters were replaced since installation. Since that time, at a minimum, the 14 PhosphoSorb™ filters are replaced annually, and ZPG™ filters are replaced as needed during the annual inspection and maintenance event, until all ZPG filters are replaced during the 4-year full replacement cycle.

Since installation, various technical issues have prevented the consistent collection of reliable samples for analysis. When in place and functioning properly, the Teledyne ISCO auto-samplers will automatically obtain storm event samples after being powered on. If the auto-samplers are not operational, samples may be collected manually, using both an extension rod and bottles or by manually selecting the pump feature on the system to collect samples within the vaults where the auto-samples would be generated. Details of the auto-sampler procedure are included in the *Draft Heavenly Mountain Resort Water Quality QAPP* (Cardno 2021). Storm events tend to trigger one or two of the automatic samplers, but not always all three. On occasion, the effluent results contained higher levels of analyzed constituents than the influent samples; however, this trend has become less prevalent since maintenance of the systems has resumed. In some cases where an incomplete sample is obtained, grab samples were collected to complete the storm sampling round. In these cases, the results do not adequately represent filtration since the grab sample timing differs from the automated sampling collection time. Corrective actions have been listed in the past and are summarized in the *Bijou Park Creek Evaluation Report* (Tormey 2017, Appendix J). Additionally, this report recommends improvements to the system and sampling collection methodology to gain more useful data for better information and future decision-making.

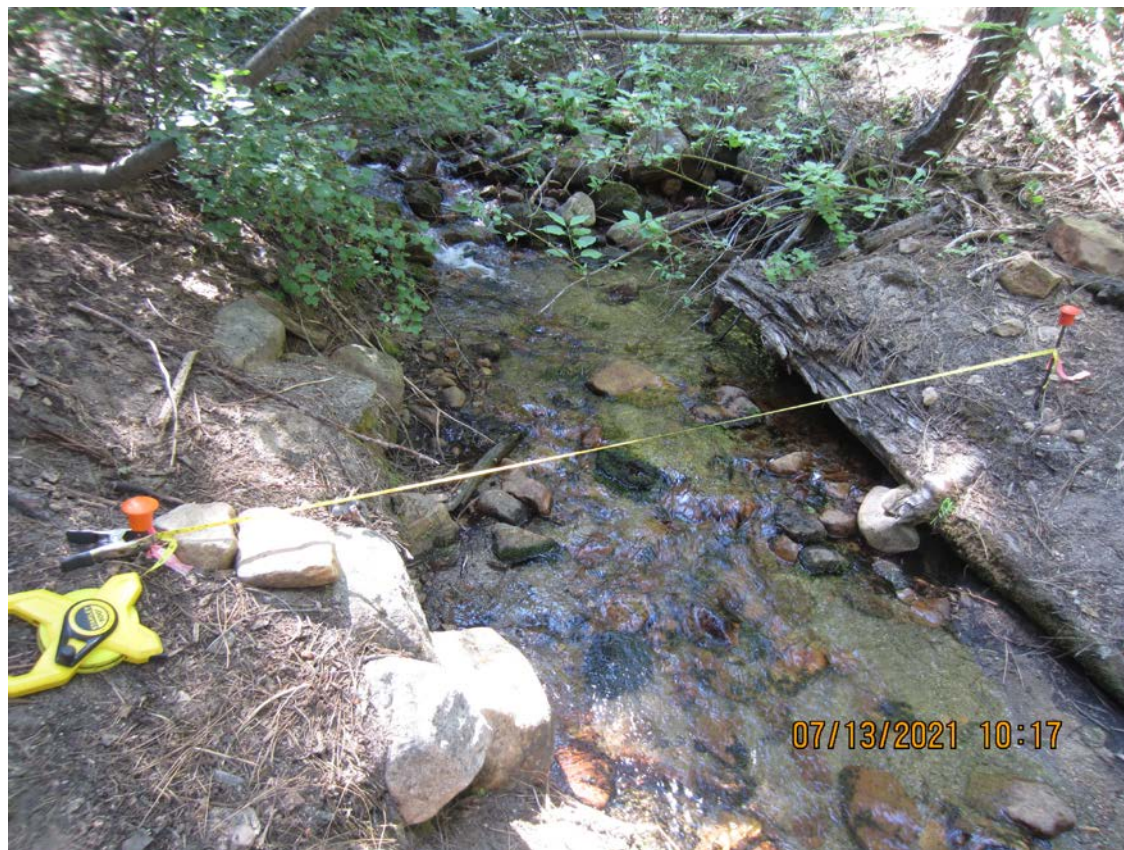
Figure 3-10 Hidden Valley Creek Reference Reach Site (43HDVC-5) in July 2021 (Pre-Fire), Looking Upstream from Right Bank

As Heavenly Valley Creek and the monitoring sites/reaches did not burn, the current conditions at the reference reach are no longer representative of an unimpaired reach for comparison. However, no other more appropriate reaches are present in the nearby vicinity. Close monitoring during the next 5-year period is recommended, and reconsideration of the site for continued use as a reference reach should be weighed, based on the site's recovery to pre-fire conditions, availability of an alternative reference reach, and implications of changing the reference reach for a project that has a long-term data set (more than 30 years). During the next 5-year period, determinations of "background" values for comparison to project values should be made based on previous correlations between streamflow and chemical characteristics at Hidden Valley Creek from past (pre-fire) monitoring.

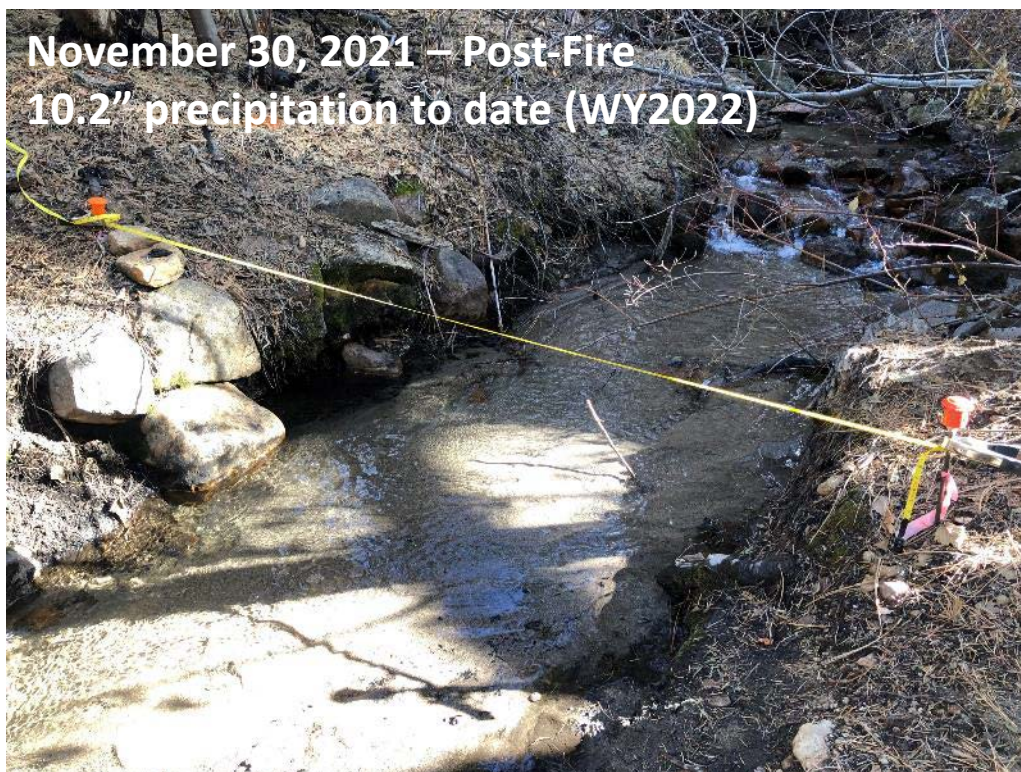
Figure 3-13 Hidden Valley Creek Reference Reach Site (43HDVC-5) in November 2021 (Post-Fire), Looking Upstream from Left Bank

had the extensive volume of downed wood on the forest floor. The riparian corridor was largely intact, with leaves of alder and currant still present in October 2021. The rebar and plastic rebar caps marking the water quality cross-section did not burn. A bulldozer fire line had been laid across the forest floor and crossed the stream approximately 20 feet below the cross-section. It appeared that the volume of woody material and rocks at the crossing location allowed the heavy machinery to remain above the water surface. Subsequent sampling events in WY 2022 (not part of this report, but relevant to discuss in term of post-fire observations) have shown substantial sediment mobilization during the fall of 2021, in part due to a substantial storm event in late October (the storm event between October 24 and 26 delivered 7 inches of precipitation), as shown in Figures 3-12 to 3-13.

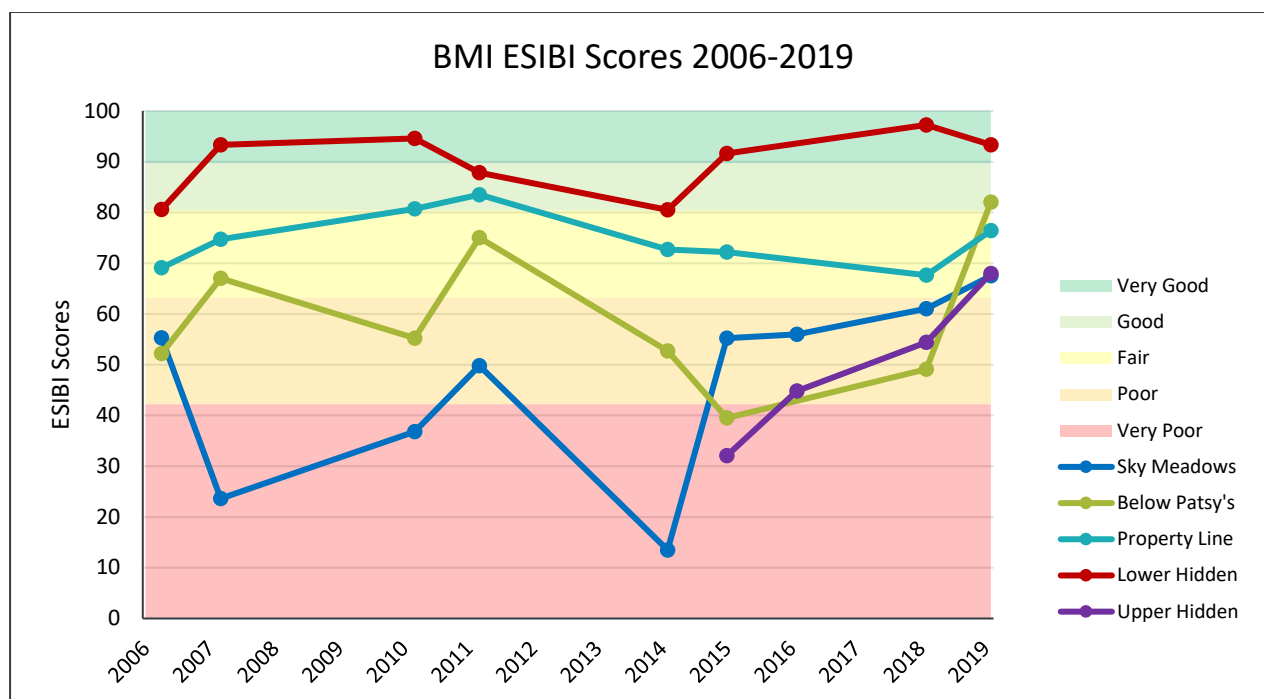
Figure 5-3 BMI ESIBI Scores for 2006–2019 by Sampling Site

- Lower Hidden Valley Creek reference site (LHC-1) – Biotic conditions are *very good/supporting* according to ESIBI and *very likely intact* according to CSCI. The ESIBI score dropped slightly from 2018, although overall scores have improved since 2011. This site has been classified as being in *good/supporting* biotic condition and as either *very likely intact* or *likely intact* since BMI sampling began in 2006.

- Upper Hidden Valley Creek reference site (LHC-2) – Biotic conditions improved from the 2018 scores to the *fair/supporting* conditions according to the ESIBI, although they are still considered *likely altered* according to the CSCI. Both threshold scores have improved over time, with a slight drop in CSCI scores in 2019, although sampling at this site only began in 2015.

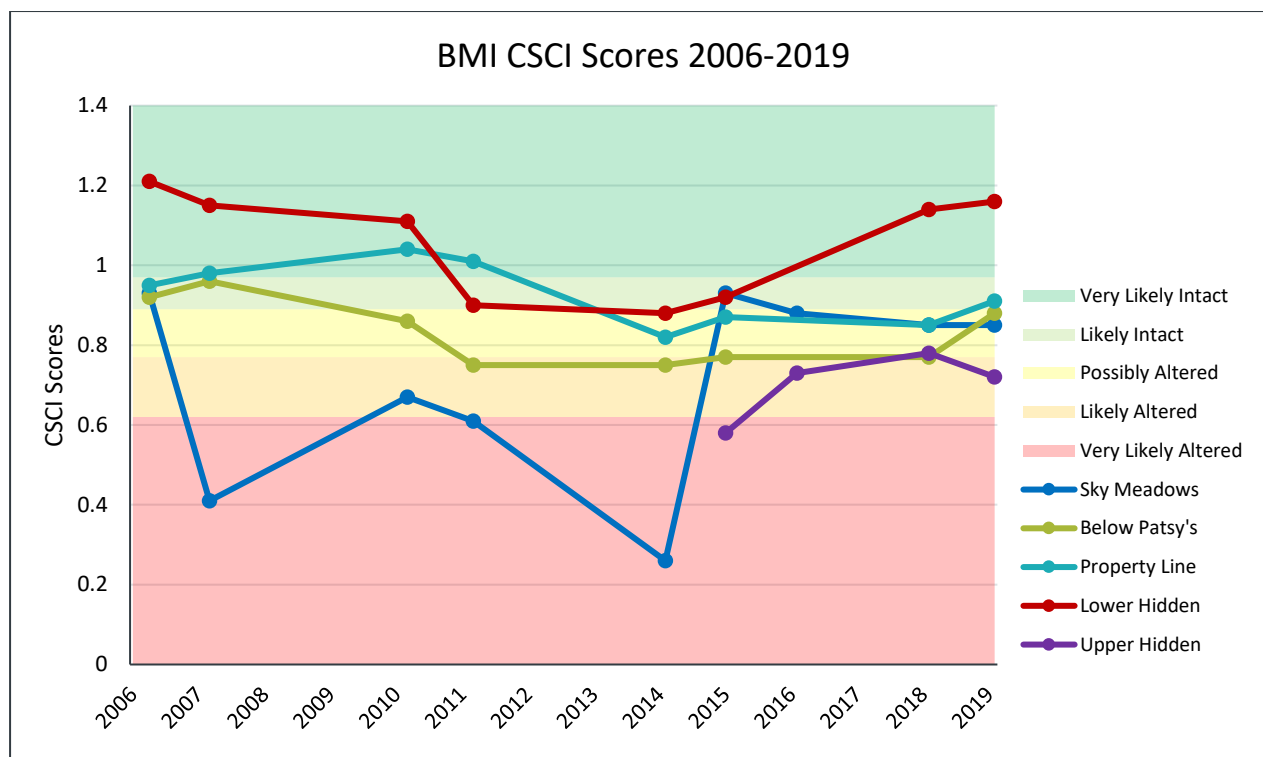
Figure 5-4 BMI CSCI Scores for 2006–2019 by Sampling Site

The 2019 BMI data show an improvement over the 2014 and 2015 data at all sites, with all sites categorized as *fair* or better according to the ESIBI scoring matrix and all sites categorized as *possibly altered* or better, with the exception of the Upper Hidden Valley Creek reference reach site (LHC-2), under the CSCI scoring methodology. The Upper Hidden Valley Creek undisturbed reference site (LHC-2) had the lowest CSCI score in 2019, though the scoring trend for ESIBI at this site is in the positive direction.

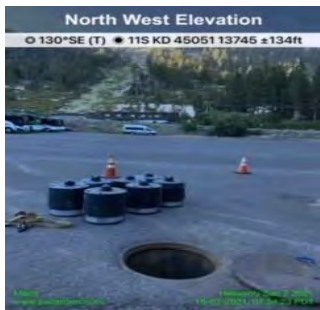
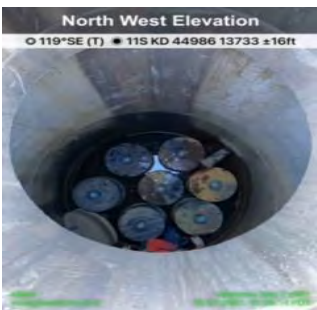
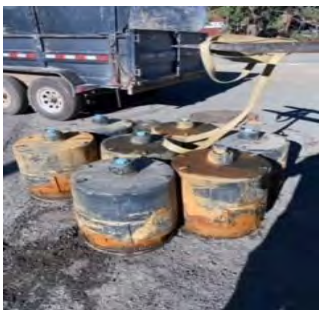
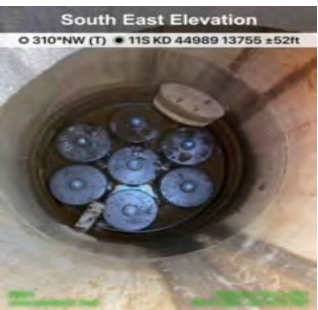
Unit #3

Cartridge bay
Maintenance completed with new filters installed.

New filters installed

Maintenance completed and system is treating runoff as designed. Maintenance included sediment removal and replacement of filters.

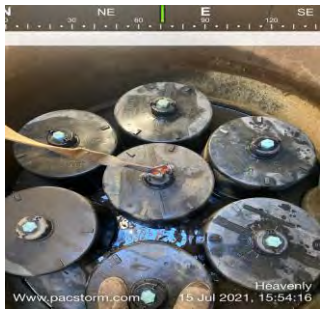
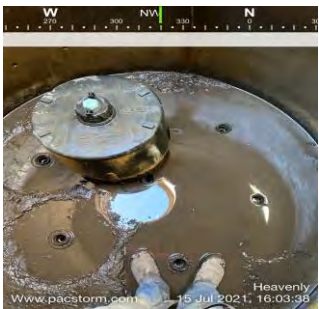
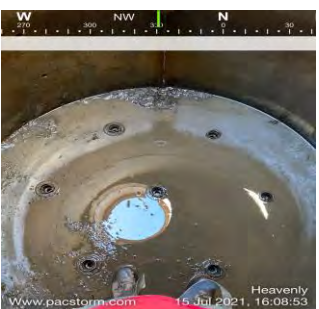
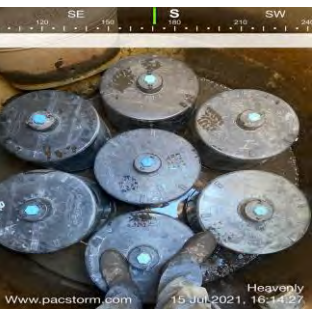
Unit #9

Cartridge bay

New filters installed

Maintenance completed with new filters installed.

Maintenance completed and system is treating runoff as designed. Maintenance included sediment removal and replacement of filters.

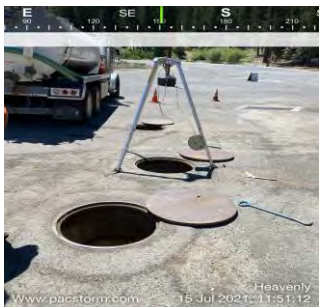
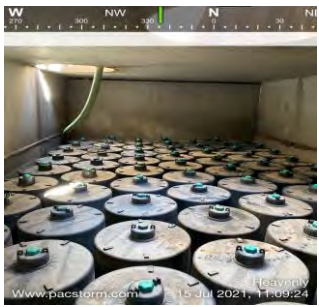
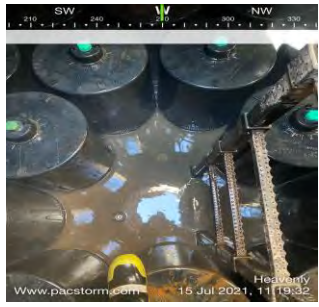
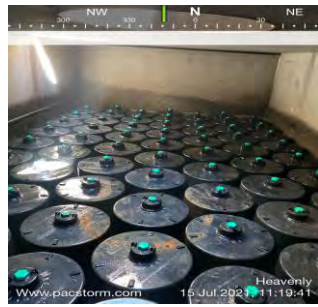
Unit #4

Partial maintenance with sediment removal due to filters are not impacted.

Partial maintenance completed with sediment being removed. No filter replacement done at this time due to media is loose and unimpacted.

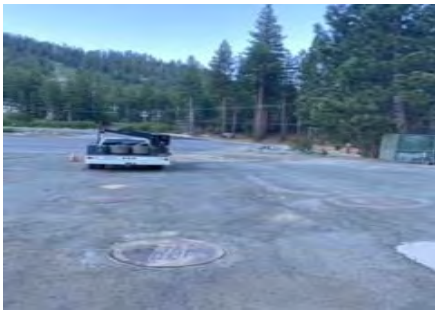
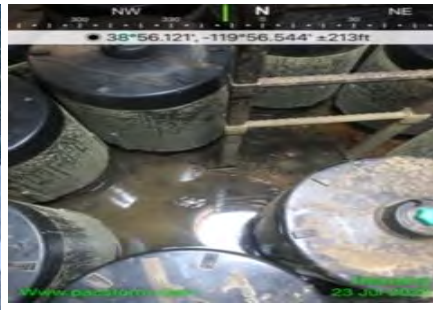
Unit #5

Partial maintenance

No filter replaced

Partial maintenance completed. Sediment removed. Power wash internal components. Filter replacement not recommended due to media is loose and uncompacted. Unit is ready for Winter.

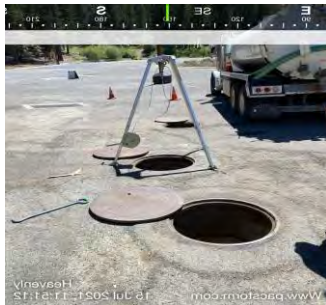
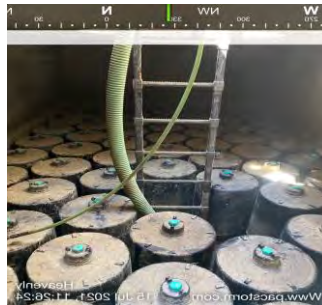
Unit #11

Partial maintenance

No filters replaced

Partial maintenance completed. Sediment removed. Power wash internal components. Filter replacement not recommended due to media is loose and uncompacted. Unit is ready for Winter.

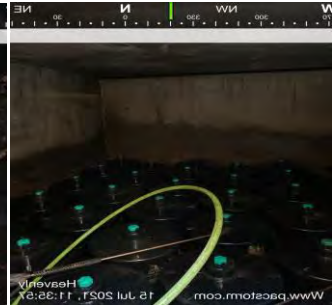
Unit #10

Maintenance was completed with filter replacements. Inlet bay was cleaned.

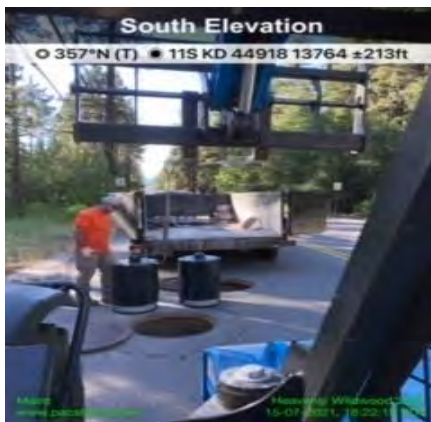
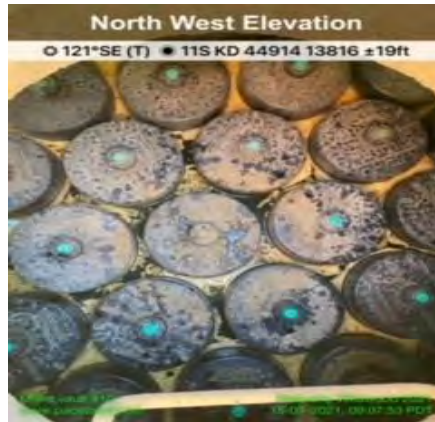
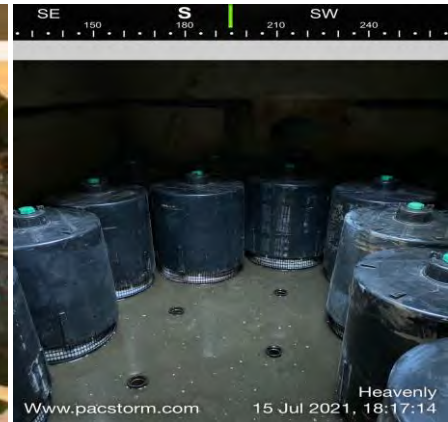
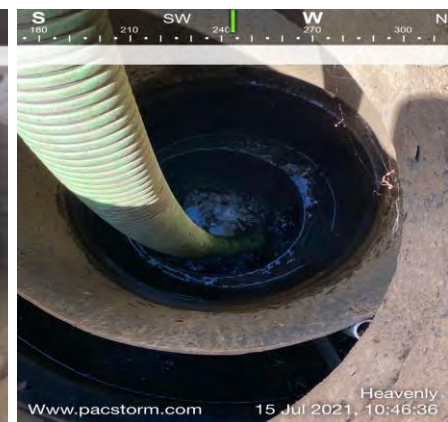
Wildwood unit

Before maintenance

During maintenance

CDS unit had sediment and static water removed.

Maintenance completed and system is treating runoff as designed. Sediment and static water removed from StormFilter and CDS unit. Manufacturer supplied OEM filters replaced at this time.

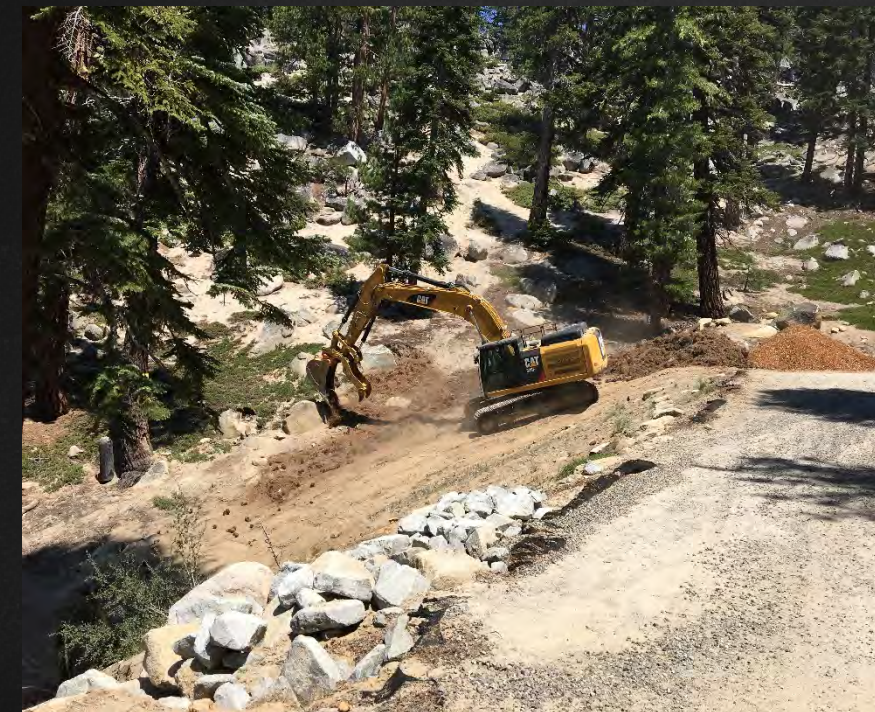
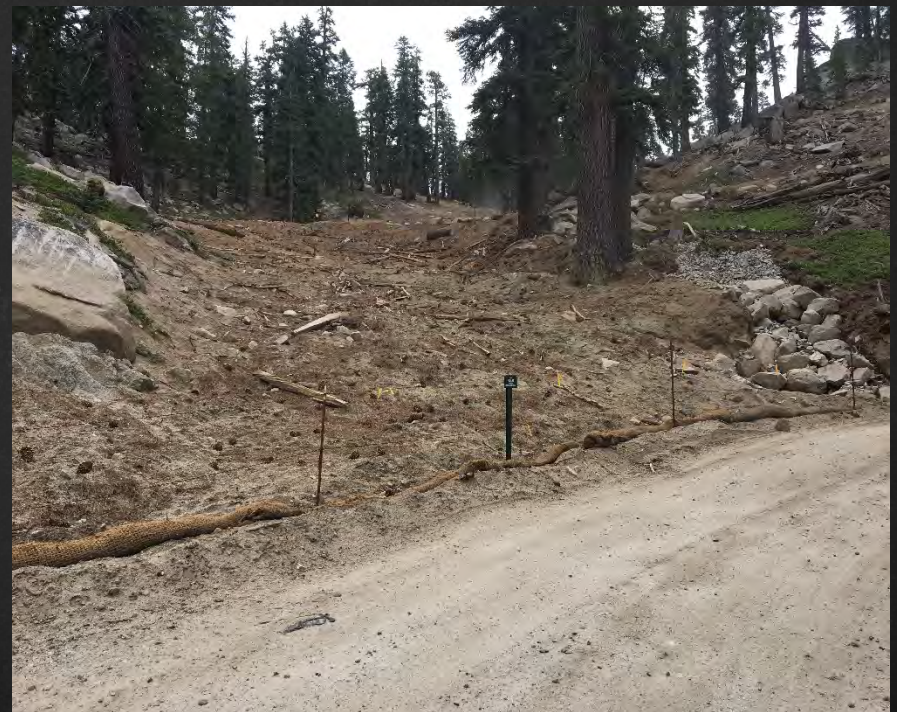
Handgrenade Restoration 2017-

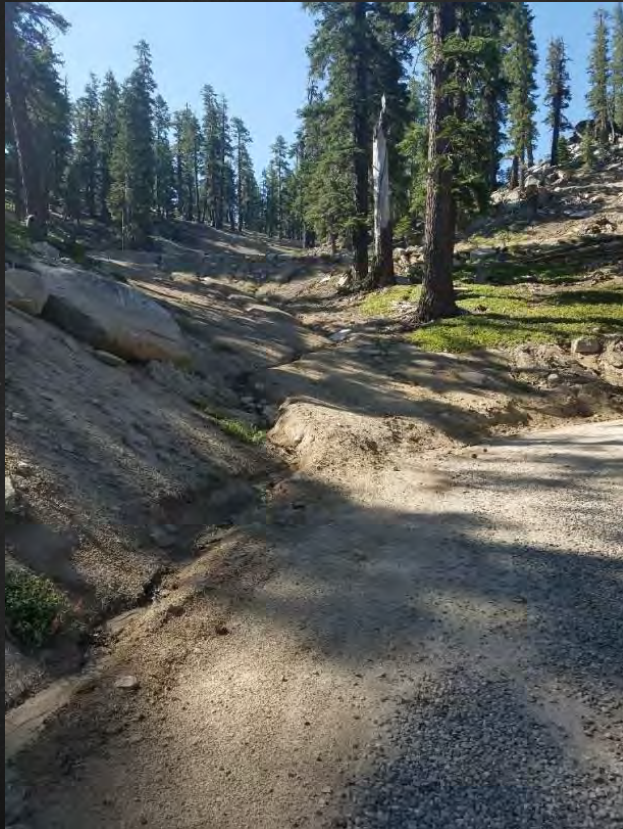
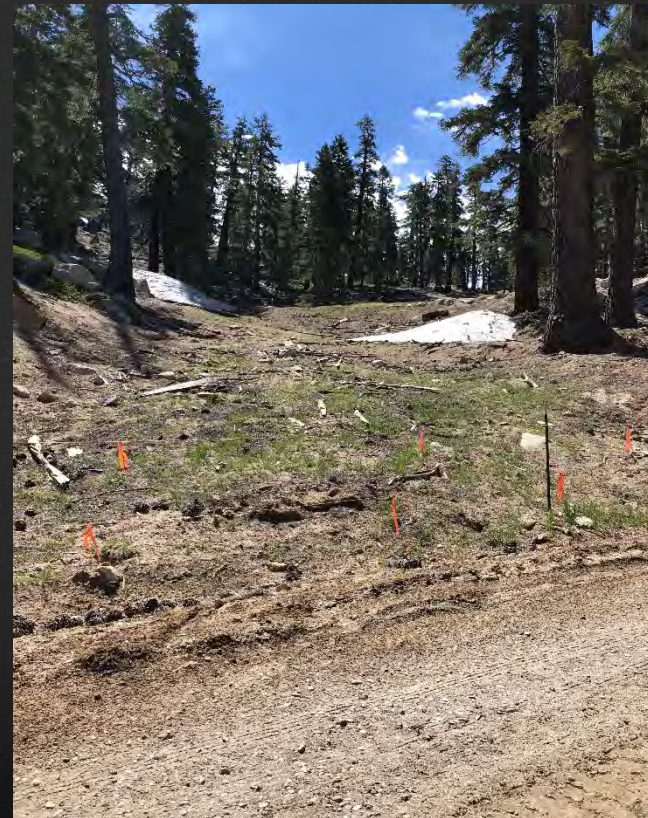
Hand Grenade Restoration 2017 VS. 2019

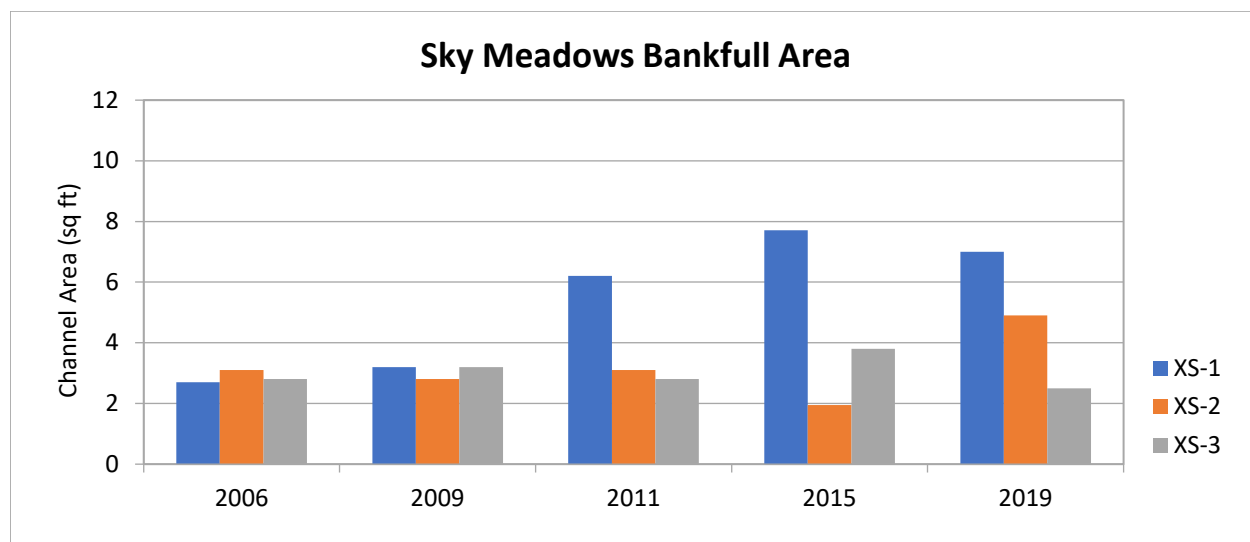
Figure H-1 Bankfull Area – Sky Meadows

The net scour/fill change from 2006 to 2019 (Figure H-2) was small at XS-2 and XS-3; however, both the channel area and net fill/scour at XS-1 has increased over time relative to the 2006 observations. It appears that this section of the reach is both widening and becoming more incised, although incision rates appeared to be stabilizing in 2019. This cross-section is directly above the California Dam snowmaking pond.

Conversely, upstream XS-3 has experienced sediment deposition (or fill) over time. As discussed in Chapter H.1.3, 2019 observations show the channel through the low-gradient meadow appears to be widening, braiding, and experiencing deposition, resulting in a greater bankfull area. This entire reach is within in a meadow, located where the stream slope decreases as it enters the lower gradient meadow, dissipating energy and allowing sediment deposition. The channel exhibits evidence of lateral channel migration, particularly at the upstream section, that is natural for alluvial meadow channels, whereby bank erosion on one side of the channel is offset by sediment fill on the other. At XS-3, the repeat surveys suggest that both lateral migration and some aggradation have occurred. Across the entire reporting period, the channel shifted laterally and bed elevations have shifted slightly, having experienced both scour and fill.

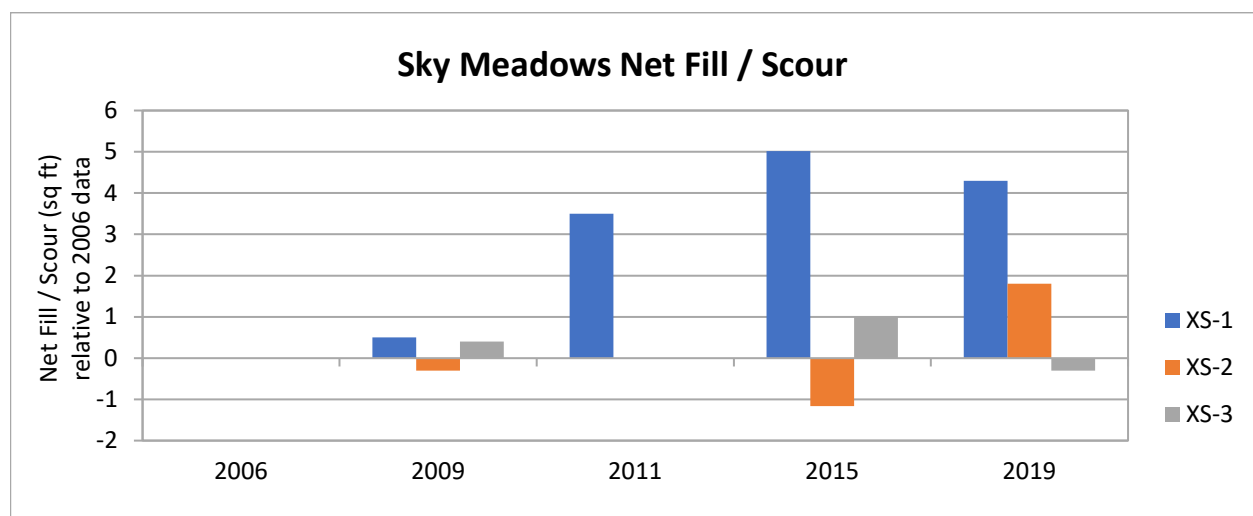
Figure H-2 Net Fill/Scour – Sky Meadows

Note: No change in net fill/scour was observed for XS-2 and XS-3 in 2011, thus reporting of “0” values

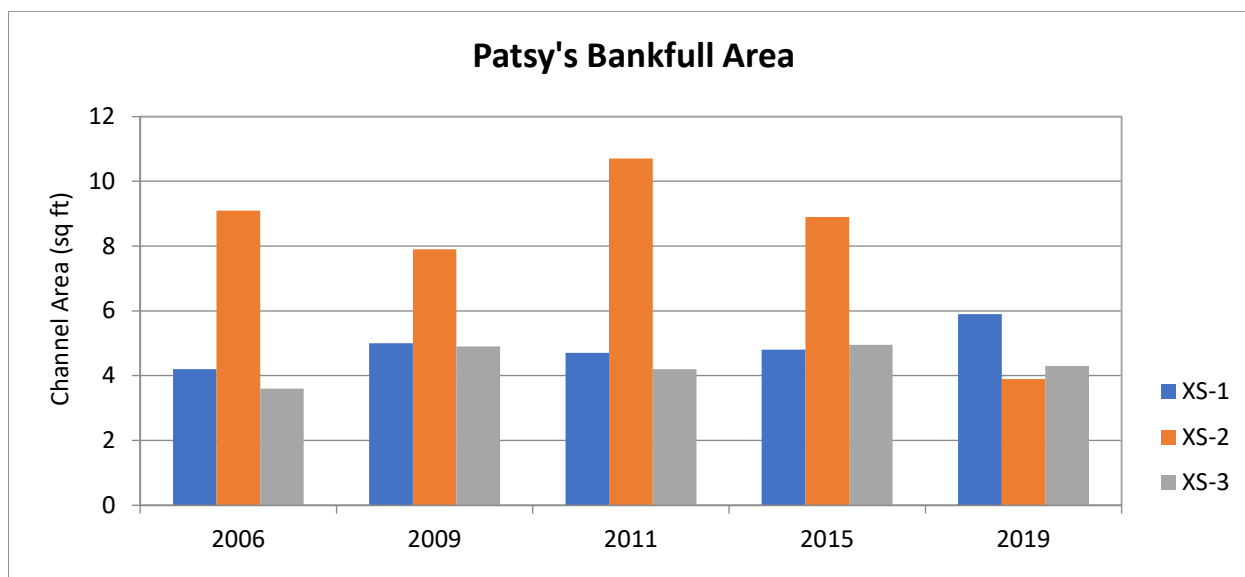
Figure H-3 Bankfull Area – Patsy's

The bankfull area geometry of Patsy’s (HVC-2) XS-1 and XS-3 have remained very similar between 2006 and 2019 (Figure H-3). XS-2 shifted dramatically in 2019, having experienced substantial deposition (Figure H-4), bringing it more line with the bankfull sizes of XS-1 and XS-3. The natural alignment and size of XS-2 may have been suitable for the deposition of material that was moved downstream.

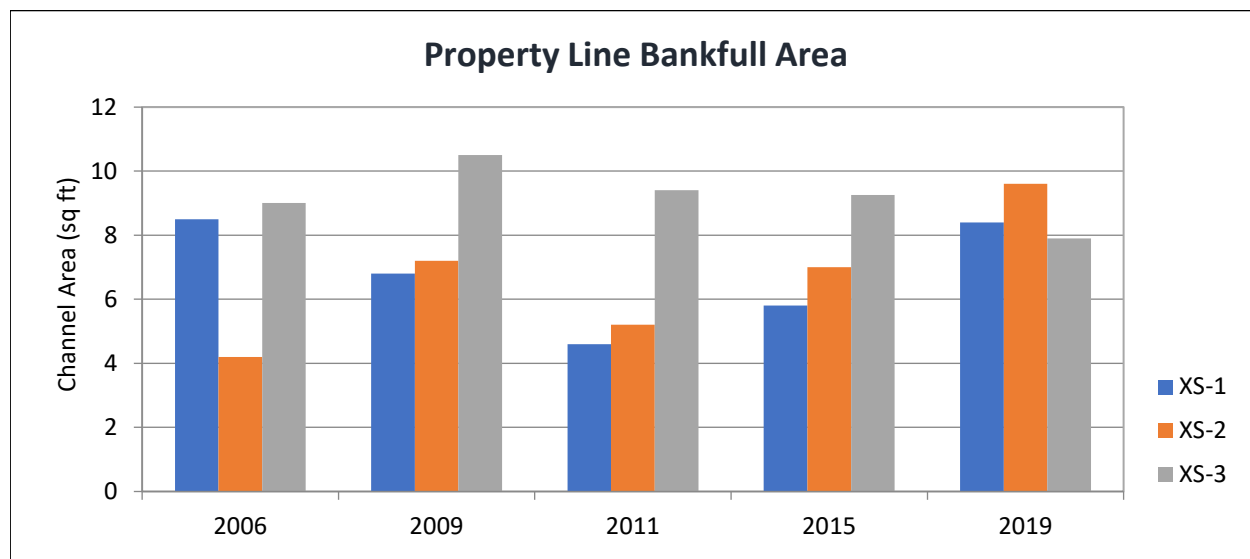
Figure H-5 Bankfull Area – Property Line

The bankfull area geometry of Property Line (HVC-3) XS-1 and XS-3 has remained consistent over time (Figure H-5) compared to 2006 data. XS-2 has experienced scour over the reporting period, particularly between 2015 and 2019 (Figure H-6). Little to no scour has occurred at XS-3 over the period of record. Fill and scour values in 2015 and 2009 at XS-1 and XS-3 are similar, suggesting a potential link in these values during low-flow water conditions (drought).
