Re: Heavenly Mountain Resort 2017 through 2021 Environmental Monitoring Program Five Year Comprehensive Report

Date: January 18, 2022

Facility Name: Heavenly Mountain Resort

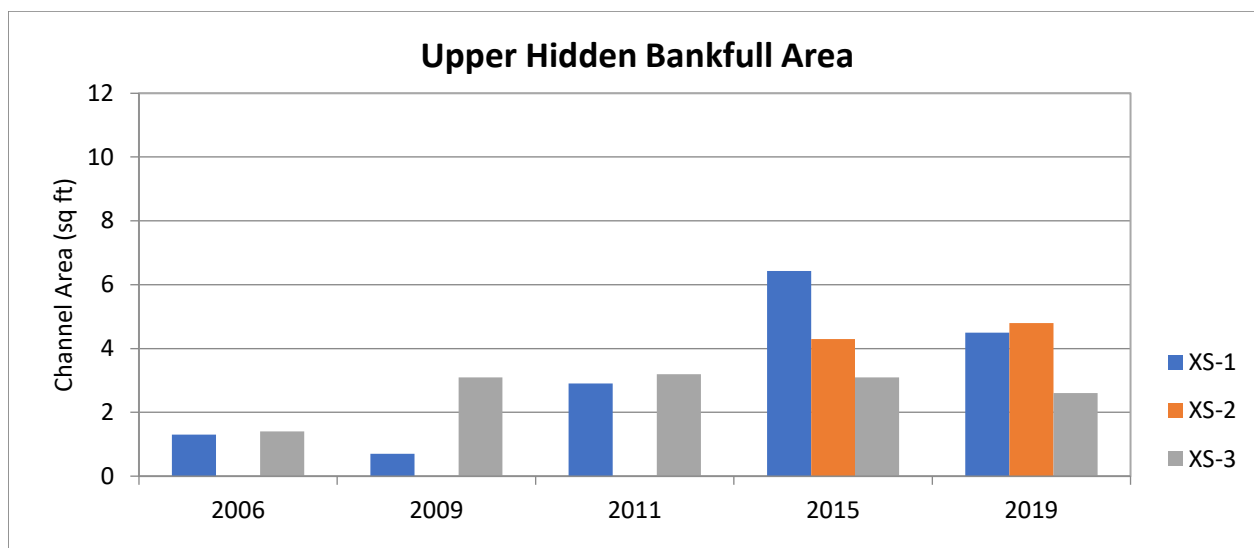
Figure H-7 Bankfull Area – Upper Hidden Valley Creek

The Upper Hidden Valley Creek reference reach (HDVC-1) cross-sections showed some variability and have typically exhibited scour, but only XS-1 and XS-3 have been located reliably in the past. Data from XS-2 are only available for 2015 and 2019. The bankfull area at all cross-sections at Upper Hidden Valley Creek is very small but increased over time at XS-1 and XS-2 (Figure H-7). The net scour/fill changes indicate that scour at all cross-sections has occurred, even though the absolute magnitude has been small (Figure H-8). XS-1 has demonstrated the most variability.

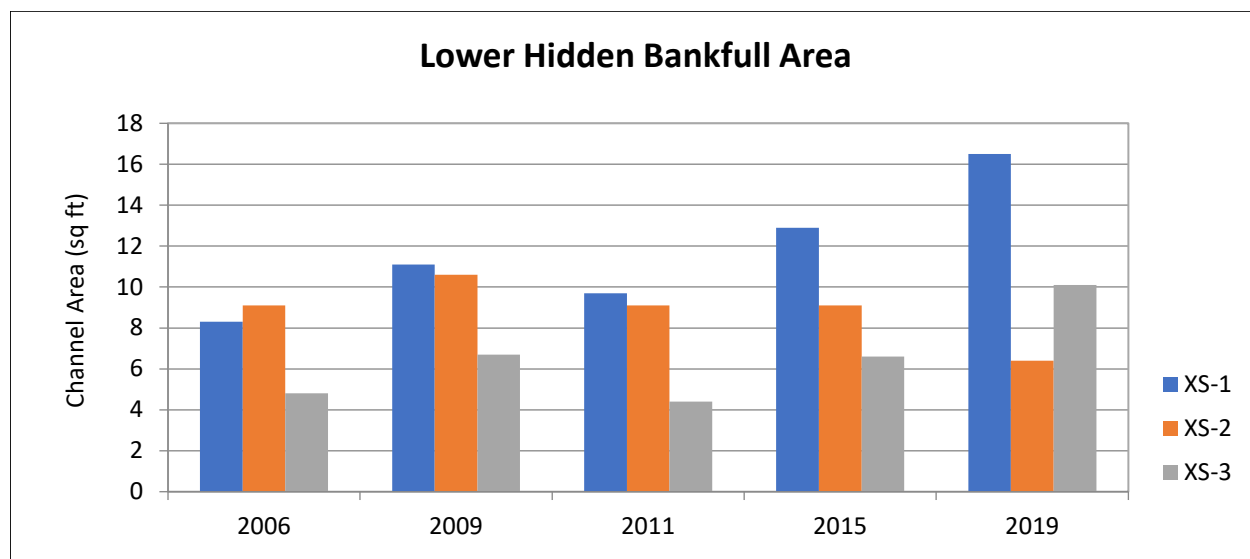
Figure H-9 Bankfull Area – Lower Hidden Valley Creek

The Lower Hidden Valley Creek reference reach (HDVC-2) cross-sections have some differences across cross-sections, since XS-1 and XS-2 are larger than XS-3. However, all three exhibited similar changes in channel area over time, with the exception of changes in 2019 (Figure H-9). The net scour/fill changes indicate that scour was dominant relative to 2006, except at XS-2, which experienced scour in 2009, followed by deposition in 2019. Scour at XS-1 and XS-3 has increased over time (Figure H-10).

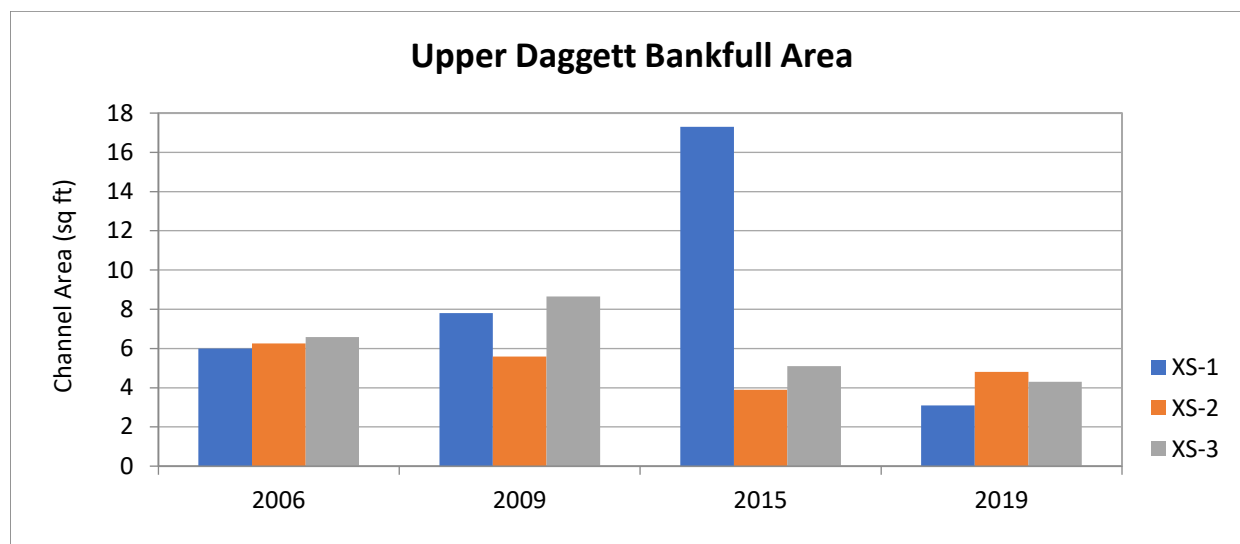
Figure H-13 Bankfull Area – Upper Daggett

The channel cross-section geometry of Upper Daggett (DC-1) saw an increase in area at XS-1 in 2015 due to channel widening, with a slight decrease in bankfull channel area at XS-2 and XS-3 (Figure H-13); however, XS-1 stabilized to pre-2015 conditions in 2019, and XS-2 and XS-3 remained consistent. The 2015 net scour/fill compared to the 2006 area increased substantially at XS-1, but deposition was observed at all three cross-sections in 2019 (Figure H-14). Emergency repairs of East Peak Dam in early summer 2015 created uncontrolled runoff, which may have altered flows into Daggett Creek (increased volume, velocity, and scour), potentially accounting for cross-sectional changes seen during surveys later in 2015.

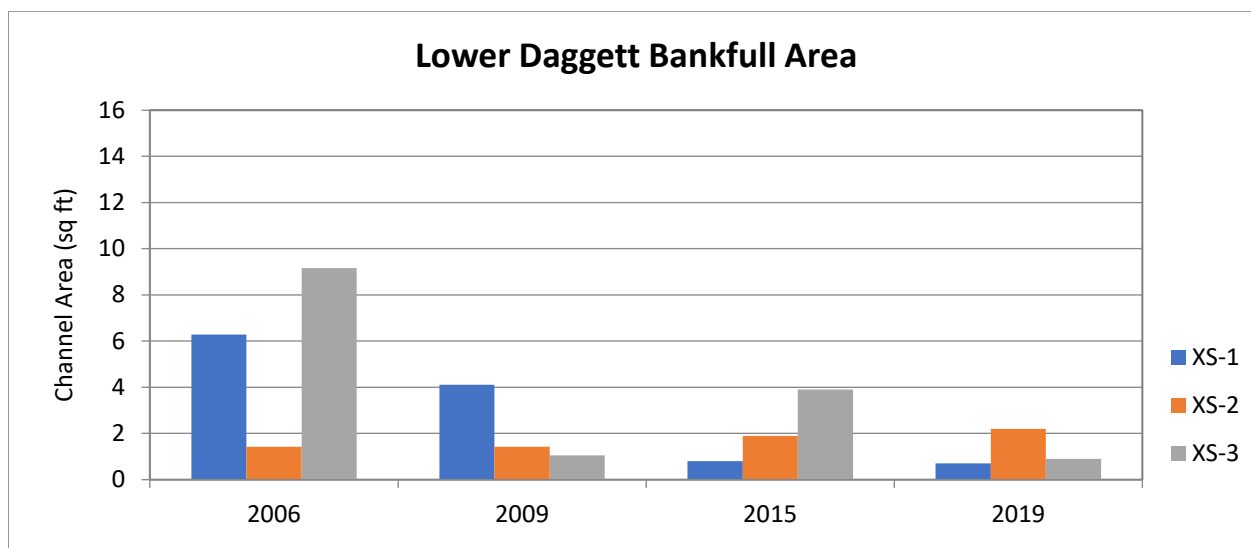
Figure H-15 Bankfull Area – Lower Daggett

The channel cross-section geometry at Lower Daggett Creek (DC-2) varies by cross-section following 2006 for XS-1 and XS-3 (Figure H-15). The bankfull channel area at XS-2 is very small, and has remained fairly consistent over the monitoring period. XS-3 and XS-1 channel area was relatively large in 2006, and both have experienced substantial deposition (Figure H-16) and both channel areas have drastically reduced in size. However, depositional rates appear to have tapered off and stabilized over time.

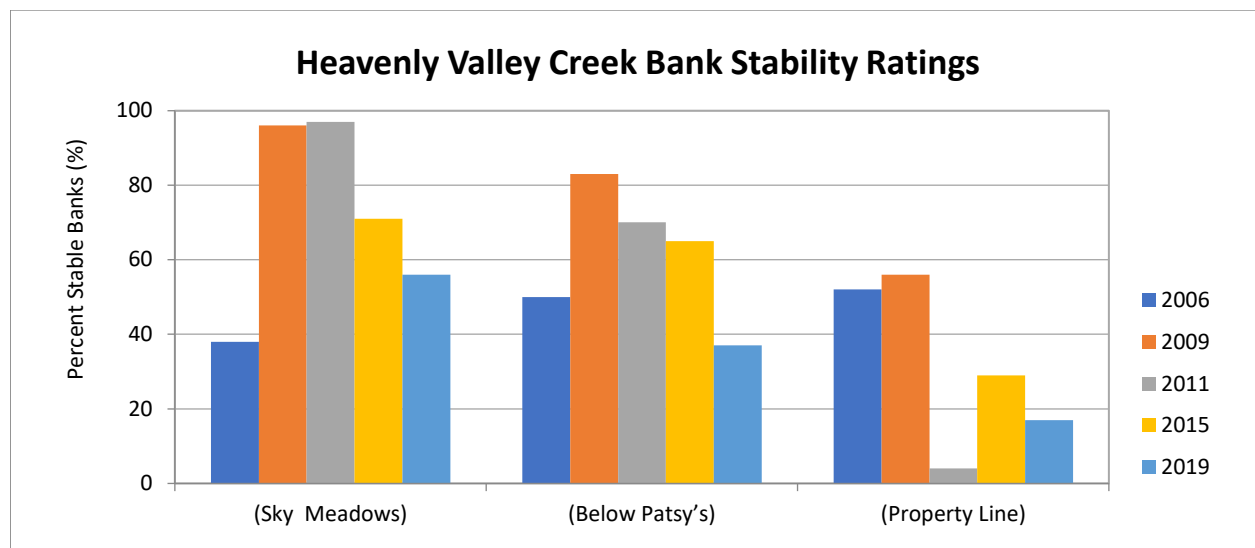
Figure H-17 Bank Stability – Heavenly Valley Creek

The Sky Meadows reach exhibits the most stable streambank measurements over the monitoring period, with the average percentage of stability at 72 percent. The stability at Sky Meadows is likely associated with the high vegetation cover (primarily graminoids) present in the meadow complex. The Patsy's reach stability average over the monitoring period is 61 percent, while the Property Line reach stability average over the same time frame is 32 percent. The reason for the decline in stability at the Property Line reach in 2011 is uncertain, although it may be due to variability in surveyors across the years. It is possible that differences in LWD (LWD observed in 2011 was 50 percent of that observed in 2009) and/or rock material along the banks and/or aggradation changes occurred during higher flows in 2011. Stability at the Property Line reach increased in 2015, but the reach experienced a slight decline again in 2019. Drought conditions from 2012 to 2015 likely account for the decreased stability and vegetation cover at both the Sky Meadows and Patsy's reaches; however, stability at these reaches continued to decline through 2019, despite above-average or average precipitation conditions preceding 2019. Stability at the Property Line reach increased in 2015, but experienced a slight decline again in 2019.

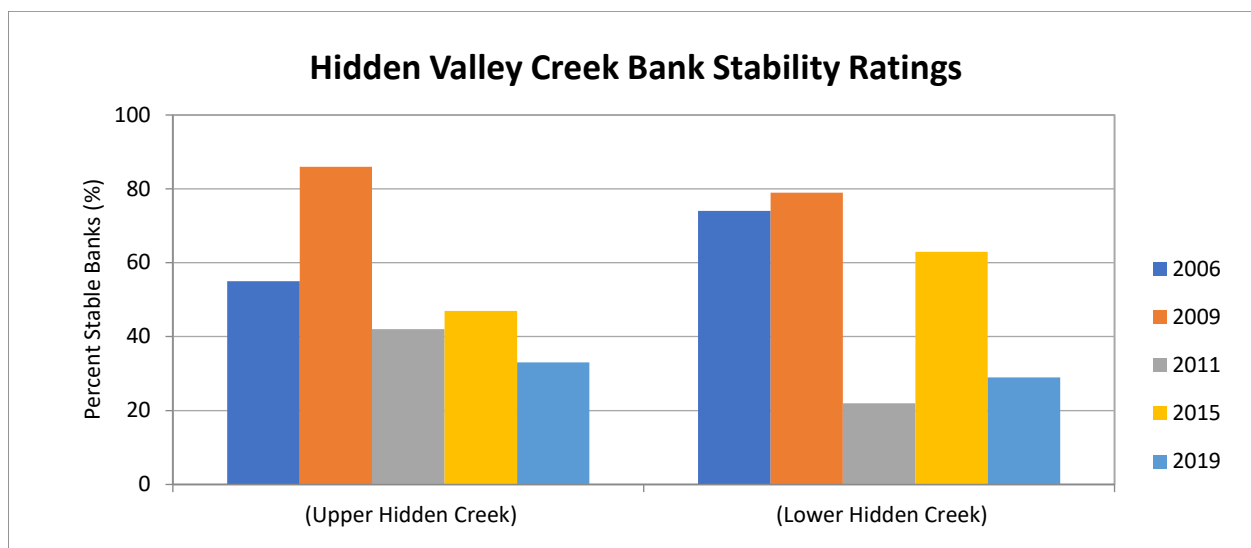
Figure H-18 Bank Stability – Hidden Valley Creek

The percent of stable banks along Hidden Valley Creek varied over time at the two reaches (Figure H-18), but similar to Heavenly Valley Creek, all stability ratings were the highest in 2009 (86 percent at Upper Hidden Valley Creek and 79 percent at Lower Hidden Valley Creek). The Lower Hidden Valley Creek reference reach displays a similar pattern to the Property Line reach, with a decline of stability in 2011, followed by subsequent increases in 2015. Stability increased at both reference reach locations in 2015; however, the increase did not meet or exceed the 2006 observations. Stability at both reaches also experienced a decline in 2019.

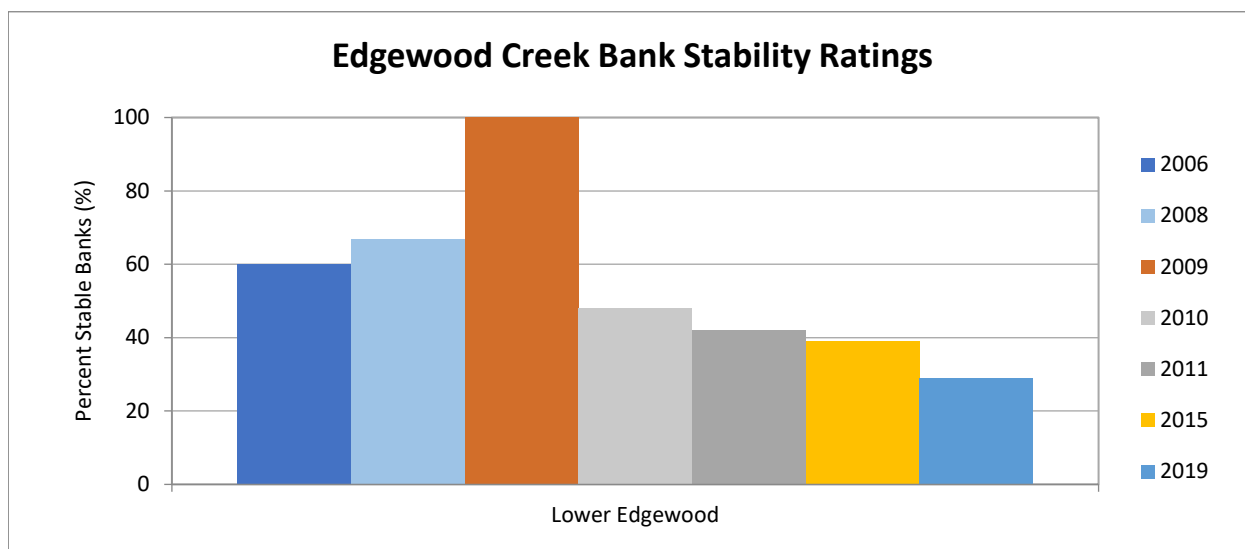
Figure H-19 Bank Stability – Lower Edgewood Creek

The percent of stable banks along Lower Edgewood Creek varied over time and has steadily decreased since its peak in 2009 (Figure H-19). The Lower Edgewood stability chart correlates with the Patsy’s reach along Heavenly Valley Creek, which showed an initial improvement in stability in 2009, followed by a slow decline. Stability measurements were not collected along Upper Edgewood Creek, with the exception of 2015. Should future measurements be collected at Upper Edgewood Creek, 2015 will be used as the baseline for comparison.

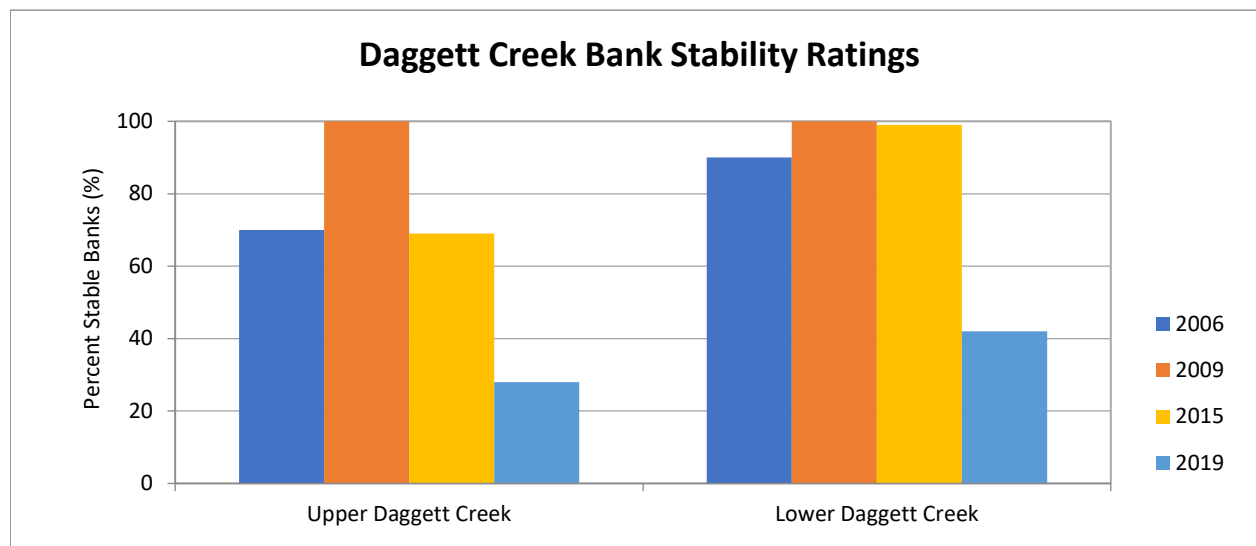
Figure H-20 Bank Stability – Daggett Creek

The percent of stable banks along Upper Daggett Creek (Figure H-20) displayed the same pattern of increased stability between 2006 and 2009 and decreased stability in 2015. Bank stability observations further declined (by over 50 percent) in 2019.
